ARCHAEOLOGICAL MONITORING OF THE  
SAN JOSE ACEQUIA (41 BX 267),  
WASTEWATER FACILITIES IMPROVEMENTS PROGRAM,  
SAN ANTONIO, TEXAS

Center for Archaeological Research  
The University of Texas at San Antonio  
Archaeological Survey Report, No. 175

1988

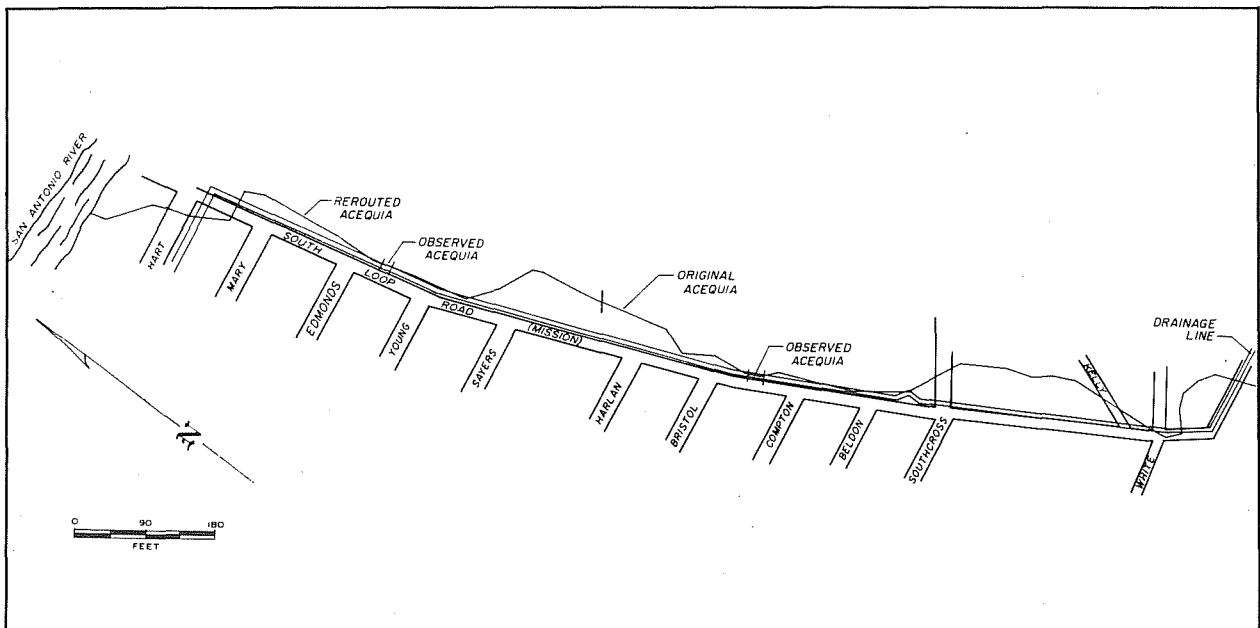
Figure 1. Original, Rerouted, and Observed San José Acequia.

In 1894, the acequia was reopened under the Texas Water Act of 1889 by landowners along its course. However, the dam was relocated farther south on the San Antonio River, near the present Mission Road bridge, and the channel rejoined the old acequia to the south (Brook 1904; Fig. 1). At that time it was described as being "four feet deep and 12 feet wide and the carrying capacity thereof shall be 100 cubic feet per second" (Water Board Records Vol. 1 August 10, 1894:4).

Wayne Cox, Center research associate, met with Dwayne Opella, Phil Handley, and Larry Rein, representatives from the PD VA Group. The areas of sensitivity were reviewed, and a copy of the Center's working map was made for field use. The PD VA Group personnel agreed to notify the Center representative when a sensitive area would be reached (estimated within two weeks), and they understood that the Center archaeologist would remain on call prior to that time. Active field monitoring began as construction approached the area of Mission Road and White Street and continued to Hart Avenue when the route turned westward away from the sensitive area (Fig. 1).

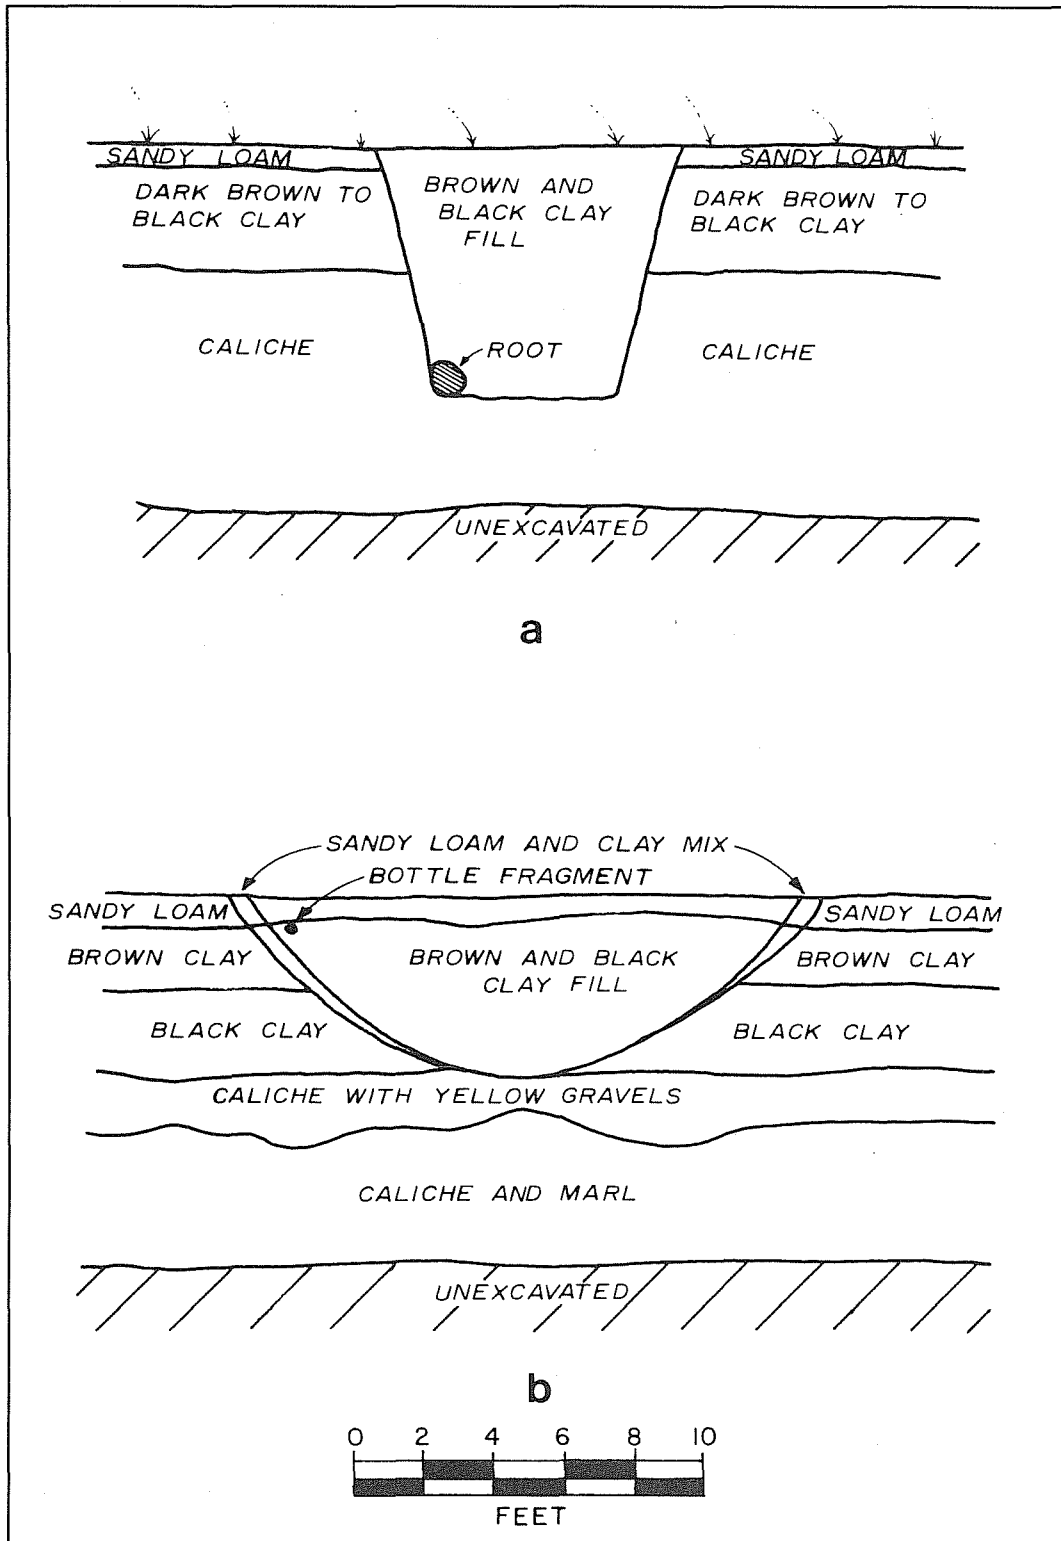
Figure 2. Profiles Observed During Field Work. a, machine excavation at East Huff Avenue; b, acequia profile at Compton Street.

The contractor notified the Center on October 23, 1986, that a feature had been revealed in a trench on Mission Road just to the east of the intersection of East Huff Avenue. A large, deep cut at roughly a right angle to the roadway had been revealed, but it was a recent excavation, not the acequia (Fig. 2,a). The cut was approximately 10 feet wide and eight feet deep. The sides were extremely sharp and cut into the underlying caliche base approximately two feet. The trench showed no sign of weathering and had marks of modern machine excavation techniques across an extremely flat bottom. Richard Garay (personal communication) has documented evidence that a western branch of the acequia was constructed in this area, but the trench revealed none of the classic characteristics of an acequia.

On December 1, the excavations had progressed beyond Southcross Street, and the acequia was exposed at a point 50 feet to the north of the intersection of Compton Street and Mission Road (Fig. 2,b). The acequia at that point was 18 feet wide and six feet deep, the width was so great primarily because the ditch had been cut on a slight angle. Photographs were taken and a search made for artifacts. An unbroken glass gallon jug with handle and screw top and one small fragment of a root beer bottle with a three color silk-screened label were recovered. Since the acequia was in use well into this century, the recent age of the artifacts was to be expected.
