## 10th Street Substation Excavation of the Acequia Madre (41BX8), San Antonio, Bexar County, Texas

10TH STREET SUBSTATION EXCAVATION OF THE  
ACEQUIA MADRE (41 BX 8), SAN ANTONIO, BEXAR COUNTY, TEXAS

Center for Archaeological Research  
The University of Texas at San Antonio®  
Archaeological Survey Report, No. 153

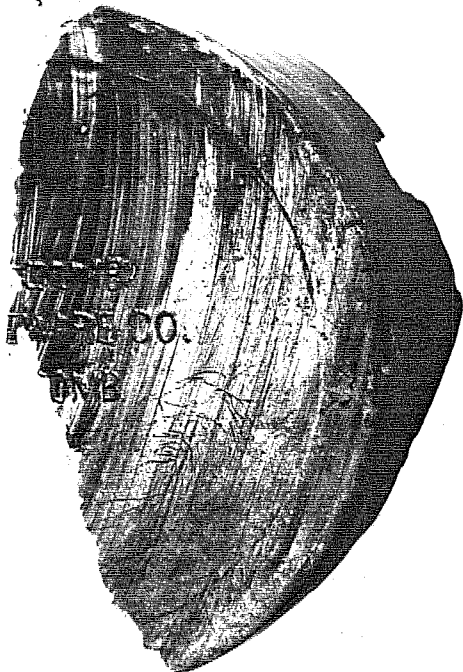
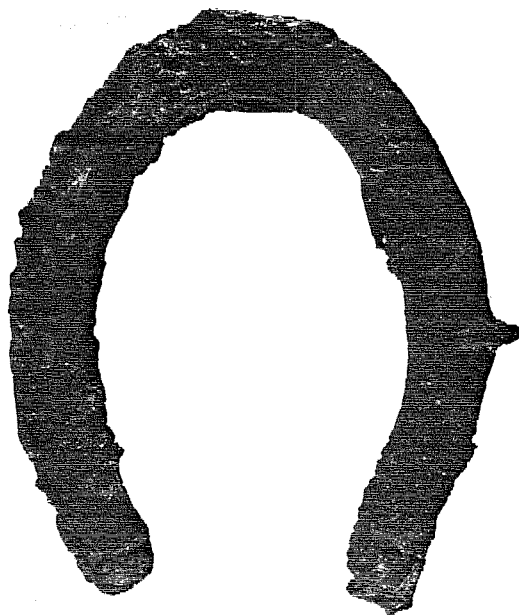
**Figure 3. Selected Ceramic and Metal Artifacts  
from the Acequia Madre at the 10th Street  
Substation.**

- a, decal-decorated porcelain plate;
- b,c, fragments of gold-decorated ironstone pitcher;
- d, luster decoration on porcelain;
- e, stoneware crock fragment;
- f, stoneware ink bottle fragment;
- g, oil can;
- h, horseshoe.

- 29 fragments of undecorated whiteware.
- 4 fragments of porcelain.
- 7 fragments of gold-decorated ironstone pitcher (Fig. 3,b,c).
- 1 fragment of a transfer print plate or saucer.
- 1 fragment of hand-painted porcelain.
- 1 fragment of a decal-decorated porcelain plate (Fig. 3,a).
- 1 fragment of luster decoration on porcelain (Fig. 3,d).
- 1 fragment of yellow ware with Rockingham glaze.
- 2 stoneware crock fragments, one a base fragment with the following:  
" . . . comb/. . . ware Co./. . . comb" (McComb Stoneware Co.,  
McComb Illinois; Fig. 3,e).
- 2 stoneware ink bottle fragments, one with "Vitreous Stone Bottles/J.  
Bourne & Son/Patentees/Denby Pottery/near Derby/P & J Arnold/  
London/England" (Fig. 3,f).
- 5 porcelain electrical insulators.
- 1 porcelain and brass electric lamp base for screw-in bulb.

- 1 top of fire hydrant.
- 1 oil can (Fig. 3,g).
- 3 spikes.
- 1 bolt.

- 5 pieces of wire.
- 1 brass gas connection.
- 1 horseshoe (Fig. 3,h).
- 1 iron pipe section, possibly holder for carbon rod.
- 5 pieces unidentified metal scrap.

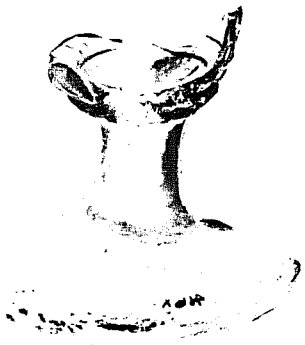
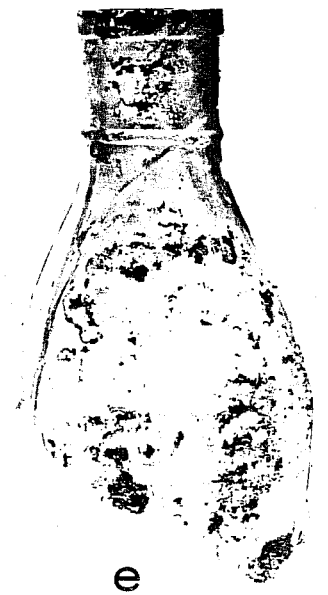
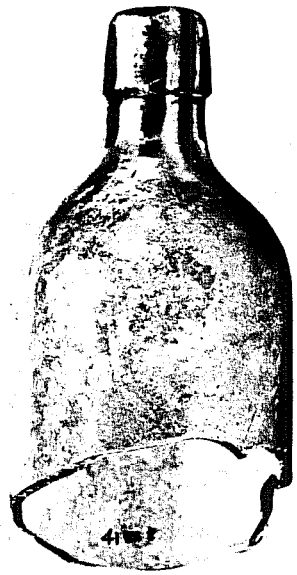
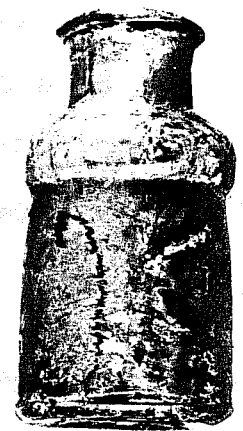
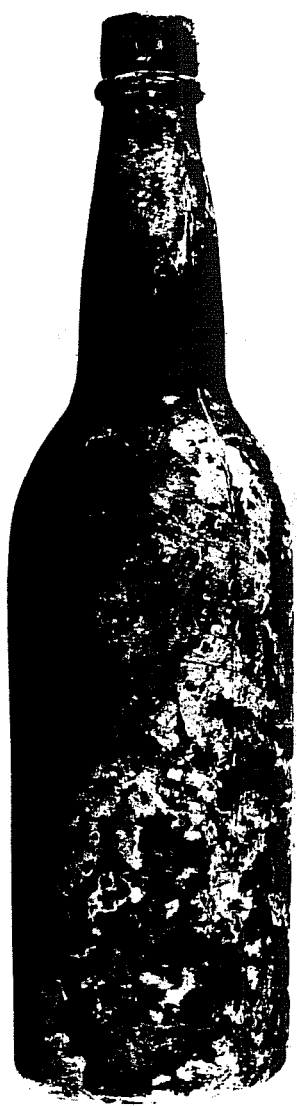
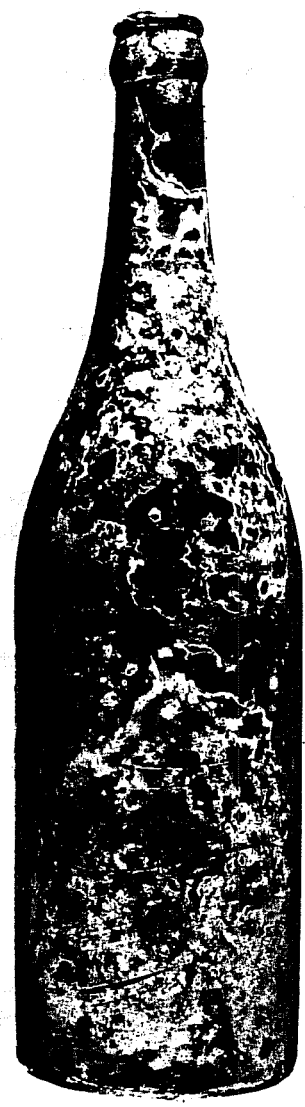
**Figure 4. Selected Glass Artifacts from the Acequia Madre at the 10th Street Substation.**

- a, goblet base;
- b, telephone pole insulator;
- c,d, molded bottles;
- e, clear bottle;
- f, short neck bottle with molded lip;
- g, condiment bottle;
- h, long neck bottle, produced in two-piece mold;
- i, long neck bottle, produced in turn mold;
- j, clear milk or cream bottle;
- k, brown square bottle with screw cap.

- 1 entire clear taper-sided condiment bottle 5-3/8 inches high  
(Fig. 4,g).
- 1 entire extruding shoulder clear bottle with sides tapering to square  
base 3-3/4 inches high (Fig. 4,e).

- 1 entire clear milk or cream bottle, square with truncated corners  
6-3/4 inches high (probably post 1880s; Fig. 4,j).
- 1 brown-shouldered long neck bottle produced in two-piece mold, seam  
extends only to base of lip, 11-1/2 inches high, bottom marked "C M  
Co./F 28" (probably 1880-1900; Fig. 4,h).

- 1 entire brown-shouldered long neck bottle, machine made in turn mold  
with crown cap, 11-1/2 inches high (probably 1892-1900; Fig. 4,i).
- 1 broken aqua-shouldered short neck bottle with molded lip, produced in  
two-piece mold (probably 1880-1900; Fig. 4,f).

- 1 brown square bottle with screw cap, 4-1/2 inches high, marked  
"P M/F S Co." on bottom (Fig. 4,k).
- 1 fragment round cobalt blue bottle.
- 1 fragment square aqua bottle produced in two-piece mold.

- 2 neck fragments of small molded bottles, 1 clear, 1 aqua (Fig. 4,c,d).
- 1 fragment ointment jar.
- 2 fragments lamp chimney.
- 2 fragments of pressed glass tumbler.

- 2 goblet base fragments, clear (Fig. 4,a).
- 1 fragment aqua telephone pole insulator (Fig. 4,b).
