ARCHAEOLOGICAL INVESTIGATIONS AT THE UNITED STATES ARSENAL SITE (41 BX 622), SAN ANTONIO, TEXAS

Center for Archaeological Research
The University of Texas at San Antonio
Archaeological Survey Report, No. 137

Test excavations were carried out at two locations on the grounds of the old U.S. Arsenal in downtown San Antonio, Texas, in December 1983. Backhoe trenching at the north end of the site revealed no indication of the location of an acequia lateral suspected to run through the area. Test excavations at the south end of the stone stable building found no indication of the location of a stairway which is presumed to have led to a second story doorway in the wall of the building. Historical research resulted in production of a history of the Arsenal from the time of its founding to the present.

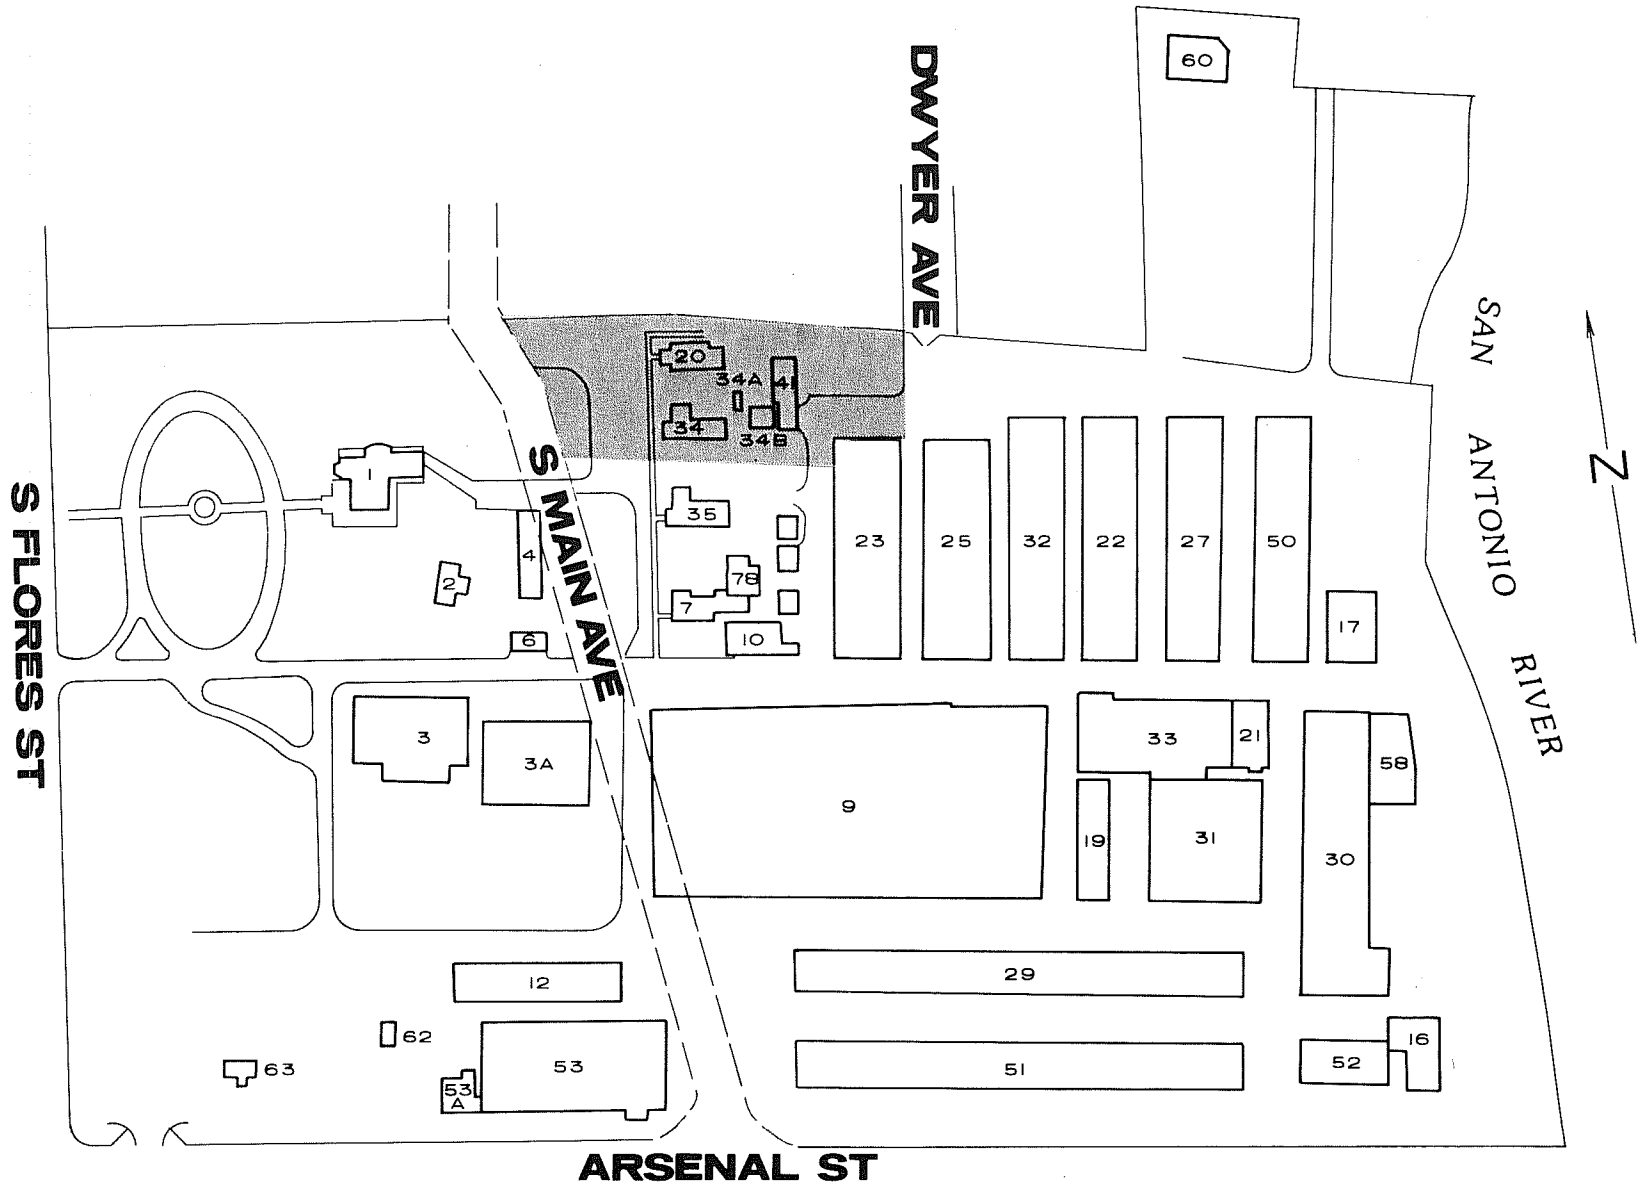
Figure 1. **Arsenal Site Plan.** Basic data and building identifications from 1946 road map (San Antonio Arsenal, Office of the Post Engineer 1946); location of South Main Avenue from 1961 site plan (General Services Administration 1961). The area investigated by trenching is indicated by darkened area.

In mid-February, the Center was requested to do additional testing at the south end of the old stone stable building (No. 21 in Fig. 1). It was hoped to determine if any indication remained of the location of an outside stairway providing access to the loft above the stable. A test pit measuring ca. 1-1/2 m x 3 m was excavated. The first level consisted of ca. 15 cm of gravel fill. A 1-m² concrete slab was found at the west end of the unit at this level, and a pipe trench at the opposite end. Excavation continued through several alternating layers of brown soil and gravel fill until a hard, cobble layer set into caliche at ca. 30 cm below the original ground surface was encountered in the area. No postholes or other traces of support for a stairway were found within this area. A profile of the south wall of this test unit is on file at the Center for Archaeological Research.

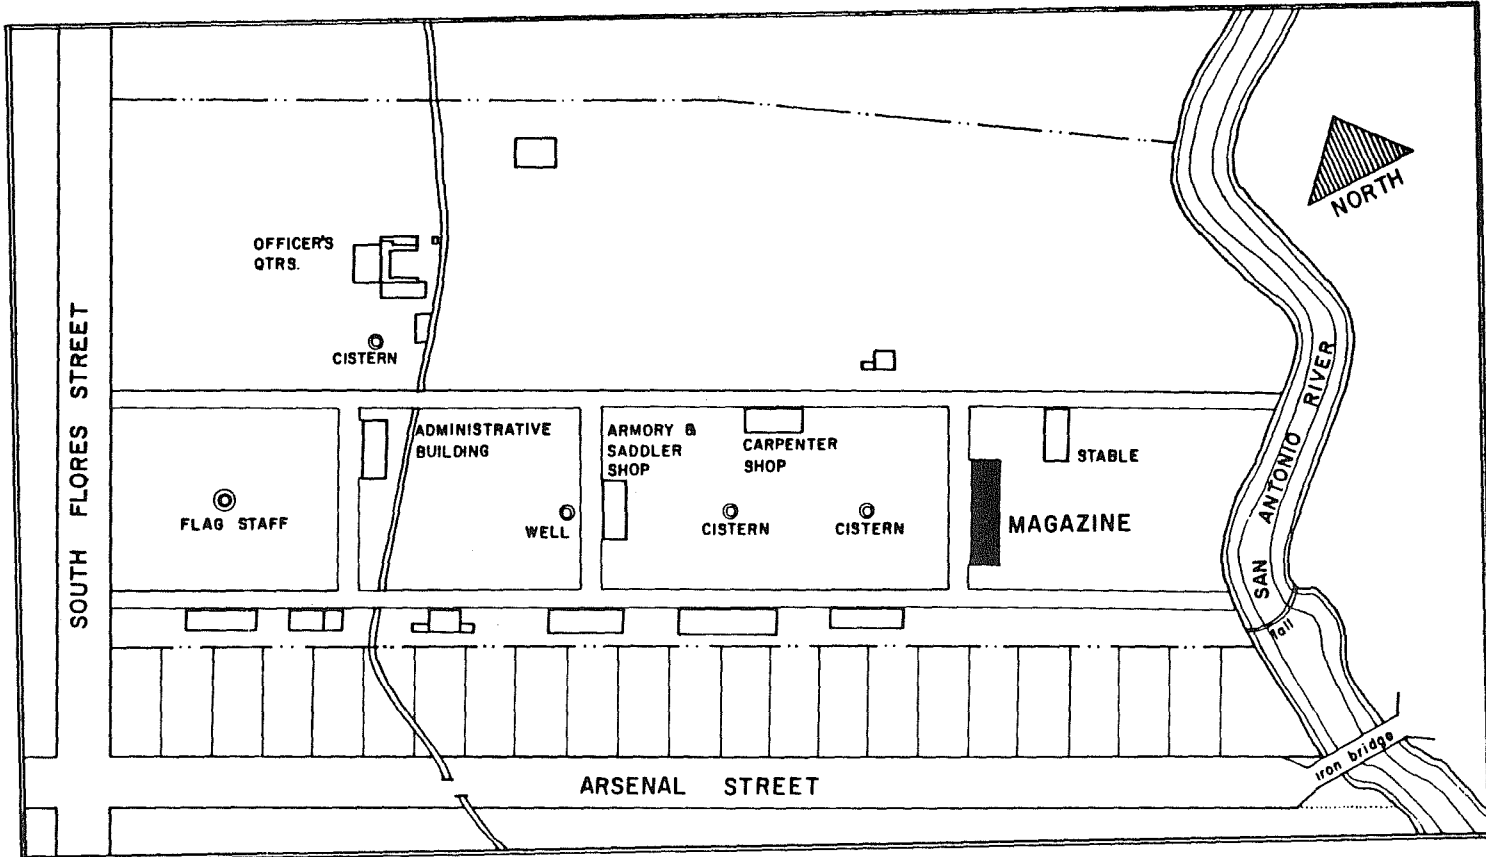
Figure 2. Map of Arsenal in 1877.

MAP DATED 1877
 HOUSE EXEC. DOC. 48,
 42nd CONG., 3rd SESSION,
 SERIAL 1565, VOL. 7

In 1877, the Arsenal consisted of five permanent stone buildings, a row of frame buildings along the southern edge of the property, and the frame carpenter shop (Fig. 2). The Army had been trying to get permission to buy a narrow strip of land between the south boundary line of the Arsenal and Arsenal Street since 1872 (Belknap 1872). The property was finally purchased from the family of Toutant Beauregard in 1881 (Russell 1881).

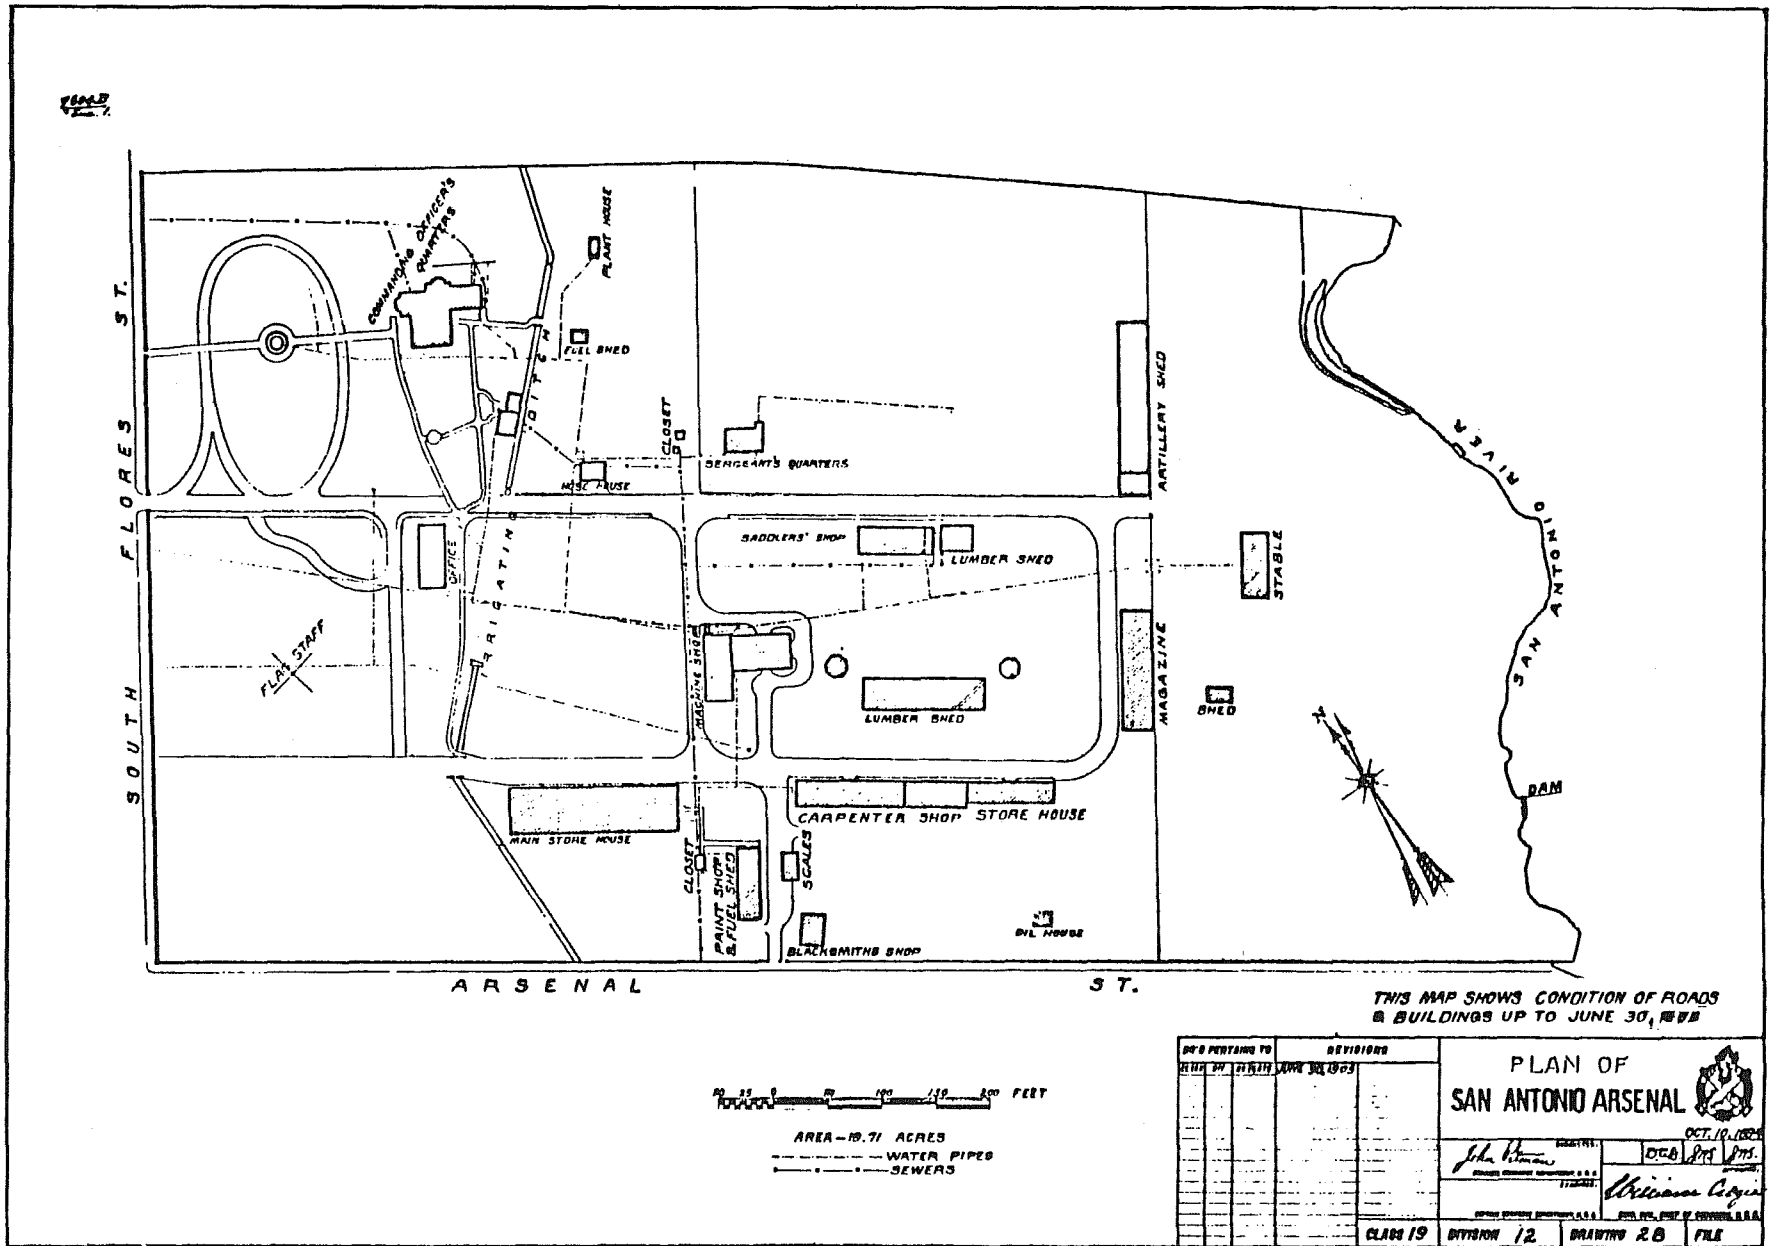
Figure 3. Plan of Arsenal from 1894-1905. From Department of the Army, Corps of Engineers (1905).

A stone storehouse was erected south of the administration building in 1883 (Fig. 3). This was the first permanent storehouse on the site, and served in that capacity until the deactivation of the Arsenal (Shank 1968; Garner 1969:6).

A plan of the Arsenal in 1894 (Fig. 3) shows the addition of a number of minor buildings and changes in the function of other buildings. However, it was not until 1919 to 1920 that another major building period occurred (**San Antonio Express** 1927). Three new storehouses, an oil house, a small arms shop, two magazines, a machine and equipment shop, barracks, and quarters eventually increased the number of buildings to 44 with a total value of \$900,000 (Garner 1969:6). The newest building on the grounds is the principal office structure, built in 1942 (Anonymous n.d.:2).

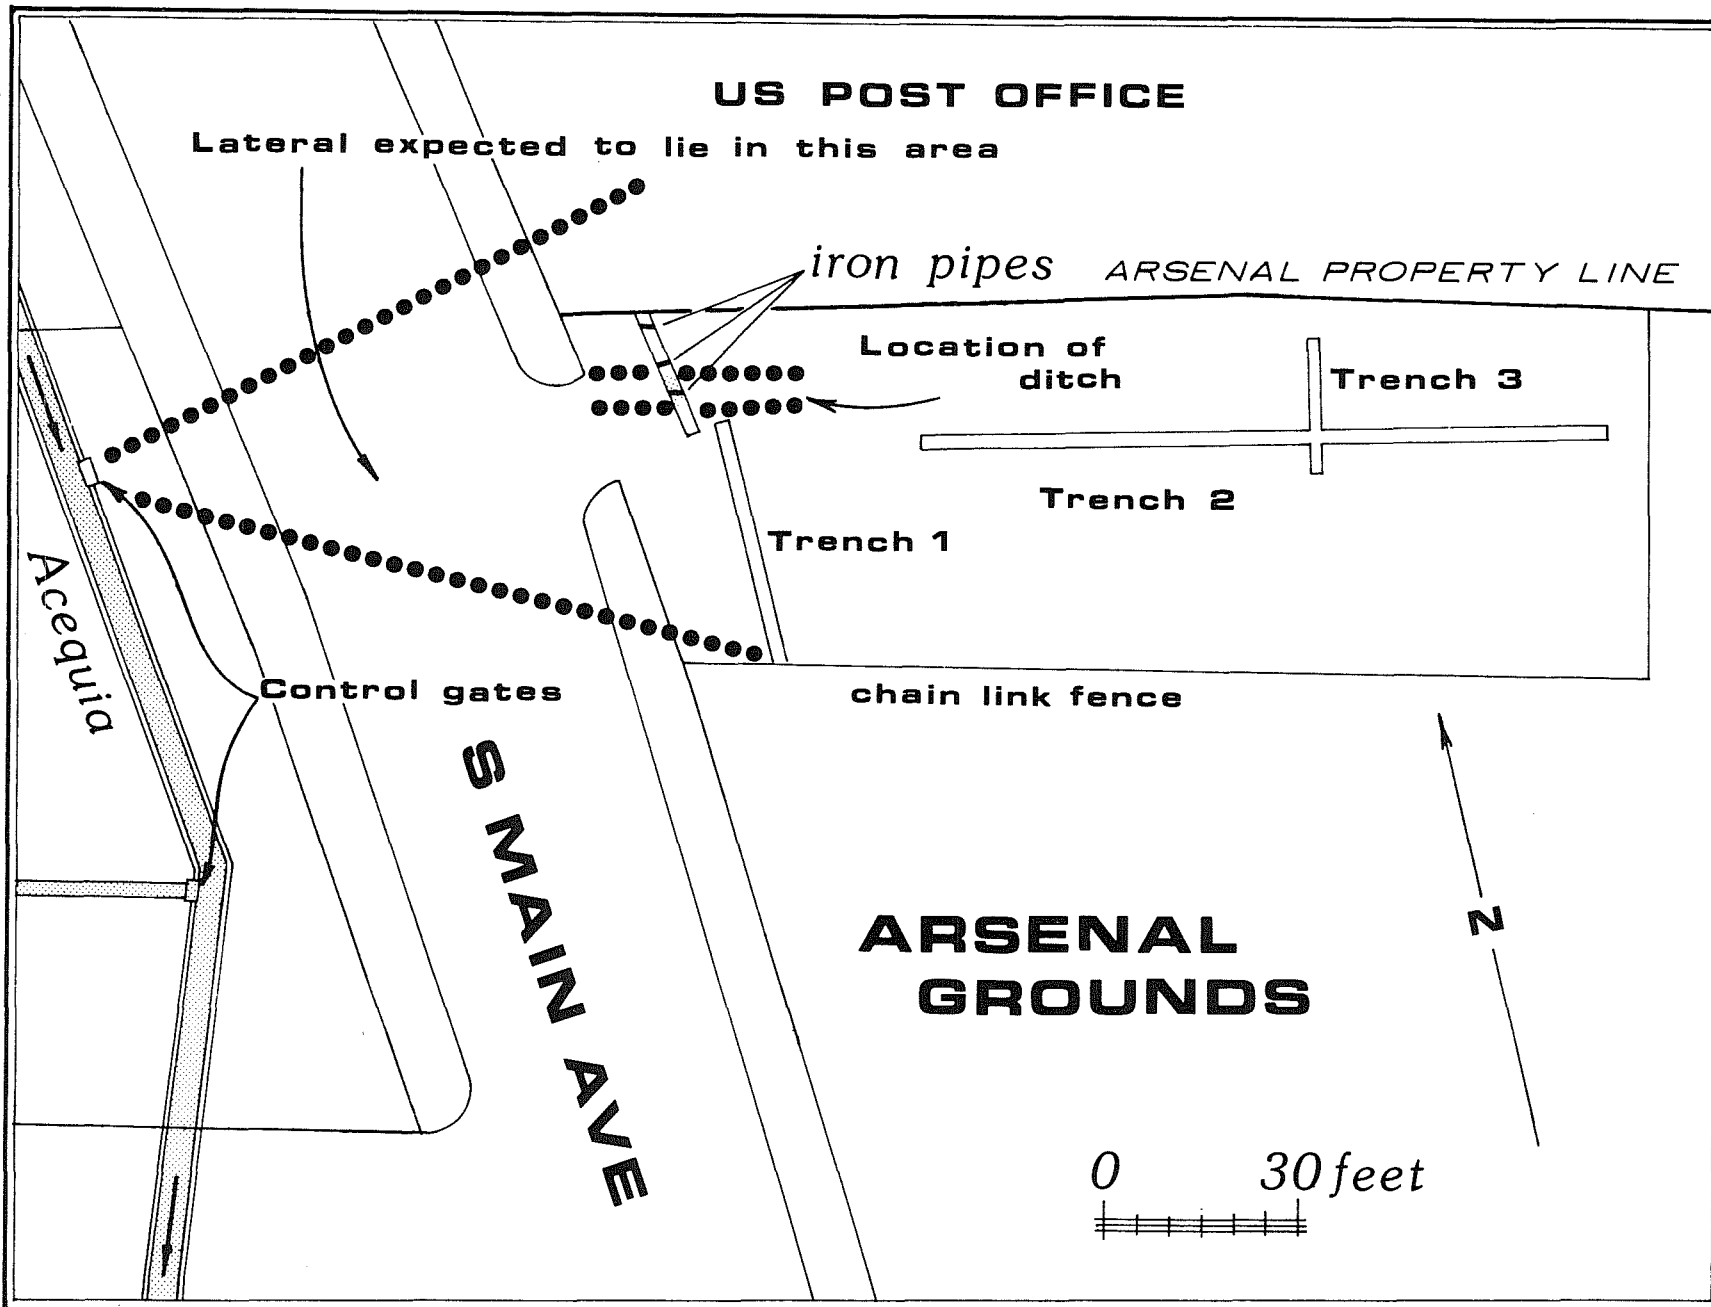
Figure 4. Plan of Backhoe Trenches.

On January 6, 1984, a series of backhoe trenches was excavated in the northwest corner of the development site, under the direction of the author and an assistant (Fig. 4). The first two trenches were positioned so as to determine whether the acequia lateral entered the area (Trench 1) or whether branches of the lateral intruded upon the site from the northern boundary (Trench 2).

In Trench 1, two gas lines were encountered which ran east-west across the area. A large disturbance six feet across was also found, which ran parallel to the gas line trenches. The trench was dug from the original ground level, which was beneath 10 inches of gravel fill laid for the asphalt paving on the western part of the lot. At first this disturbance was thought to be the acequia lateral, but a 5-1/2-inch iron pipe was found in a 15-inch trench in the bottom of the disturbance, at eight feet below the original surface.

Trench 2 ran east-west across most of the area under investigation. There were no signs of disturbance of any kind except for the presence of a number of two-foot-square concrete footing pads. These bore the marks of the 8- x 8-inch posts which once supported a temporary frame structure in this area (No. 20 in Fig. 1). Two small (2-1/2 inch) gas pipes and an electric line crossed (in a north-south direction) this trench. Caliche bedrock was found

After the size and depth of the large disturbance in Trench 1 were noted, Trench 3 was excavated in order to determine if the deep pipe trench/disturbance could have preempted the original acequia lateral. If so, the lateral, with or without the pipe trench, might have continued toward a junction with the river to the east. Trench 3 revealed the same soil profile as that of Trench 2, with no disturbances.
