## Archaeological Investigations in the Courtyard of Mission Nuestra Señora de la Purisima Concepción Acuña (41BX12)

# Archaeological Investigations in the Courtyard of Mission Nuestra Señora de la Purisima Concepción Acuña (41BX12)

Texas Antiquities Permit No. 2820

Prepared for:  
Los Compadres and National Park Service  
6701 San José Drive  
San Antonio, Texas 78233

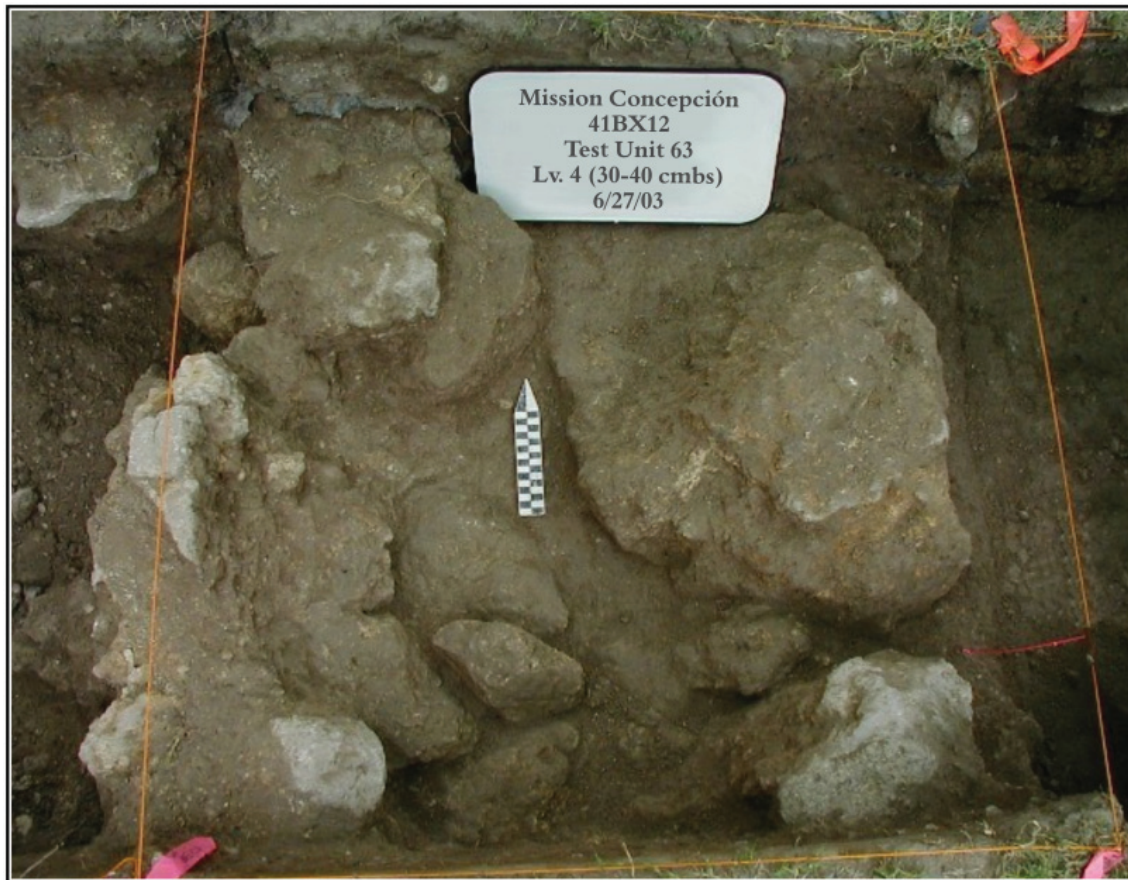
Figure 5-2. Alignment 1 uncovered in Test Unit 63.

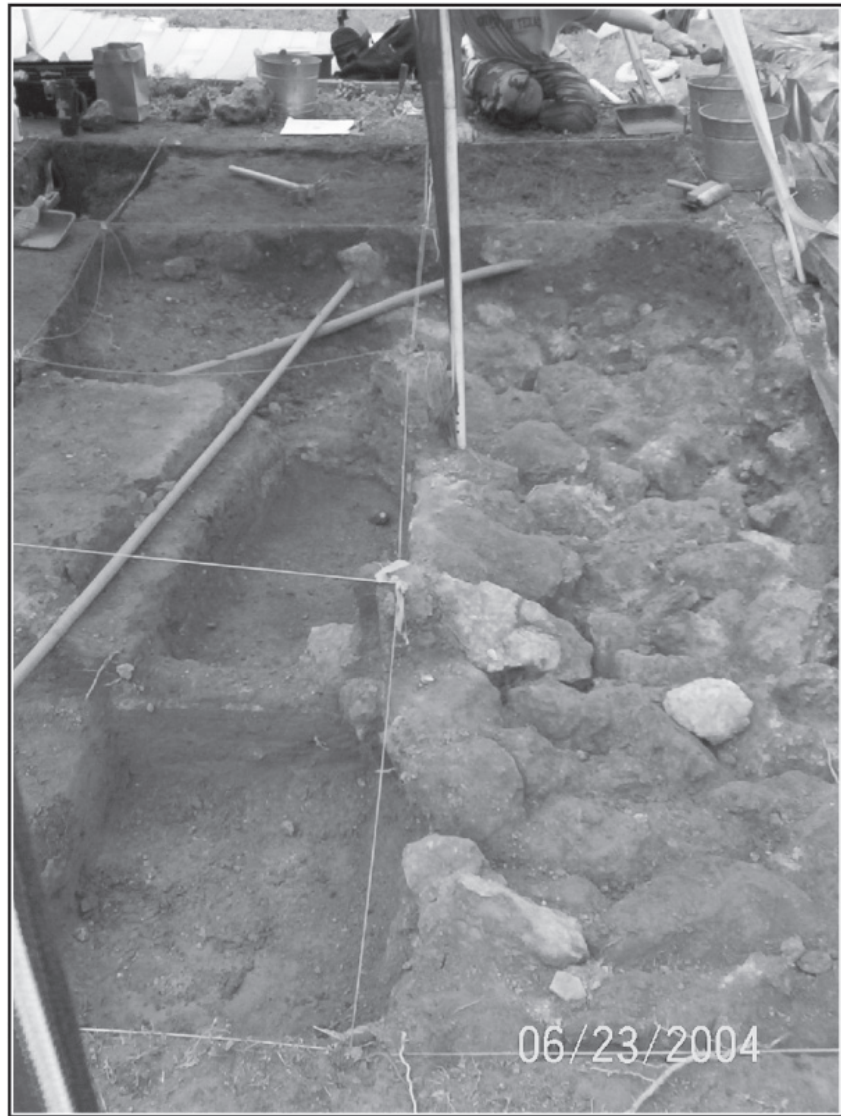
Figure 5-3. *Alignment 1 in Test Units 78 through 92.*

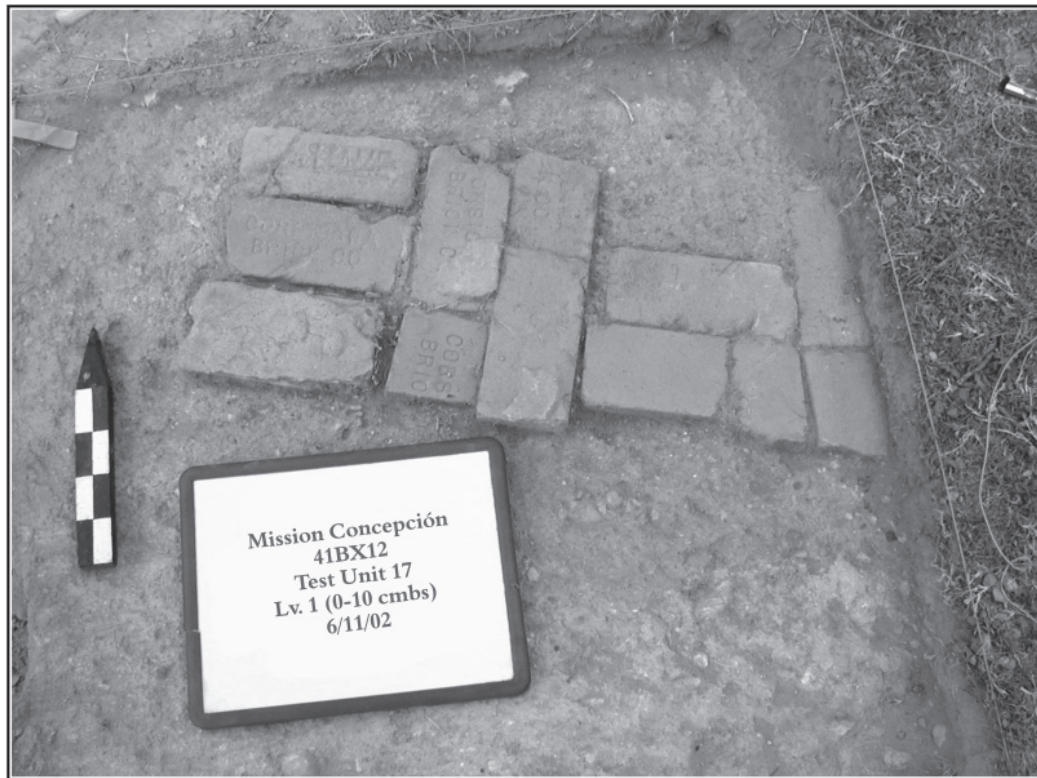
Figure 5-4. Partial layer of bricks forming sidewalk in Test Unit 17.

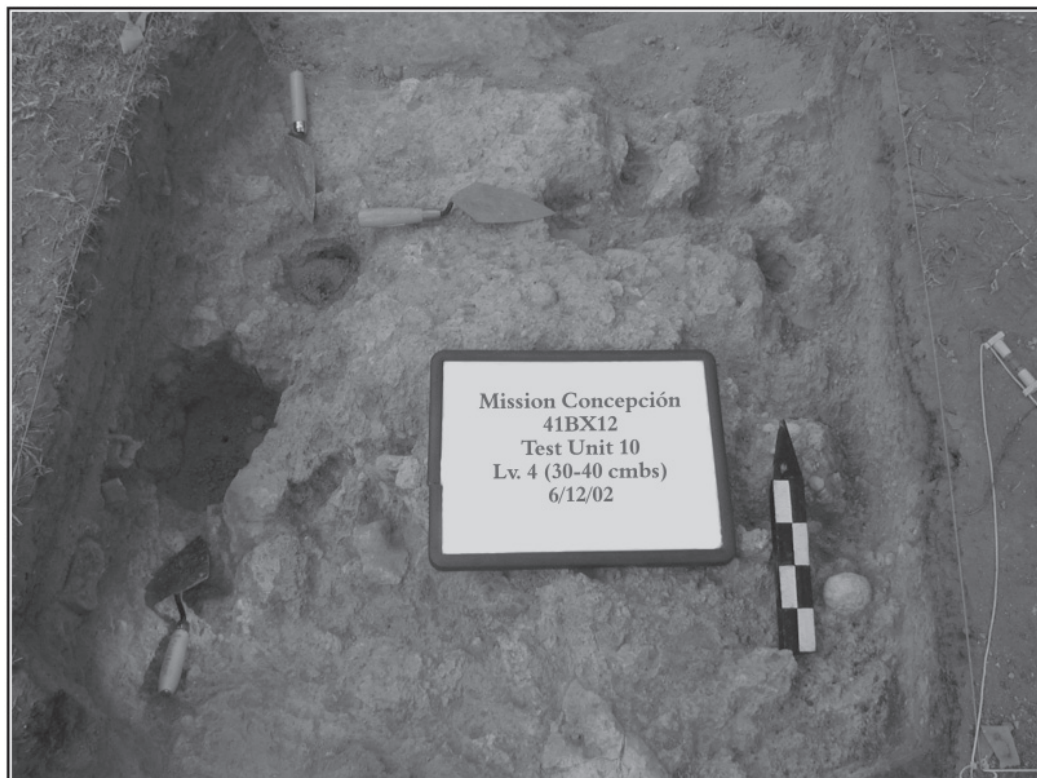
Figure 5-5. An intact portion of Alignment 2 uncovered in Test Unit 10 (note the possible posthole in northwest corner of the unit).

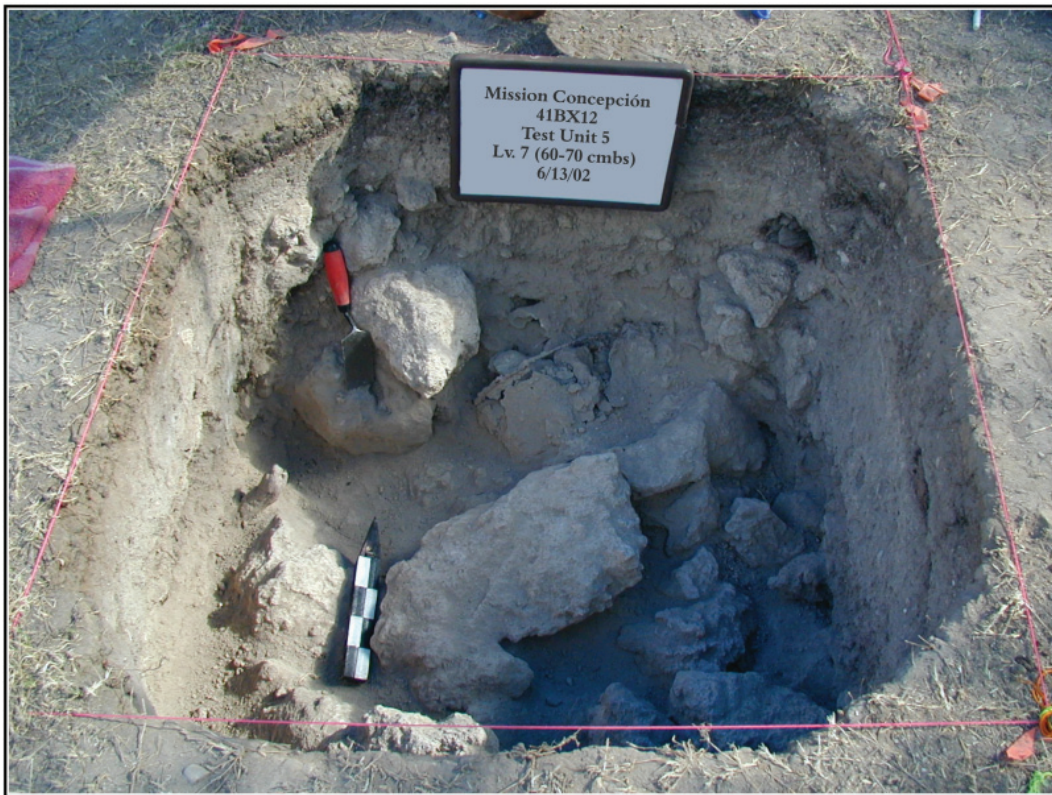
Figure 5-6. Disturbed portion of Alignment 2 uncovered in Test Unit 5.

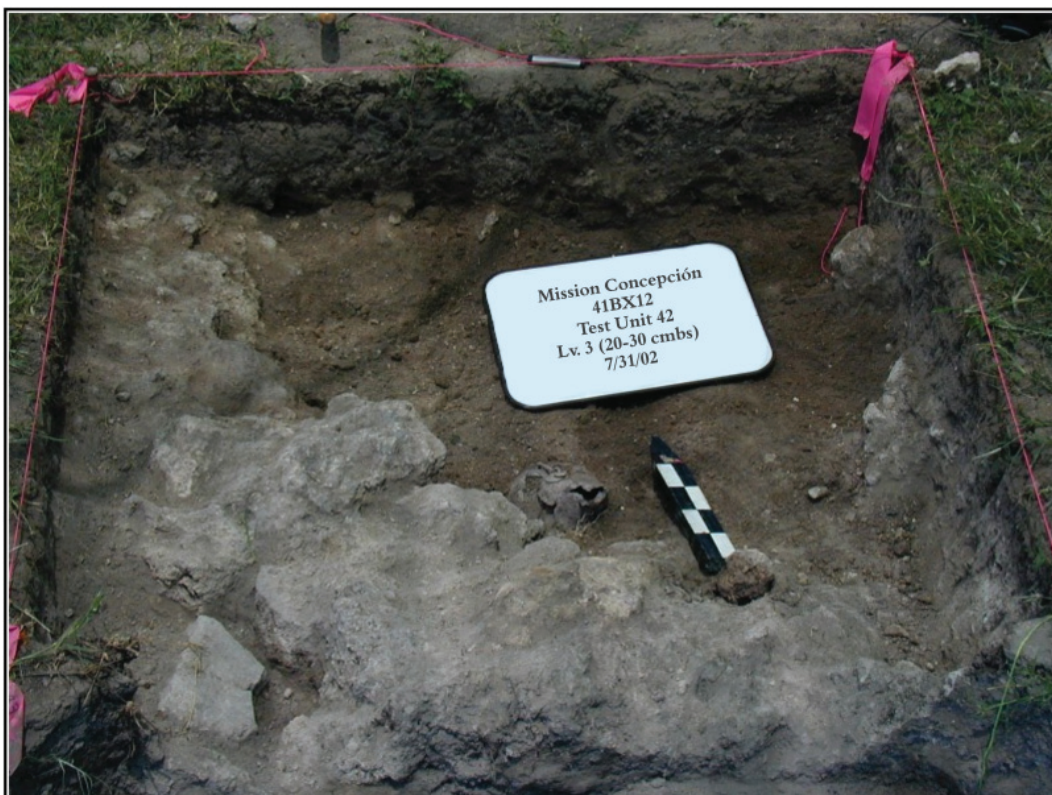
Figure 5-7. Portion of Alignment 2 uncovered in Test Unit 42.

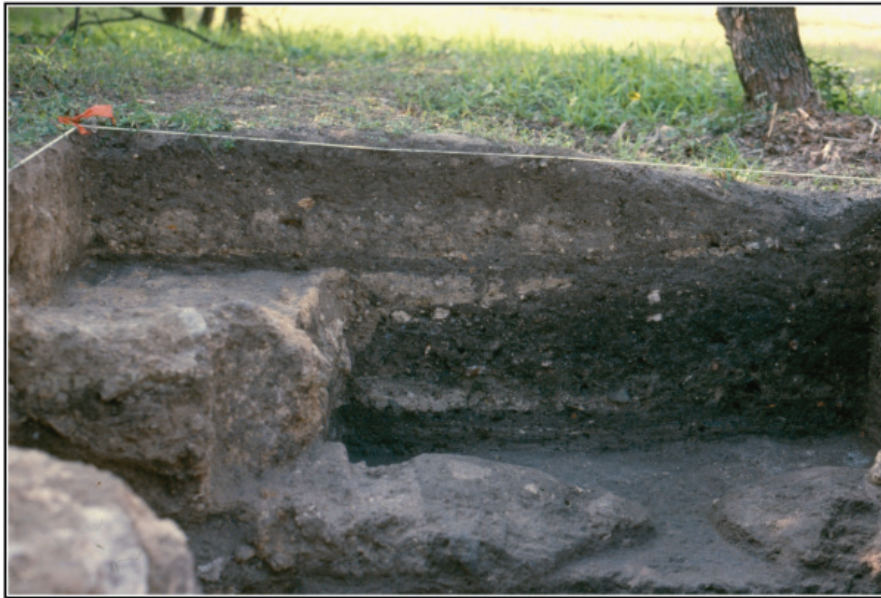
Figure 5-8. Ivey and Fox (1999) excavations, Block I, probable southwest corner of structure represented by Alignment 2.

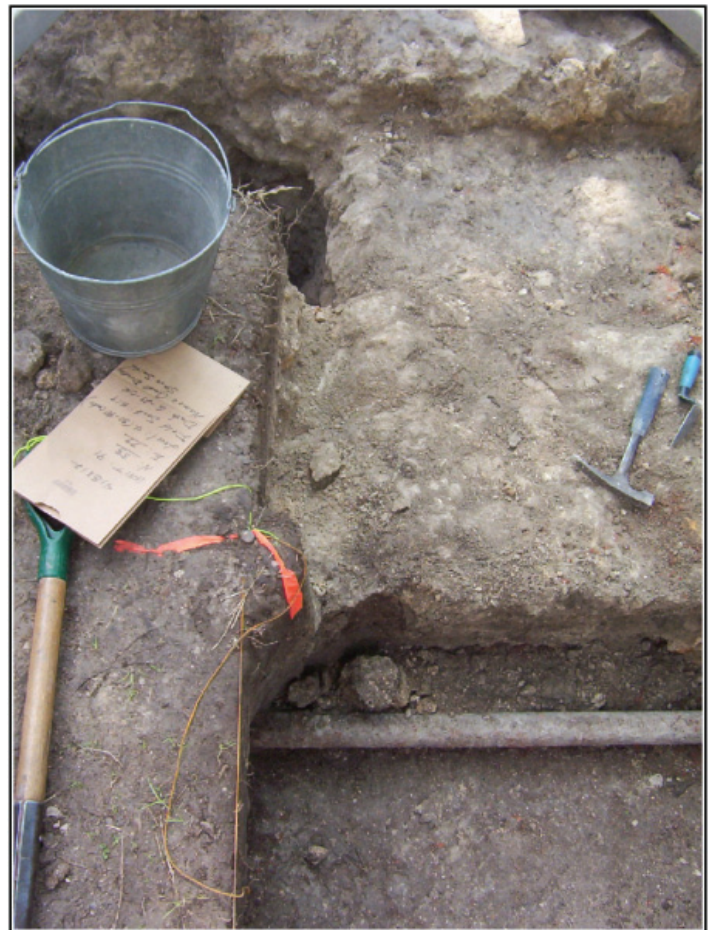
Figure 5-9. Alignment 2 (at top of photo) and Buttress 1 (center of photo) in Test Unit 91.

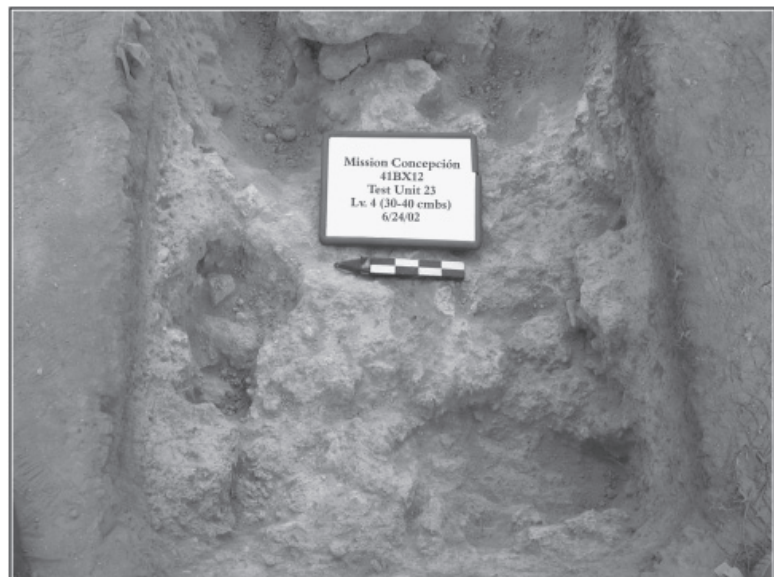
Figure 5-10. Intact portion of Alignment 3 revealed in Test Unit 23.

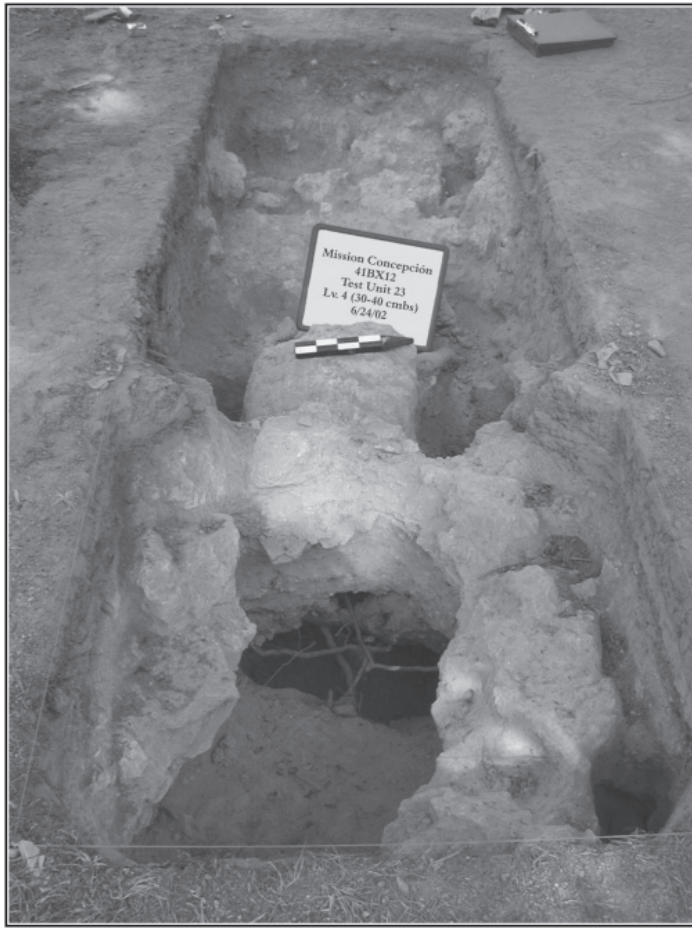
Figure 5-11. *Alignment 3 uncovered in Test Units 23, along with wall fall present in adjacent Test Units 13 and 20.*

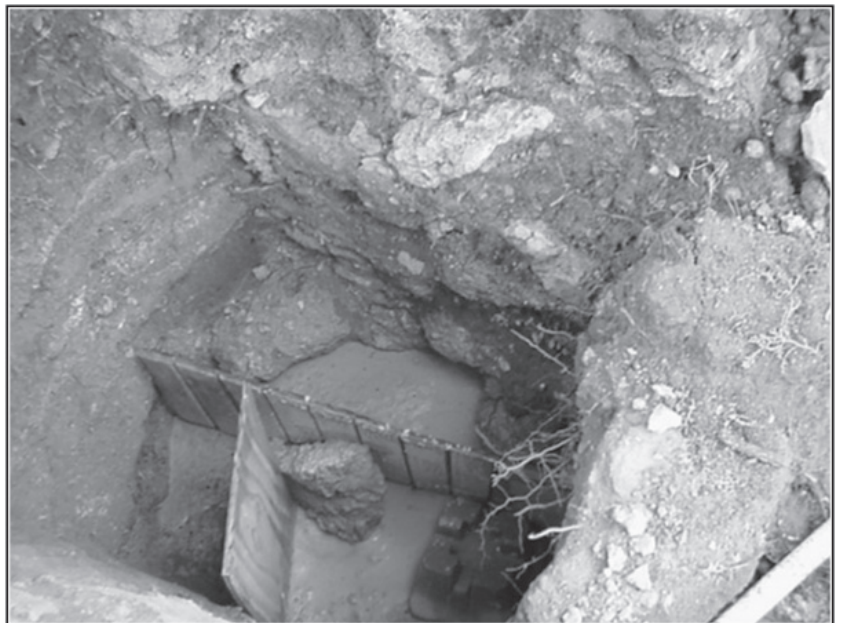
Figure 5-12. *Cement slurry at bottom of Test Unit 30.*

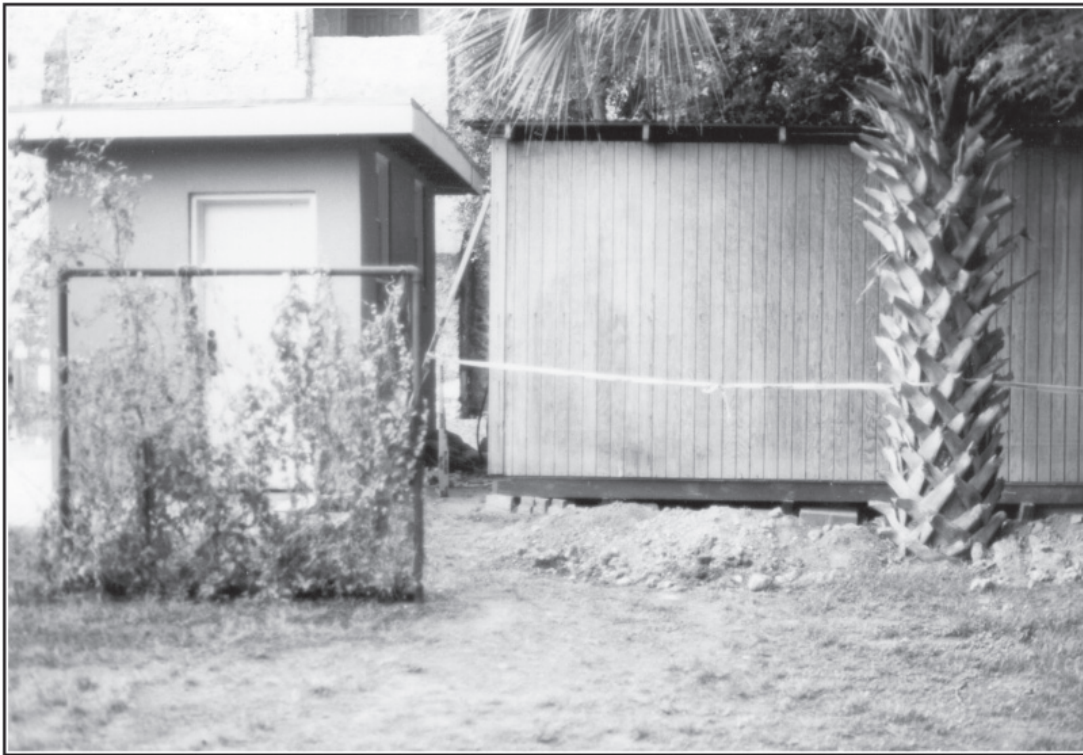
Figure 5-13. Restroom facilities and storage shed in courtyard installed in the late 1940s and removed in the late 1980s.

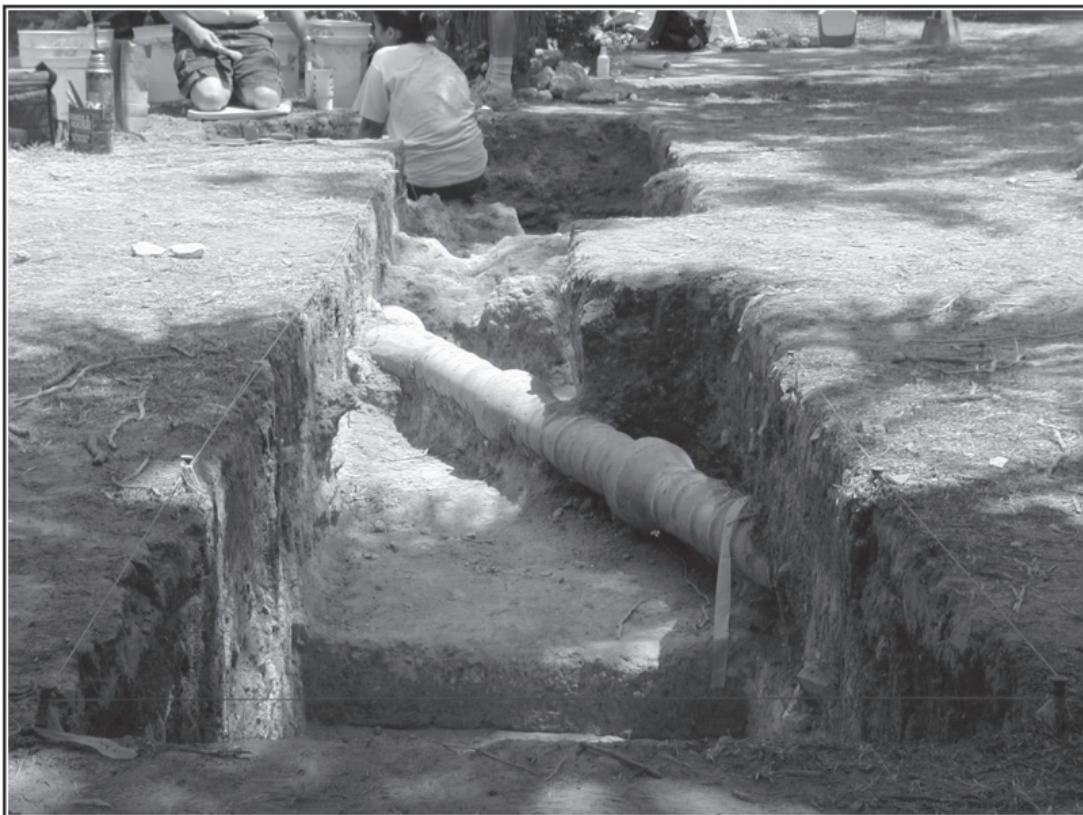
Figure 5-14. Concrete sewer pipe south of remnants of possible buttress in Test Units 8, 16 and 9.

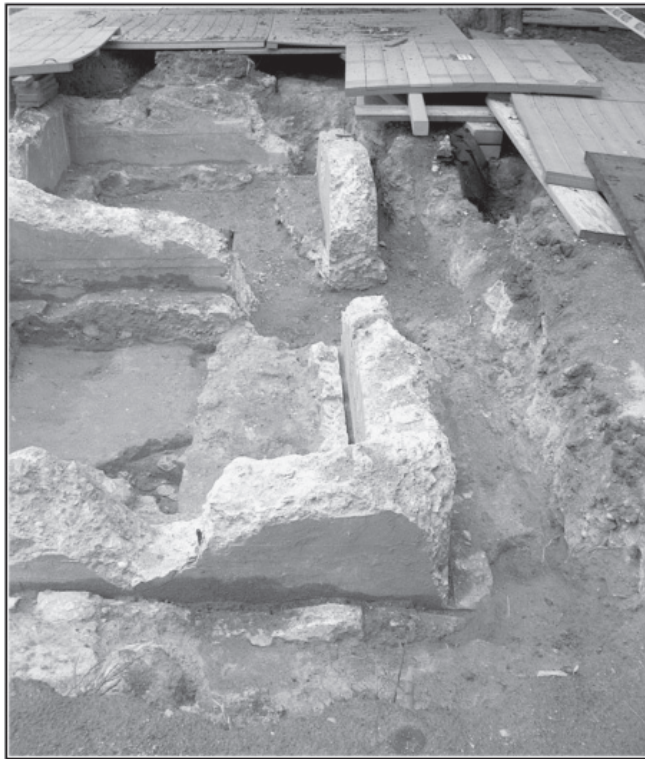
Figure 5-15. Foundation remnants of restroom facility.

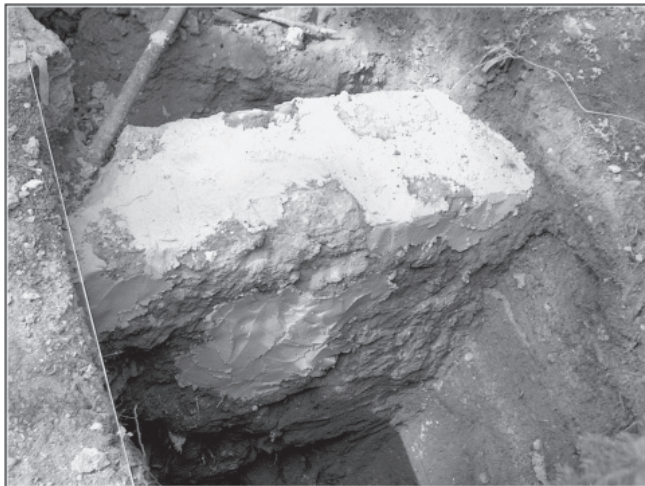
Figure 5-16. Cement-reinforced stone wall identified in Test Unit 15.

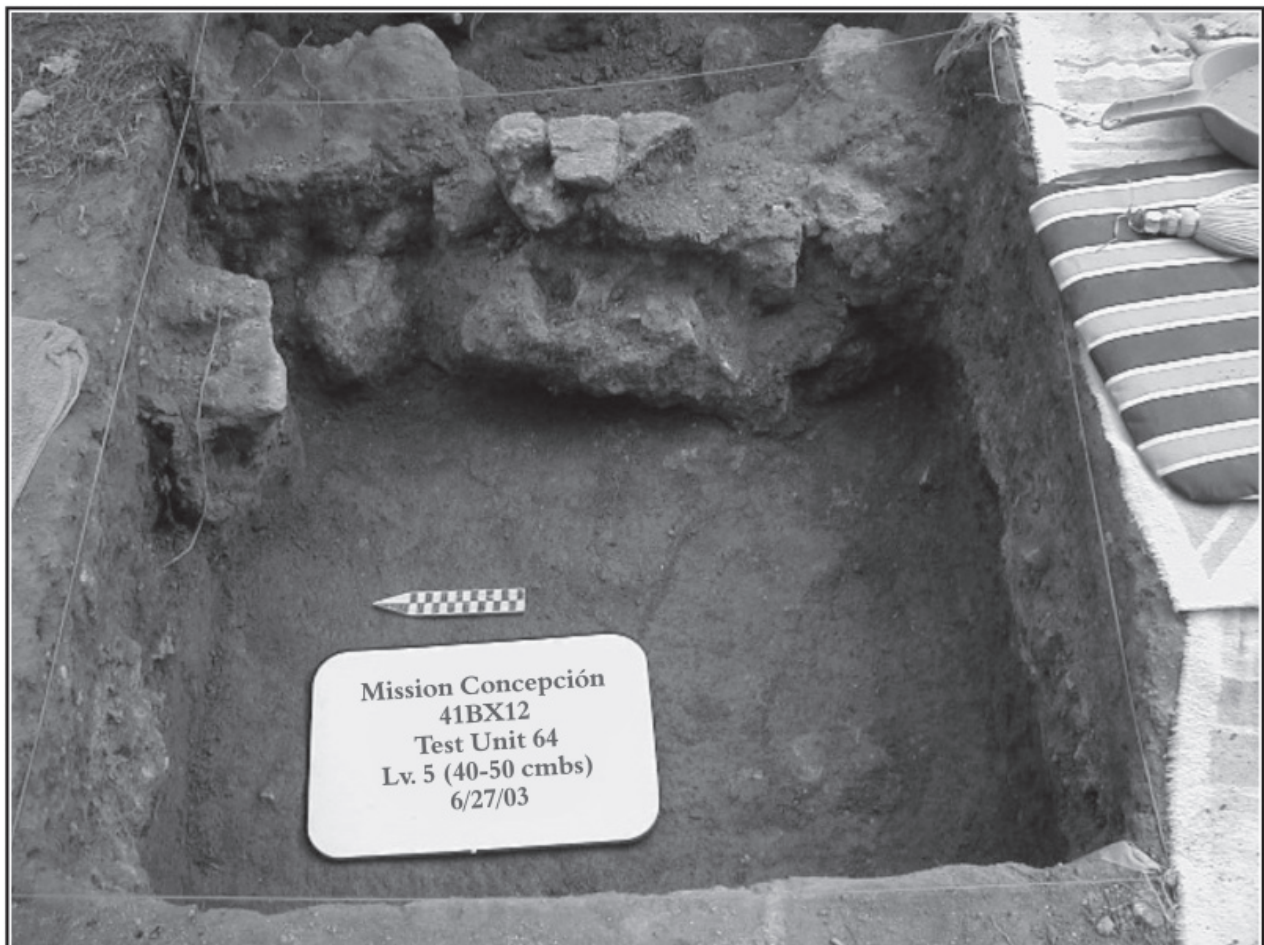
Figure 5-18. Eastern face of Alignment 1 as seen in Test Unit 64.

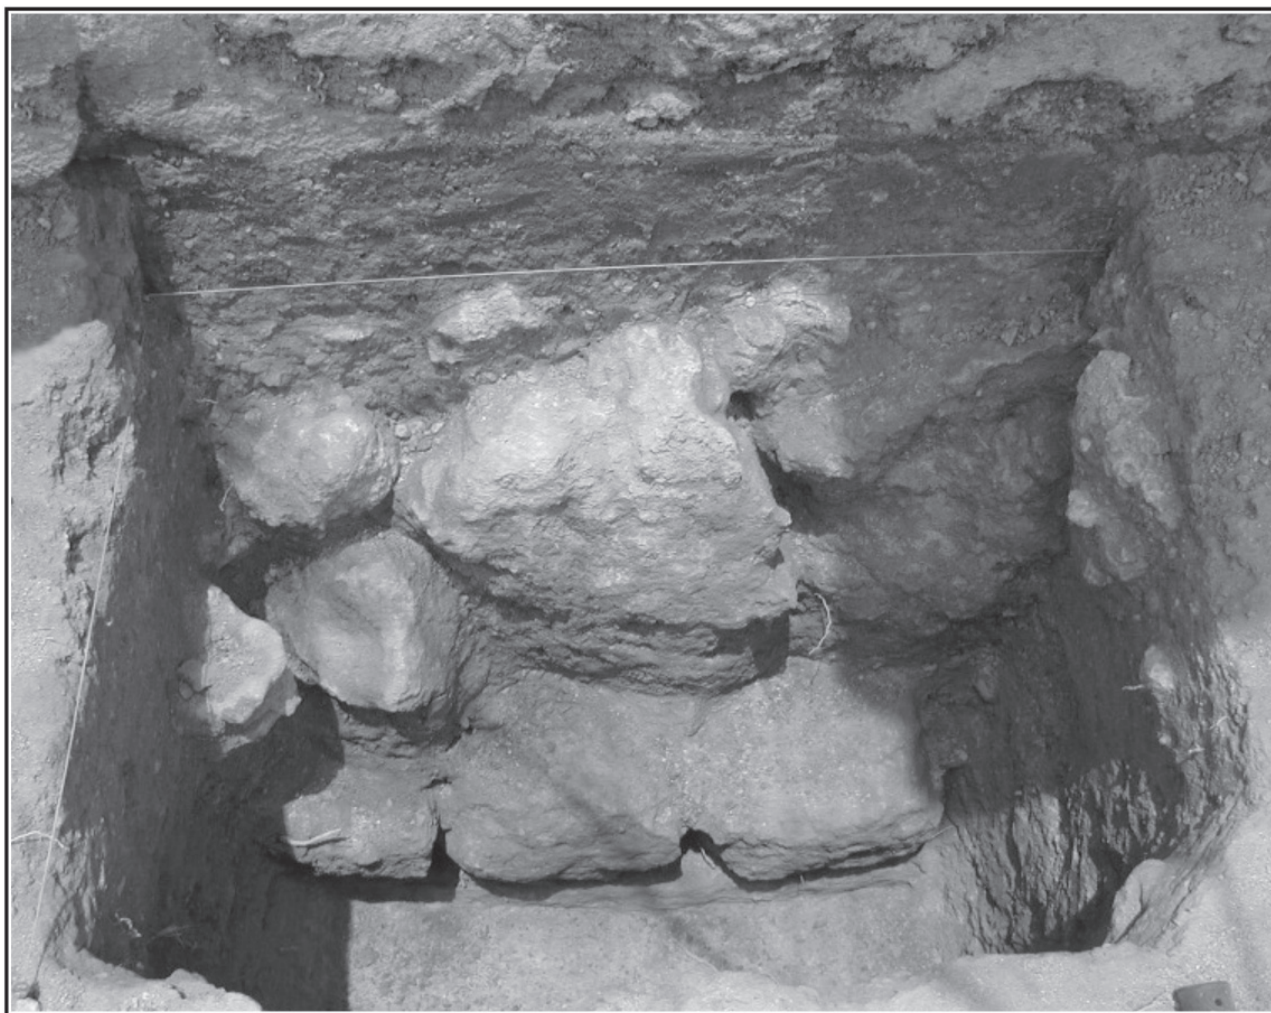
Figure 5-19. Foundation of Convento wall exposed in Test Unit 66.

The principal goal of these units was to determine the depth of the foundation of the east wall of the *convento* and examine the foundation itself. The top of the foundation began roughly 20 cmbs. The foundation consisted of large boulders of limestone that expanded toward the base creating a trapezoidal appearance. The rocks are held in place by what appears to be mortar. The outline of a trench that would have been dug for the foundation rocks could not be discerned in the north or south walls of TU 66. The large rocks that form the foundation and its trapezoidal shape are different from architectural Alignments 2 and 3. The difference may reflect

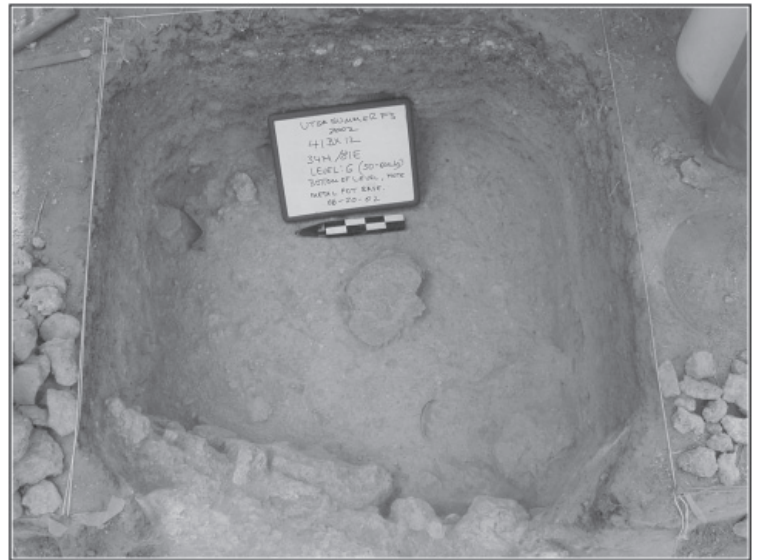
Figure 5-20. Layer of red sand that formed surface of foot path within courtyard.

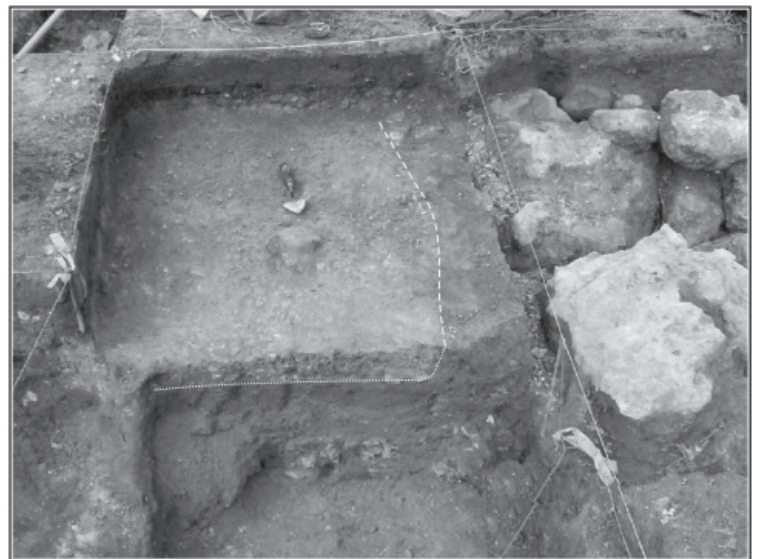
Figure 5-21. Test Unit 89 (Area 2, Block I) excavation with hard-packed gravel surface (Feature 3) exposed.

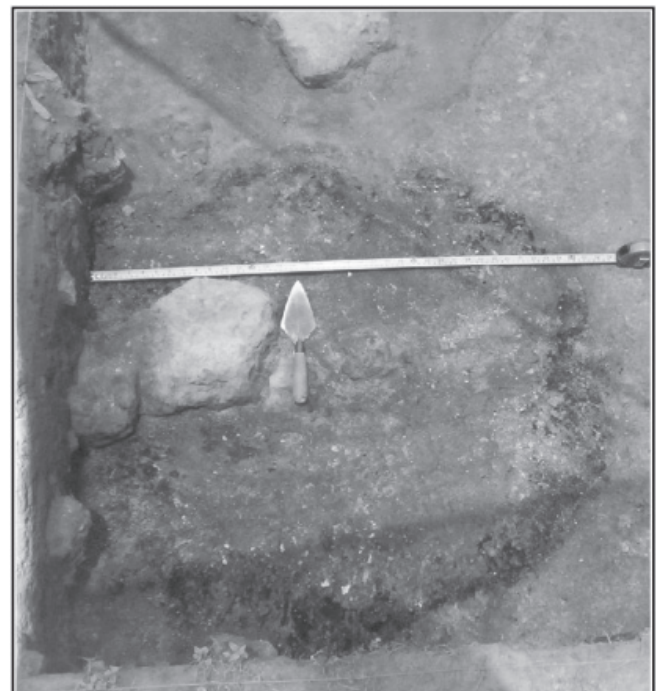
Figure 5-22. Feature 1, Test Unit 82.

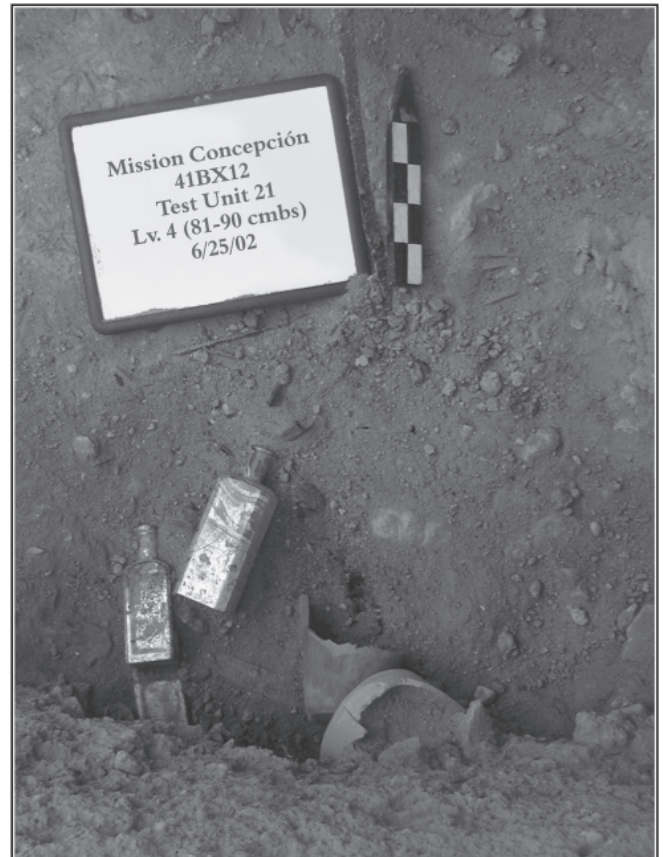
Figure 5-26. Garbage in Feature 5, Test Unit 21.

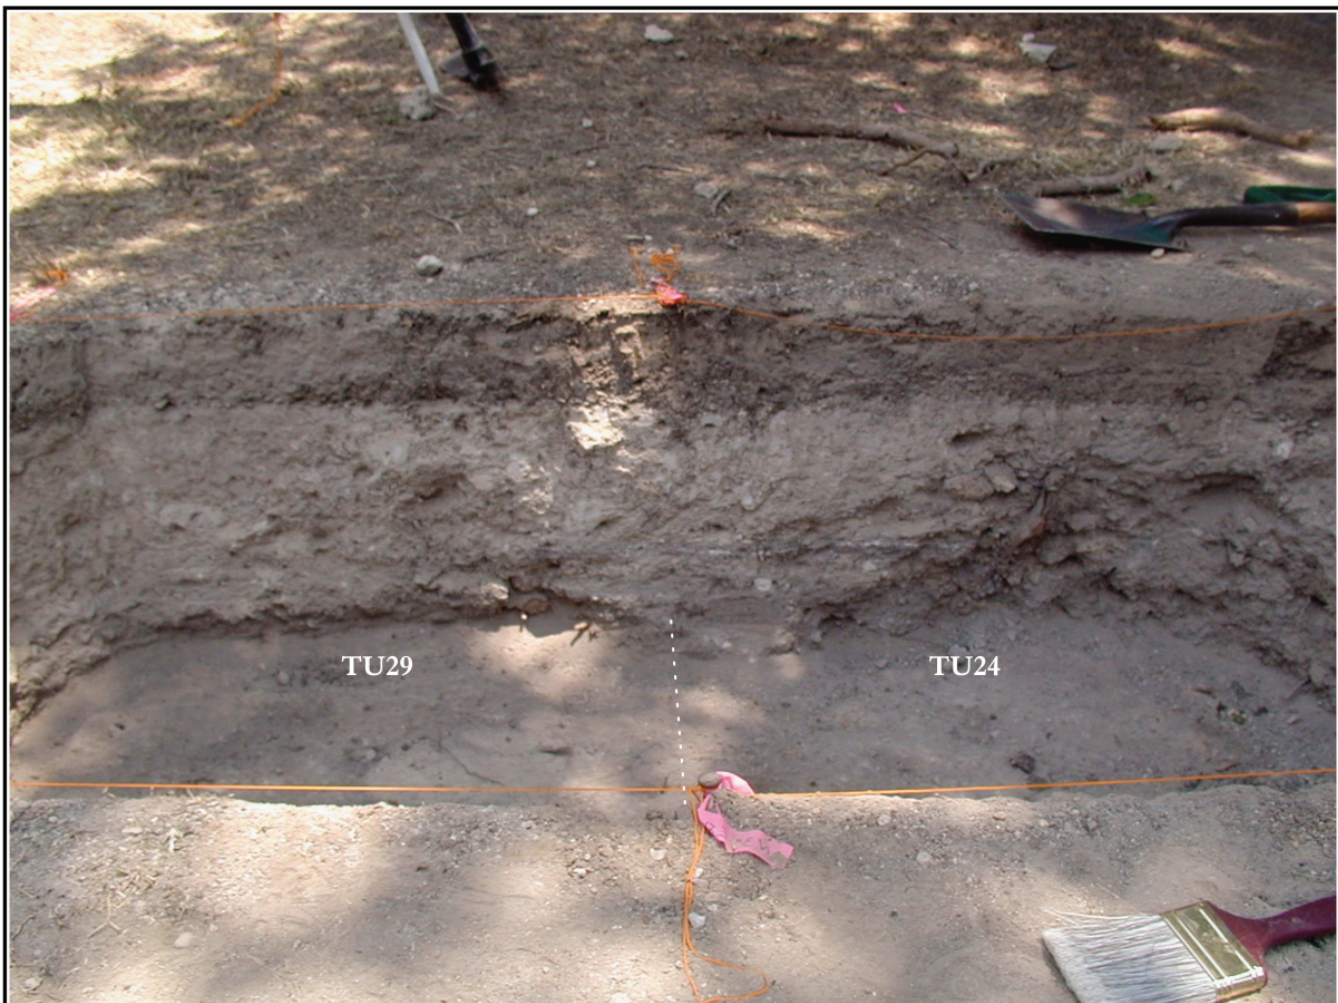
Figure 5-27. Hard-packed level surface below top soil in Test Units 24 and 29.

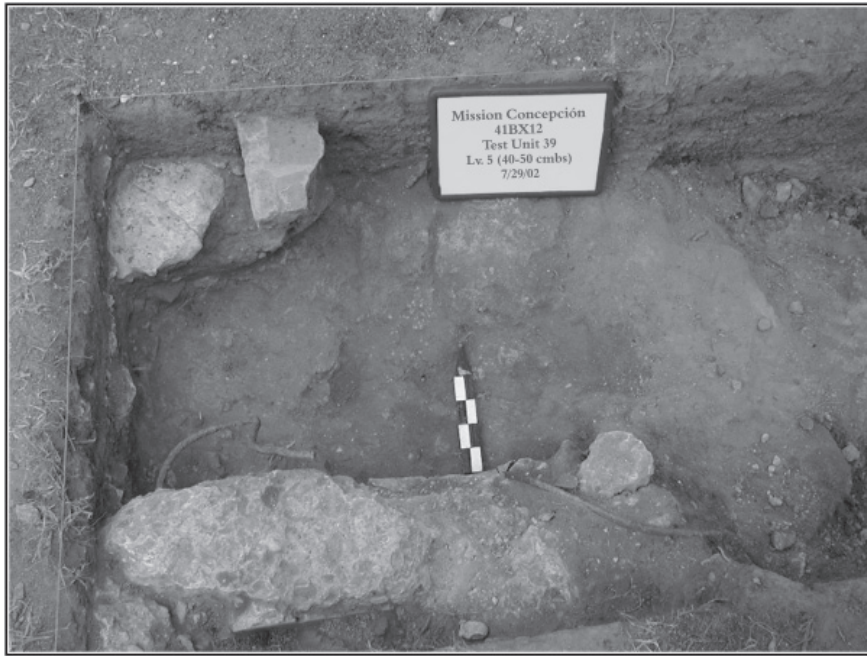
Figure 5-29. Remnant of concrete foundation of restroom facility in Test Unit 39.

associated with this facility were exposed at the bottom of Level 2 (10-20 cmbs) in each of the test units (39, 73, 68, 98, and 99). Spanish colonial foundation remains were identified beneath the 1940s bathroom when the bathroom was removed.

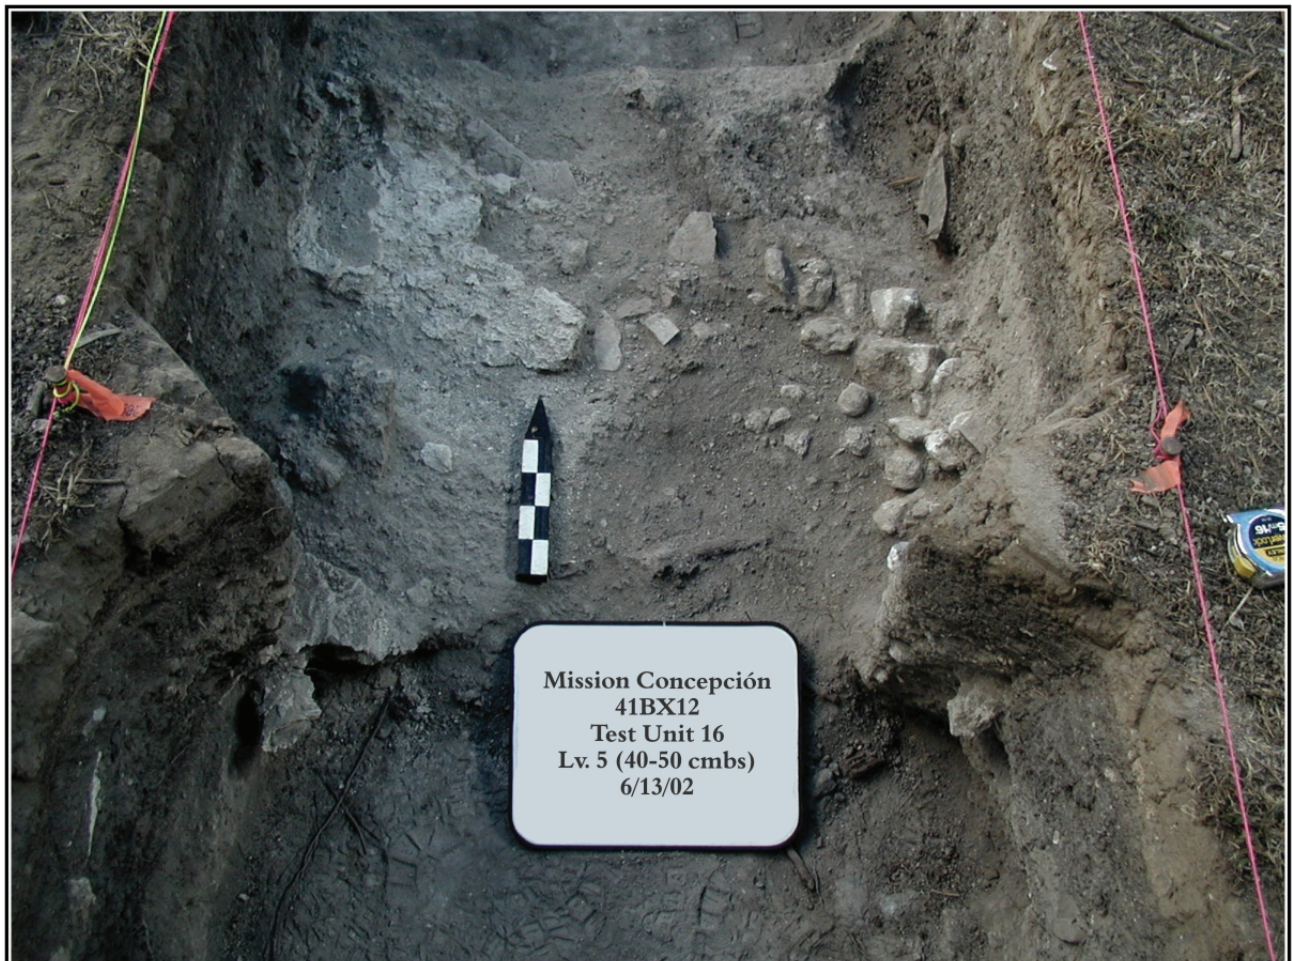
Figure 5-30. Plaster surface exposed in Test Unit 16, Area 5.

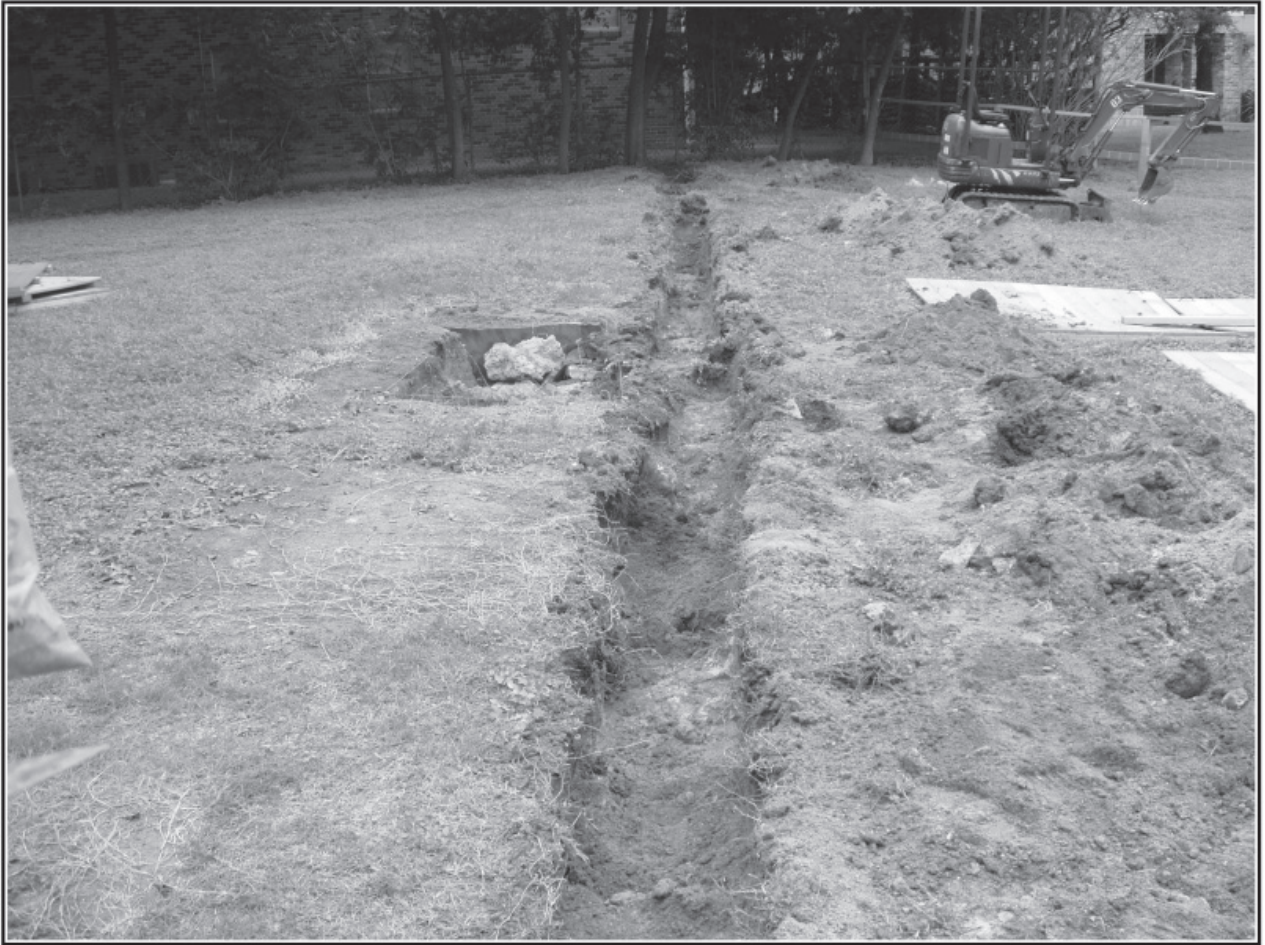
Figure 5-32. Southern portion of Trench 3 excavated by small trackhoe.
