Archaeological Services Associated with Improvements to Miraflores at Brackenridge Park, San Antonio, Bexar County, Texas

Texas Antiquities Permit No. 4653

Prepared by:
Center for Archaeological Research
The University of Texas at San Antonio
Archaeological Report, No. 387

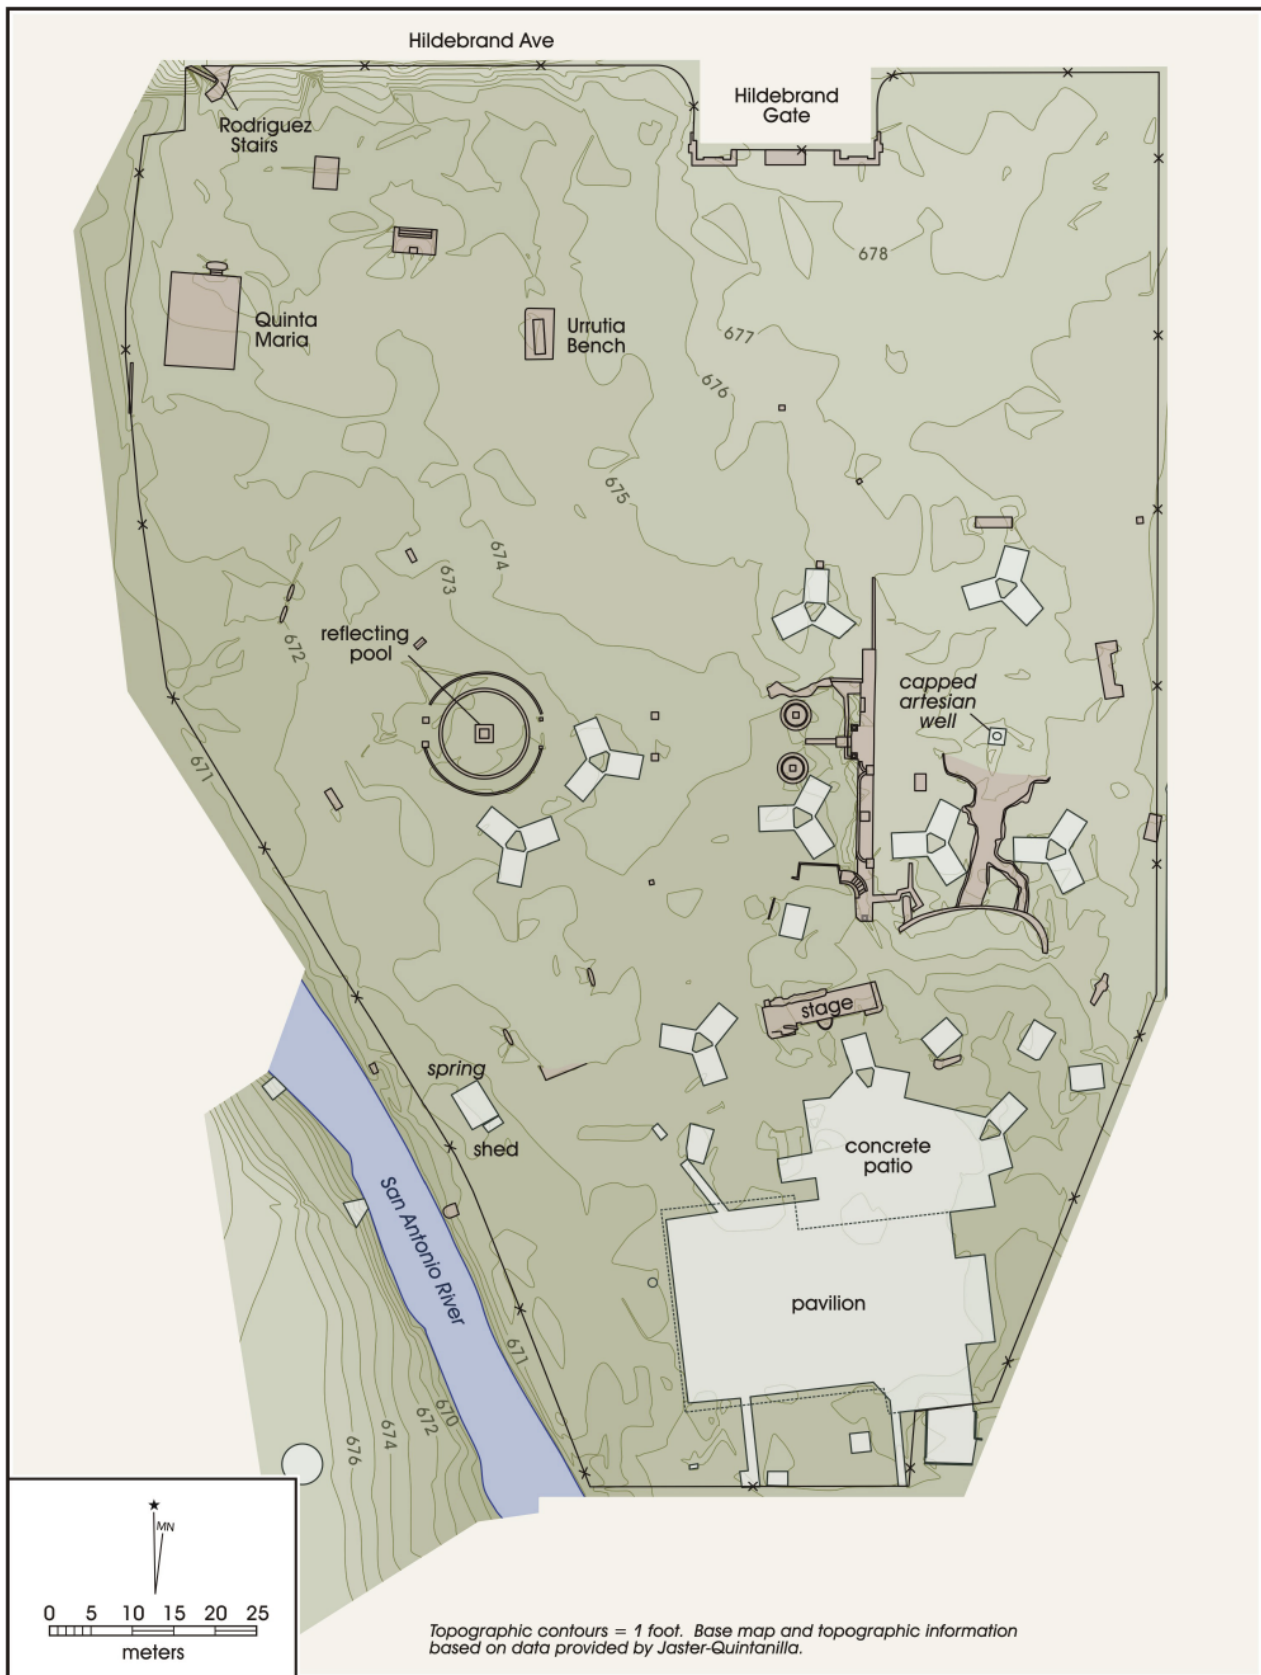
Figure 1-2. The Miraflores Project area.

The project area is located in San Antonio, Bexar County, Texas, near the 800 block of East Hildebrand Avenue, across from The University of the Incarnate Word. The project area, located on the San Antonio East quadrangle map, is trapezoidal in shape (Figure 1-2), and is surrounded by a chain link fence on all four sides. A wrought iron gate is present on the north side flanked by two decorative fountain pieces. The San Antonio River bounds the west and southwest portions of the property.

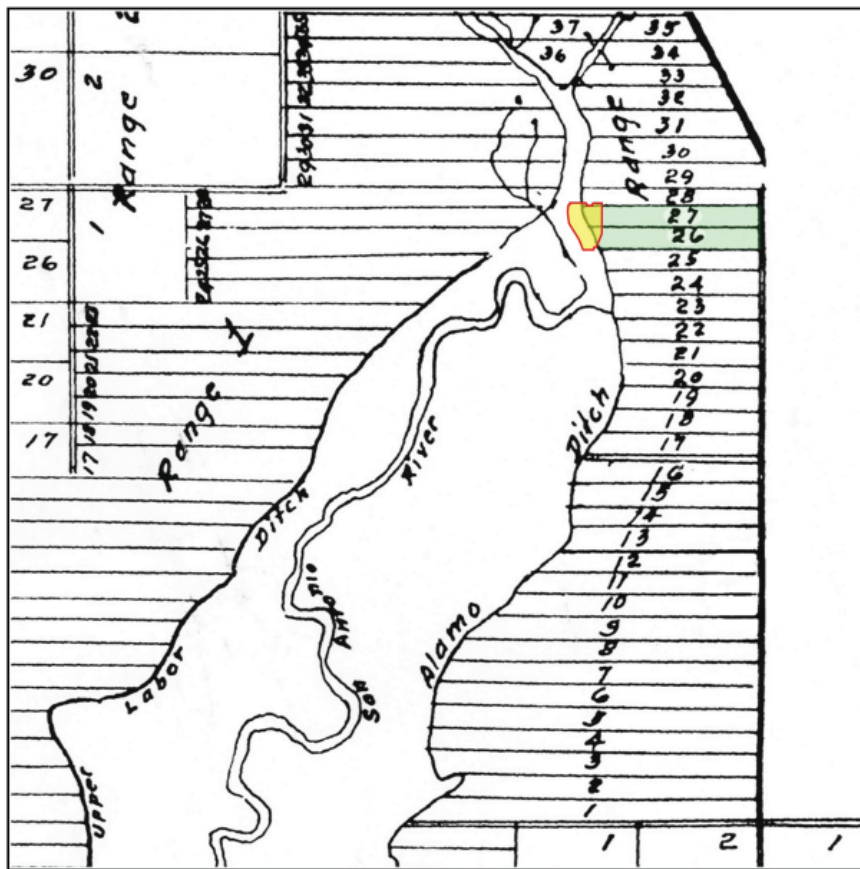
Figure 2-1. Map of the portions of land delineated by Don Juan Antonio Perez de Almazan, Alcade Mayor, in 1731. The Project area is located in Lots 26 and 27 in Range 1 (yellow with red border).

The project area was located just to the northeast of the Mission Valero Upper Labors. The Upper Labor Acequia tied into the San Antonio River to the west of Miraflores. The park is located in the lands that were portioned off by Don Juan Antonio Perez de Almazan, Alcade Mayor, in 1731. The project area is located within Range 1, Lots 26 and 27 (Figure 2-1).

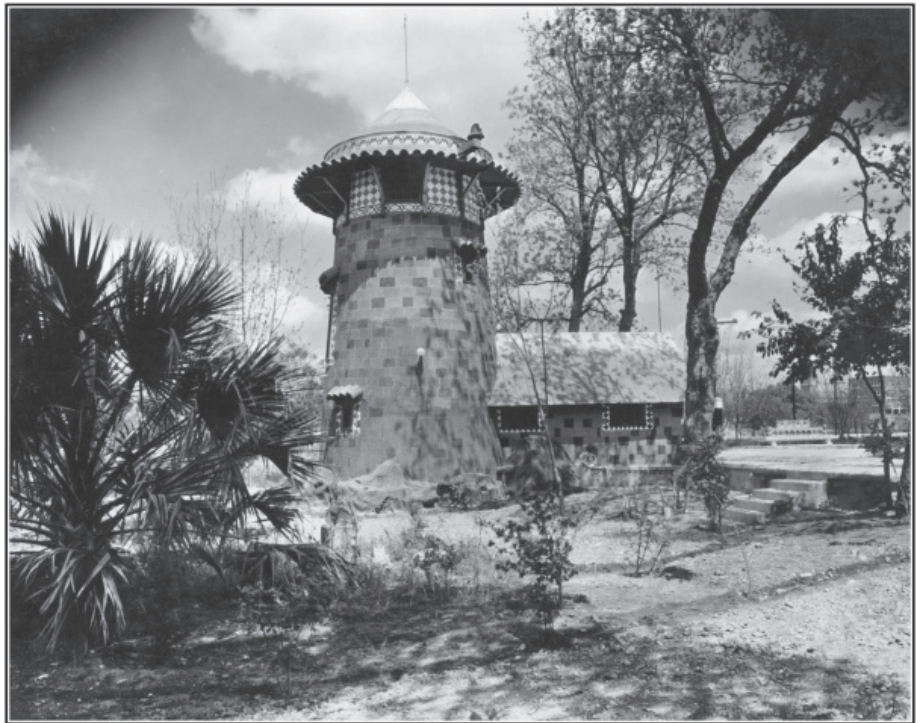
Figure 2-2. Photograph of the library tower ca. 1930.

the southern end of the garden was reminiscent of a windmill (Figure 2-2), possibly built to pay homage to Don Quixote. This building housed Dr. Urrutia's library. The structure is no longer standing, though the footprint was located within the current project area. The second building located on the premises is a guest house Dr. Urrutia dubbed "Quinta Maria" (Figure 2-3). This structure was built in 1923 and was restored by Southwestern Bell in 1981. A recent viewing of the 1939 aerial of the project area reveals a possible footbridge that crosses the San Antonio River and connects into a path that leads to the reflecting pool in the western portion of the project area (Figure 2-4). This footbridge is no longer present.

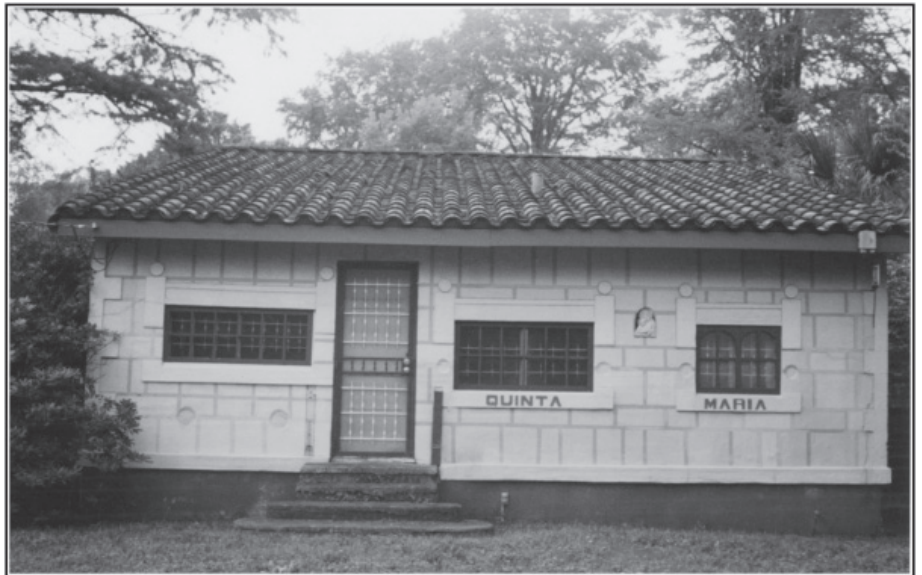
Figure 2-3. Photograph of Quinta Maria.

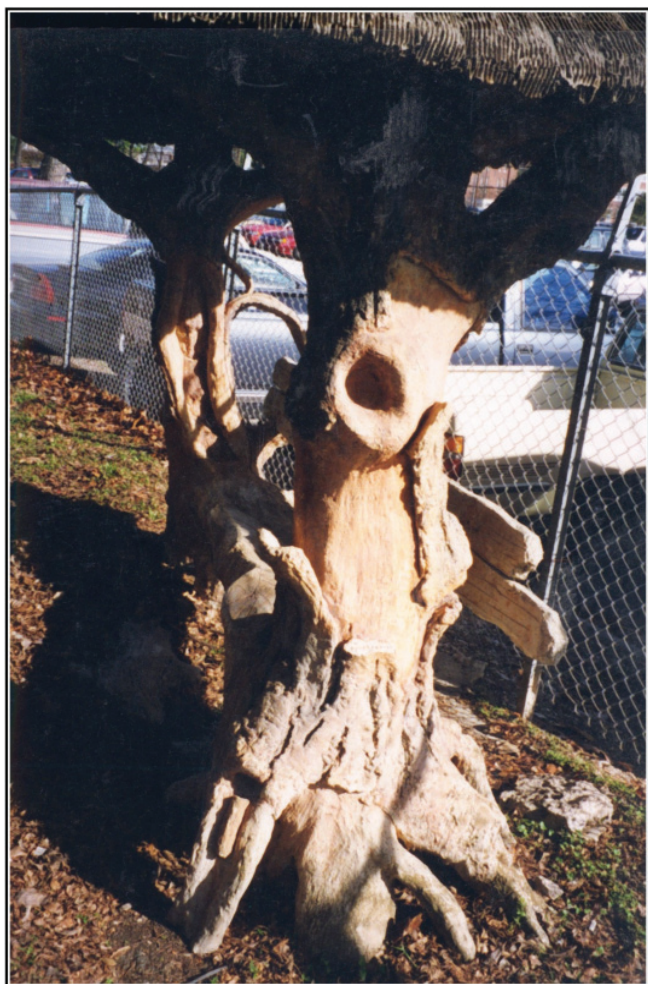
Figure 2-5. Photograph of bench created by Dionicio Rodriguez.

Urrutia constructed this garden to try to recreate the atmosphere of gardens found in his hometown in Mexico. The location just adjacent to the San Antonio River provided him with a ready water source that played into his design of the park. Urrutia commissioned several artists to produce works displayed in the park. Most notable is Dionicio Rodriguez, an artist from Toluca, Mexico who had perfected a process by which he was able to carve chemically treated concrete to look like wood (Figure 2-5). Several pieces of Rodriguez's work can

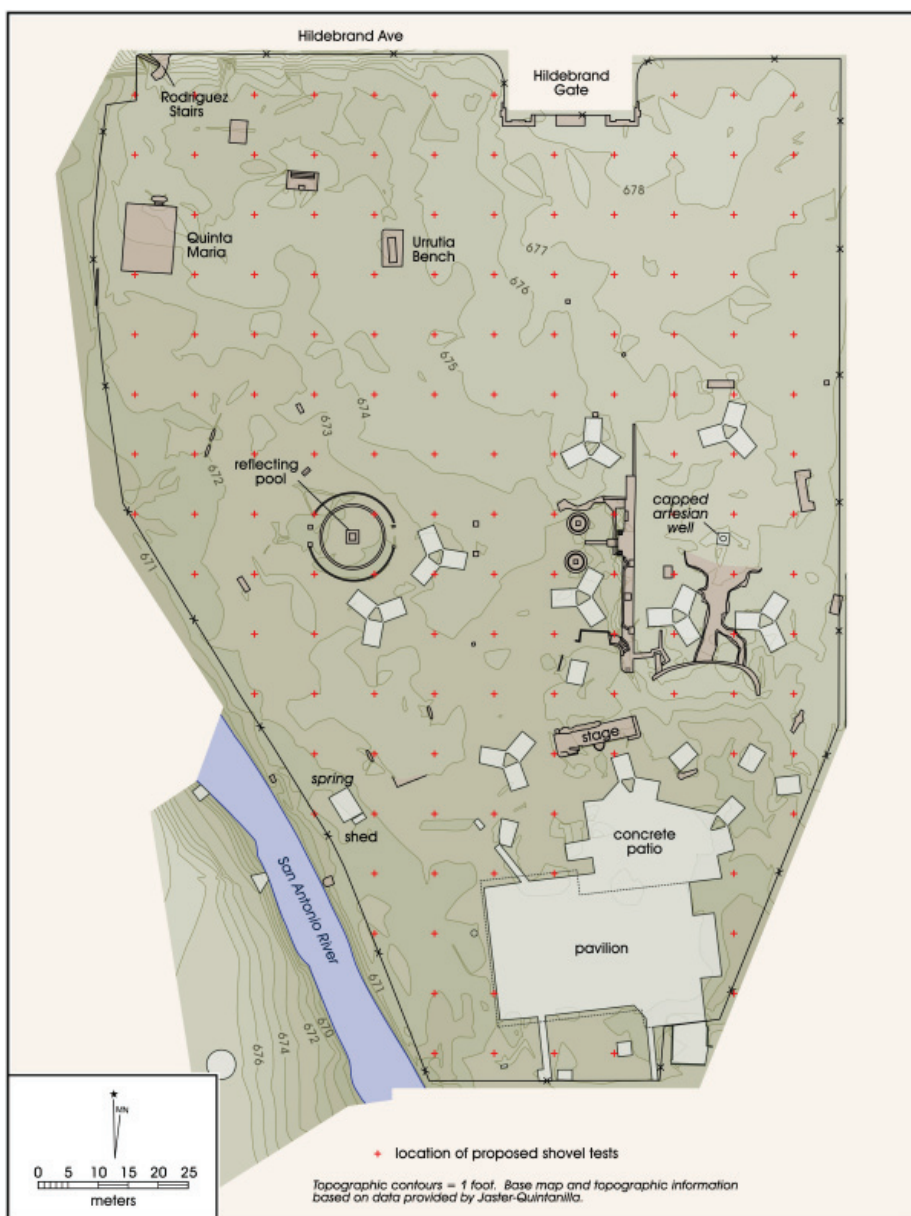
Figure 3-1. Map of the project area showing the location of the proposed shovel tests.

Prior to testing, CAR has reviewed historic aerials and maps of the project area as well as the NHRP nomination form, historic photographs, and the Westkaemper thesis (1985) to gain insight as to the layout and possible architectural features at the site. To prepare for the fieldwork, CAR laid out a 10 meter by 10 meter grid over the entire project area. Next, CAR staff excavated shovel tests at 10 meter intervals to determine the extent of the buried cultural remains (Figure 3-1). Prior to the fieldwork, it was estimated that approximately 176 shovel tests would be excavated within the project area. That actual number was lower because large sections of the park could not be tested due to standing water.

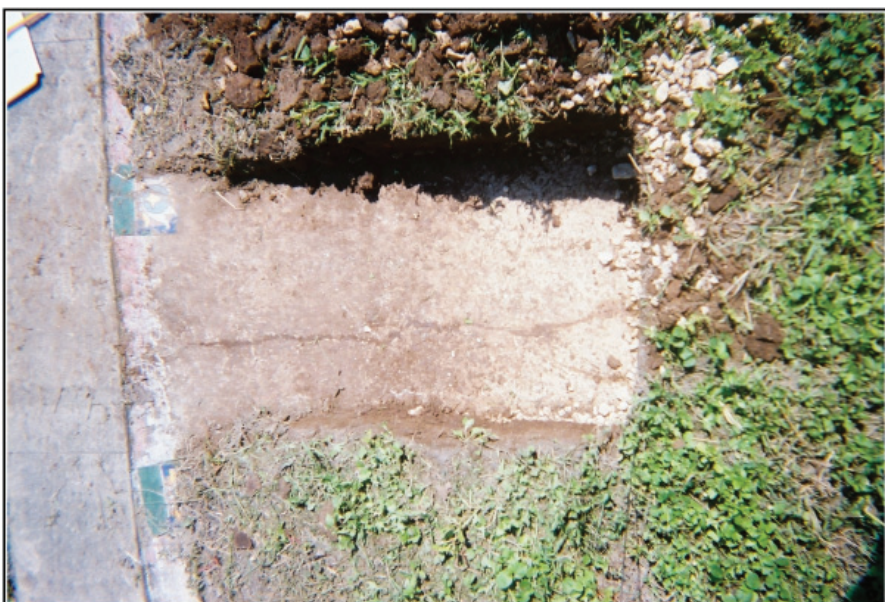
Test Unit 2 was excavated to uncover a portion of the interior of the reflecting pool (Figure 4-1). The unit was 50 cm x 50 cm and started at the interior edge of the reflecting pool where one tile was exposed on the surface. The edge of the pool slopes towards the center. The pool had been filled in with gravel and then capped with soil. The southern wall profile of the unit revealed that between 11 and 21 cmbs (to the base of the pool basin) gravels had been used to fill in the pool. The inner ring of the pool edge appears to have been painted with red paint (Figure 4-2). No additional tiles were noted along the pool basin. The unit produced no cultural material.

Figure 4-2. Photograph of Test Unit 2, located within the reflecting pool.

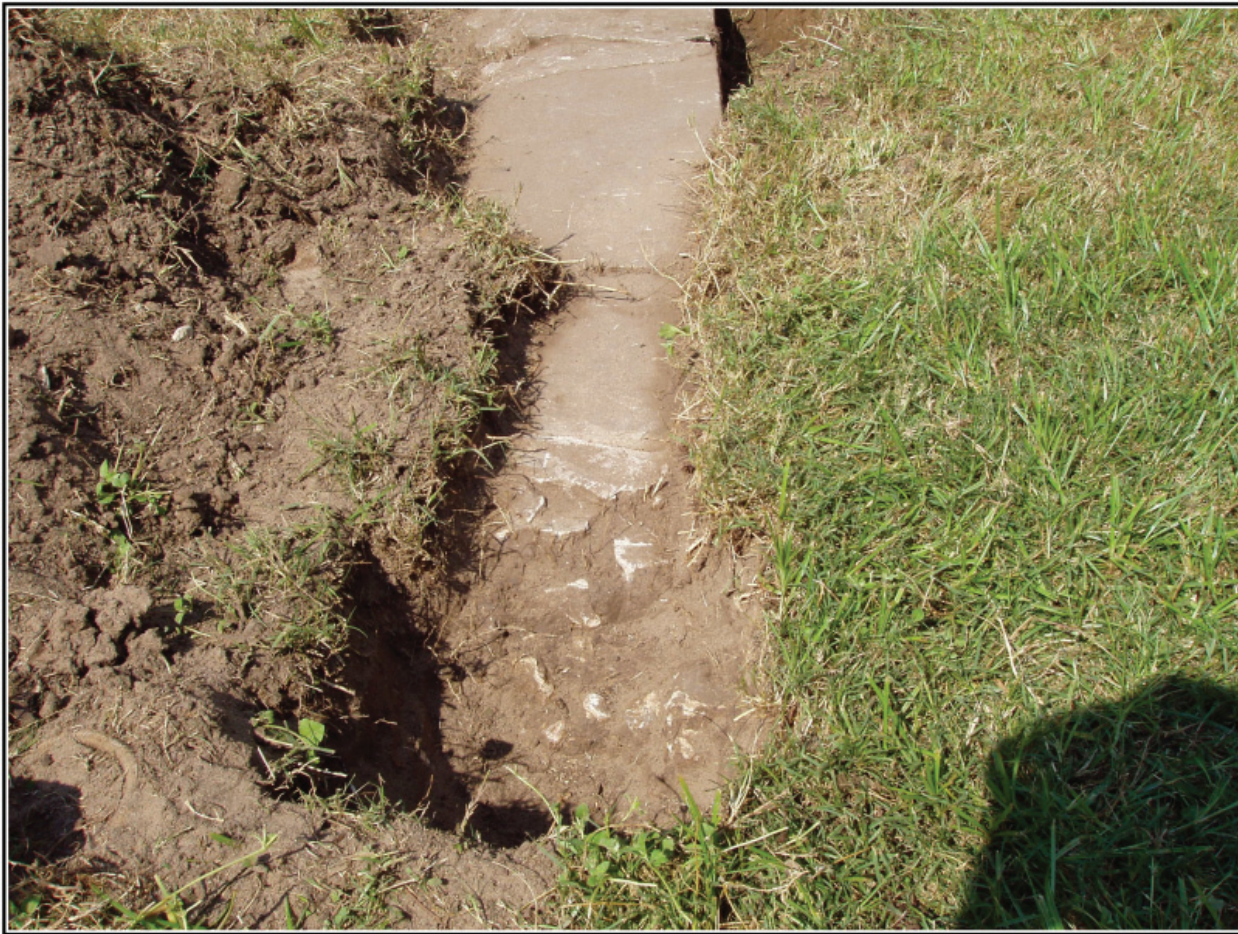
Trench 3 was excavated over ST 33 in the west-central part of the park (Figure 4-1). ST 33 had exposed a cement curb. The trench was instrumental in uncovering a longer portion the curb and it also revealed that the curb is no longer intact but rather is sheared off at both ends. The trench was approximately 281 cm wide and 41 cm across at its maximum. The curb was encountered 10 cm below the surface (Figure 4-3). The curb could either be part of the lining of the gravel path leading in the direction of Quinta Maria, or may have been used as a platform for a piece of art work. Artifacts encountered while

Figure 4-3. Photograph of the cement feature uncovered in ST 33 and Trench 3.

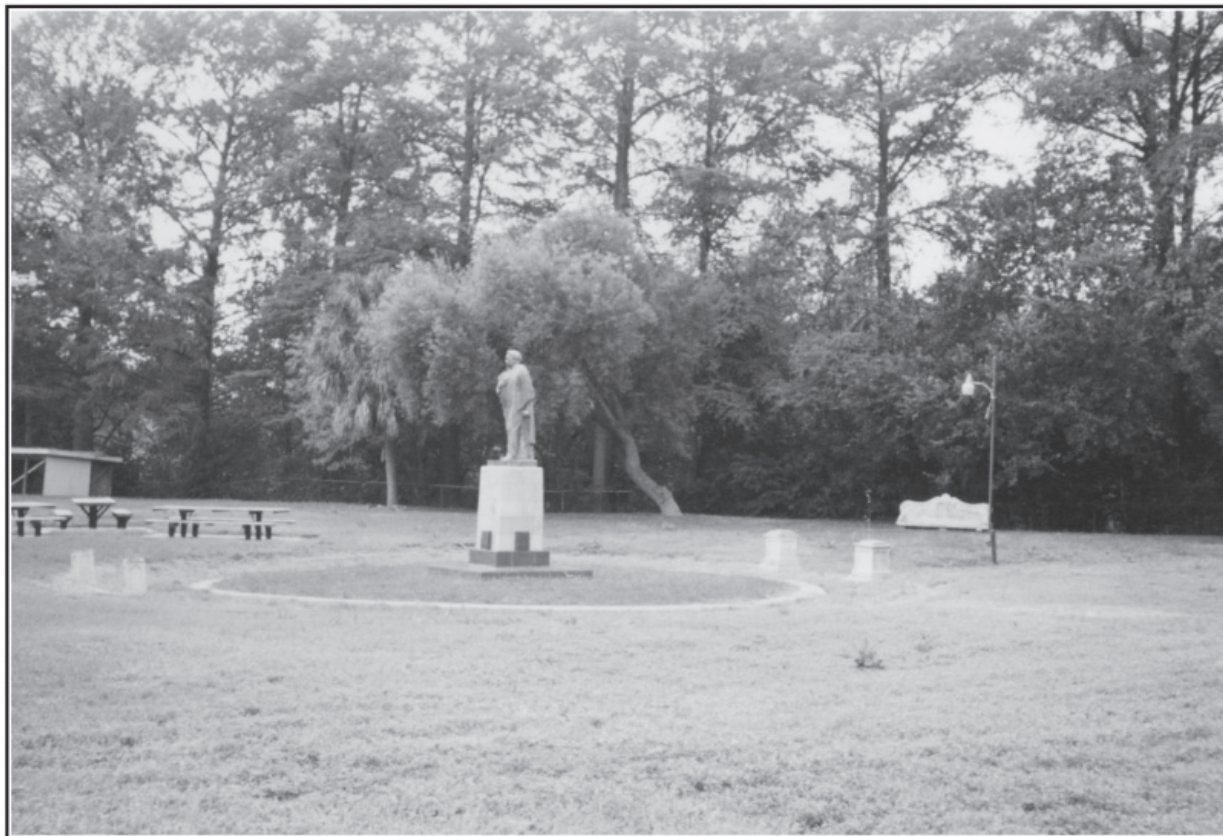
In other areas such as the reflecting pool, the stage, and the pool south of the artesian well, large amounts of fill appear to have been brought in to level and perhaps raise the grade, and bury abandoned features. The reflecting pool was capped with a layer of gravel, and then sandy soil (Figure 5-1). Also, the brick pathway from the reflecting pool to the main gravel path is buried under 15-20 cm of fill (Figure 5-2). It is likely

Figure 5-1. Photograph of the filled in reflecting pool.

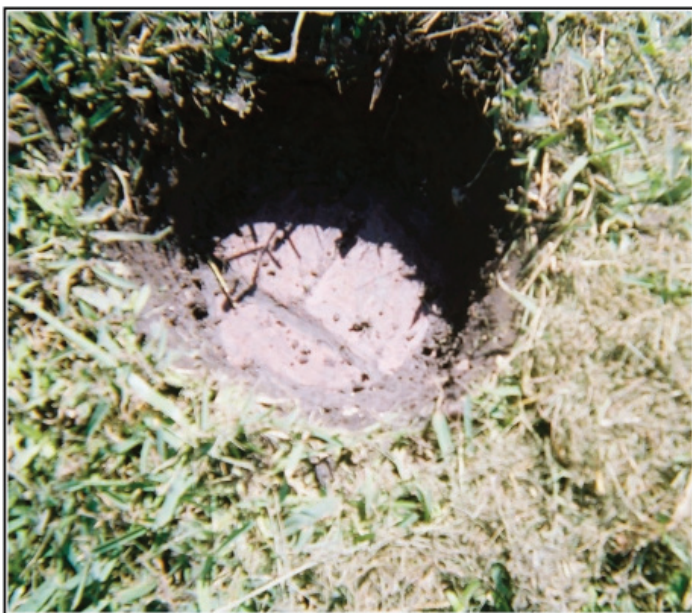
Figure 5-2. Photograph of Shovel Test 99 revealing portion of brick pathway below surface.

that the brick walkway was purposefully covered, because the entire area contains fill and the picnic tables (which were installed in the 1960s) appear to have been placed over the path. Just to the northwest of the reflecting pool is the *Banco del Amor* (Figure 5-3). Comparisons of modern and historic photographs of the bench reveal that today there is approximately one to one and a half feet (45 cm) of sediments covering the base of the feature.

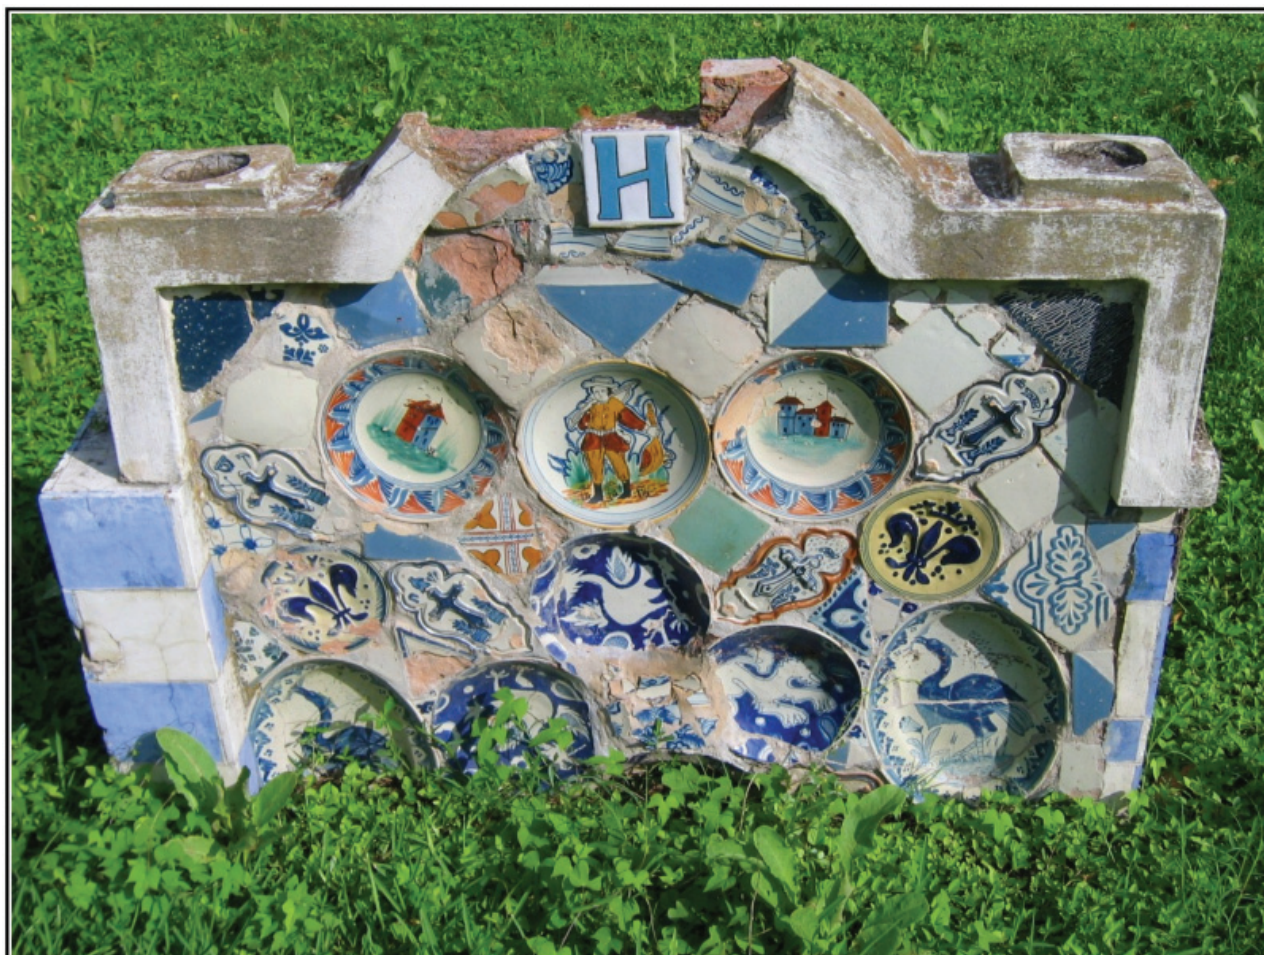
Figure 5-3. Recent photograph of the Banco del Amor. Fill completely covers the bench seat.

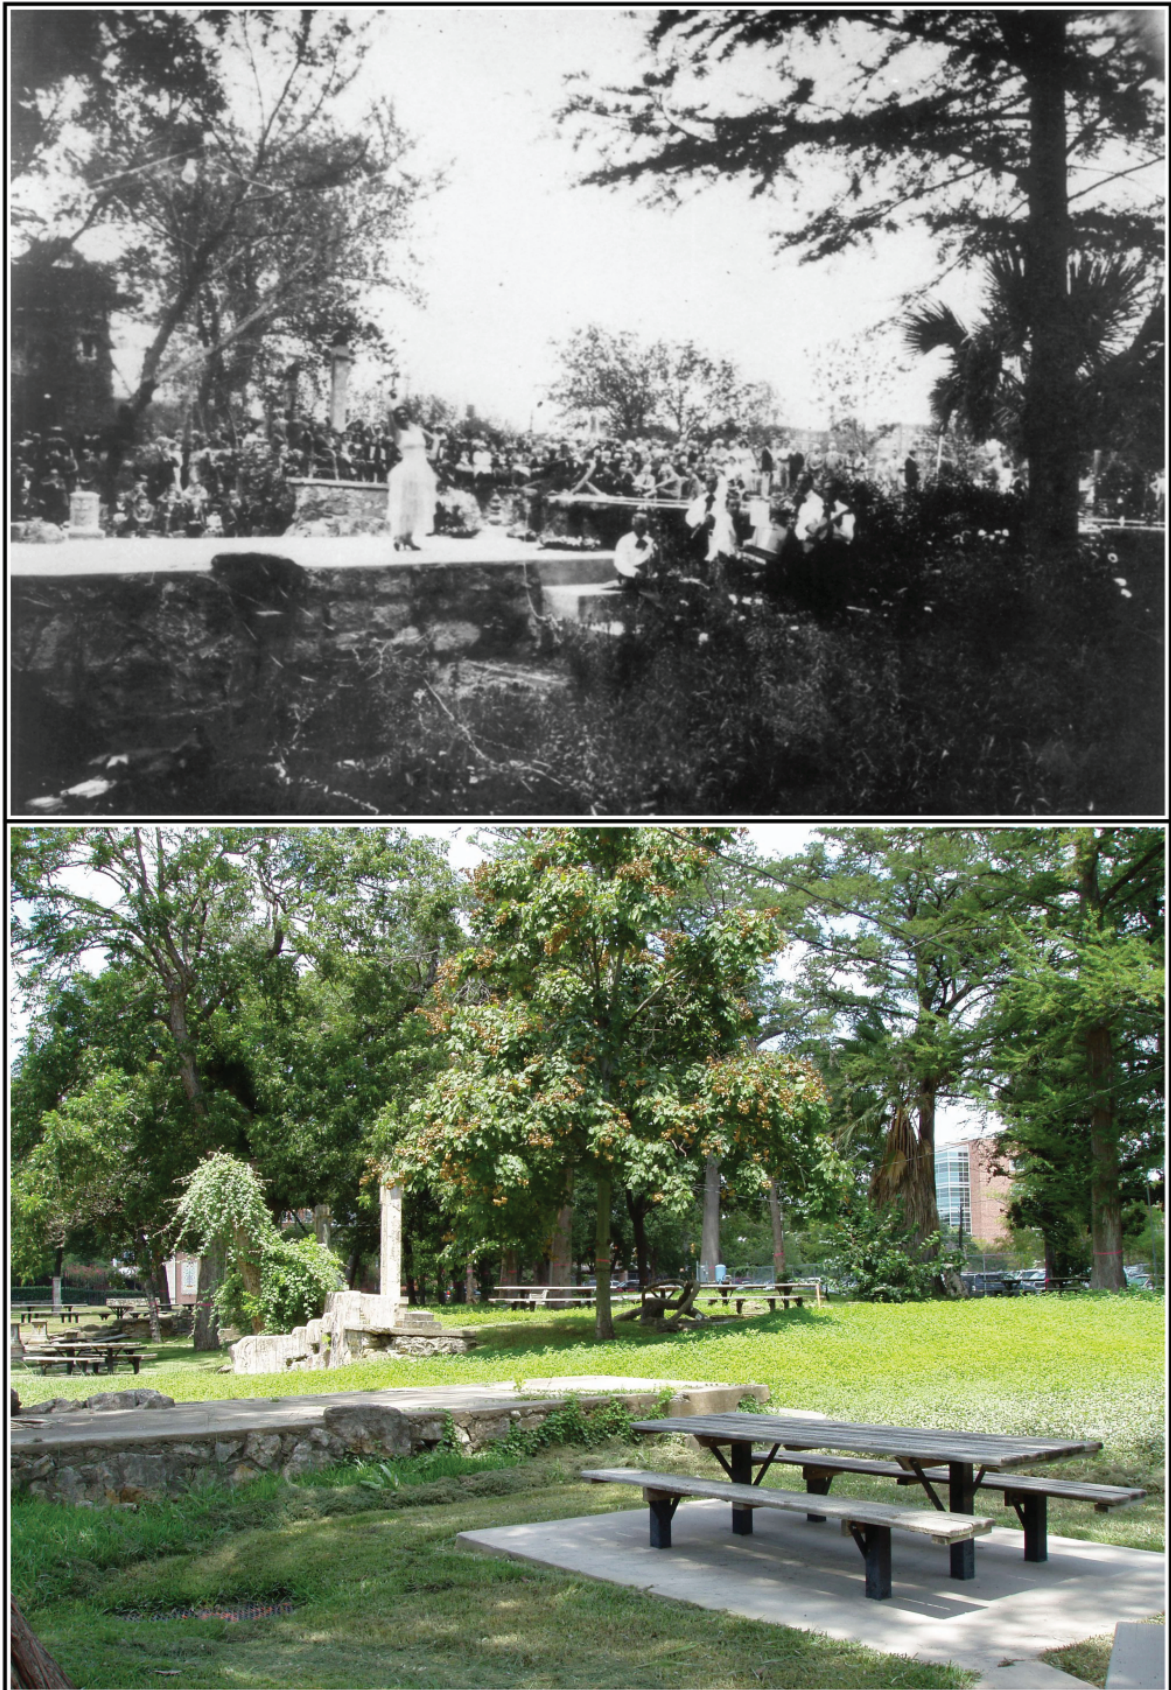
Historic photographs of the stage reveal that there is up to four feet (120 cm) of fill in some areas surrounding the feature (Figure 5-4). Shovel Test 103, located at the eastern edge of the stage, revealed that another step is present below the modern surface. Early photographs reveal additional tile work along the western portion of the stage that is now buried. The photographs also indicate that a water feature ran beneath the middle of the stage. The entryway for this channel is barely visible today.

Figure 5-4. *Historic and recent photograph of the stage indicating the amount of fill present today.*

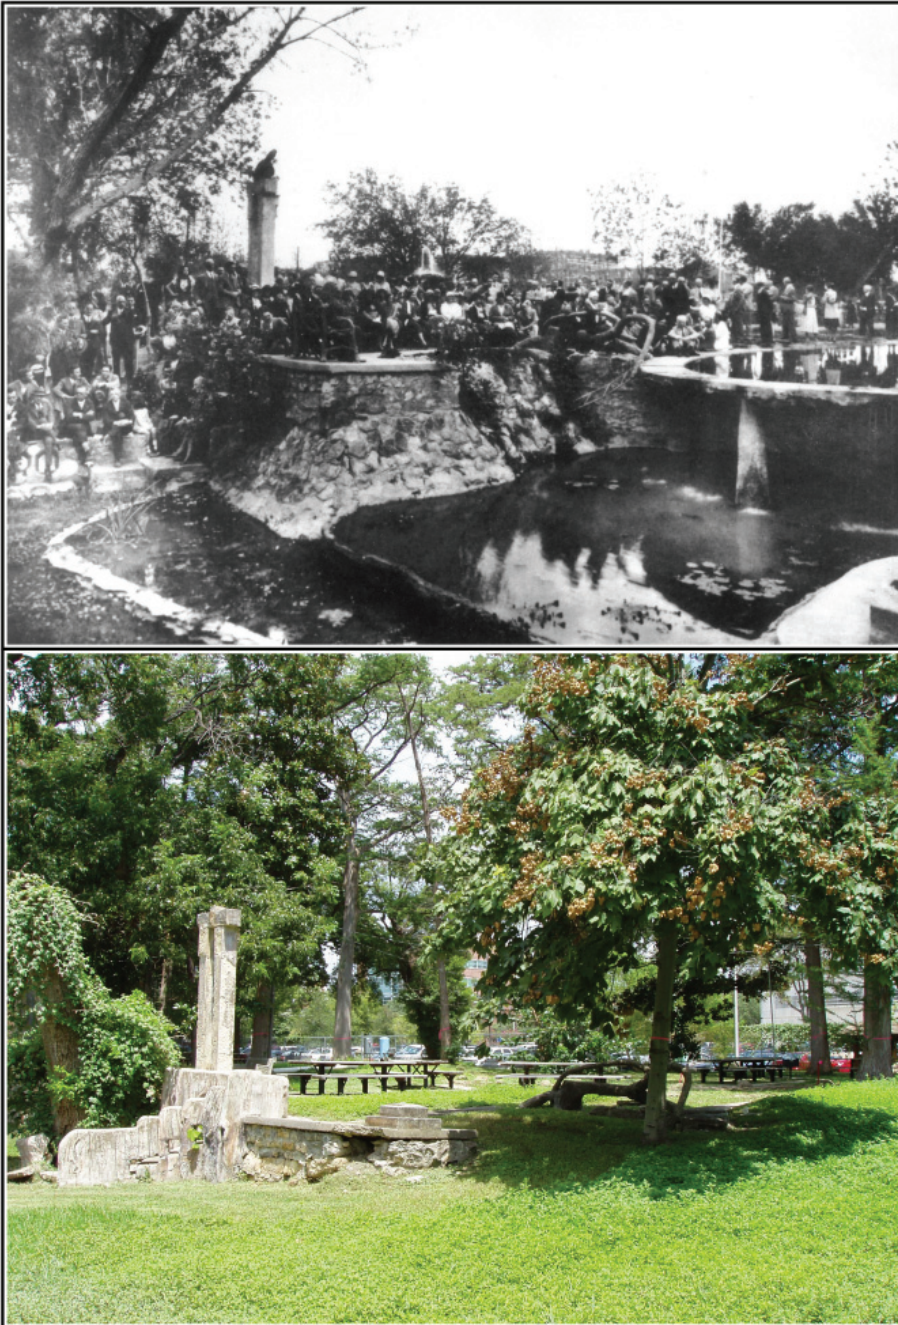
today, but shovel tests reveal that about half of the feature has been sheared away. Shovel Tests 105 and 111 reveal that the pool rim does not extend further than these points. Hard packed caliche was used to fill in the remaining portion of the pool to create a slope to the picnic tables near the pavilion. The caliche fill also creates a slope in the area that was the lower pool that housed water plants at the base of the upper pool. Auguring in Trench 1 indicates that the base of the lower pool is approximately five feet below the current surface. Historic

Figure 5-5. Historic and recent photograph of the lower and upper pool. Recent photograph confirms the amount of fill in the area.

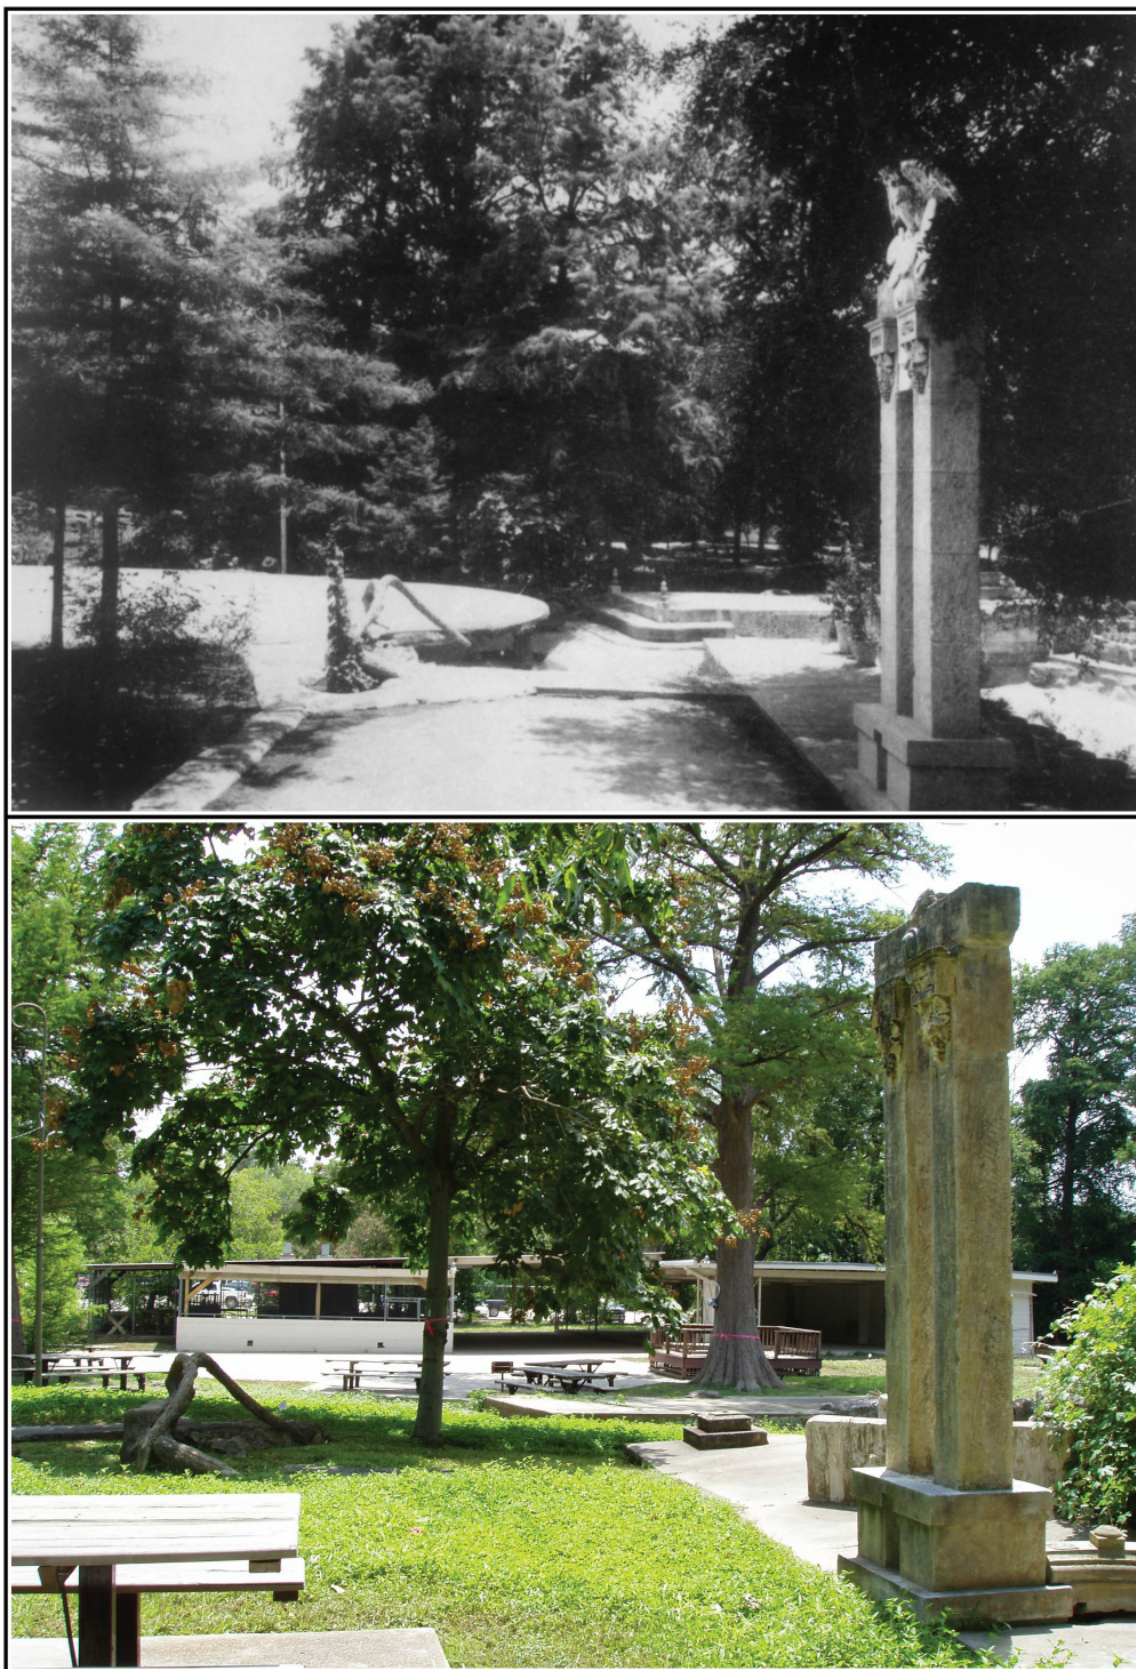
Figure 5-6. Comparison of historic and recent photographs of the path leading alongside the upper pool.

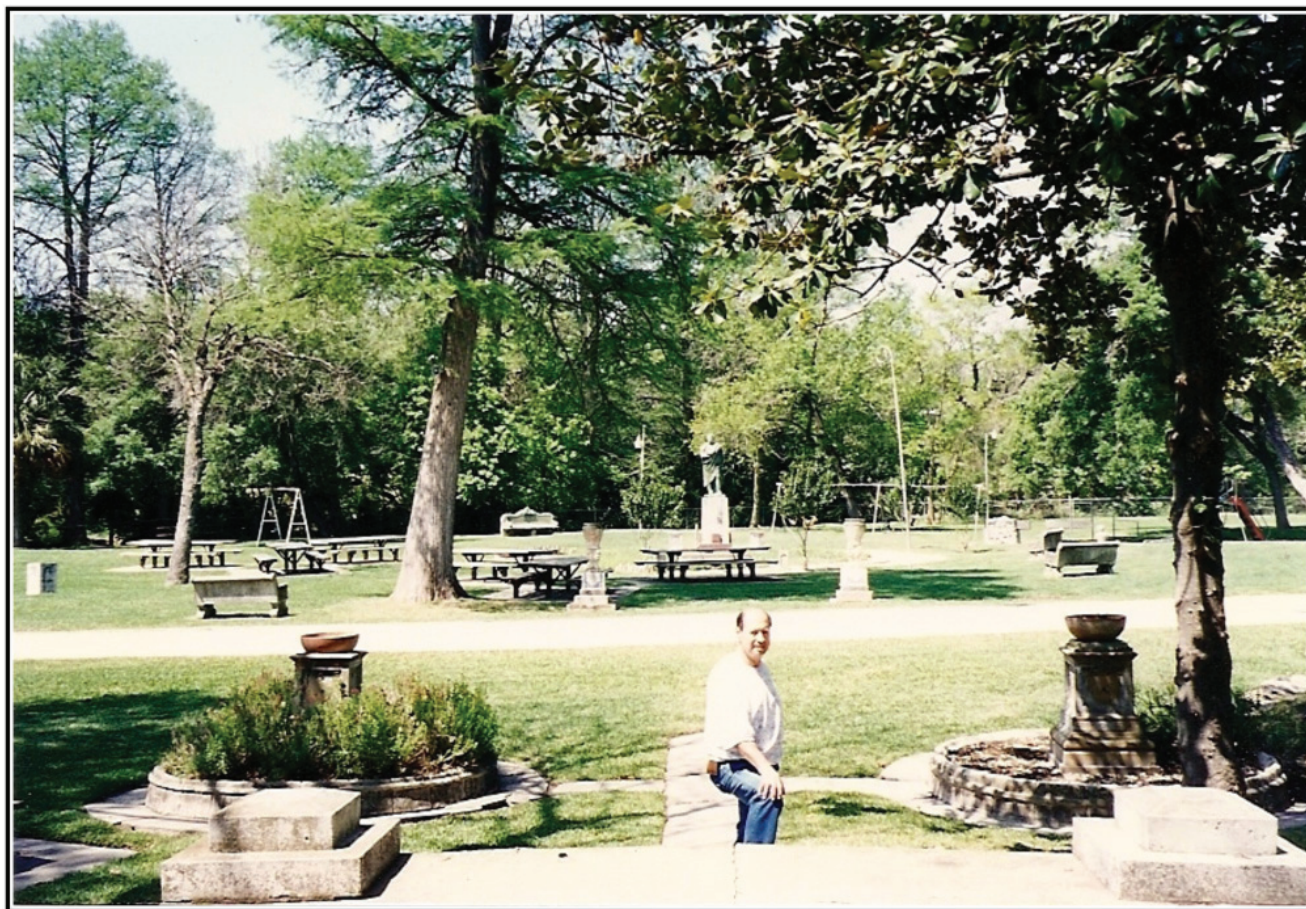
Figure 5-7. Photograph taken by family members in 1995 showing the gravel path and reflecting pool in background.

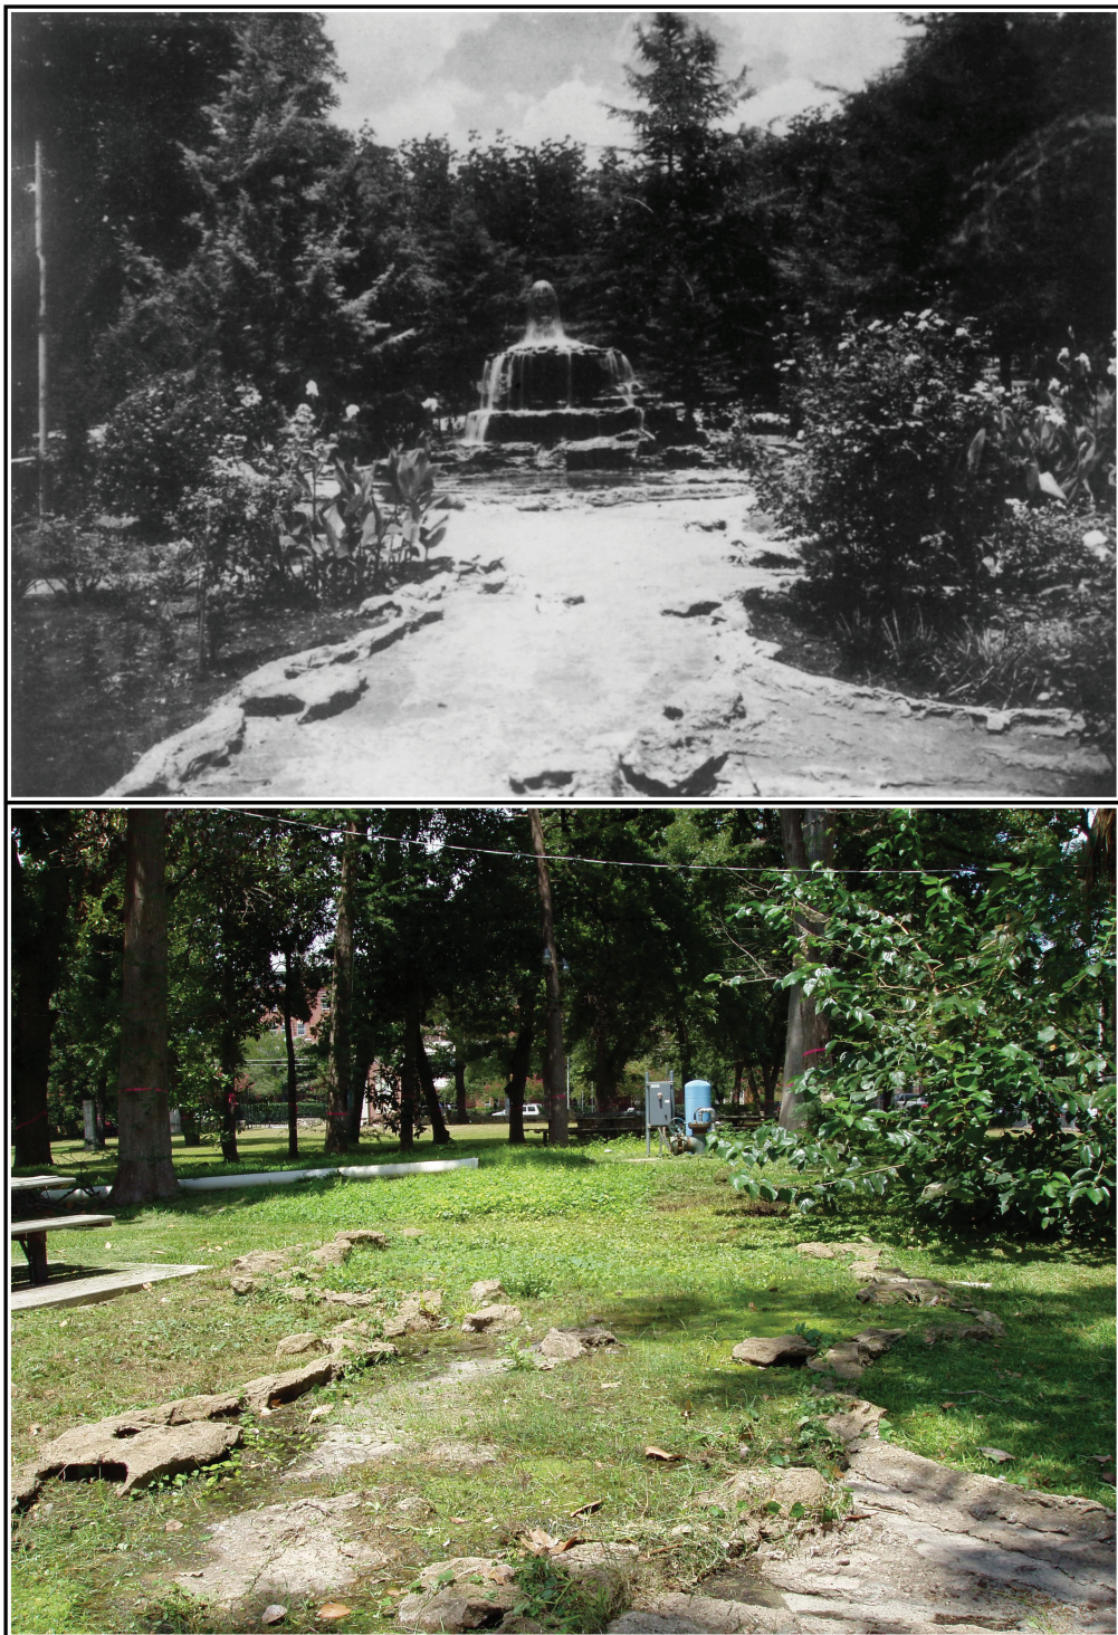
Figure 5-8. Comparison of historic and recent photographs of the artesian well fountain. Recent photograph shows the overgrowth on the water paths.

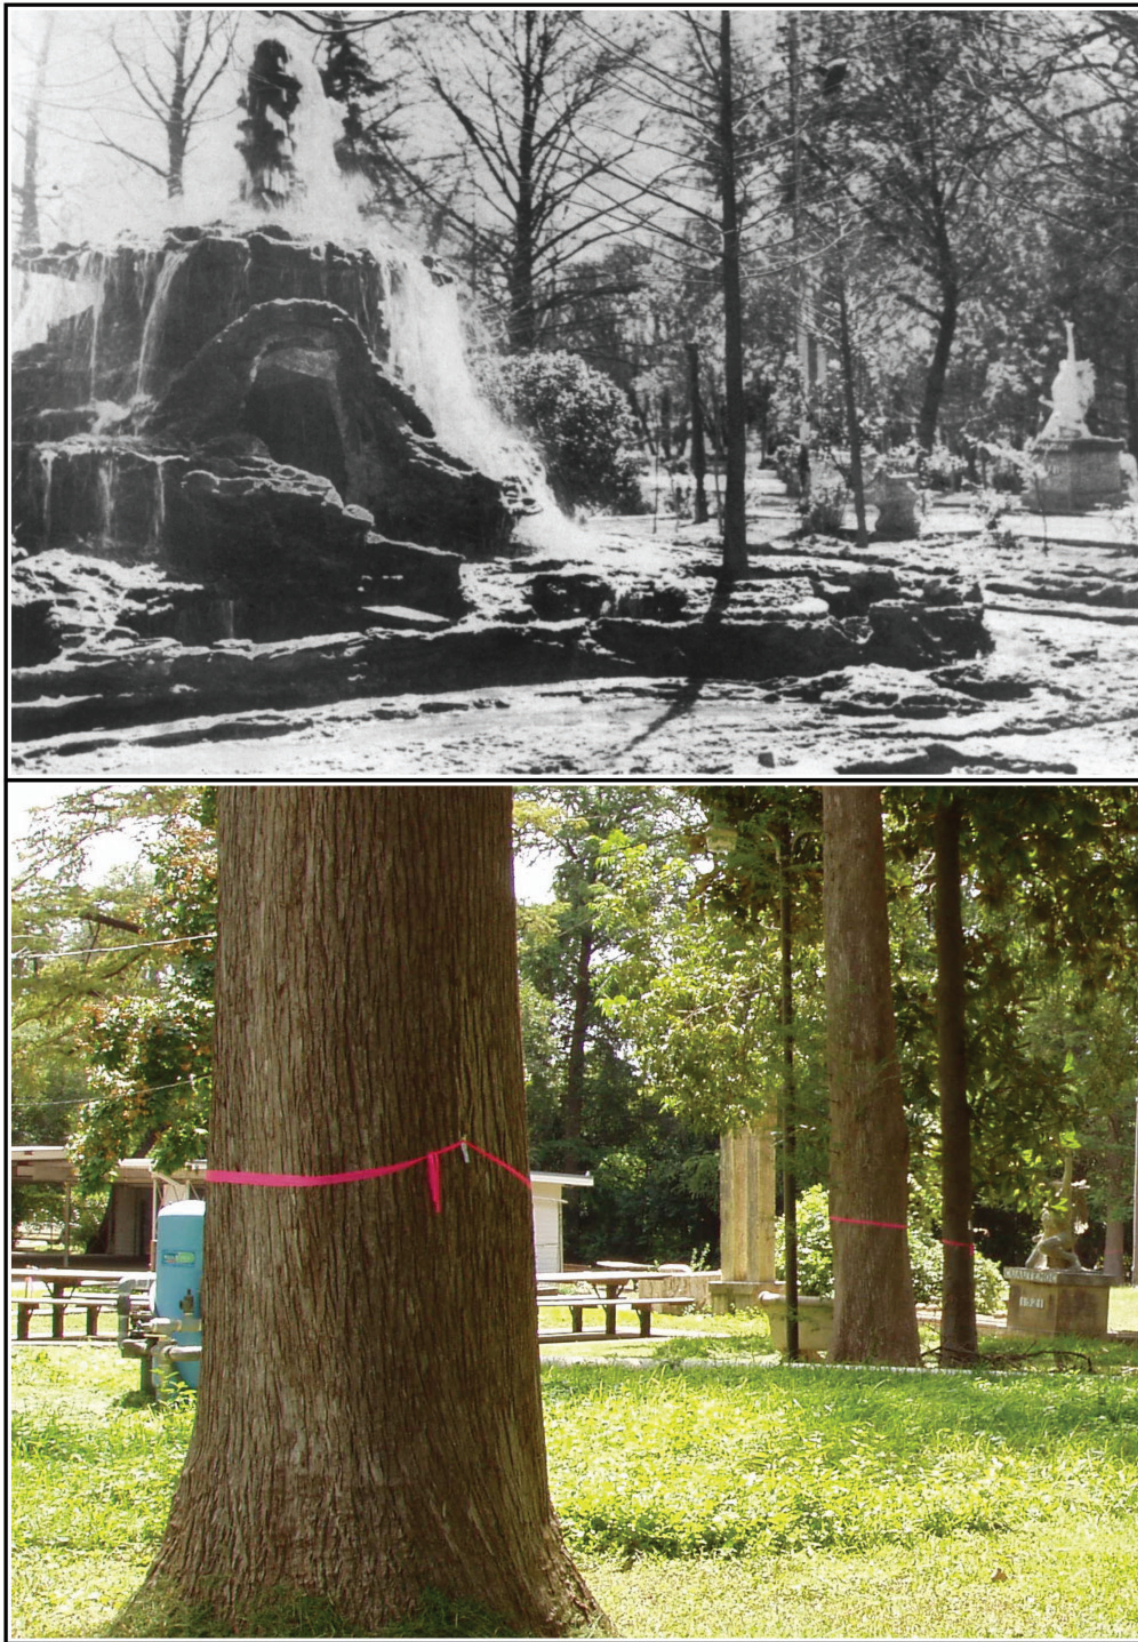
Figure 5-9. Comparison of historic and recent photographs of the fountain. Recent photograph shows the remarkable growth of a number of large trees as well as the removal of the fountain.
