Archaeological Services Associated with Improvements to Miraflores at Brackenridge Park, San Antonio, Bexar County, Texas

Texas Antiquities Permit No. 4653

Prepared by:
Center for Archaeological Research
The University of Texas at San Antonio
Archaeological Report, No. 387

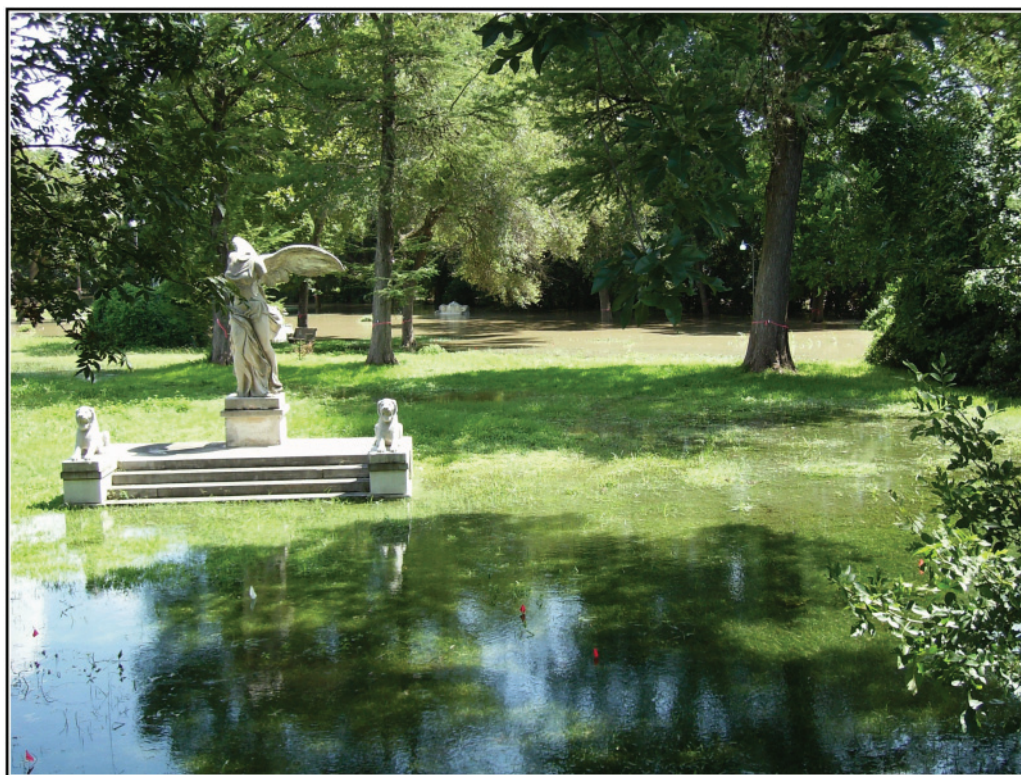
tested due to the swampy conditions (Figure 5-10). With the exception of the northeast portion situated above the 100 year flood plain, the remainder of the project area typically saw water seeping into the shovel tests and trenches between 40 and 60 cm below the current surface. The water table appears to have been lower during construction of the features within the park between the 1920s and the 1940s. Currently, several of the features, including the reflecting pool path, would be waterlogged if the upper layers of soil are removed to expose them (Figure 5-11).

Figure 5-10. Photograph of standing water found in the northwest portion of the project area prior to the testing.

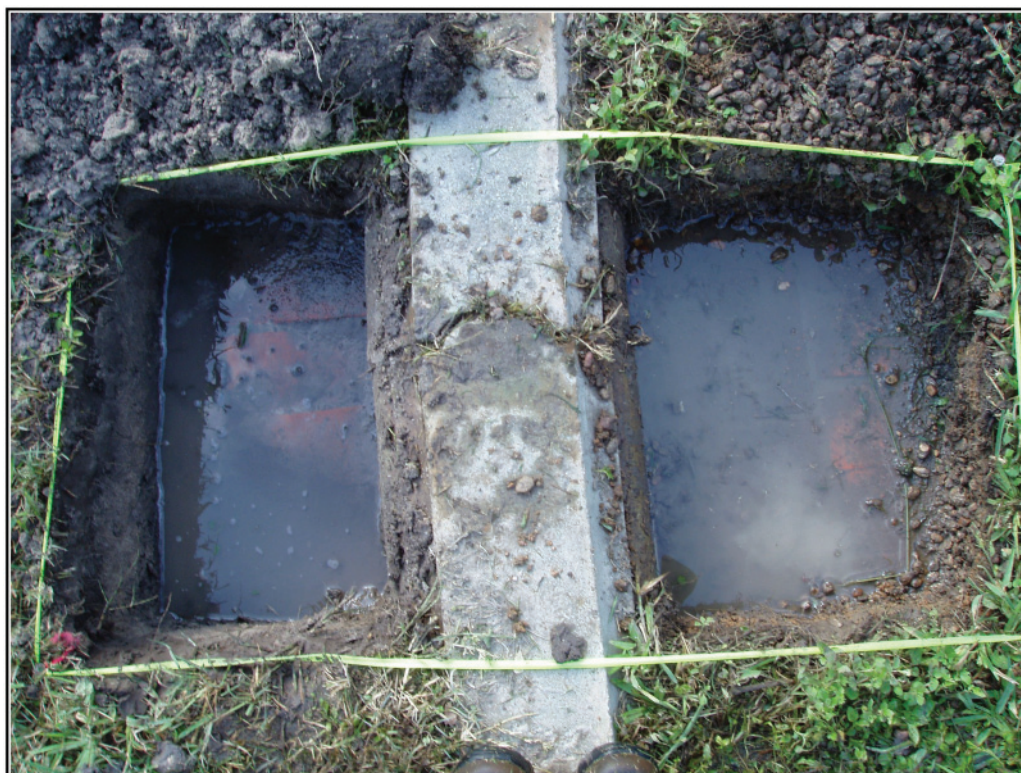
Figure 5-11. Photograph of water seeping into Unit 1 located along the reflecting pool path.

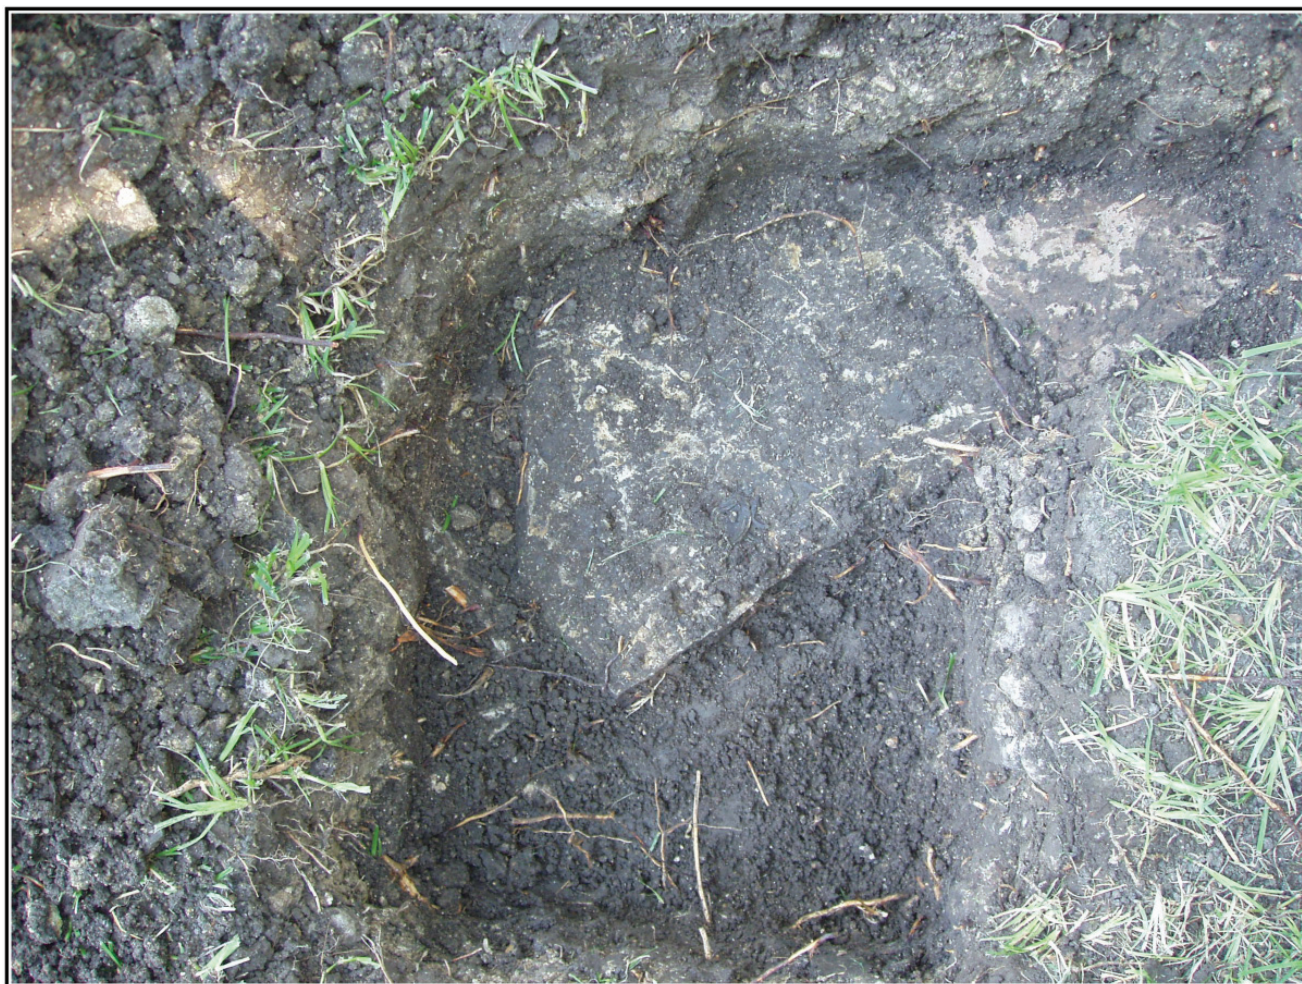
reflecting pool pathway. ST 109 encountered large limestone pavers (Figure 5-12). The shovel test was widened into a hand-excavated trench to investigate the feature and revealed several adjoining limestone pavers.

Figure 5-12. Photograph of the unknown feature uncovered in Shovel Test 109.

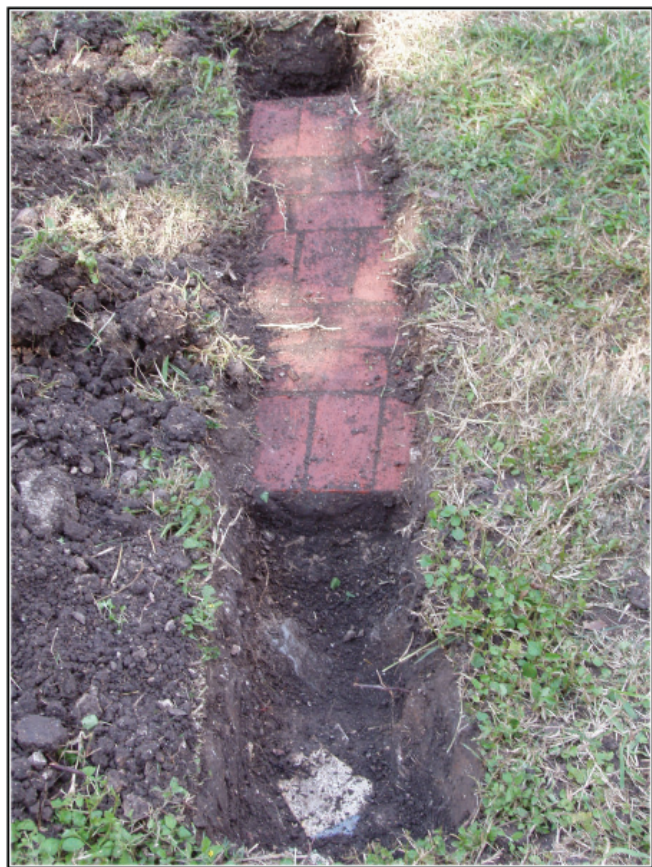
Figure 5-13. Photograph of the brick paved path outside of the library footprint.

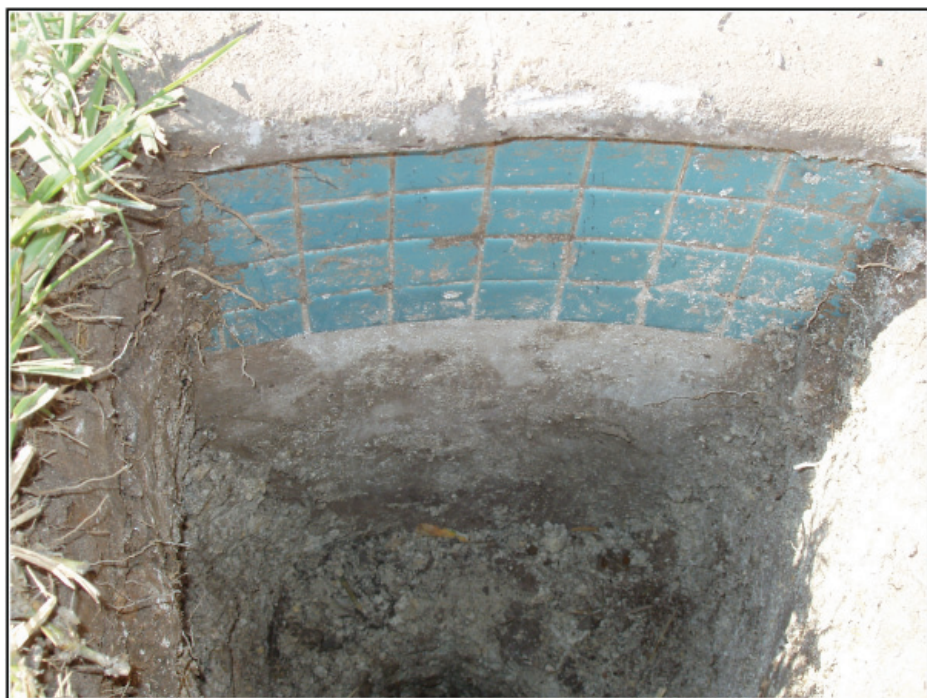
Figure 5-14. Photograph of Shovel Test 117 revealing the edge of the swimming pool.
