Archaeological Testing Associated with the Stabilization of Room 4 at Mission San Juan Capistrano, San Antonio, Bexar County, Texas

©2006
Archaeological Report, No. 368
Center for Archaeological Research
The University of Texas at San Antonio

Texas Antiquities Permit No. 4126

In May 2006, The Center for Archaeological Research excavated one test unit at the exterior north wall of Room 4, west of the chimney at Mission San Juan Capistrano. The excavation occurred to assess the condition of the foundation and the dimensions of a more recent concrete footing before restoration of the collapsed north wall. The excavation found disturbed deposits throughout the test unit, but was able to locate and record the architectural features for Ford, Powell, and Carson, Architects and Planners, Inc., the project sponsors. A composite map of all excavations conducted at the mission since 1931 is included with descriptions of the agency, dimensions and location of all excavations as reported to aid future cultural resource management of Mission San Juan Capistrano.

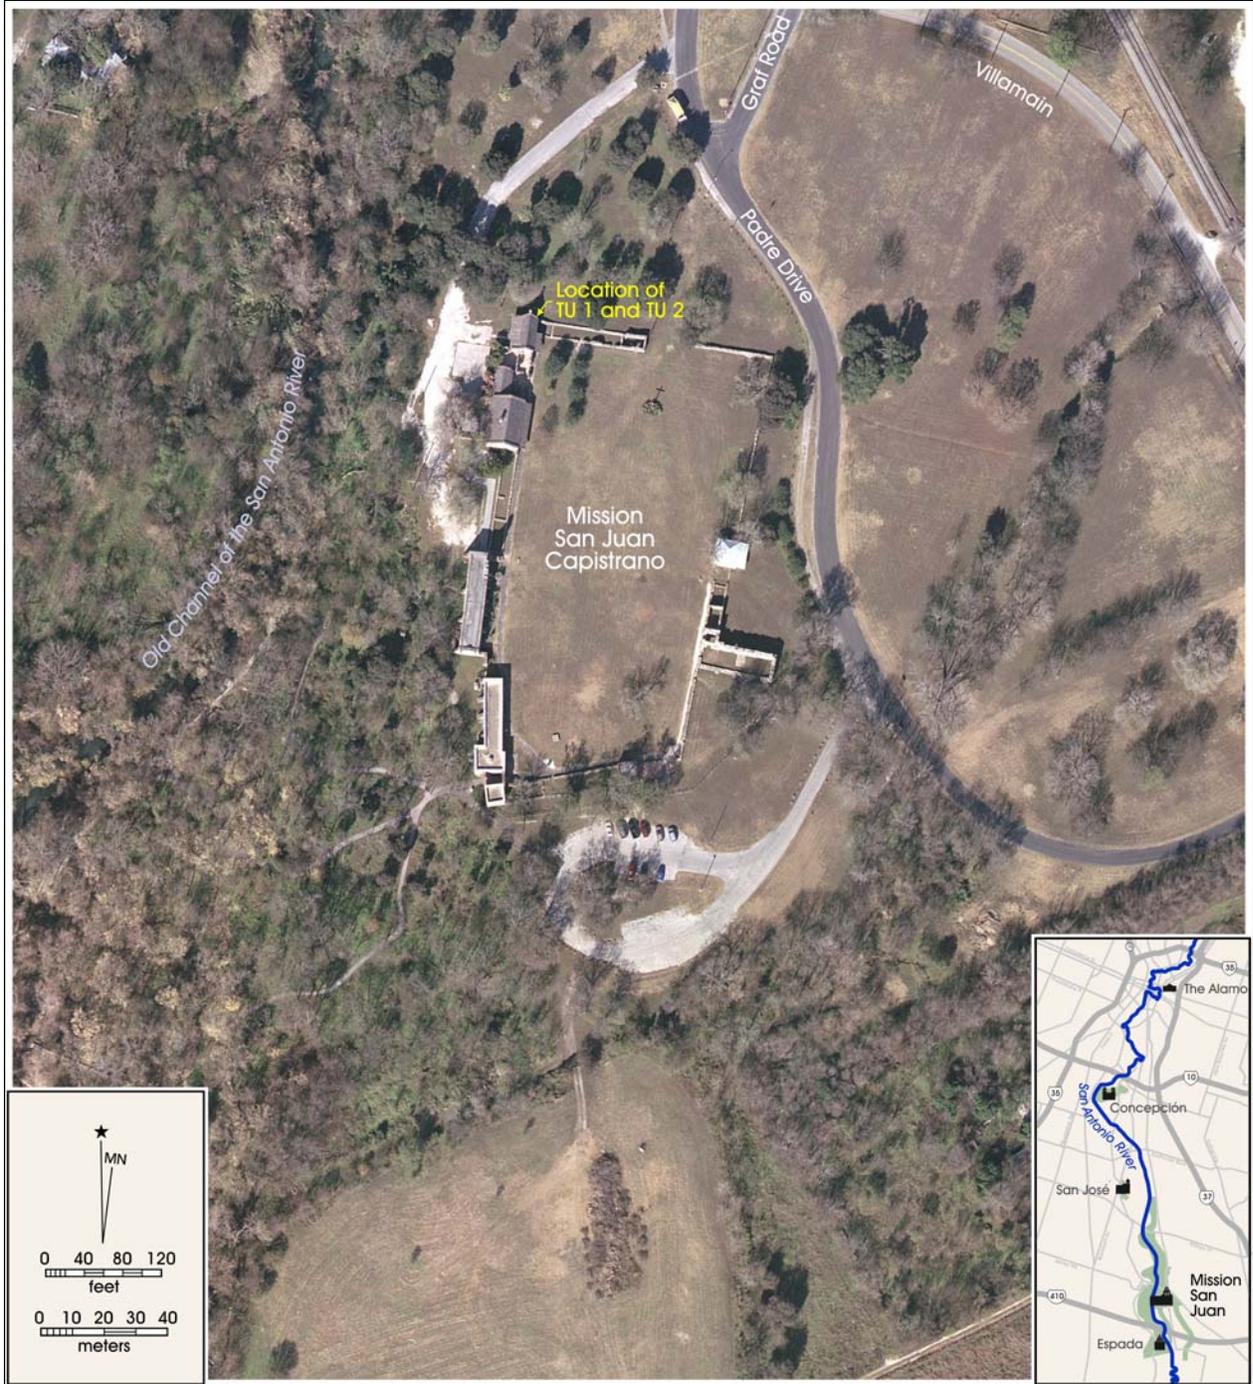
Figure 1. The location of Test Units 1 and 2 within Mission San Juan Capistrano.

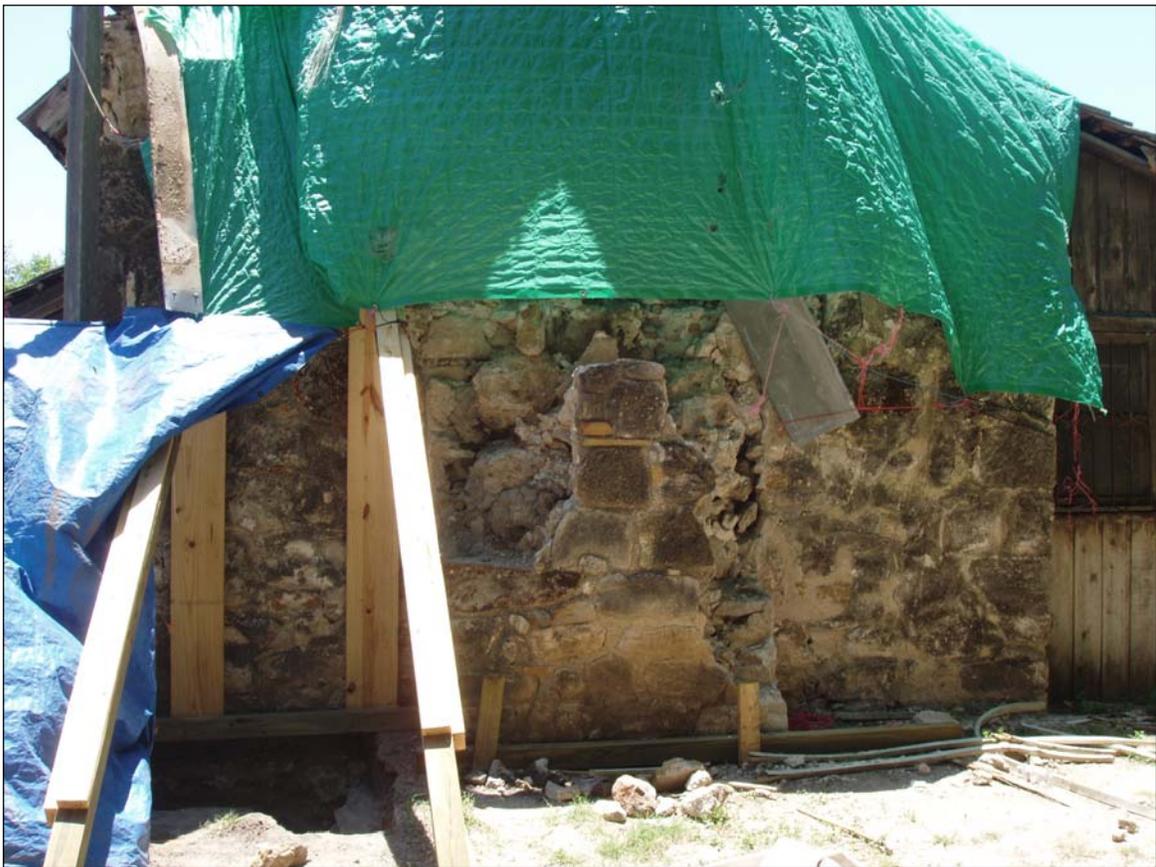
Figure 2. *The collapsed chimney and north wall of Room 4.*

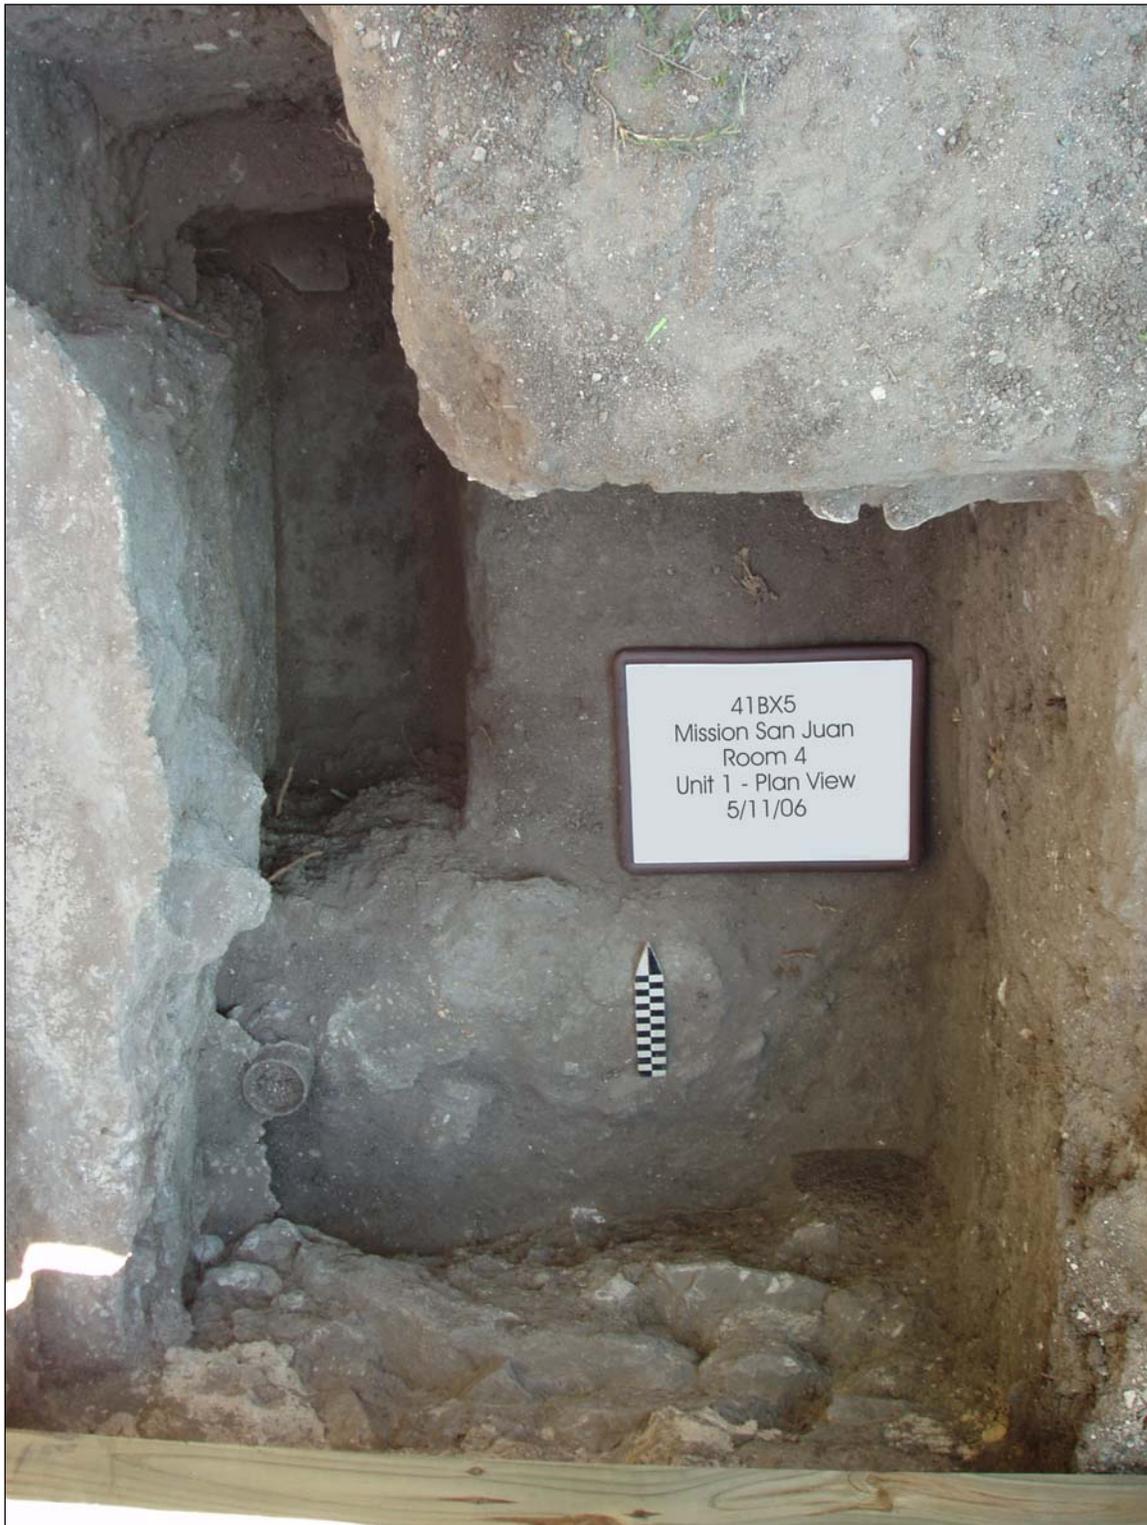
Figure 9. Photograph of final excavation of Test Unit 1.

CAR exposed the chimney footing and part of the exterior north wall of Room 4 in Test Unit 1, a 1-x-1-m (3.28-x-3.28-ft) test unit, 30 cm (11.81 in) east of the chimney (Figure 8). The unit datum was placed north of the unit. All elevations were taken from the ground surface at this point. Ground surface rises toward the building so elevations below surface were approximately 5 cm deeper near the north wall. Most of the 1-x-1-m unit was excavated to 70 cmbd (2.3 ft). In order to find the bottom of the concrete footing supporting the chimney, the northwest corner (40-x-60 cm; 1.31-x-1.97 in) was excavated deeper to 100 cmbs (3.28 ft). We also expanded 40 cm of the northwest corner 40 cm to the north in Test Unit 2 to locate the corner of the concrete footing. The units exposed 117 cm (3.84 ft) of the chimney footing (north to south) and 100 cm (3.28 ft) (east to west) of the north wall foundation (Figure 9).

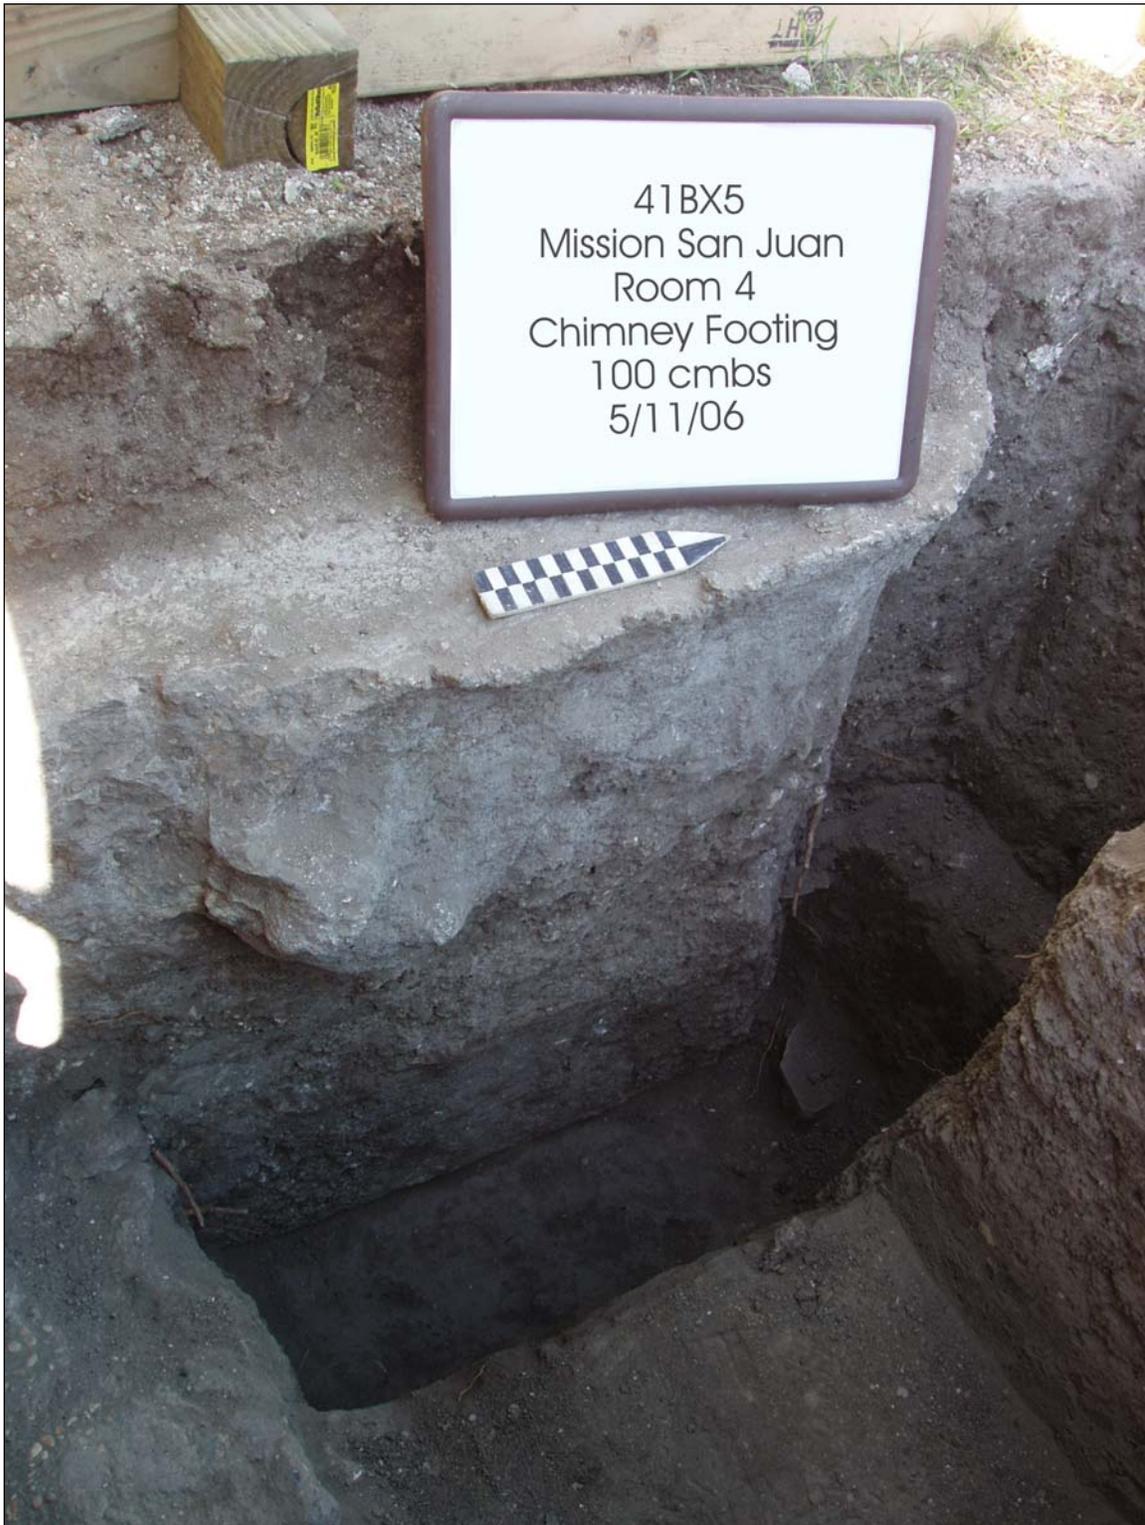
Ford, Powell, and Carson, Inc. was interested in determining the parameters of the foundation and the chimney footing of Room 4. The excavation revealed the surface of the chimney footing at 12 cmbs (4.72 in) and the edge 45 cm east of the chimney. The base of the chimney footing is at 100 cmbs. The height of the footing (top to bottom) is 88 cm (34.5 in) (Figure 10). At 48 cm (1.57 in), we uncovered a pylon set in concrete supporting the chimney footing. The center of this pylon is approximately 20 cm north of the foundation and 5 cm from the edge of the footing (Figures 8 and 9). At 69 cmbs, excavations uncovered overflow concrete across the northern portion of the unit from the pylon installation (Figure 8). Excavations revealed the base of the foundation at 60 cmbs (Figure 11). Mortar and rock crumbled from the foundation despite careful excavation. There is no recent footing supporting the foundation (Figure 12).

Figure 10. *Photograph of the chimney footing exposed in Test Unit 1.*

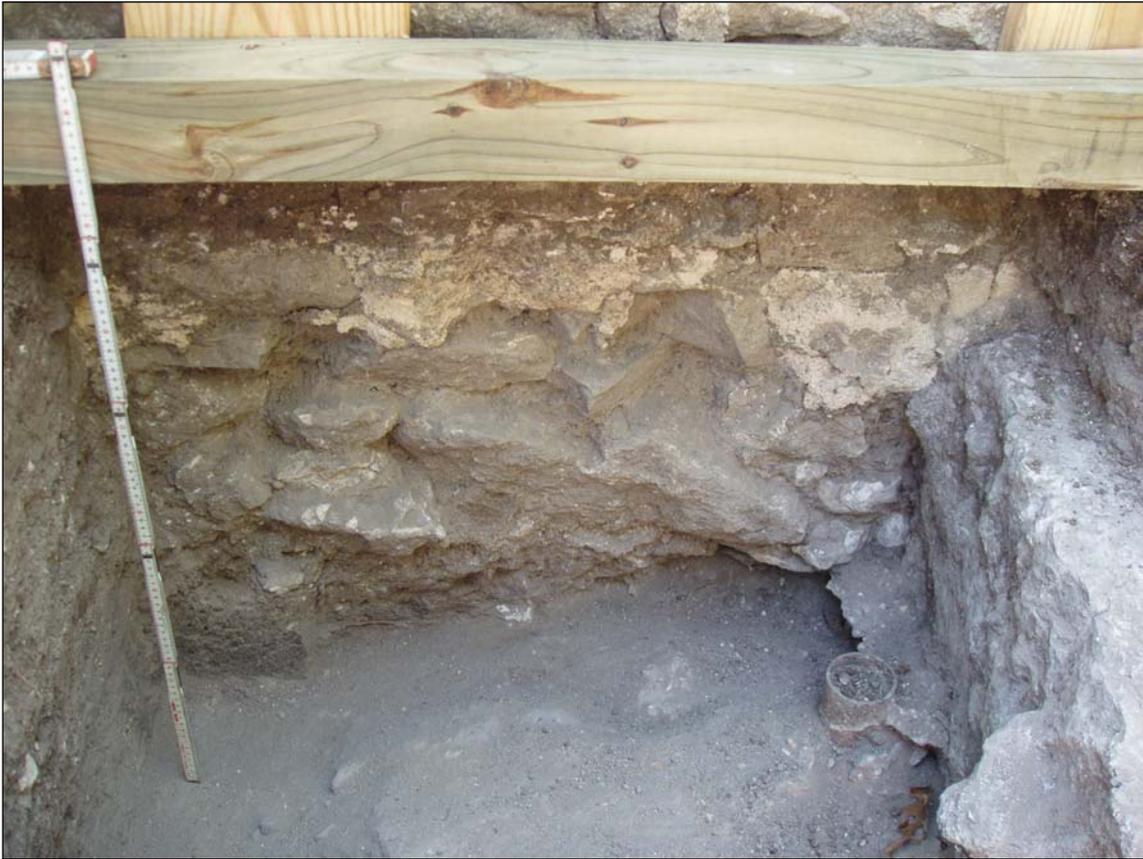
Figure 12. *Photograph of the foundation.*

Artifacts recovered from the testing included numerous ceramics from the eighteenth and nineteenth centuries, fragmented animal bone, building materials, and a few glasswares. All these artifacts were discovered in the upper 70 cm of the test unit. None is believed to contribute to new knowledge of the mission; therefore, the Center for Archaeological Research recommends that the restoration of Room 4 proceed.
