Archaeological Investigation of the Gristmill at Mission San Jose y San Miguel de Aguayo, San Antonio, Texas

**Archaeological Investigation of the Gristmill
at Mission San José y San Miguel de Aguayo,
San Antonio, Texas**

©copyright 1998
Center for Archaeological Research
The University of Texas at San Antonio
Archaeological Survey Report, No. 272

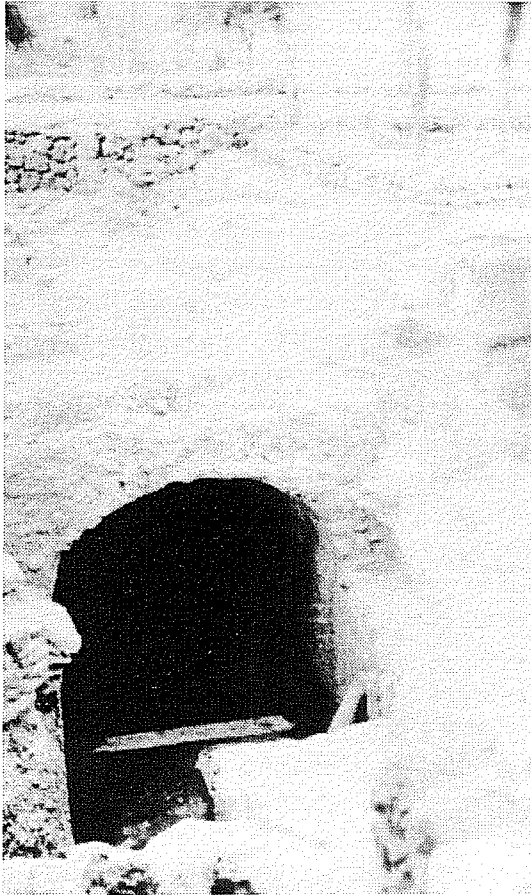
Figure 2. *Vaulted turbine housing, facing south.* Courtesy Daughters of the Republic of Texas Library.

The WPA reconstruction followed plans designed by Ernst Schuchard (then an employee of Pioneer Flour Mills in San Antonio). In short, Schuchard’s research culminated in the mill that exists today: water from the acequia would have been directed into the forebay through a sluice. The sluice apparently would have had a mechanism (most probably a wooden gate) to control the flow of water into the forebay. An aperture near the bottom of the forebay would have discharged water into the vault directly onto the mill turbine. The mill wheel itself was horizontal with a series of angled paddles radiating from the shaft. Wa-

ter entering the vault would have struck the paddles with enough force to turn the grindstones (Schuchard 1934:9). An engineer who studied the mill at San José concluded that the forebay's design ensured that water entered the vault and struck the turbine at a constant rate. The overall quality of the flour is improved when the number of revolutions per minute of the millstones can be kept at a uniform rate (Czibesz 1955:4).

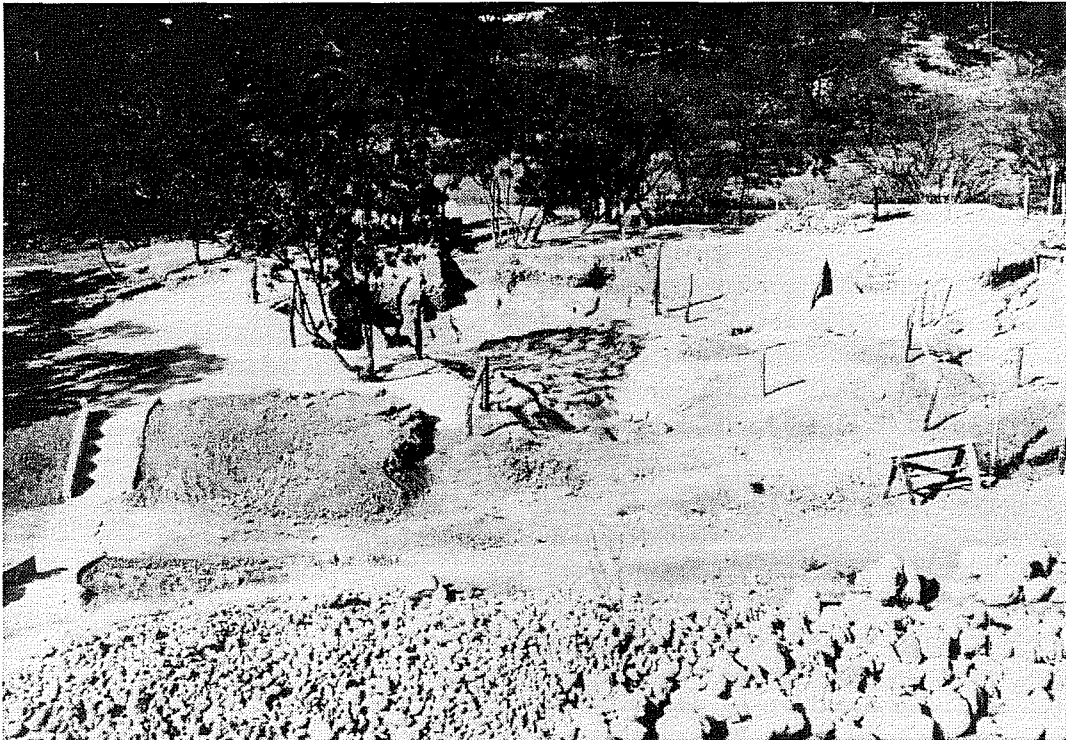
Figure 3. *Gristmill reconstruction, facing north.* Courtesy San Antonio Missions NHP.

It was thought that the stairs identified in Area A were Colonial in origin; however, excavation and archival research strongly support a modern origin. Clark states as much, and also shows the stairs on a site map with the date "1933" in parentheses (1978:54, Figure 3). While it might be assumed that Clark found evidence for the origin of the stairs in Smith's field notes, this is never explicitly stated in Clark's report. Figure 3

shows the stairs as they looked during the 1930s reconstruction. It is not clear in the photo if the stairs are a reconstruction of a preexisting Colonial feature, or an entirely new construction built by Smith. The associations of the soils in the east wall of Area A (Units A, B, and C) with the stairs and the artifact content of these soils support the latter.

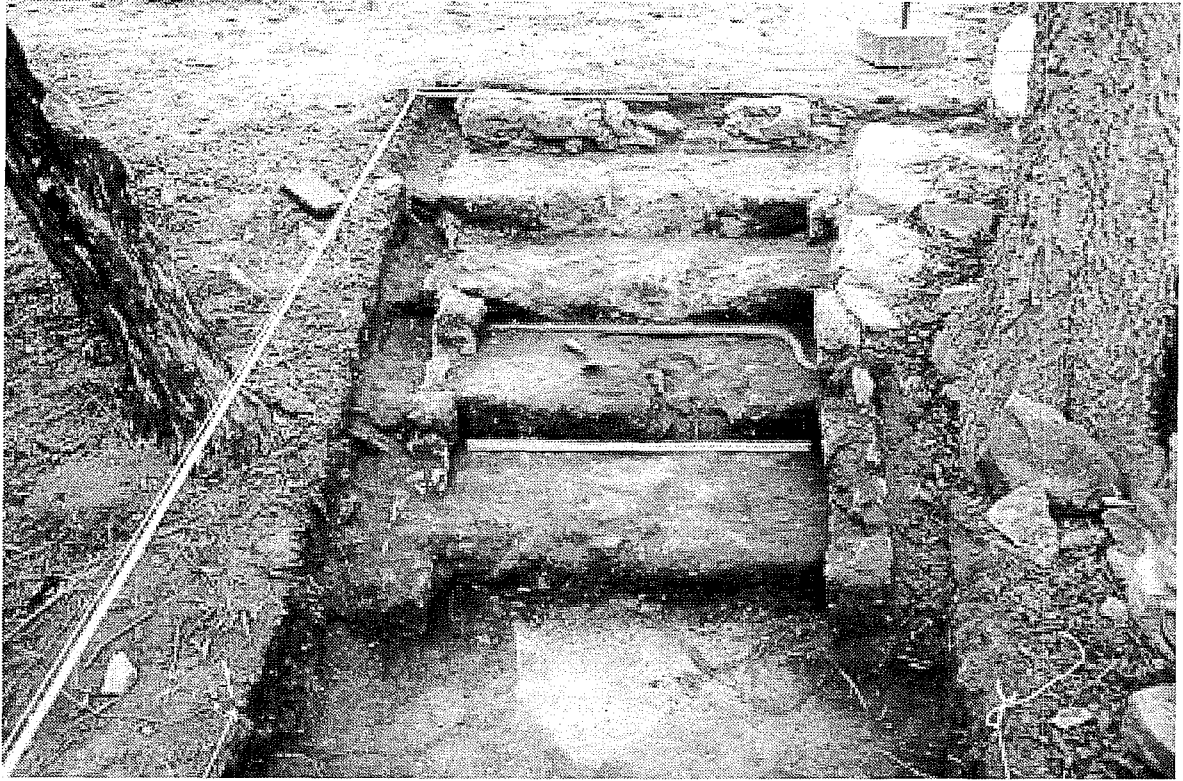
Figure 5. *South stairway, Area A.*

limestone stairs on the south (Feature 1) and north sides (Feature 2) of the acequia were collected separately. Along both outside edges of the stairs a course of stone was placed and cemented with a loose sandy mortar. Both sets of stairs were fairly uniform in size. Each step was approximately 40 inches wide (excluding the single course of stone on each side), six to seven inches thick, and between 14 and 20 inches deep.

The first two steps on the south side were fragmented; the first step apparently as the result of grounds-keeping activities and erosion, and the second from erosion only (Figure 5). The next three steps were better preserved, showing only slight damage from erosion. A triangular flagstone, with a maximum width of 27 inches and a maximum length of 24 inches, was identified after the last step at the bottom of the south stairs.

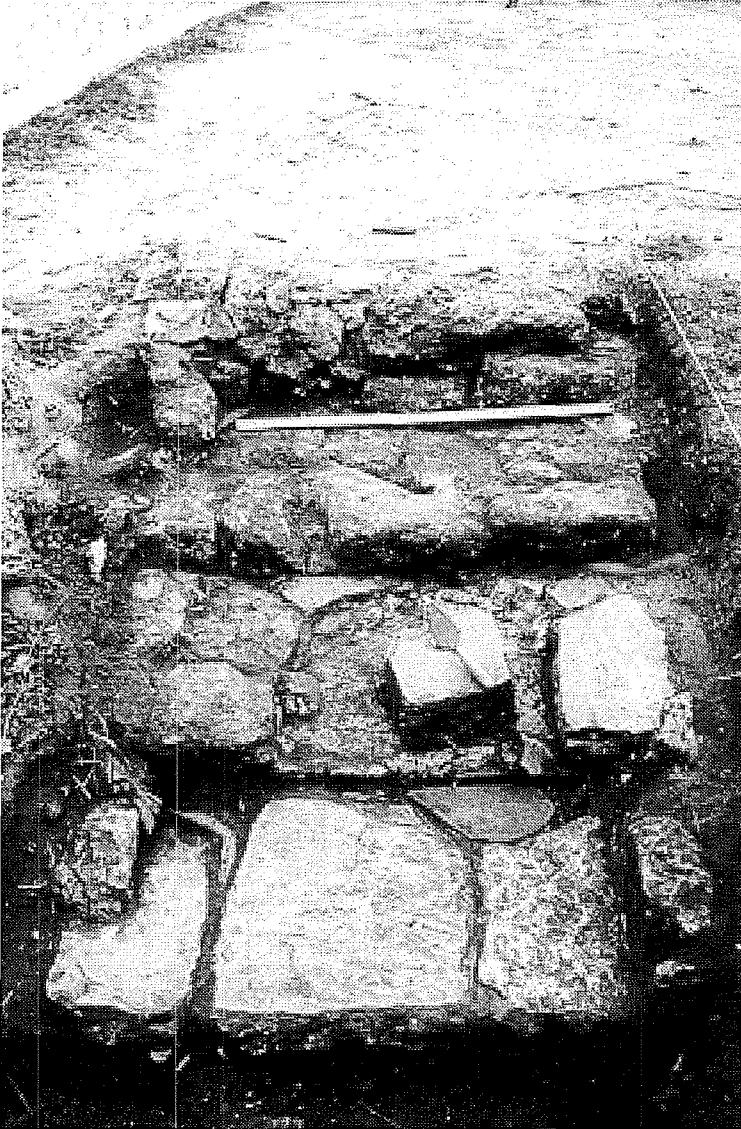
Figure 6. North Stairway, Area A.

The stairs on the north side of the acequia were also cleared of overburden. Only four steps were identified on this side (Figure 6). A photograph taken during the WPA reconstruction (Figure 3) suggests that in ca. 1934 there were five steps, so it appears the

topmost step is missing. The northern staircase was relatively less intact and less uniform than the southern staircase. The intrusion of large roots from a nearby hackberry tree are probably responsible for the fragmentation of the north stairs. The topmost remaining step had been repaired at an unknown time with Portland cement. The other steps were in pieces, with 50 percent of the third step missing. Besides the topmost step, all the steps on the north side of the acequia were constructed with the same loose, sandy mortar found in the south stairs.

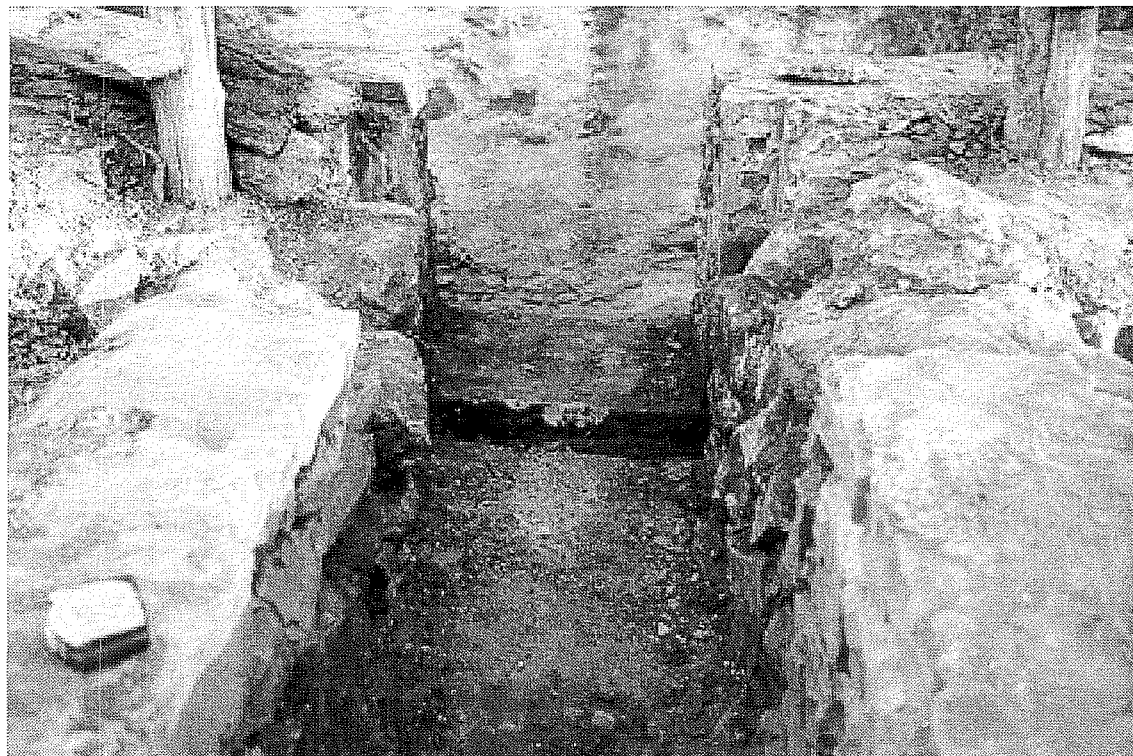
Figure 8. *Excavated sluice, looking north toward the mill.*

Area B was centered around the stone-lined sluice leading from the acequia to the forebay (Figure 8). Excavation of the sluice was undertaken to determine its association with the acequia and existence of any unknown structures related to the operation of the mill itself. An arbitrary datum was established along the west wall of the sluice (584.15 ft amsl).

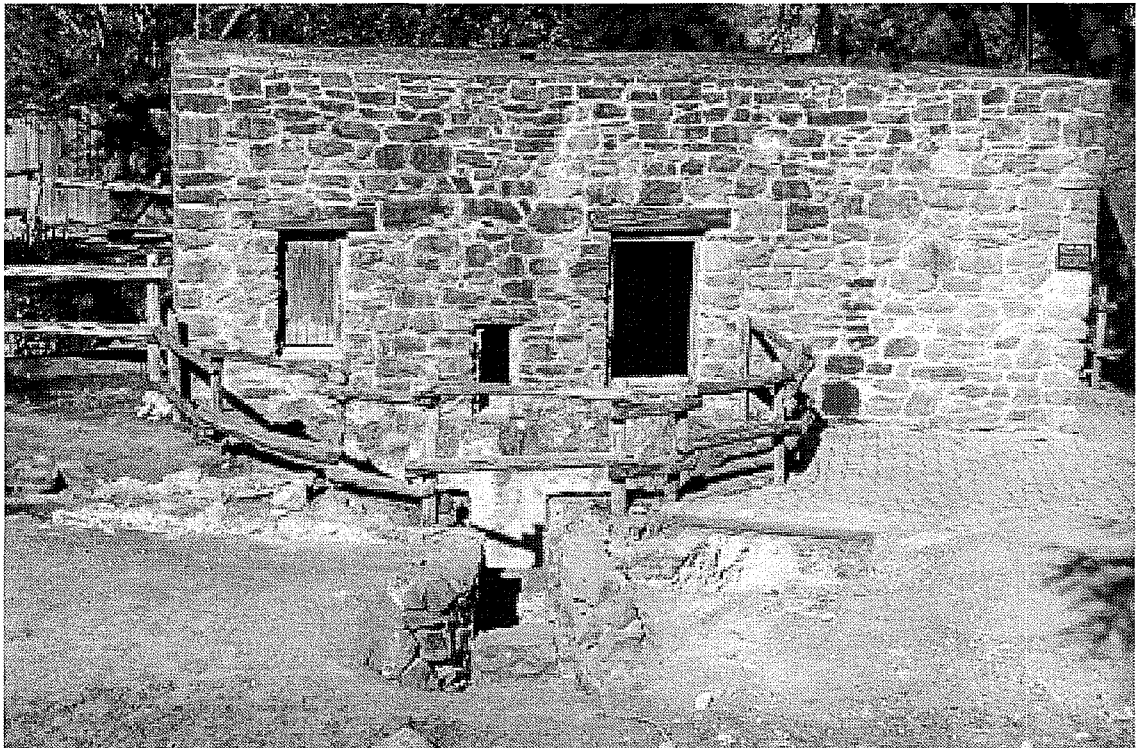
Figure 9. Area B, after excavation, looking north from the mission wall.

Unit H, measuring 2.5 x 3 ft, was adjacent to the east wall of the sluice. The northern edge of the unit is delineated by the south wall of Feature 5. Zone 1 is similar to Zone 1 in Unit E, with pea-sized gravels to a depth of 3–5 inches below the surface. Directly under this zone was a layer of sandy clay mixed with limestone cobbles up to six inches in diameter. This second zone continued to the bottom of the wall, 20–23 inches below the top of the wall. As with Feature 3, the limestone cobbles were mortared with a loose, sandy mortar and showed no formal coursing (Figure 9).
