Archaeological Excavation of the Priest Quarters, Mission San Francisco de la Espada, 41BX4, San Antonio, Texas

Center for Archaeological Research
The University of Texas at San Antonio
Archaeological Survey Report, No. 295
2000

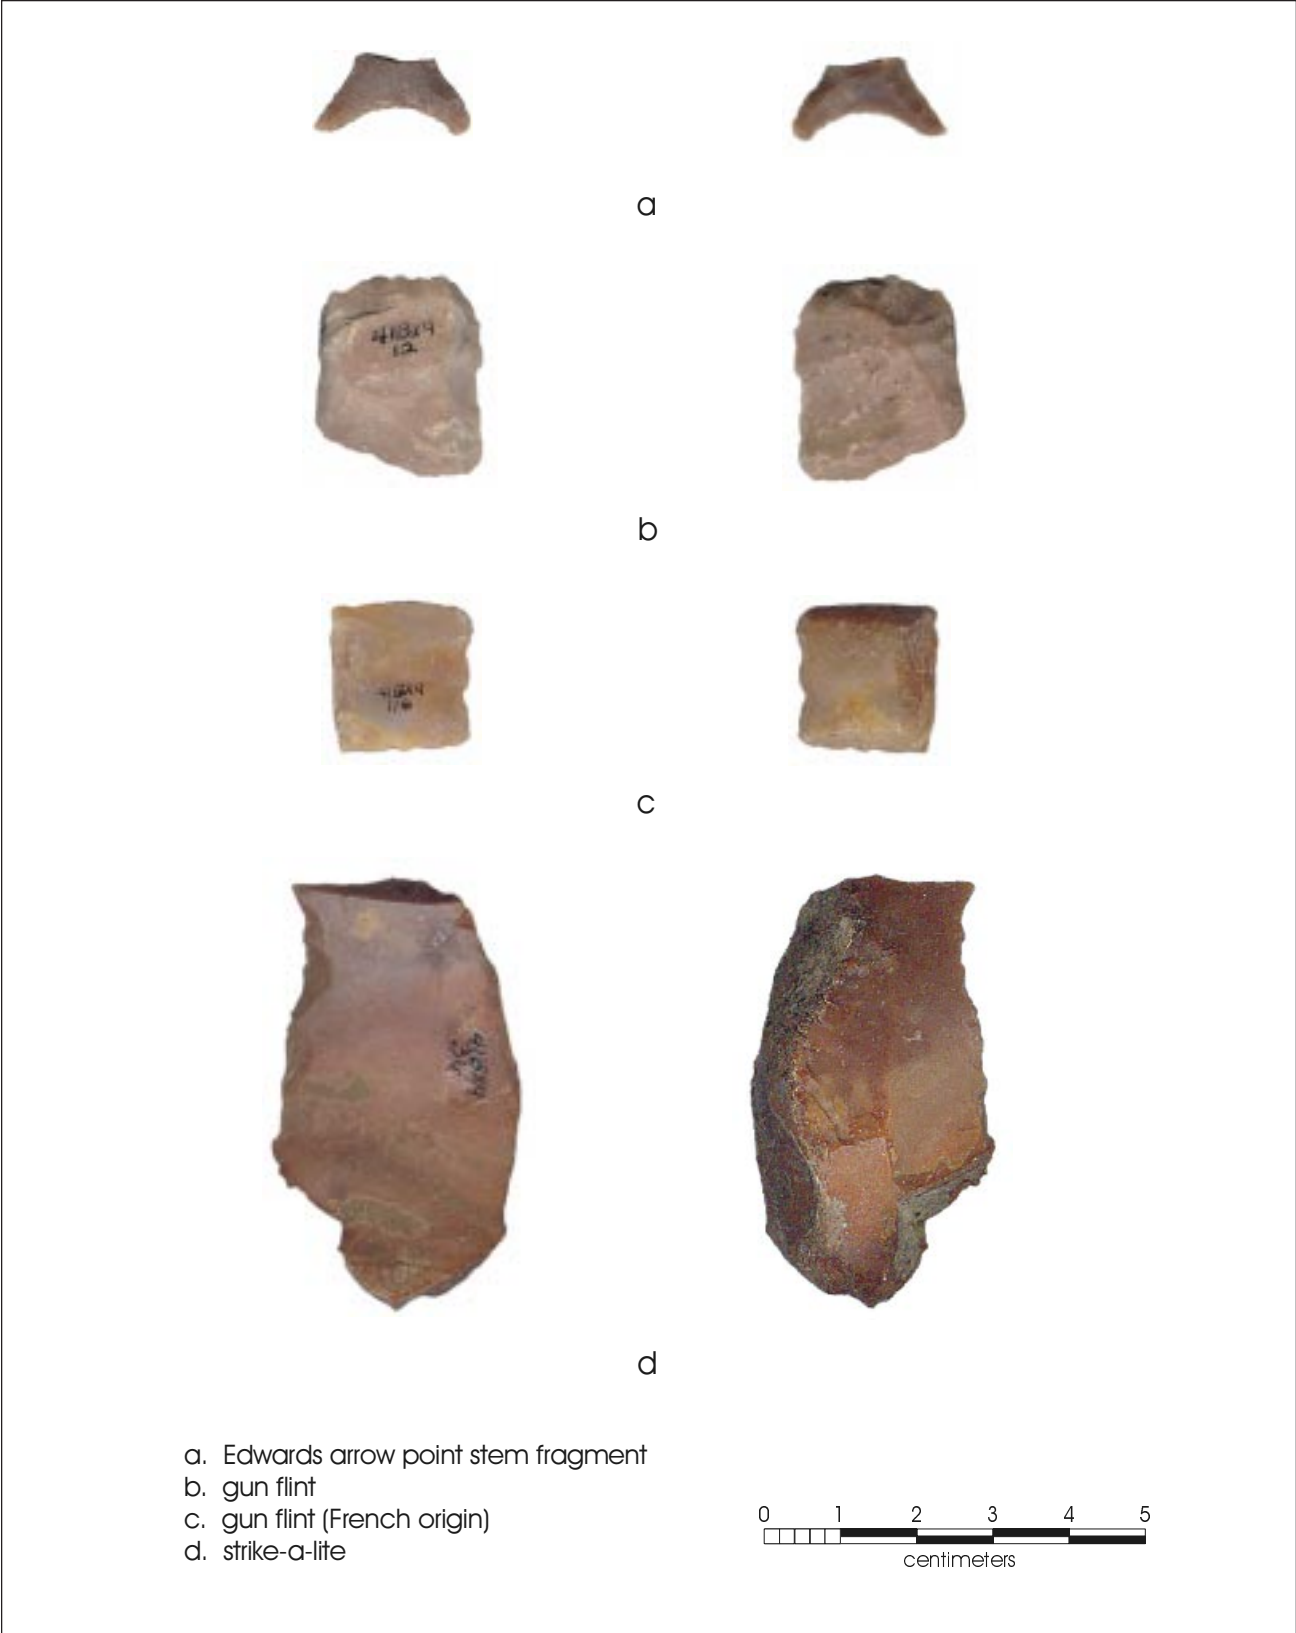
a. Edwards arrow point stem fragment
b. gun flint
c. gun flint (French origin)
d. strike-a-lite

Figure 20a-d. *Chipped Stone from the current project.* a) Edwards Arrow Point and Stem Fragment; b) Gunflint; c) Gunflint (French origin); d) Strike-a-lite.

A single stem fragment is classified as an arrow point. It was recovered from Level 3 (20-30 cm bs) in Unit 6 (Figure 20a). Judging from its widely expanding stem, its concave base, and narrow neck, it is likely to

Five gunflints and four strike-a-lites were identified. Three of the gunflints have a roughly rectangular shape and are made on tertiary (n=2) and secondary (n=1) hard hammer stone flake blanks (Figure 20b). They are only marginally retouched, most of the invasive flake scars that penetrate the face of the specimens result from use. A fourth specimen is a bifacially flaked trapezoidal gunflint. Use-related crushing is evident along all edges and moderate polish is present on flake scar ridges of both faces. These four gunflints are made of locally available tan to brown colored fine-grained chert. The final gunflint is made on a nearly square midsection of a trapezoidal blade (Figure 20c). The four edges are unifacially retouched on the dorsal face and form steep angles. Use-related step fracturing is present on the ventral face of the specimen only along one edge. In terms of morphology and manufacture

Three of the four strike-a-lites are unifacially retouched artifacts representing recycled Prehistoric scrapers. All three are of fine-grained dark gray to brown chert blades or blade-like flakes. Dorsal cortex is present on all specimens and may be a purposeful design feature to enhance gripping. The multiple “working-edges” on all three specimens are characterized by heavy crushing verging on rounding distributed along the dorsal face of the artifacts. A few isolated irregularly spaced flake scars are also present on the ventral face of the specimens but are not evident along all utilized edges. The fourth strike-a-lite is a longitudinally curved distal blade fragment (Figure 20d). Crushing and step-fractured flake scars are distributed along the ventral face of one longitudinal edge. The opposite edge appears to also have been used although use-wear is light. The corticate dorsal surface adjacent this edge may have prevented the generation of sparks along this edge.
