## Archaeological Investigation of the Southeast Building Complex, Old Ursuline Academy Campus, 41BX235, San Antonio, Texas

Center for Archaeological Research  
The University of Texas at San Antonio  
Archaeological Survey Report, No. 118

This report outlines the results of an archaeological investigation associated with a complex of buildings located in the southeast portion of the Old Ursuline Academy campus, San Antonio, Texas. An analysis of the physical characteristics of the buildings is provided. A proposed history based on field observations and archival research is offered. Additional information is presented regarding legends concerning the early years of Ursuline Academy.

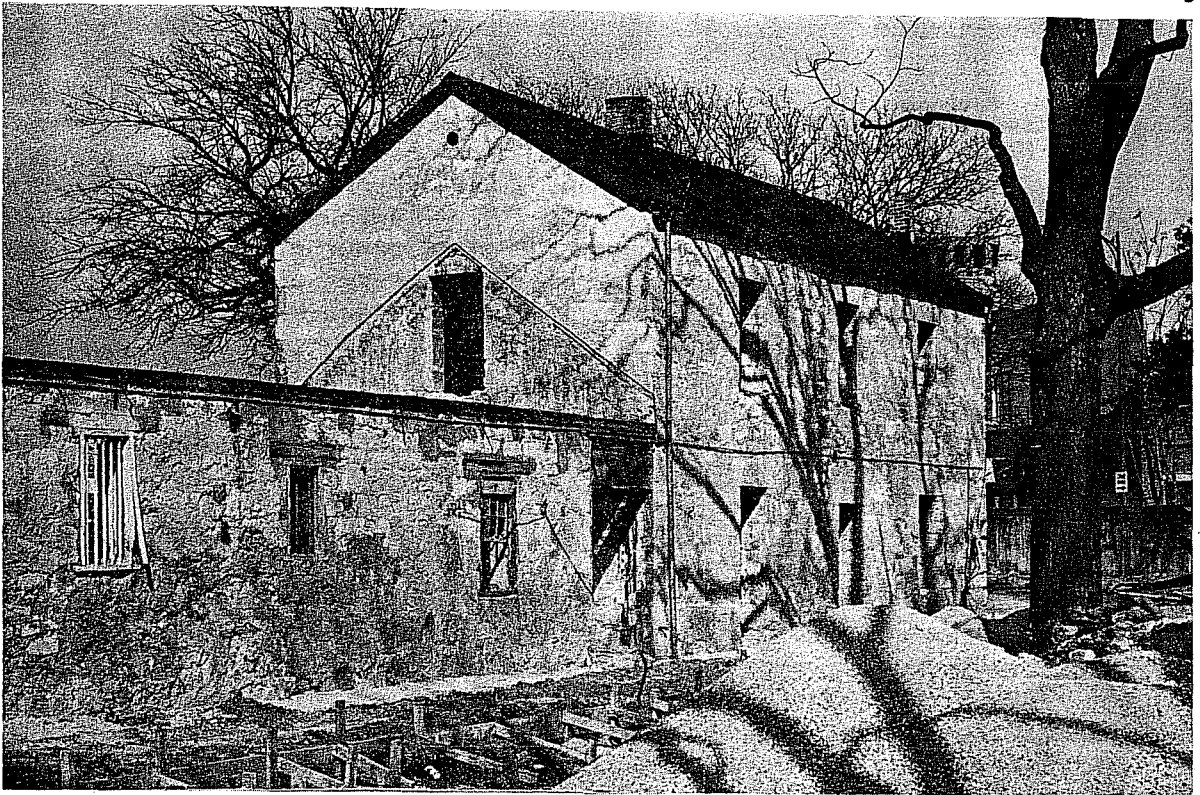
Figure 3. *Old Ursuline Academy, Views of Southeast Building Complex.*  
a, south side of Buildings 1 and 2, looking northeast; b, north side  
of Buildings 2 and 3, looking southwest.

rubble set on larger limestone foundation stones (Fig. 3). The east wall of this building is actually the west wall of Building 1. The limestone rubble material of the other walls varies in height from ca. three to seven feet. Within this rubble level evidence of remodeling and/or repair is represented by a change in mortar used in the wall construction. At the lower levels, the mortar is brownish gray in color. The higher levels contain a pale pinkish mortar. This changeover was not observed at any specific elevation, but rather varied in height from wall to wall and from place to place along any one wall. Milled lumber embedded in the limestone rubble level was also noted, as were window casements that varied in style. Capping the limestone rubble level was a pale pinkish mortar similar to that used on the upper portions of the rubble layer. These walls were capped by wooden planks, ca. eight inches wide, to which the rafters were attached. The south wall exterior was not overlaid with a plaster coat, but patches of mortar were noted, indicating repair activities had taken place. The exterior of the north wall was overlaid with plaster and, in recent times, painted white. Episodes of earlier plastering and painting were noted beneath the outer layer of plaster. Examination of the south wall exterior revealed a limestone rubble wall supported by a foundation of larger limestone rocks. The rubble construction varied in height from two to four feet and was topped by soft, irregular-shaped caliche blocks that were packed with earth. The caliche block layer extended in places to a height of seven feet. Crude adobe blocks, irregular in shape and also packed with earth overlaid the caliche block layer. These adobe blocks continued to a height of 18 feet forming the roof gable. In the northwest corner of this wall a doorway, three feet wide, is framed by cut limestone blocks. As on the south wall exterior, no plaster finish was observed. This wall also had a window, which has subsequently been filled in and plastered over on the inside.
