ARCHAEOLOGICAL MONITORING OF THE
SAN JOSE ACEQUIA (41 BX 267),
WASTEWATER FACILITIES IMPROVEMENTS PROGRAM,
SAN ANTONIO, TEXAS

Center for Archaeological Research
The University of Texas at San Antonio
Archaeological Survey Report, No. 175

In January 1986, the Center for Archaeological Research entered into a contract to monitor construction for a sewer line for the San Antonio Wastewater Improvements Program. The primary concern was if the San José Acequia would be in the location of construction. Monitoring operations began in October of the same year and continued until January 1987. The acequia was exposed in three locations and proved to be an unlined ditch.

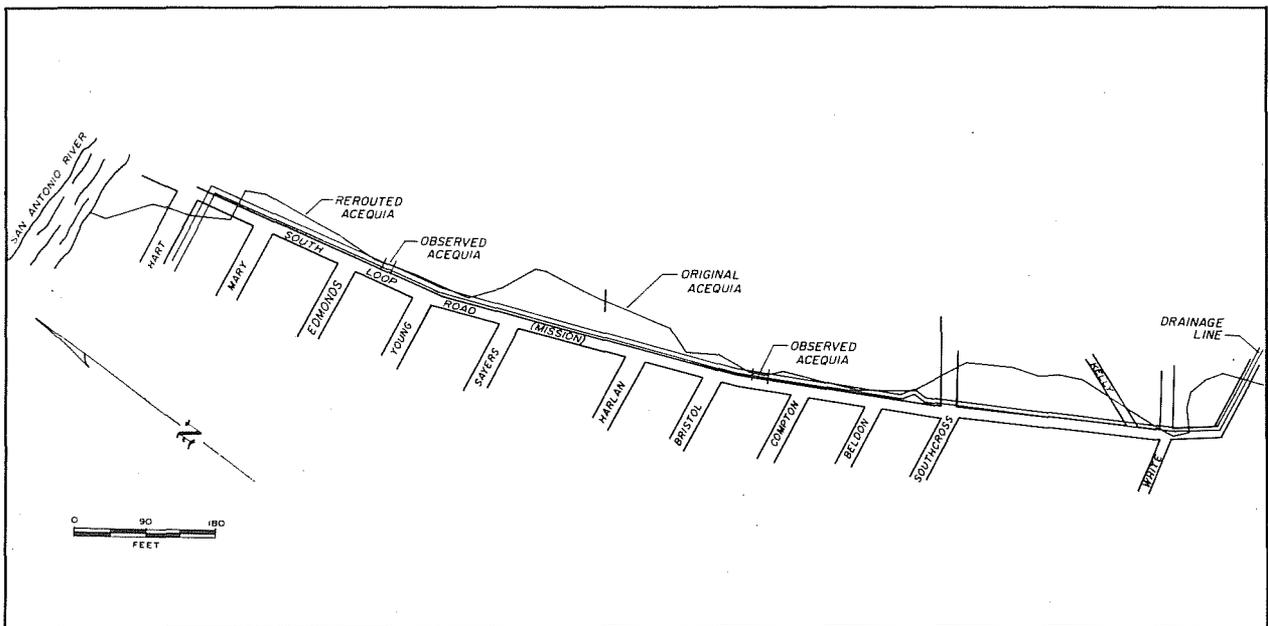
Figure 1. Original, Rerouted, and Observed San José Acequia.

In 1894, the acequia was reopened under the Texas Water Act of 1889 by landowners along its course. However, the dam was relocated farther south on the San Antonio River, near the present Mission Road bridge, and the channel rejoined the old acequia to the south (Brook 1904; Fig. 1). At that time it was described as being "four feet deep and 12 feet wide and the carrying capacity thereof shall be 100 cubic feet per second" (Water Board Records Vol. 1 August 10, 1894:4).

Wayne Cox, Center research associate, met with Dwayne Opella, Phil Handley, and Larry Rein, representatives from the PD VA Group. The areas of sensitivity were reviewed, and a copy of the Center's working map was made for field use. The PD VA Group personnel agreed to notify the Center representative when a sensitive area would be reached (estimated within two weeks), and they understood that the Center archaeologist would remain on call prior to that time. Active field monitoring began as construction approached the area of Mission Road and White Street and continued to Hart Avenue when the route turned westward away from the sensitive area (Fig. 1).

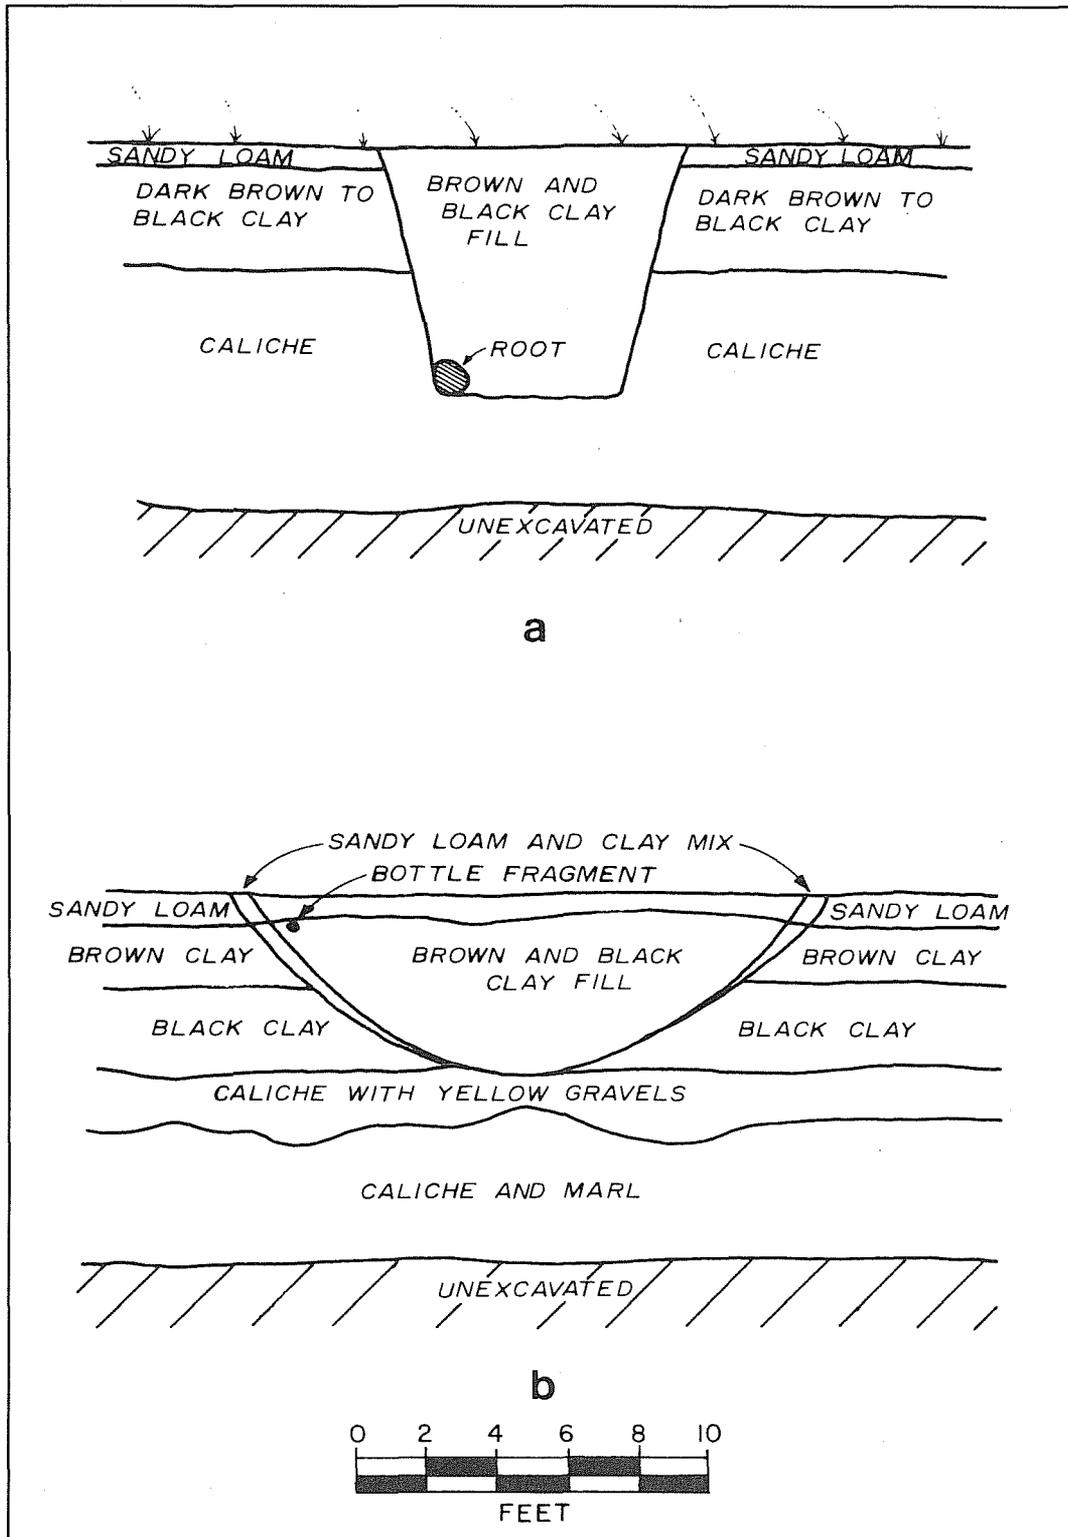
Figure 2. Profiles Observed During Field Work. a, machine excavation at East Huff Avenue; b, acequia profile at Compton Street.

The contractor notified the Center on October 23, 1986, that a feature had been revealed in a trench on Mission Road just to the east of the intersection of East Huff Avenue. A large, deep cut at roughly a right angle to the roadway had been revealed, but it was a recent excavation, not the acequia (Fig. 2,a). The cut was approximately 10 feet wide and eight feet deep. The sides were extremely sharp and cut into the underlying caliche base approximately two feet. The trench showed no sign of weathering and had marks of modern machine excavation techniques across an extremely flat bottom. Richard Garay (personal communication) has documented evidence that a western branch of the acequia was constructed in this area, but the trench revealed none of the classic characteristics of an acequia.

On December 1, the excavations had progressed beyond Southcross Street, and the acequia was exposed at a point 50 feet to the north of the intersection of Compton Street and Mission Road (Fig. 2,b). The acequia at that point was 18 feet wide and six feet deep, the width was so great primarily because the ditch had been cut on a slight angle. Photographs were taken and a search made for artifacts. An unbroken glass gallon jug with handle and screw top and one small fragment of a root beer bottle with a three color silk-screened label were recovered. Since the acequia was in use well into this century, the recent age of the artifacts was to be expected.
