Archaeological Investigations at Fort Martin Scott (41GL52) in Gillespie County, Texas

ARCHAEOLOGICAL INVESTIGATIONS AT FORT MARTIN SCOTT (41 GL 52) IN GILLESPIE COUNTY, TEXAS

Center for Archaeological Research
The University of Texas at San Antonio
Archaeological Survey Report, No. 169

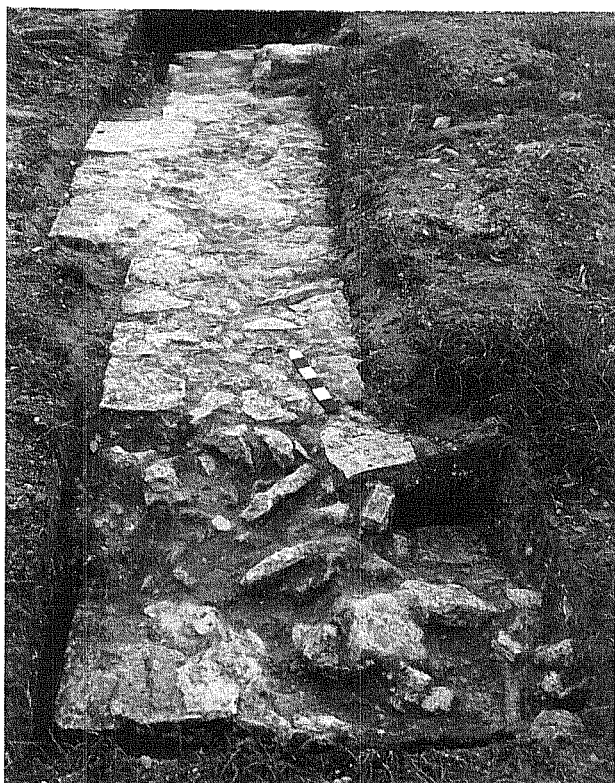
Figure 7. Foundation Remnants for Structure E. a, foundation cleaning; b, west wall; c, east wall.

The extant portions of walls were cleaned (Fig. 7,a). Additional trenching and hand excavation were necessary to completely uncover the west (Fig. 7,b) and east walls (Fig. 7,c). Both the east and west walls contained a foundation for a chimney base. Both were located in the center of the walls (Fig. 8,a). Two interior walls, oriented roughly north-south, were also identified and excavated. Only short sections of the front (south) and back (north) walls were cleared.

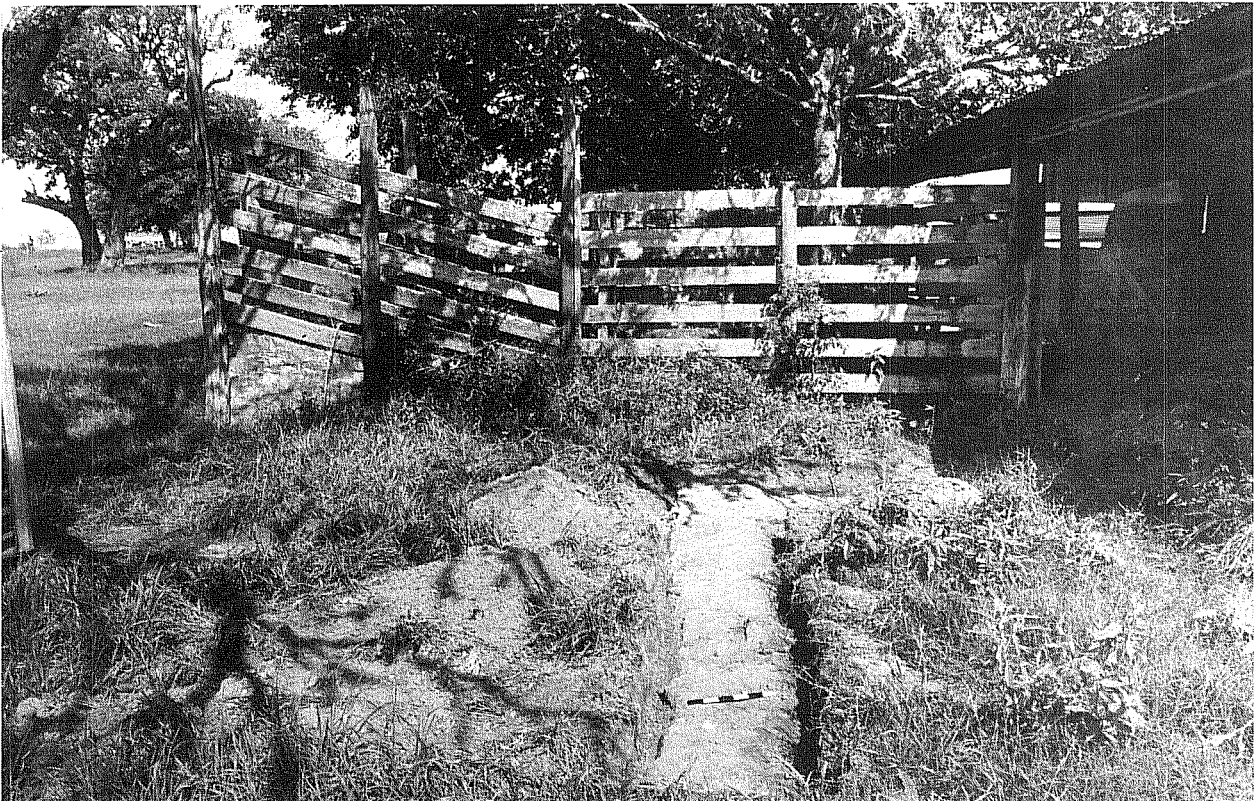
Figure 9. Foundation Remnants for Structures G and J. a, Structure G; b, Structure J.

A total of two test trenches was excavated at a 90° angle to the suspected location of the west wall. Both test units evidenced small amounts of mortar and rubble but without any *in situ* sections of wall. Excavation of the western one-third of the south wall produced similar results. Two additional test trenches (ca. 12 inches deep) near the southeast corner of the south wall also produced similar results. The areas currently exposed represent the only sections of foundations remaining from Structure G (Fig. 9,a).

(Fig. 9,b). The main wall section (outer wall) was ca. two feet thick, while the cross (interior) wall was ca. 18 inches thick. Both walls were composed primarily of rubble and deteriorated mortar (Fig. 10).

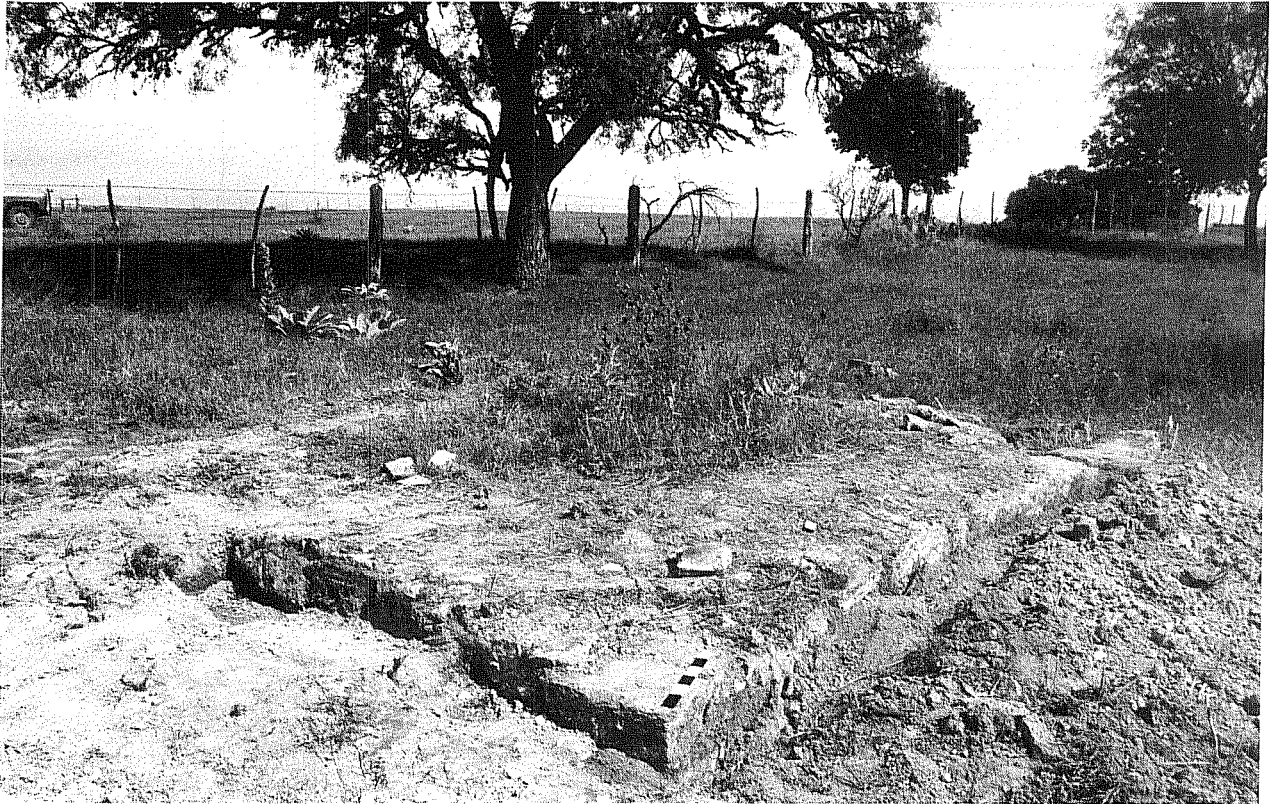
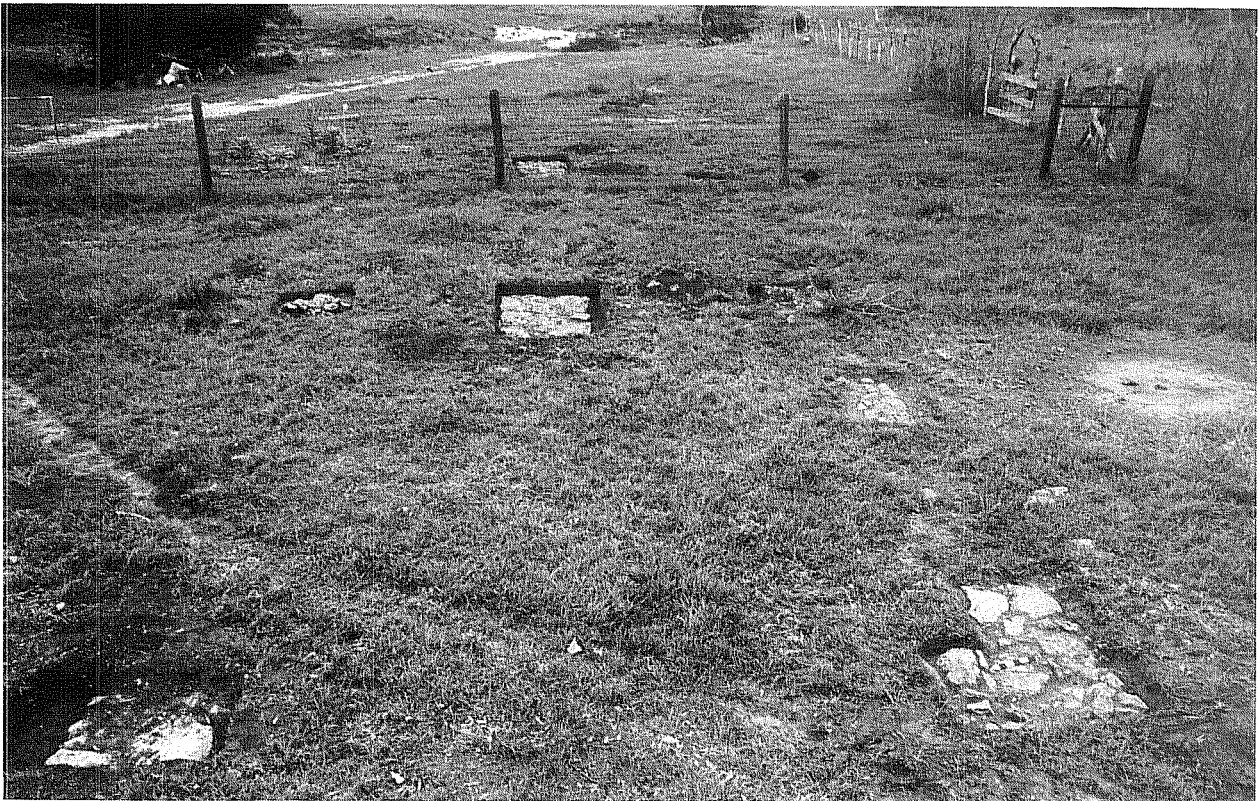
Figure 11. Foundation Remnants for Bake Oven and Structure 0. a, bake oven; b, Structure 0.

Structure M is located adjacent to Barons Creek and is ca. 50 feet south of the northeast corner of the property leased by the City to the Fredericksburg Heritage Federation (Fig. 4). The 1853 Freeman Inspection Report described the bake house as a log structure with dimensions of 14 x 20 feet (Fig. 2). The only remaining evidence for this structure is the remains of the foundation for a cut-stone bake oven (Fig. 11,a).
