ARCHAEOLOGICAL INVESTIGATIONS AT THE UNITED STATES ARSENAL SITE (41 BX 622), SAN ANTONIO, TEXAS

Anne A. Fox

Center for Archaeological Research
The University of Texas at San Antonio
Archaeological Survey Report, No. 137

1986

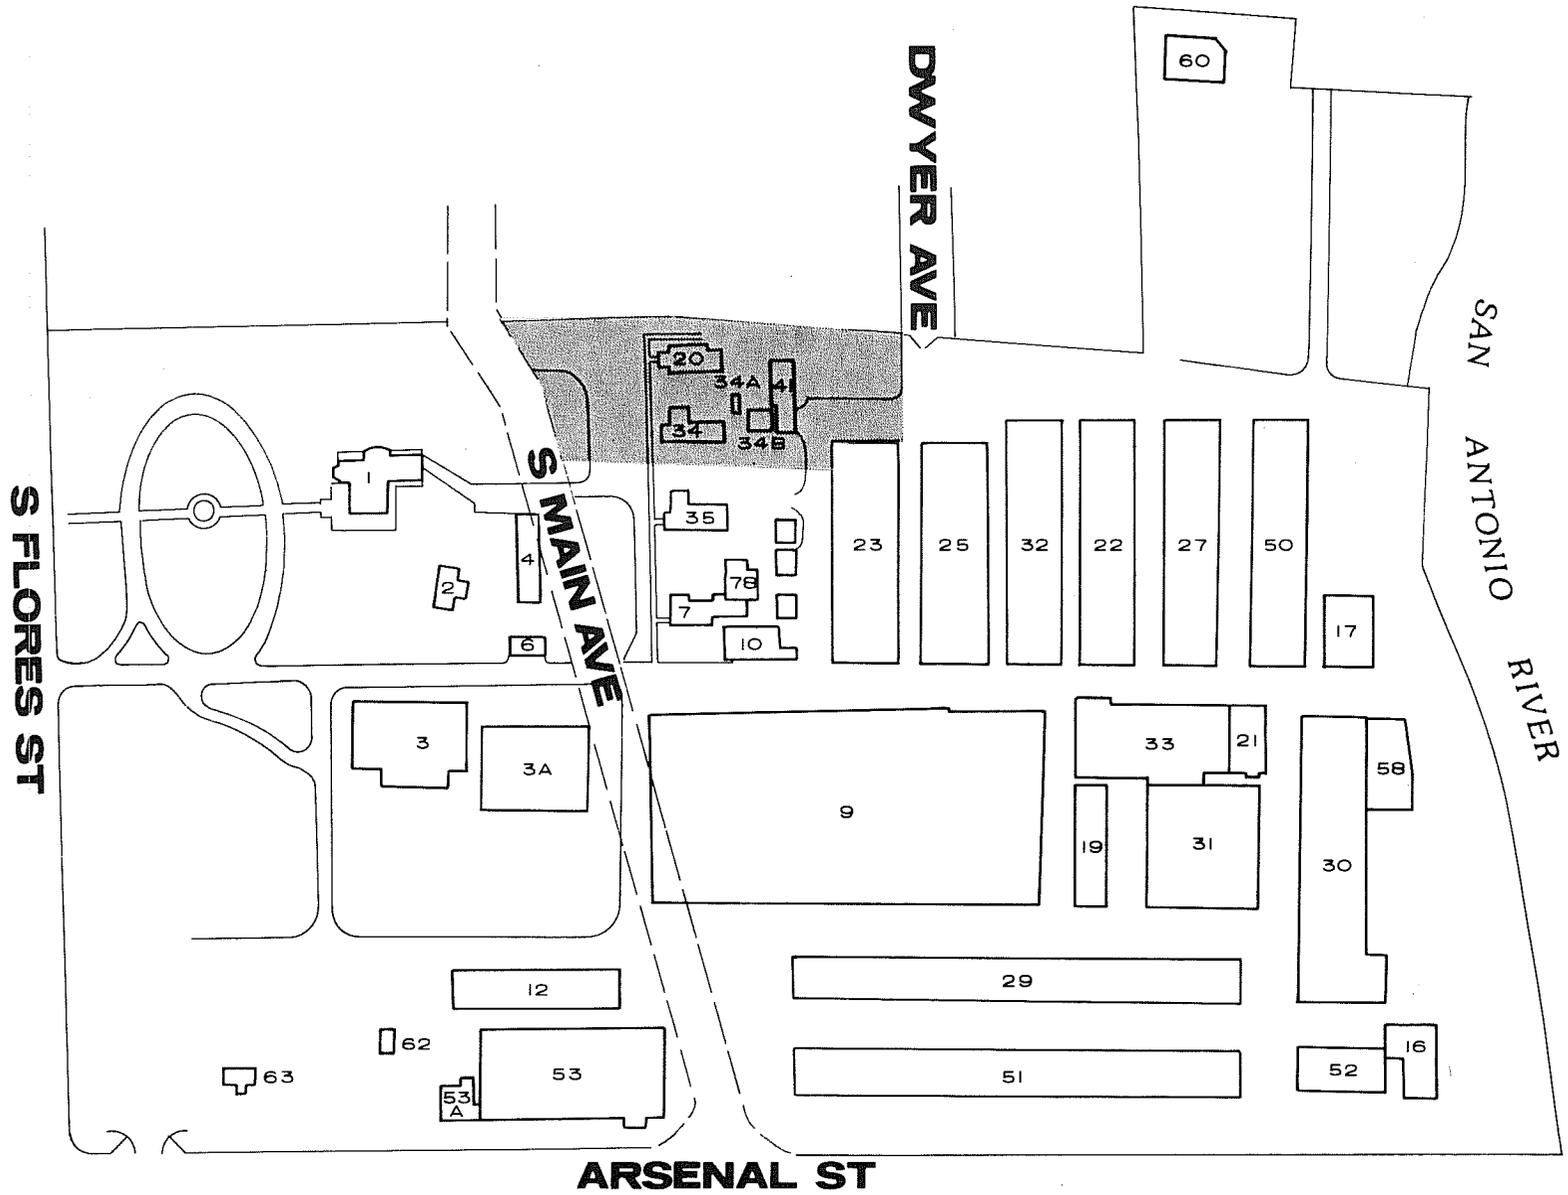
Figure 1. **Arsenal Site Plan.** Basic data and building identifications from 1946 road map (San Antonio Arsenal, Office of the Post Engineer 1946); location of South Main Avenue from 1961 site plan (General Services Administration 1961). The area investigated by trenching is indicated by darkened area.

- 1 Commanding Officer Quarters
- 2 Servants Quarters
- 3 Post Headquarters
- 3A Main Office
- 4 Hot House
- 6 C. O. Garage
- 7 Post Engineers
- 7B Engineers Carpenter Shop
- 9 Shops
- 10 Battery Charging Shed
- 12 Post Property
- 16 Loading Platform
- 17 Utilities Shop
- 19 Storehouse
- 20 Post Dispensary
- 21 Auto Repair Shop
- 22 Storehouse
- 23 Storehouse
- 25 Storehouse
- 27 Storehouse
- 29 Storehouse
- 30 Shop and Storage
- 31 Storehouse
- 32 Storehouse
- 33 Packaging Section
- 34 Inspection Division and Guard Station
- 34A Lavatory - Building 34
- 34B P. E. Blacksmith Shop
- 35 Plant Section and Safety Office
- 41 P. E. Paint Shop and Storage
- 50 Storehouse
- 51 Storehouse
- 52 Storehouse
- 53 Change House and Cafe
- 53A Cafe Store Room
- 58 Shop Area
- 60 Salvage Yard and Office
- 62 Motor Pool Office
- 63 Wash Rack, Motor Pool

Trench 2 ran east-west across most of the area under investigation. There were no signs of disturbance of any kind except for the presence of a number of two-foot-square concrete footing pads. These bore the marks of the 8- x 8-inch posts which once supported a temporary frame structure in this area (No. 20 in Fig. 1). Two small (2-1/2 inch) gas pipes and an electric line crossed (in a north-south direction) this trench. Caliche bedrock was found

In mid-February, the Center was requested to do additional testing at the south end of the old stone stable building (No. 21 in Fig. 1). It was hoped to determine if any indication remained of the location of an outside stairway providing access to the loft above the stable. A test pit measuring ca. 1-1/2 m x 3 m was excavated. The first level consisted of ca. 15 cm of gravel fill. A 1-m² concrete slab was found at the west end of the unit at this level, and a pipe trench at the opposite end. Excavation continued through several alternating layers of brown soil and gravel fill until a hard, cobble layer set into caliche at ca. 30 cm below the original ground surface was encountered in the area. No postholes or other traces of support for a stairway were found within this area. A profile of the south wall of this test unit is on file at the Center for Archaeological Research.

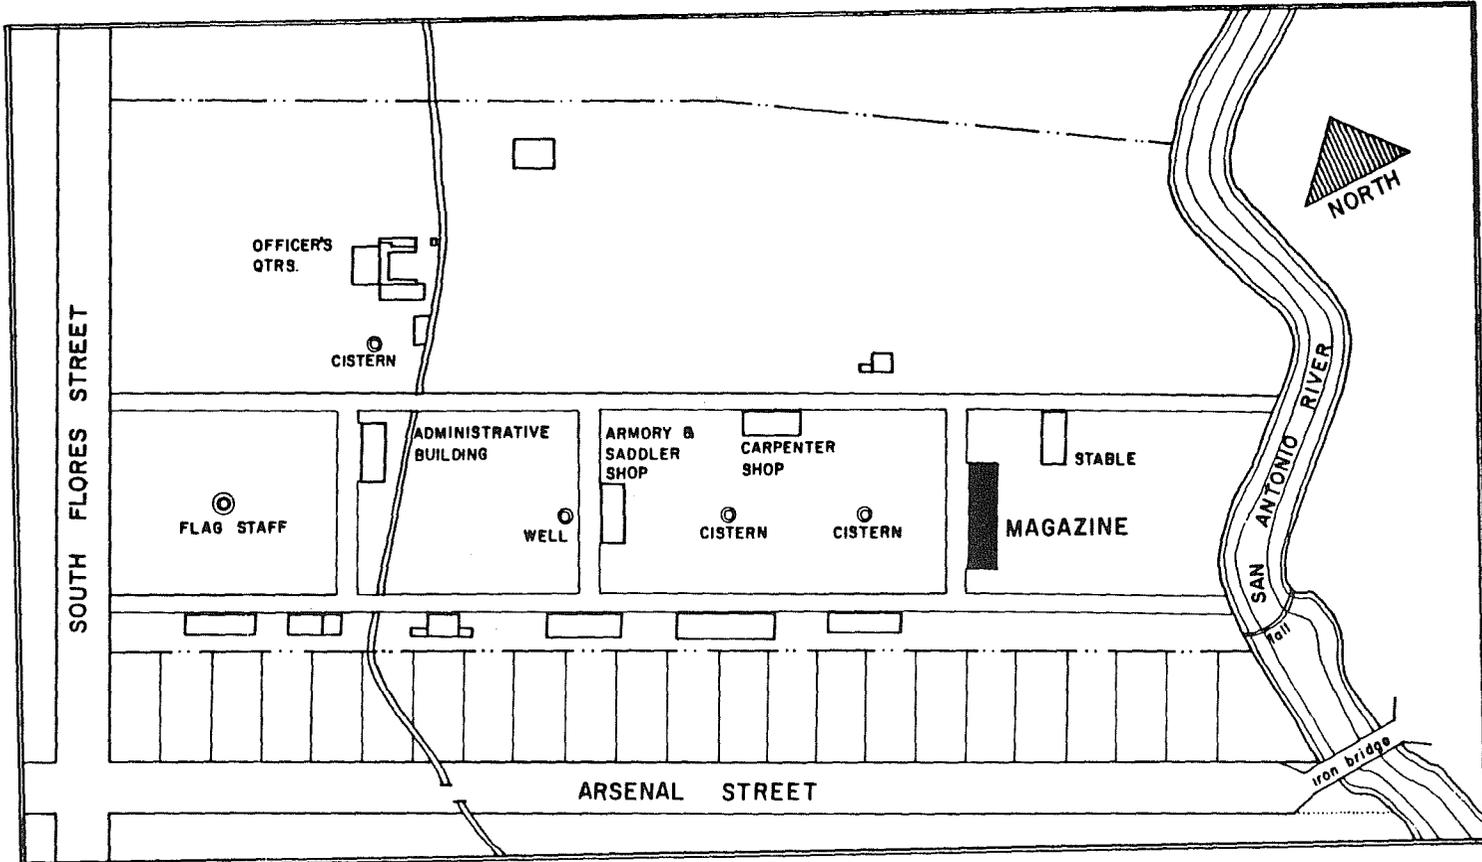
MAP DATED 1877
HOUSE EXEC. DOC. 48,
42nd CONG., 3rd SESSION,
SERIAL 1565, VOL. 7

Figure 2. Map of Arsenal in 1877.

In 1877, the Arsenal consisted of five permanent stone buildings, a row of frame buildings along the southern edge of the property, and the frame carpenter shop (Fig. 2). The Army had been trying to get permission to buy a narrow strip of land between the south boundary line of the Arsenal and Arsenal Street since 1872 (Belknap 1872). The property was finally purchased from the family of Toutant Beauregard in 1881 (Russell 1881).

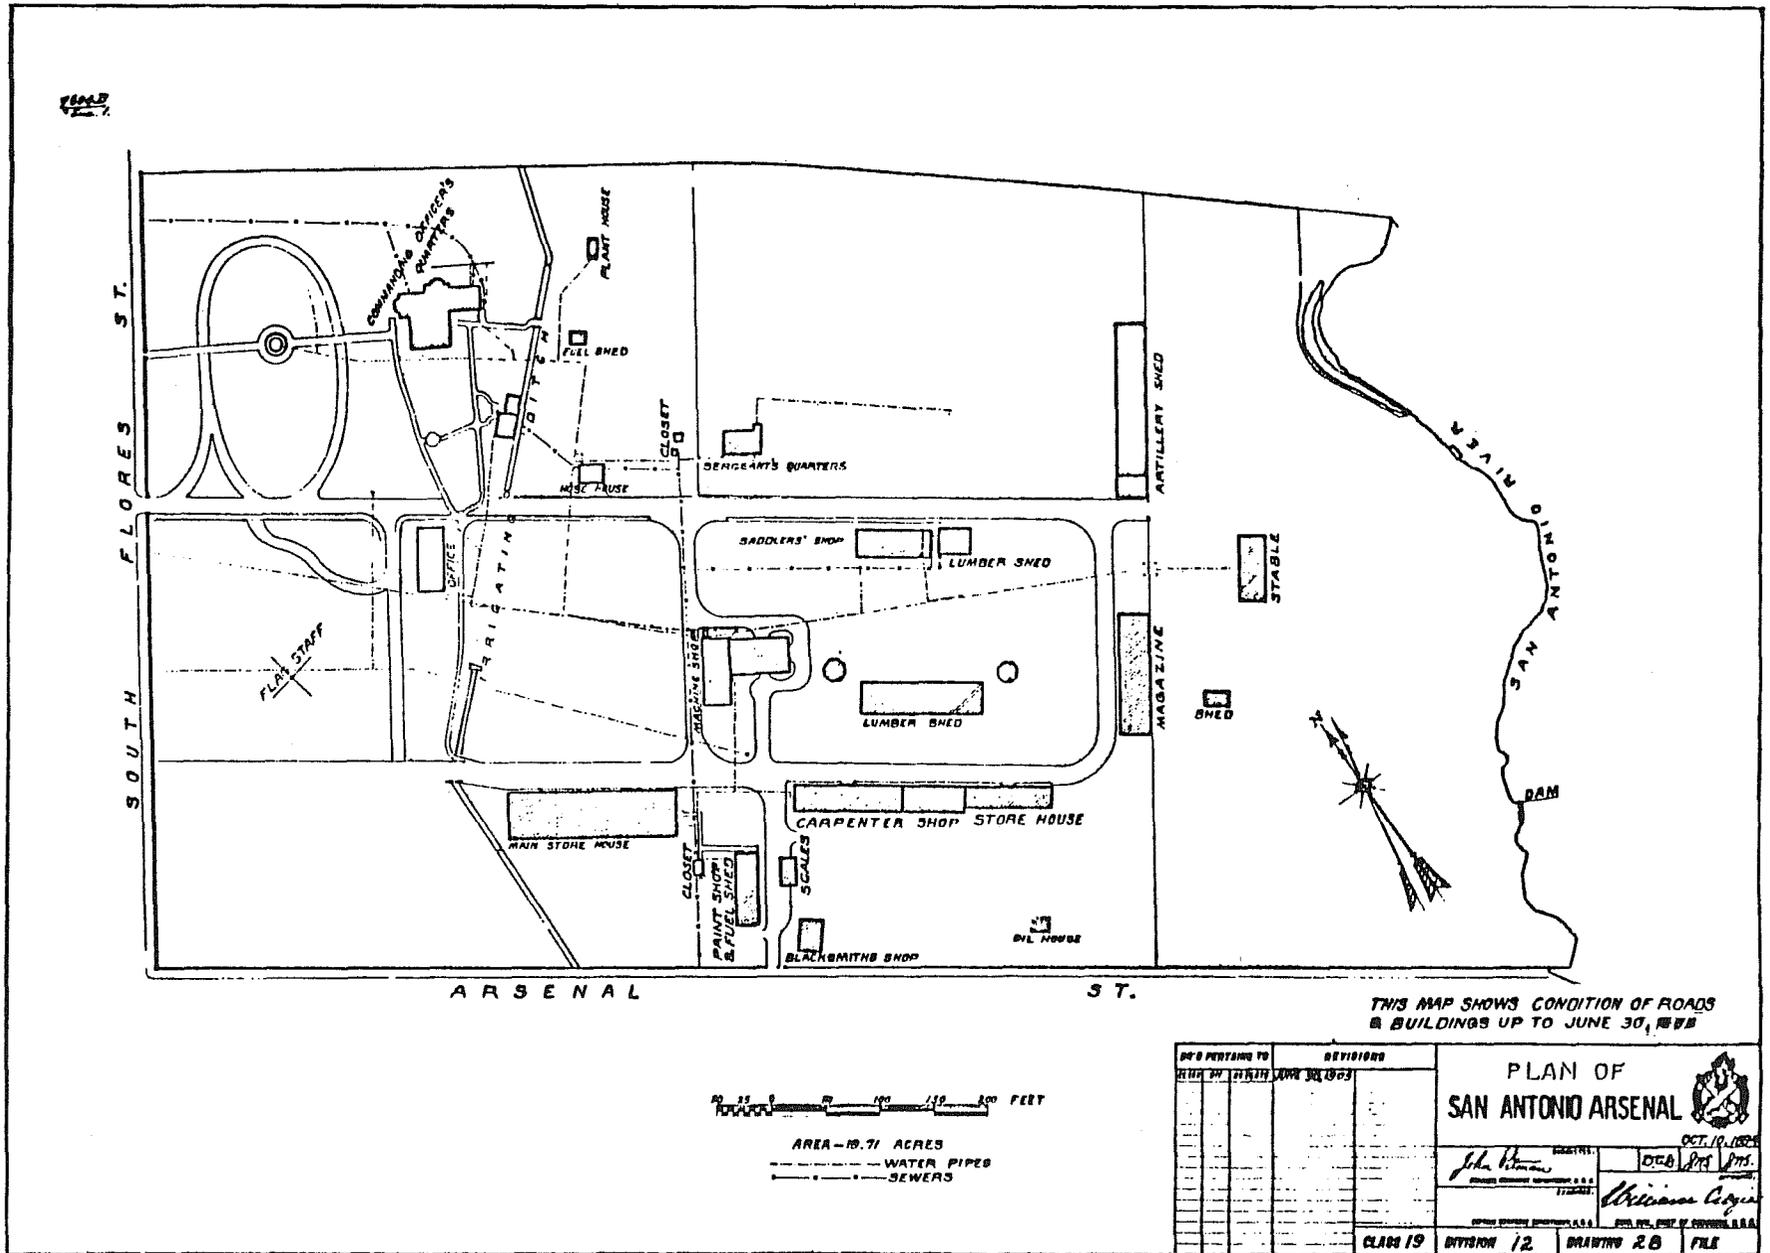
Figure 3. Plan of Arsenal from 1894-1905. From Department of the Army, Corps of Engineers (1905).

A stone storehouse was erected south of the administration building in 1883 (Fig. 3). This was the first permanent storehouse on the site, and served in that capacity until the deactivation of the Arsenal (Shank 1968; Garner 1969:6).

A plan of the Arsenal in 1894 (Fig. 3) shows the addition of a number of minor buildings and changes in the function of other buildings. However, it was not until 1919 to 1920 that another major building period occurred (**San Antonio Express** 1927). Three new storehouses, an oil house, a small arms shop, two magazines, a machine and equipment shop, barracks, and quarters eventually increased the number of buildings to 44 with a total value of \$900,000 (Garner 1969:6). The newest building on the grounds is the principal office structure, built in 1942 (Anonymous n.d.:2).

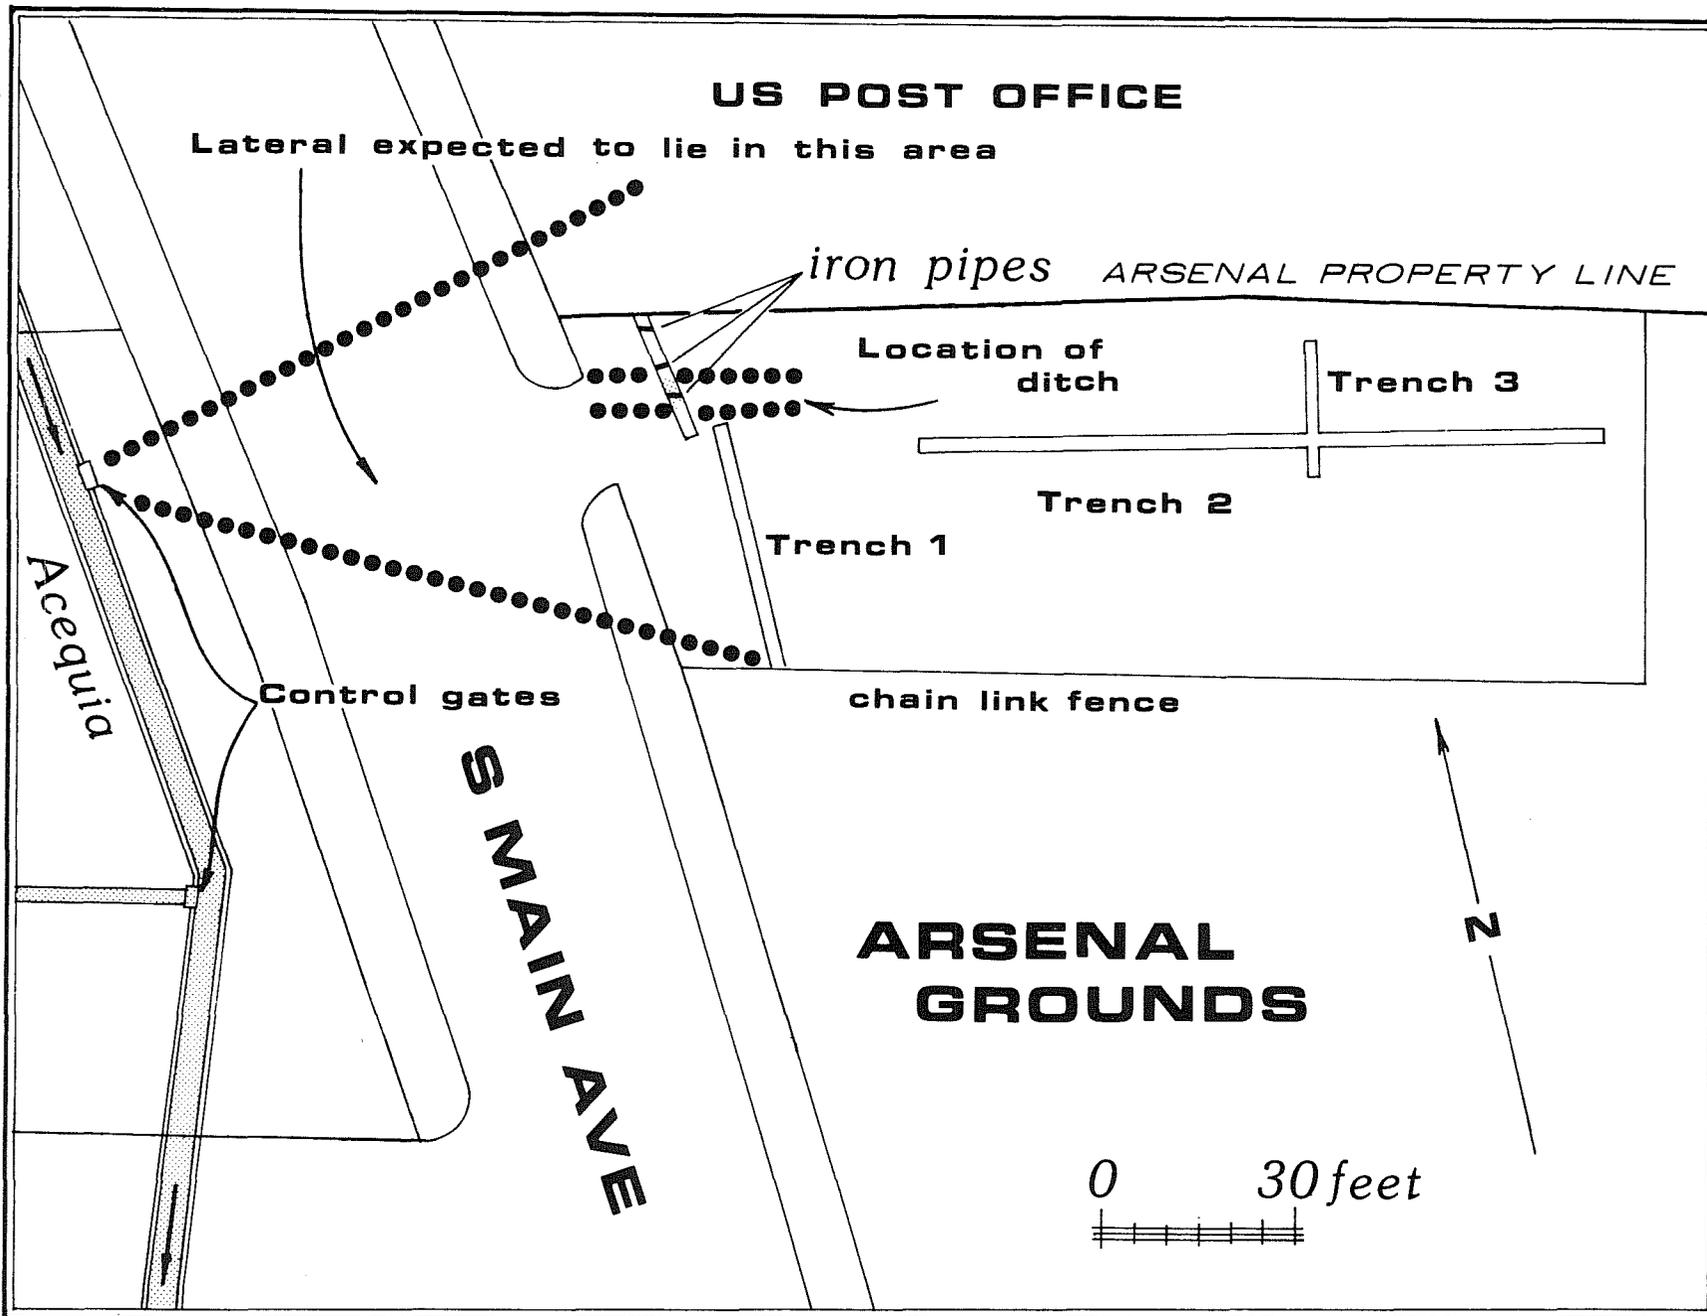
Figure 4. Plan of Backhoe Trenches.

On January 6, 1984, a series of backhoe trenches was excavated in the northwest corner of the development site, under the direction of the author and an assistant (Fig. 4). The first two trenches were positioned so as to determine whether the acequia lateral entered the area (Trench 1) or whether branches of the lateral intruded upon the site from the northern boundary (Trench 2).

In Trench 1, two gas lines were encountered which ran east-west across the area. A large disturbance six feet across was also found, which ran parallel to the gas line trenches. The trench was dug from the original ground level, which was beneath 10 inches of gravel fill laid for the asphalt paving on the western part of the lot. At first this disturbance was thought to be the acequia lateral, but a 5-1/2-inch iron pipe was found in a 15-inch trench in the bottom of the disturbance, at eight feet below the original surface.

in Trench 2 at ca. 30 inches below the present surface. The soil above is reddish brown loam with a medium clay content, grading to dark brown at the surface.

After the size and depth of the large disturbance in Trench 1 were noted, Trench 3 was excavated in order to determine if the deep pipe trench/disturbance could have preempted the original acequia lateral. If so, the lateral, with or without the pipe trench, might have continued toward a junction with the river to the east. Trench 3 revealed the same soil profile as that of Trench 2, with no disturbances.
