## ARCHAEOLOGICAL INVESTIGATION TO LOCATE THE NORTHWEST CORNER OF MISSION CONCEPCIÓN SAN ANTONIO, BEXAR COUNTY, TEXAS

Anne A. Fox

Center for Archaeological Research The University of Texas at San Antonio Archaeological Survey Report, No. 212

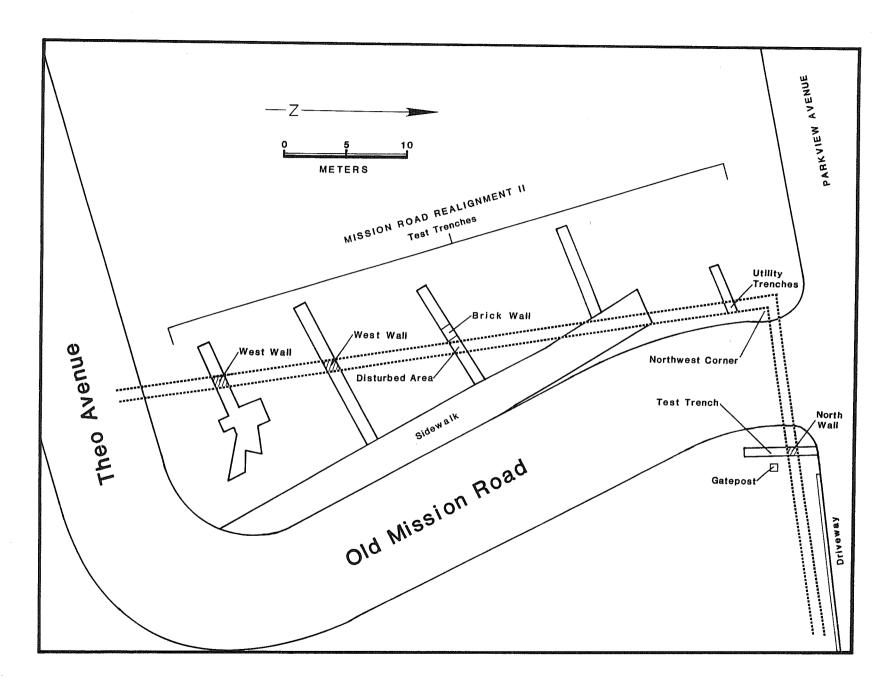
Figure 2. Project Map. Shown are previous and current test trenching that indicate the west and north wall alignments, and the projected northwest corner of the Mission Concepción quadrangle.

A backhoe trench 80 cm wide and approximately 5 m long was laid out 60 cm from the western face of the southernmost brick gatepost on the south side of the entrance drive to the St. John's Seminary buildings (Figure 2). The trench long axis was oriented to magnetic north. Approximately 1.25 m north of the gatepost, at ca. 75 cm below the surface, the top of the north wall of the compound was found. The wall was found to measure approximately 75 cm in thickness. The depth to the bottom of the wall was not determined, but it continued more than 1 m below the surface, where the trenching stopped.

The location of the northwest corner of the mission compound can be determined by projecting the lines of the west and north walls until they meet (Figure 2). This bit of information can now be added to the accumulated data about the outlines of the mission recovered by previous archaeological investigations. It can also be used in the future to relocate the northwest corner on the ground when the time comes to suitably indicate the mission walls on or above the ground surface.
