**ARCHAEOLOGICAL MONITORING IN CONNECTION WITH THE
SAN ANTONIO WASTEWATER FACILITIES IMPROVEMENTS PROGRAM,
SAN ANTONIO, BEXAR COUNTY, TEXAS**

Anne A. Fox and I. Wayne Cox

Center for Archaeological Research
The University of Texas at San Antonio®
Archaeological Survey Report, No. 194

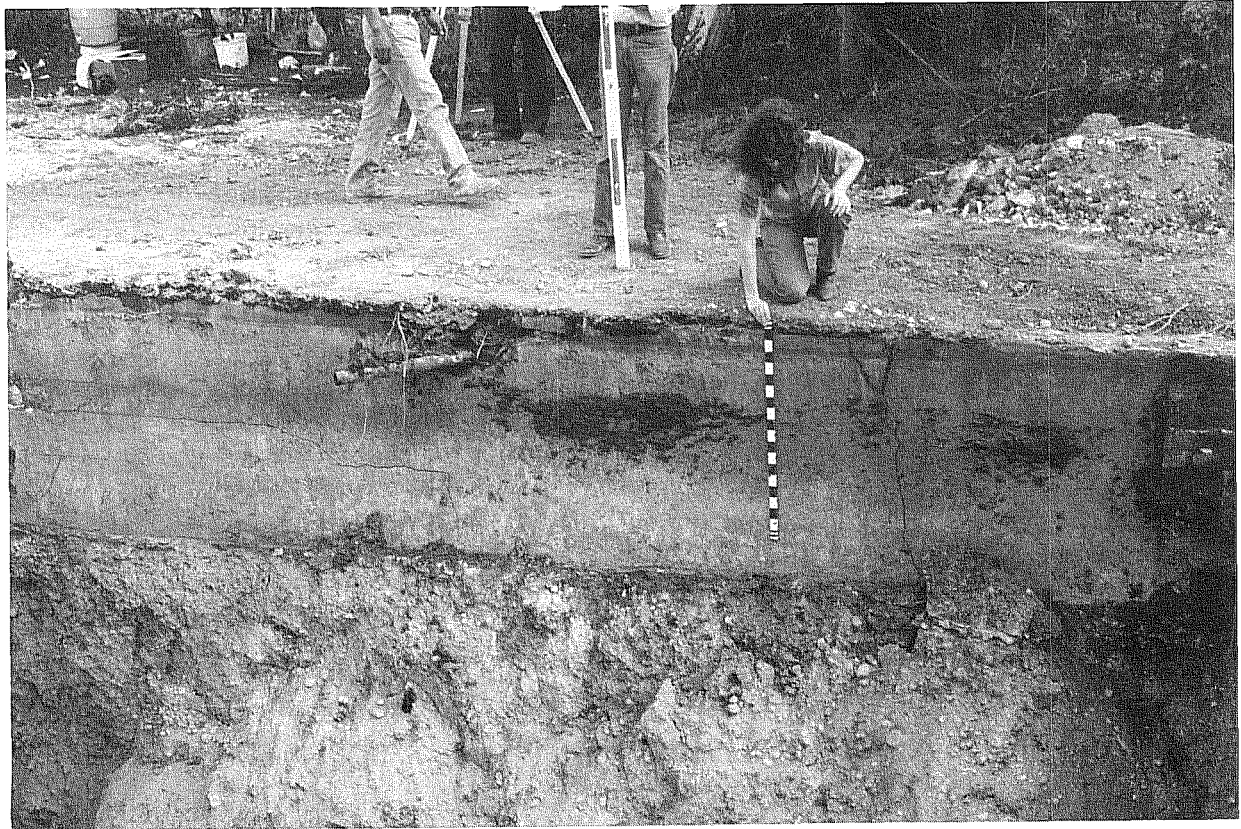
Figure 5. Construction Details of the Auxiliary Building. a, view of cement sealed interior wall of structure; b, brick construction exposed by the pipeline trench.

the northeast corner collapsed into the trench allowing a view of the interior of the structure. The interior of the wall was sealed with a thin coating of cement, upon which a water line was visible ca. 44 inches above a three-inch concrete floor (Fig. 5,a). The brick patterning (Fig. 5,b) was exactly the same as that utilized in construction of the Hot Wells bathhouse. The floor of the structure sloped from 40 inches in depth from the water line on the southeast to 45 inches on the northwest. This information, coupled with the visible water line, seems to indicate that the structure served as a bathing pool. Further supporting this conclusion is the increased buttressing and wall thickness at the deeper end to contain the water pressure. The exposed portion of the structure was extensively photographed, and elevations were recorded by the project engineers. All data and photographs are on file at the CAR.

No prehistoric or historic archaeological remains were encountered, except for the foundation of an auxiliary building to the Hot Wells Hotel. The cutting of the sewer trench across the southeast corner of this otherwise unidentified structure allowed the identification of the building as a bathing pool. No recommendations are forthcoming from this project for eligibility for sites for National Register status or State Archeological Landmark designation.
