**ARCHAEOLOGICAL
INVESTIGATIONS AT THE
GRESSER HOUSE (41 BX 369)
San Antonio, Texas**

James E. Ivey

Center for Archaeological Research
The University of Texas at San Antonio
Archaeological Survey Report, No. 60

1978

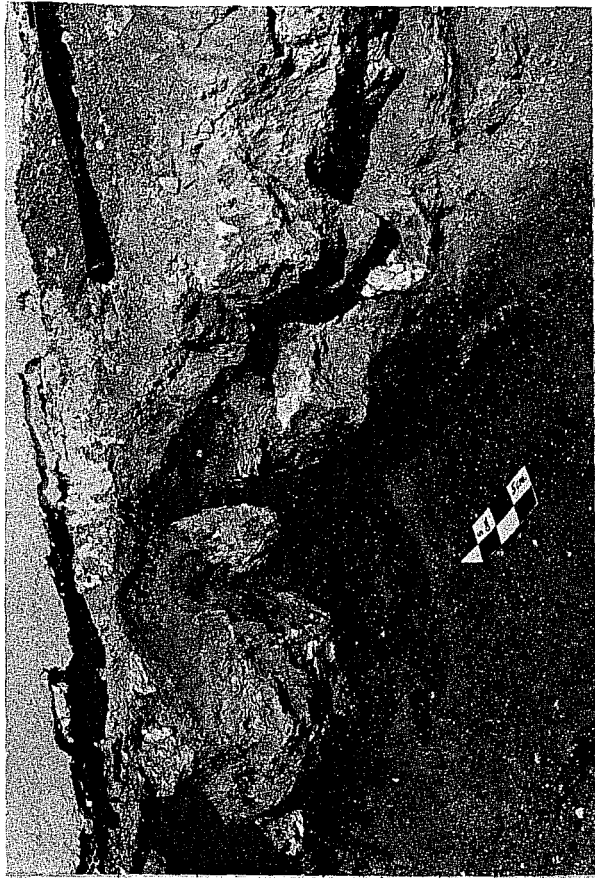
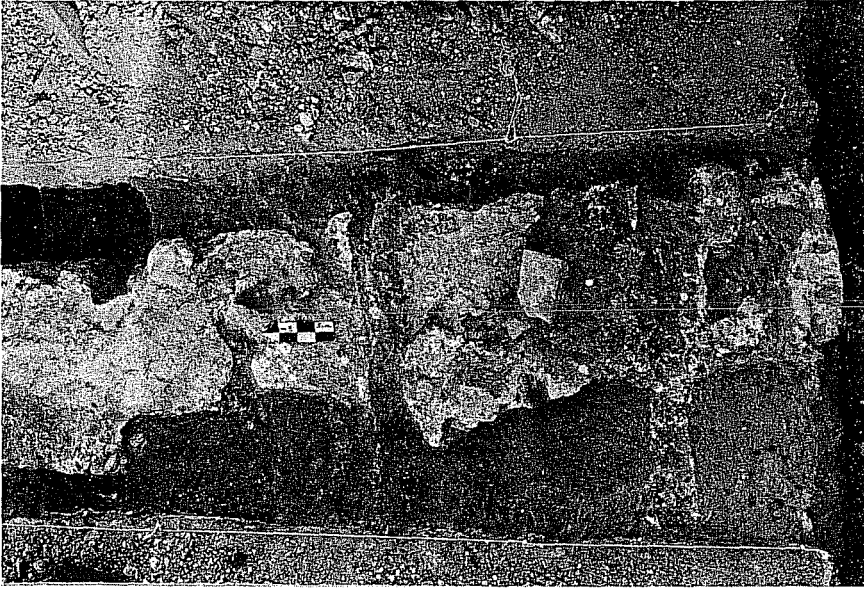
Figure 5. Views of Excavations. a, foundation remains at area F; b, foundation remains between areas A and C.

The old wall foundations were cut into this stratum. The foundation consisted of lumps of caliche and soft limestone bonded with white sandy lime mortar. This material had been placed directly into a trench which was cut into the brown clay

and filling the trench to its edges (Fig. 5). The foundation averaged 45 cm in width and about 33 cm in depth below the present surface.

After the excavations of test pits 1 through 4 had revealed the nature of the foundation, subsequent limited examinations were made to find other foundation traces. In area F, a portion of caliche construction was found, merging with the stones of the Gresser House on the north. At the same point it was noted that the Gresser House structure seemed to have a joint in its foundation at the line of the west face of the interior north-south wall, implying that the west half of the Gresser House was added to the east half after its initial construction.

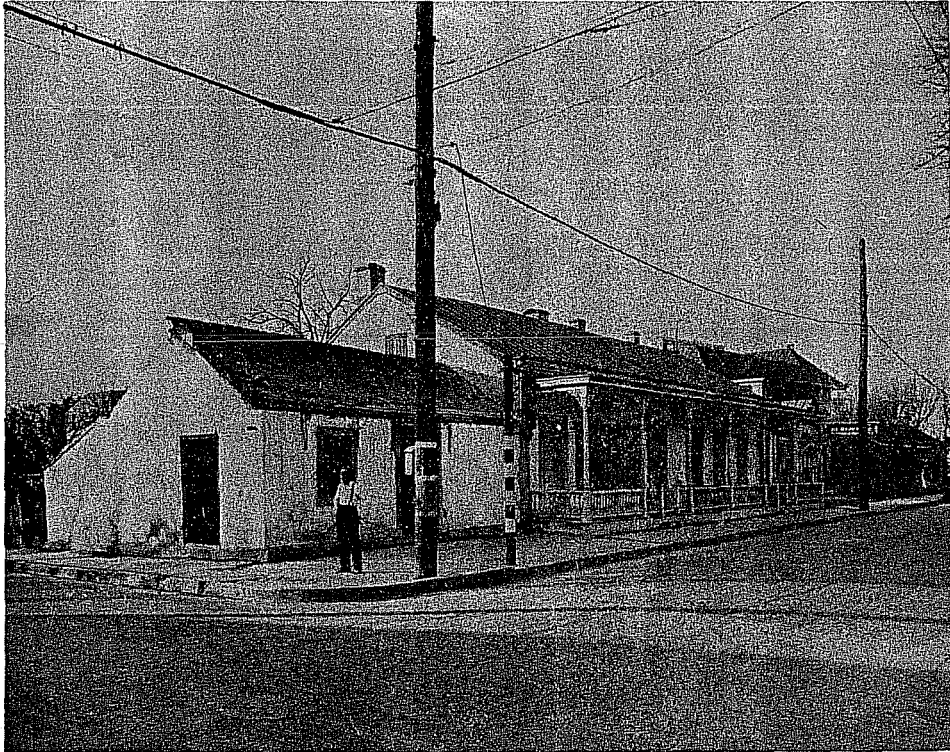
Figure 8. *The Gresser House.* a, Photograph taken in 1928 when the Casas House was still standing. Note what appears to be fire damage to the roof and walls; b, South wall of Gresser House during renovation. The outline of the Casas House roof is visible on the wall plaster.

We can go into somewhat more detail than this. In the 1928 photograph (Fig. 8,a), the Casas House can be seen to have a stone footing somewhat wider than the walls. It is possible that the walls above the foundation were of wooden construction rather than of stone. In a 1939 newspaper article about La Villita we find a detailed description of what was probably the Casas House: "It was built of cedar posts, erected upright and held together with rawhide. The interstices were filled with mud, which was used as a stucco and the house was kept in a whitewashed condition . . . No nails were used in building the framework of this house, the rafters for the roof being cedar posts tied together with rawhide, and the house originally had a thatched roof" (*San Antonio Express*, December 31, 1939). This use of wood tied with rawhide is probably the construction technique called *chamacuero* in early deeds of San Antonio (Fox 1977:3, 4). The term apparently came from *chamada*, brushwood or kindling, and *cuero*, hide, and is probably virtually interchangeable with the term *palisado*, a construction of vertical posts usually chinked with mud.
