**Annual Report to
Texas State University-San Marcos,
Hays County, Texas,
for Texas Antiquities Permit No. 5509**

Texas Antiquities Permit No. 5509

Archaeological Studies Report No. 26

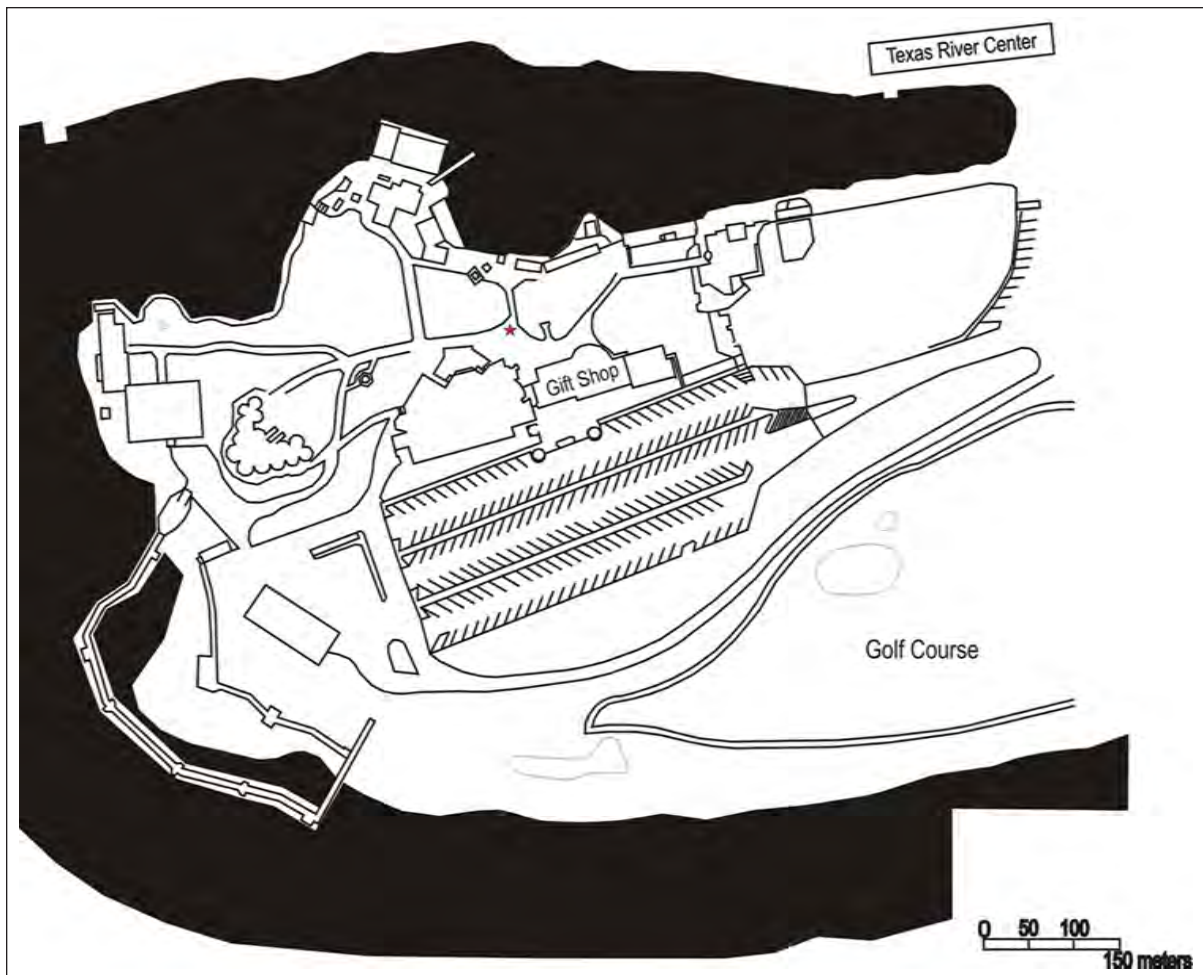
Figure 4-1. Location of Aquarean Center waterline repair (red star).

On January 14, 2010, CAS archaeologists Julian A. Sitters and David Yelacic monitored the repairs to a waterline just north of the Aquarena Spring's Gift Shop (Figure 4-1). This area lies close to the center of SAL 41HY160. A breach of the waterline prompted the expedited excavation of a 50x50-centimeter (cm) area to a depth of

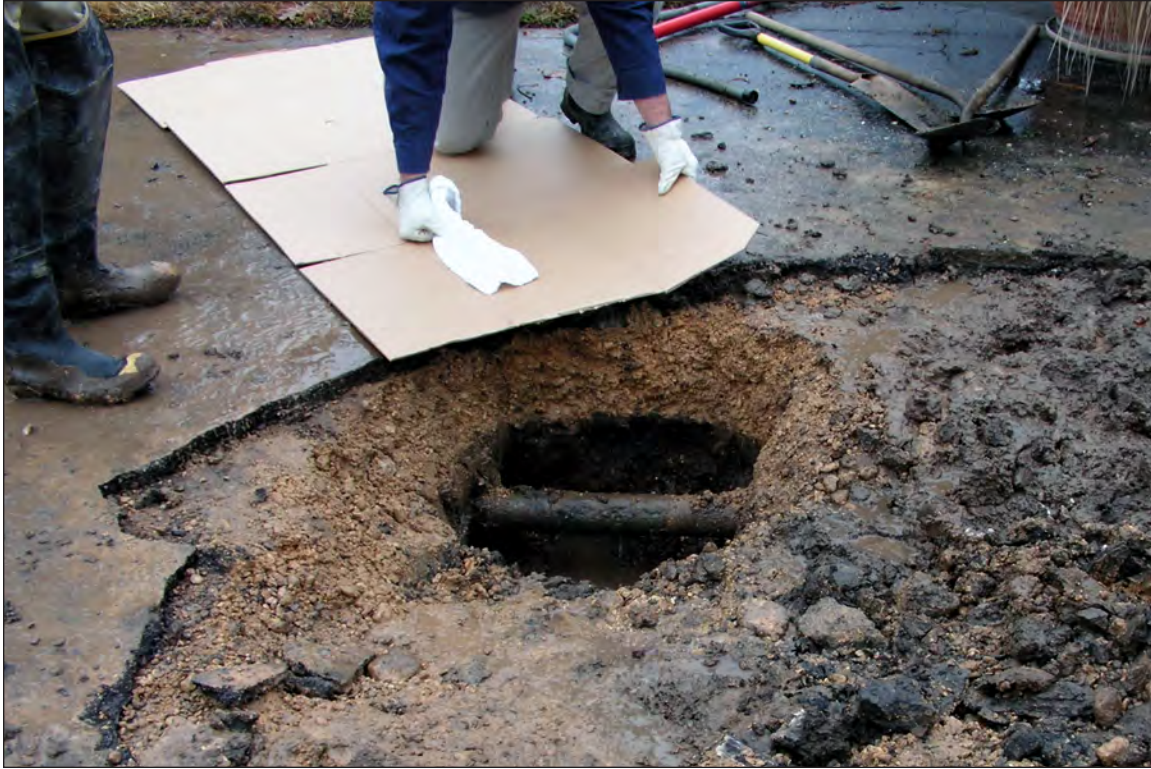
Figure 4-2. Excavation of waterline location.

approximately 66 cm to address issues with the corroded waterline (Figures 4-2 and 4-3). While the waterline in question was considered a "dead line," it was connected to conduits that supply water to the infrastructure at the Aquarena Center. The exposed waterline line lay approximately 35 cm below the ground surface (Figure 4-4).

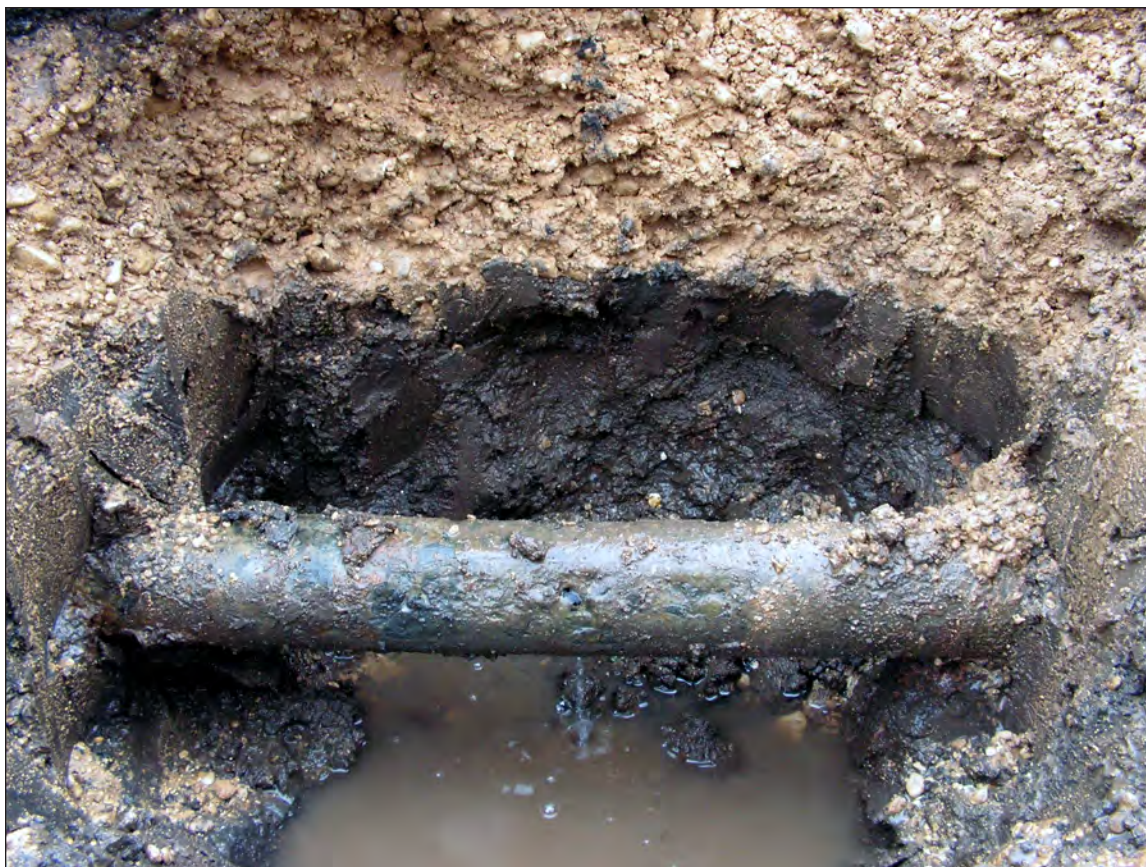
Figure 4-4. Exposed waterline.

No cultural materials were observed in the excavation pit or in the spoil pile. The top 30 cm of the profile consisted of construction fill. Below the construction fill, 30–65 cm, the soil was black clay (7.5YR 1.5/1; see Figure 4-4).

As no cultural materials were observed, no additional archaeological investigations were warranted or recommended.

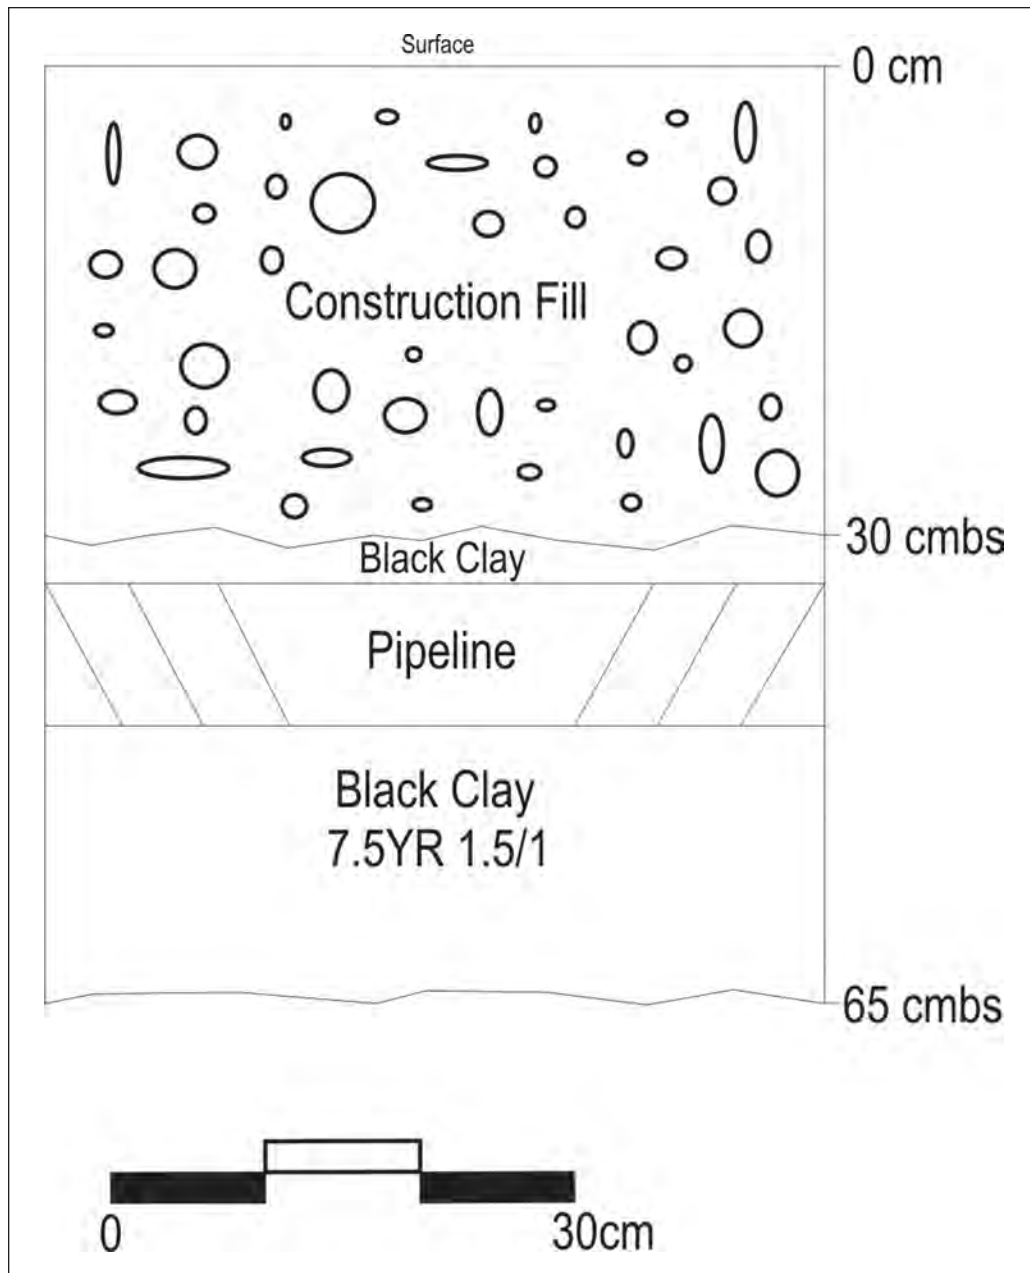
Figure 4-5. Excavation wall profile.

Archaeologists observed the excavation of sediment adjacent to the conduit. The observed sediment was devoid of any cultural material. A schematic profile (Figure 4-5) was drawn, and it appeared that the sediment encountered had been previously disturbed, probably by the initial construction of the plumbing infrastructure. The waterline was quickly repaired, and no additional excavations were conducted.

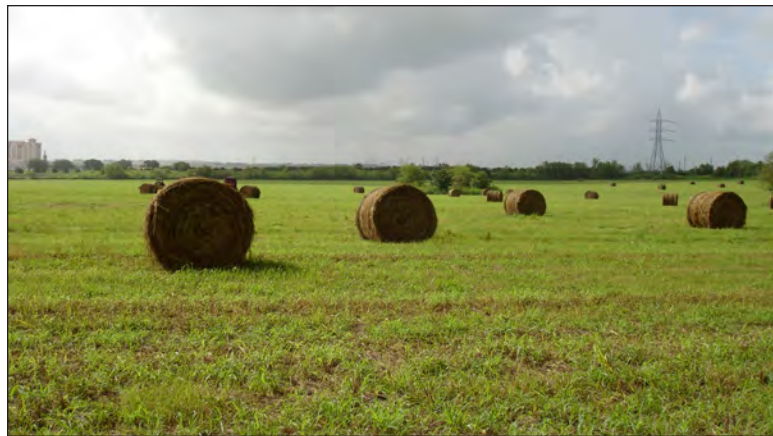
Figure 5-2. Overview of Center for Research Commercialization project area; facing southwest.

The modern-day parcel under archaeological investigations consists of 38 acres characterized as an agricultural field primarily used for hay cultivation (Figure 5-2). A group of trees are located in the center of the parcel and along the northwestern and southwestern fence lines. The centrally located group of trees surrounds a stock pond that is fed by a drainage system, running from the northwest to the southwest corner of the property. During times of heavy rain, the field floods due to poor drainage conditions.

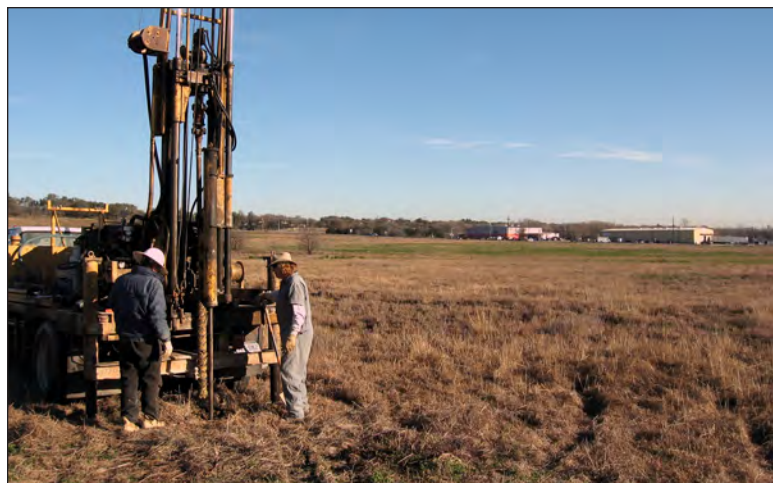
Figure 5-3. Geotechnical boring by Holt Engineering; facing north.

Monitoring of geotechnical boring was conducted by CAS archaeologist Julian A. Sitters on February 2, and 18, 2010. Geotechnical surveying was conducted by Holt Engineering and consisted of six bore holes, labeled Bore Holes A, B, C, D, E, and F (Figures 5-3 and 5-4).

surface. Sitters conducted limited sediment screening on the sediments extracted from Bore Holes A, B, and F. Bore Hole A was excavated to a depth of 4.5 m (15 ft), Bore Hole B to 2.7 m (9 ft) and Bore Hole F to 6 m (20 ft) below ground surface. No cultural materials were encountered during monitoring or limited screening of these three bore holes. The surface visibility at Bore Holes A, B, and F was poor, only 30 percent. The results are presented in Tables 5-1 through 5-3.

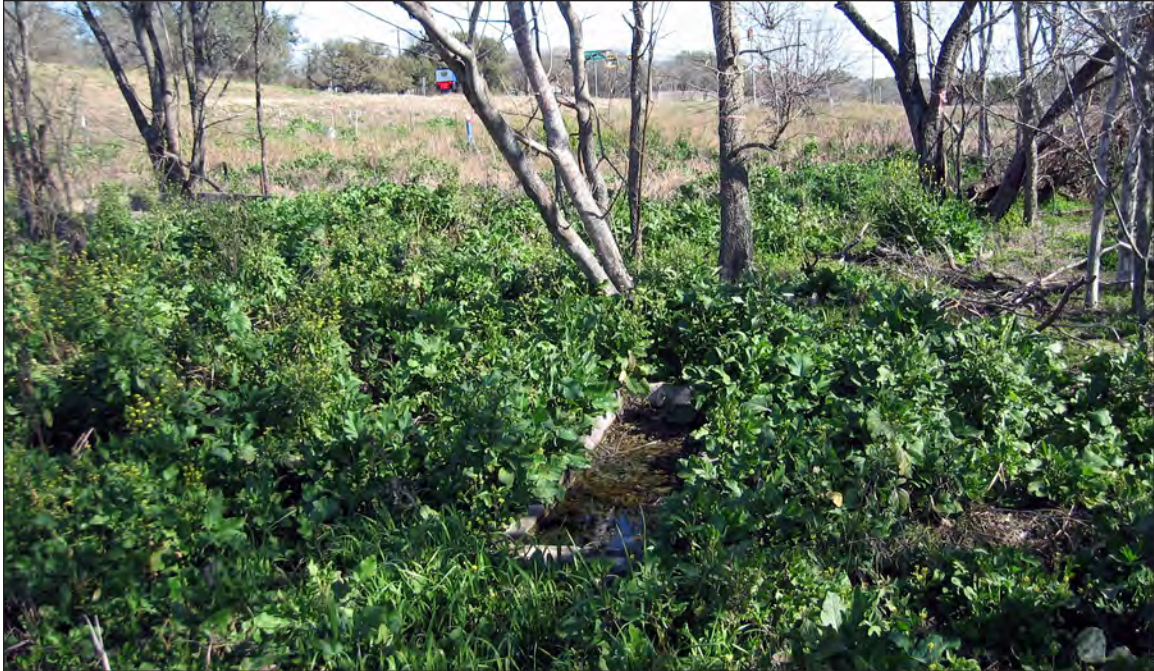
Figure 5-5. Concrete trough.

surrounding area. A concentration of cultural materials was identified and documented during this brief survey. This concentration was in a small grove of trees along the northwestern fence line and consisted of two concrete structures (water containment structures; Figure 5-5 and 5-6), one whiteware ceramic sherd, machine-

During the systematic pedestrian survey, CAS archaeologist relocated Cultural Material Locations 1 and 2. Location 1 consisted of an above-ground concrete cistern measuring 2.08 m in diameter (see Figure 5-6) and a concrete trough measuring 2.05 x 0.70 m (see Figure 5-5). These features were observed next to a collapsed structure consisting of a corrugated tin roof measuring approximately 2.5 x 3.5 m (see Figure 5-7). The corrugated tin was attached to machine-cut wood with round nails, suggesting a modern age. Farm equipment parts and a single whiteware ceramic sherd were also noted on the ground surface. Location 2 contained fragmented concrete slabs, thin corrugated sheet metal, and bound barbed wire. These materials were considered to be modern in age and associated with discarded trash along the property boundary.

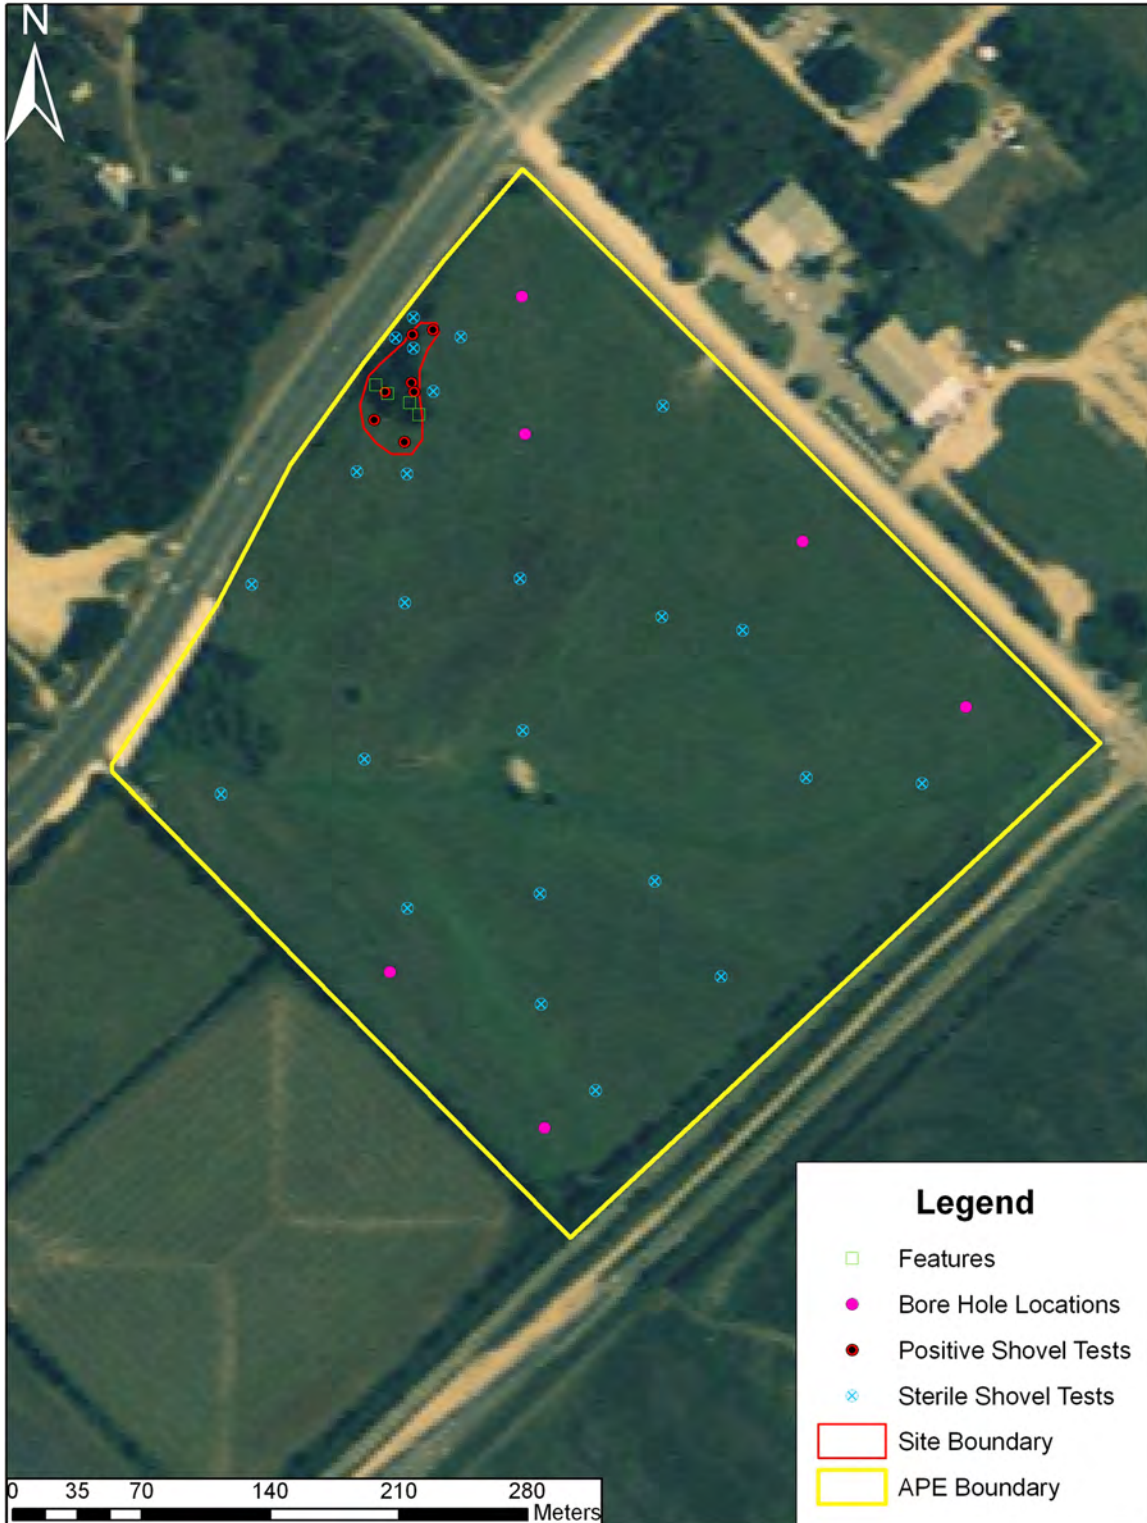
Figure 5-8. Shovel test locations, bore hole locations, and site boundary.

Nineteen shovel tests were excavated in conjunction with the systematic pedestrian visual survey (see Figure 5-8; Appendix A). Only one shovel test excavated yielded cultural material (TR1, ST1). This shovel test was excavated approximately 50 m northeast of Location 1. Encountered cultural material consisted of a single cut nail and a piece of window glass at a depth of 0–20 cmbs. An additional 12 shovel tests (TR1, ST1.1 through ST1.12) were excavated to determine the vertical and horizontal distribution of possible cultural deposits. Five of the additional 12 shovel tests contained cultural material between 0 and 40 cmbs, with the majority located between 0 and 20 cmbs (Appendix A). Encountered material included window glass, clear and blue glass, earthenware and whiteware ceramic sherds, and faunal bone.

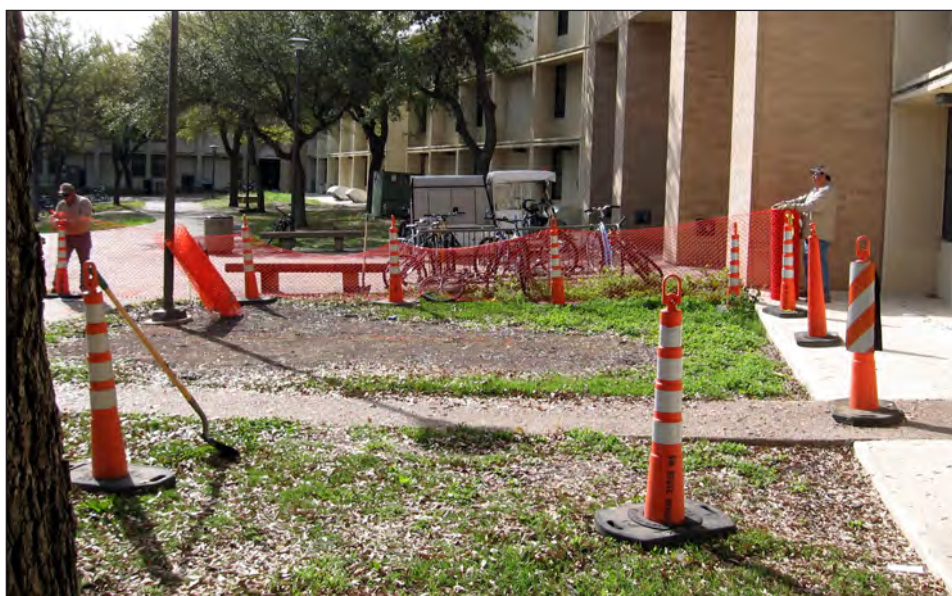
Figure 6-1. Trench location in front of Blanco Hall.

On March 23, 2010, Texas State University Facilities Services excavated a trench 4 m wide and 2.1 m deep in order to repair a fractured condensation line located in front of Blanco Hall (Figures 6-1 and 6-2). At the request of the University, CAS archaeologist Julian A. Sitters conducted monitoring of the excavation to assess potential impacts to culturally sensitive material(s).

amount of fill was brought in to provide support for the new building. In some areas it is believed that as much as 20 ft of fill was deposited. The fill is not just restricted to the location of Blanco Hall, but also extends out past Blanco Hall into the surrounding area. This information was provided by University Facility and Irrigation employees. This was based on past work experiences within

As no cultural materials were observed, no additional archaeological investigations were warranted or recommended.

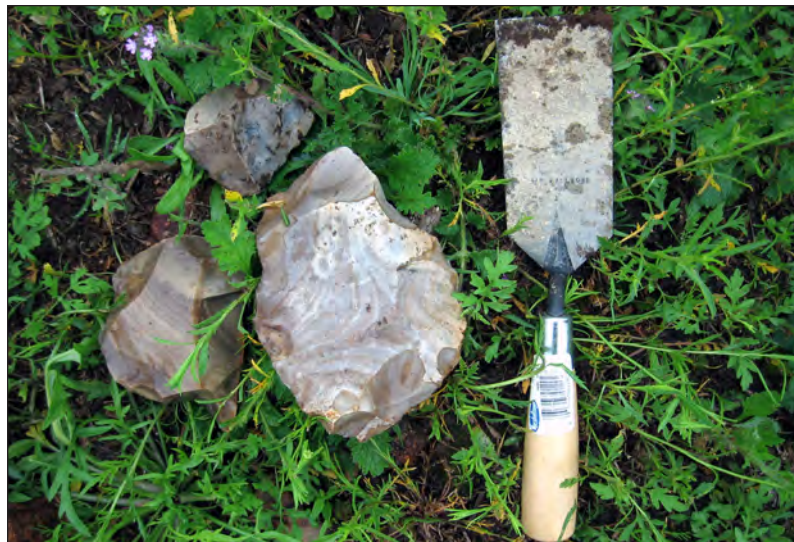
Figure 7-3. Possible flake cores.

No cultural materials were recovered or identified within any of the four trenches; however, cultural materials were present on the surface near Trenches 2 and 3. Noted cultural material included a tested cobble and possible flake cores (Figure 7-3). The presence of these materials on the surface suggests a lack of buried cultural material. All excavated trenches contain the same stratigraphic profile; a general description of this sequence is presented below.

While no prehistoric cultural remains were encountered in any of the excavated trenches, the presence of chipped stone artifacts near Trenches 2 and 3 indicates that prehistoric cultural materials are present at Freeman Ranch. CAS recommends that future impacts at Freeman Ranch either be monitored, similar to the current effort, or preceded by archaeological survey such as the one that recorded site 41HY447 (Yelacic and Lohse 2008).

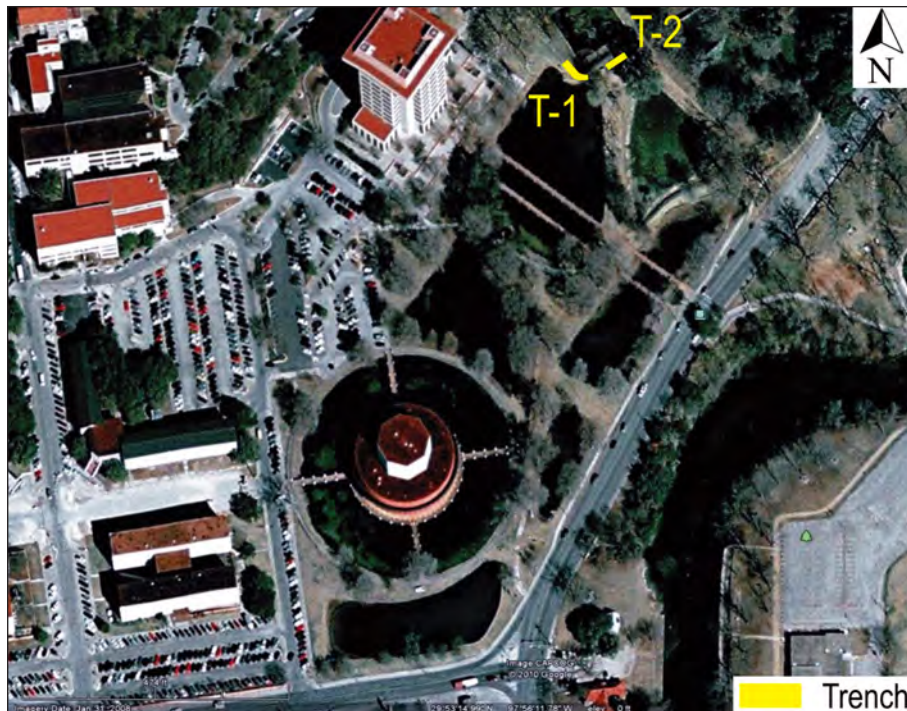
Figure 8-1. Backhoe trench locations.

addition to multiple fish ponds. The San Marcos River is located slightly downslope from the project area. Two backhoe trenches were excavated to the east of the JC Kellam administrative building, between one of the old fish ponds and a cement water retention pond to the north (Figures 8-1 and 8-2). The trenches were excavated until the waterlines were exposed, which was at roughly 120–170 cmbs.

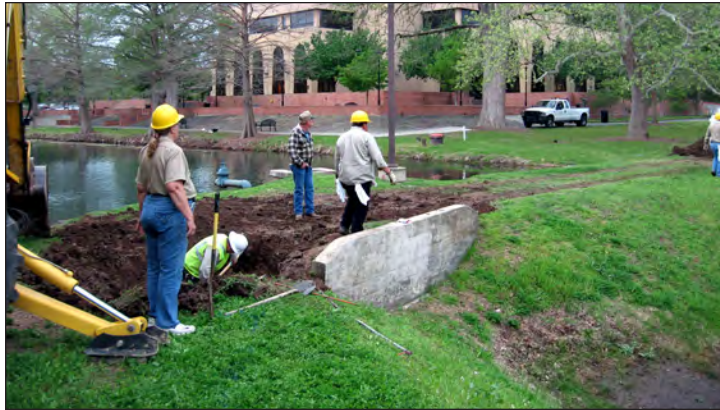
Figure 8-2. Texas State Facilities Services excavating Trench 2.

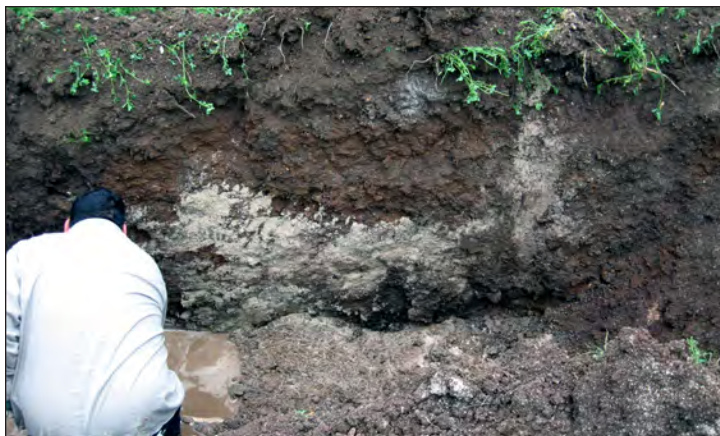
Figure 8-3. Trench 2 profile.

- The upper deposit consists of a mottled clay loam, 10YR 3/3–2/2.
- The bottommost deposit consists of construction fill.
- Cultural materials were present in both trenches (backfill).
- Trench 1 measured 120 cm in depth.

- Trench 2 measured 170 cm in depth, 160 cm wide, and roughly 6 m long.
- Each trench was closed once the waterlines were reached.

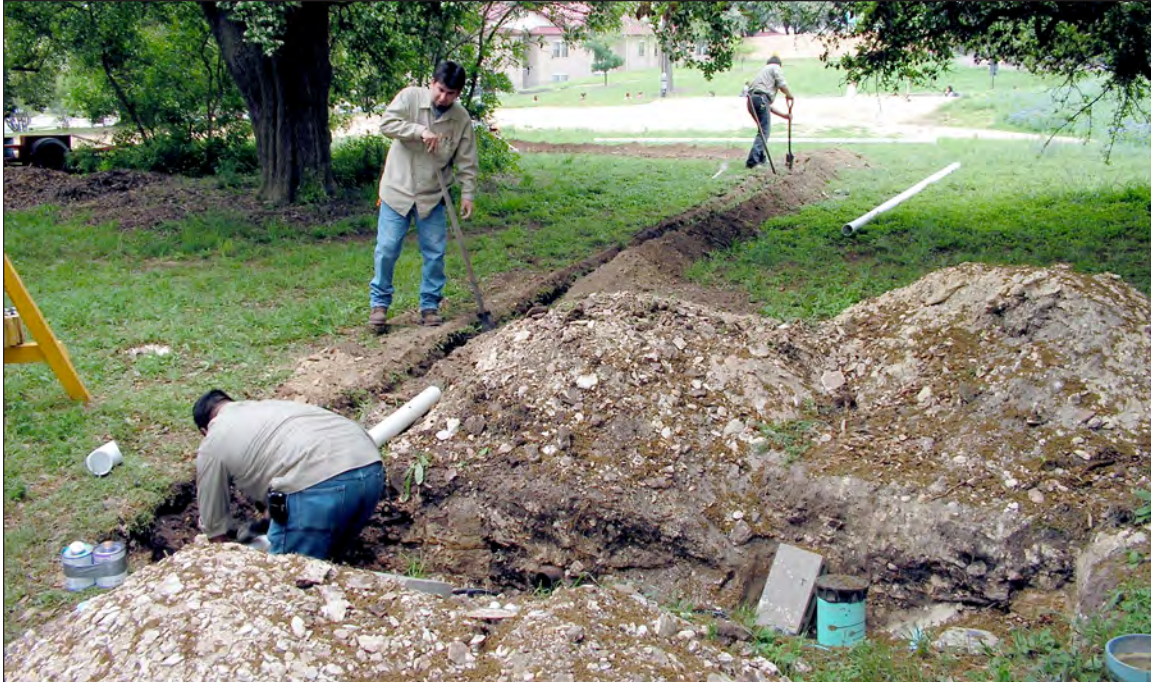
Figure 9-2. Texas State University’s Grounds and Irrigation crewmembers excavating trench adjacent to the President’s House; facing southwest.

On April 13, 2010, CAS archaeologist David Yelacic conducted archaeological monitoring of trench excavations by University Grounds and Irrigation crewmembers to install a new sprinkler system for the President's House. Excavations were located between the President's House to the southeast and the Family and Consumer Sciences Building to the northwest (Figure 9-1). The project entailed manual excavation of two pits, which exposed the main waterline connection (tap trench) and the terminus connection (terminal trench) (Figure 9-2). A linear trench was mechanically excavated by a Ditch Witch. The distance between the tap and

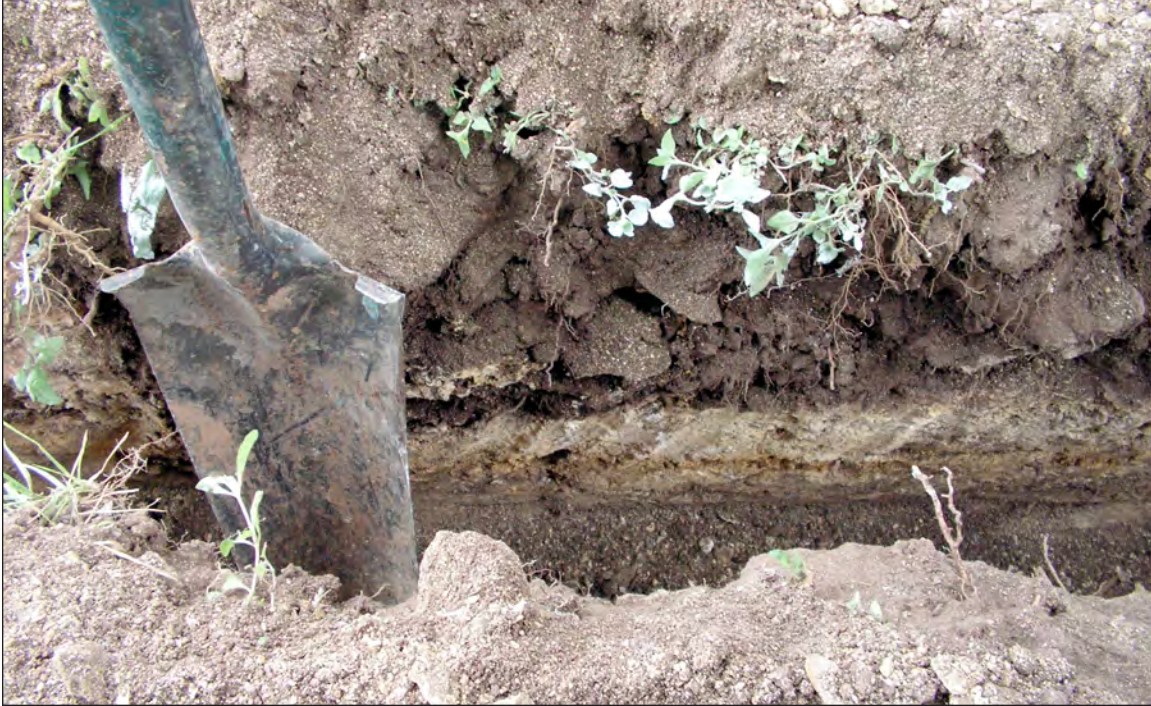
Figure 9-3. Trench profile.

The tap trench measured approximately 2 x 1 m and was less than 50 cm deep, and the terminal trench measured approximately 1 x 0.60 m and was about 50 cm deep. In both trenches, profile exposures revealed 15–20 cm of topsoil directly overlying marly, chalky limestone bedrock (Figure 9-3). The irrigation line trench was excavated mechanically and measured less than 20 cm wide, approximately 35 cm deep, and about 60 m long. On the northwest end of the irrigation line trench, beginning at where it connected to the tap trench and extending to where it intersected the “chill line” trench, topsoil increased in thickness from 15–20 cm to approximately 25 cm. The “chill line” trench appears similar to a dirt road, and is the result of an extension of a main waterline from near the Student Recreation Center to a recently constructed building east of the current project area. Sediments exposed when the irrigation line trench intersected the “chill line” were different from those exposed in the remainder of the project area. These sediments

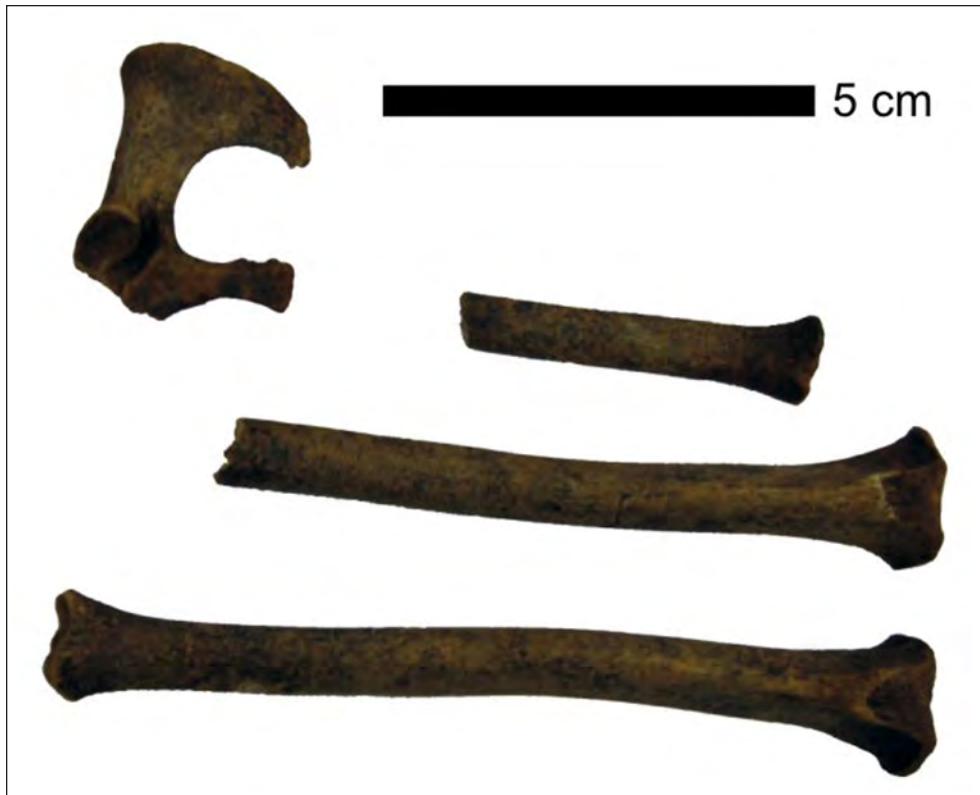
Figure 10-8. Faunal remains *Canis* sp.

Faunal remains consist of four bones from a juvenile individual that compares favorably to *Canis* sp. (Figure 10-8). Two elements are the left and right tibiae. One element is a partial left innominate with pubis and ischium. The fourth

The right tibia is lacking the distal end, marked by a fresh break. The proximal epiphysis is unfused and missing. A small abrasion occurs near the proximal articular surface. Epiphyseal fusion surfaces are not damaged. Size comparison of the two tibiae suggests they are from the same individual.

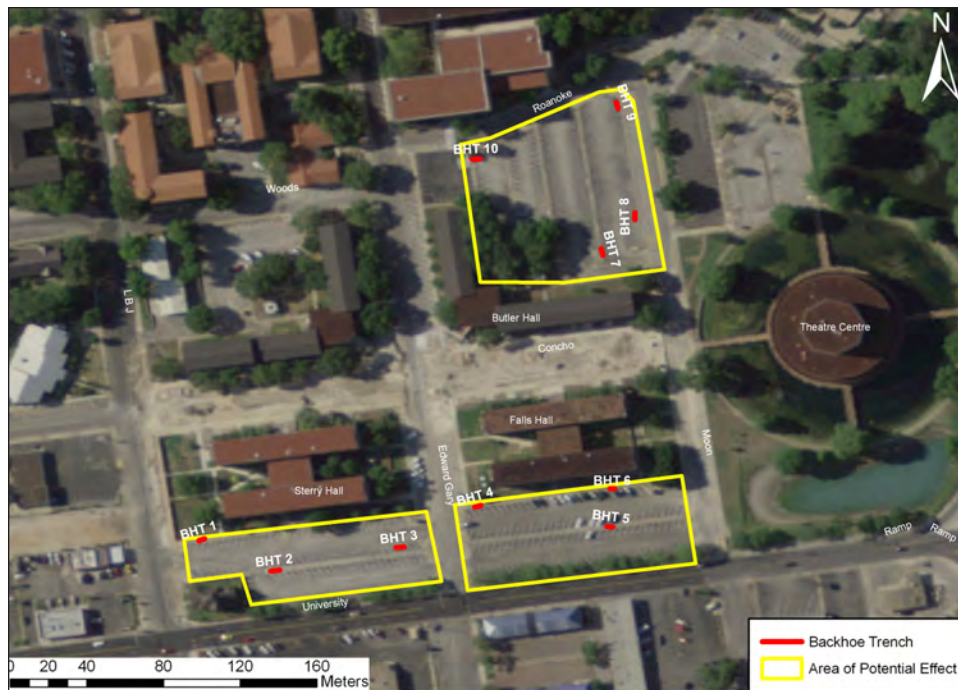
Figure 11-5. Backhoe trench locations within APE.

Investigations were conducted on September 11, 18, and 25, 2010, and consisted of monitoring 10 backhoe trenches excavated by Myers Concrete of San Marcos, Texas. Investigations also included examining removed soils and exposed soil profiles. Three of the 10 trenches excavated were located in the parking lot of Sterry Hall, three were located in the parking lot of Falls Hall, and four were located in the parking lot of Butler Hall (Figure 11-5).

The sample of excavations generally covers the entire APE, and provides reasonably complete coverage of areas thought to have a moderate-to-high probability of containing cultural deposits (see Figure 11-5). The first three backhoe trenches (BHTs 1, 2, and 3), located in the Sterry Hall parking lot, were the farthest from the river (i.e., farthest to the west) and highest in elevation. BHT 1 was the westernmost excavation, and soils encountered exhibited A/Ap-Btk1-Btk2-Bt/C-C profile beneath a combined 37 cm of asphalt and construction fill. The A/Ap horizon extended from 37 to 72 cmbs and contained mottles, likely associated with construction-associated mixing. The Btk1 horizon, extending from 72 to 102 cmbs, appeared intact and contained lithic debitage. The Btk2 horizon extended to

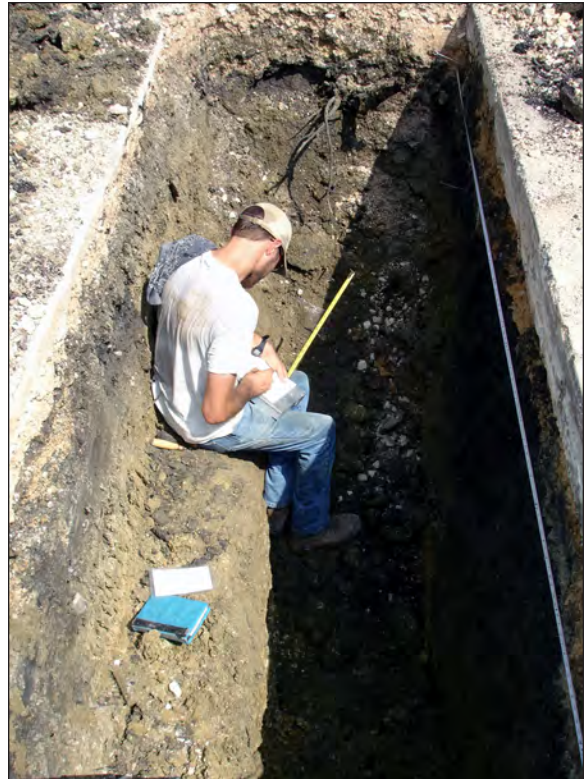
Figure 11-6. Archaeologist David Yelacic completing a trench wall profile.

approximately 10 ft (3.04 m) in length and 3.28 ft (1 m) in width. Trench depths across the APE ranged from 5.5 to 10 ft (1.71 m to 3.04 m) based on varying depths of sterile subsoils. All trenches deeper than 4 ft (1.22 m) were stepped to ensure safety. Excavations began with by removing asphalt paving and subsurface fill, and exposing intact underlying soils. Once these soils were exposed they were systematically removed in 12-inch (ca. 30 cm) levels for vertical control. Sediments from each level were placed in separate piles, and archaeologists collected no fewer than five 5-gallon bucket samples of each level/sediment pile to be screened through ¼-inch mesh screen to recover any artifacts present. Once each trench was completed, trench wall profiles were recorded and samples were taken (Figure 11-6). The trench was then refilled with the excavated sediments.

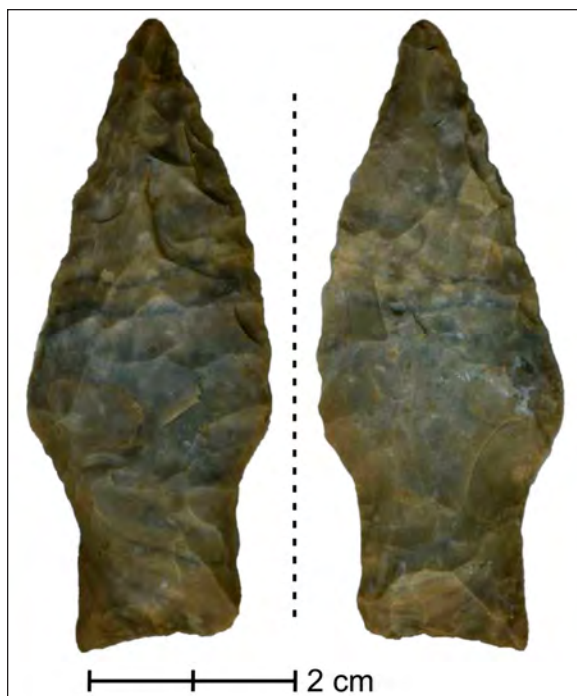
Figure 11-7. Nolan-like projectile point recovered from BHT 10; dorsal and ventral views.

A Nolan-like projectile point (see Figure 11-7), dating to the Middle Archaic period

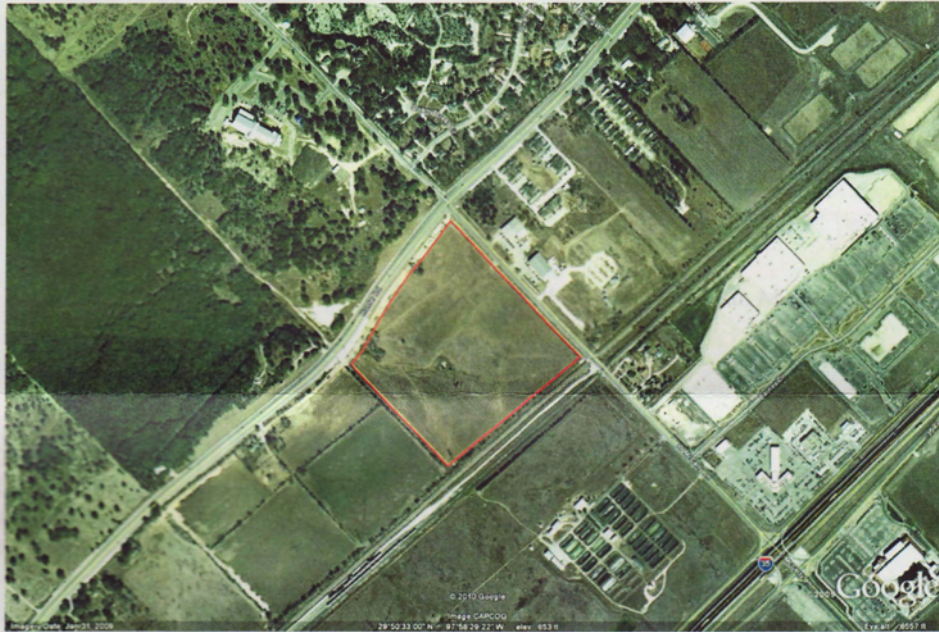
Figure 1. Google Earth © aerial image (downloaded August, 2010) of proposed project area, outlined in red, at the southern corner of the intersection of McCarty Road and Hunter Road, showing wooded spaces, agricultural pasture land, and recent constructions on surrounding tracts of land.

CAS suggests that the proposed undertaking will similarly have no negative impact whatsoever on historic properties. No standing buildings are located within the project area, and no historically significant buildings are located and visible within several hundred feet of the project area (Figure 1). Additionally, an aerial photo from 1952 was reviewed, and this image, too, shows no standing architecture near the proposed project area (Figure 2).
