Archeological Investigations for Fort Stabilization and Restoration, For McKavett State Historical Park, Menard County, Texas: 1978-1990 Seasons

ARCHEOLOGICAL INVESTIGATIONS FOR FORT STABILIZATION AND
RESTORATION, FORT MCKAVETT STATE HISTORICAL PARK,
MENARD COUNTY, TEXAS: 1978-1990 SEASONS

REPORTS OF INVESTIGATION, NUMBER 105

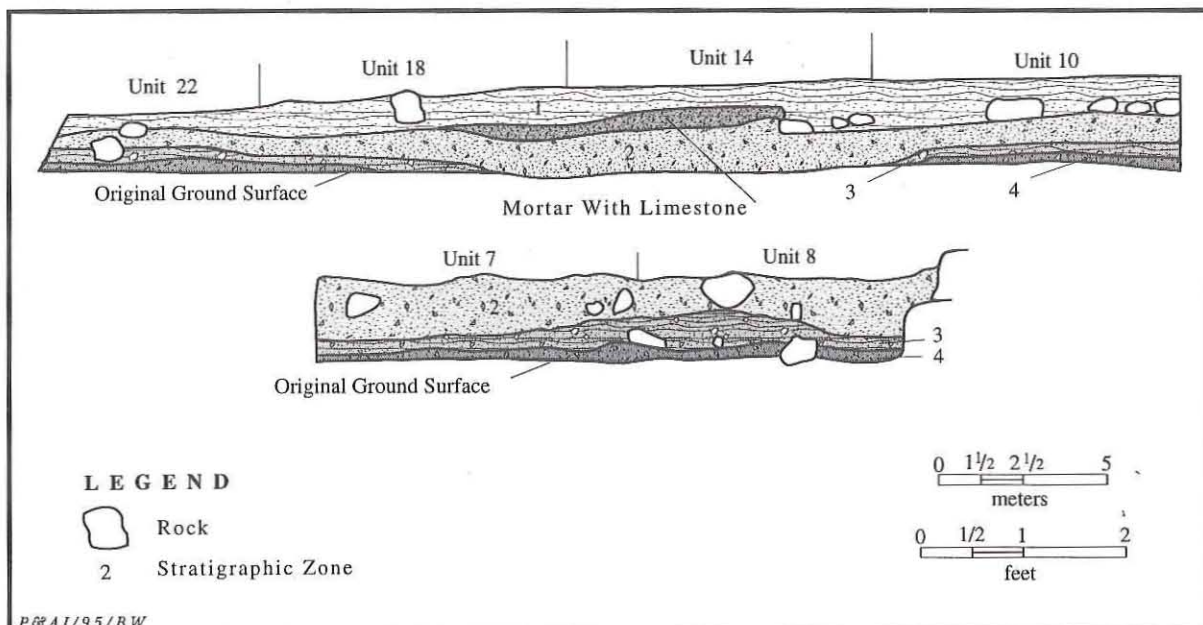
Figure 19. Profiles of Room 0 in Officers' Quarters 4. View to the west of the east walls of Units 10, 14, 18, and 22 (unexcavated) and view to the north of the south walls of Units 7 and 8 (unexcavated).

The third layer was a compact brownish red to reddish to orangish brown clay loam to silt with moderate amounts of rounded stream gravels, few artifacts, and less disturbance than the wall fall layer above. The clay indicates that this layer was derived from the original ground surface, perhaps as backfill, and the gravels indicate sediment transported from below the bluff. The fourth layer was unconsolidated tan to light gray to grayish red mortar-rich clay loam and sand with numerous small angular rubble spalls representing debris from wall construction or chinking during the

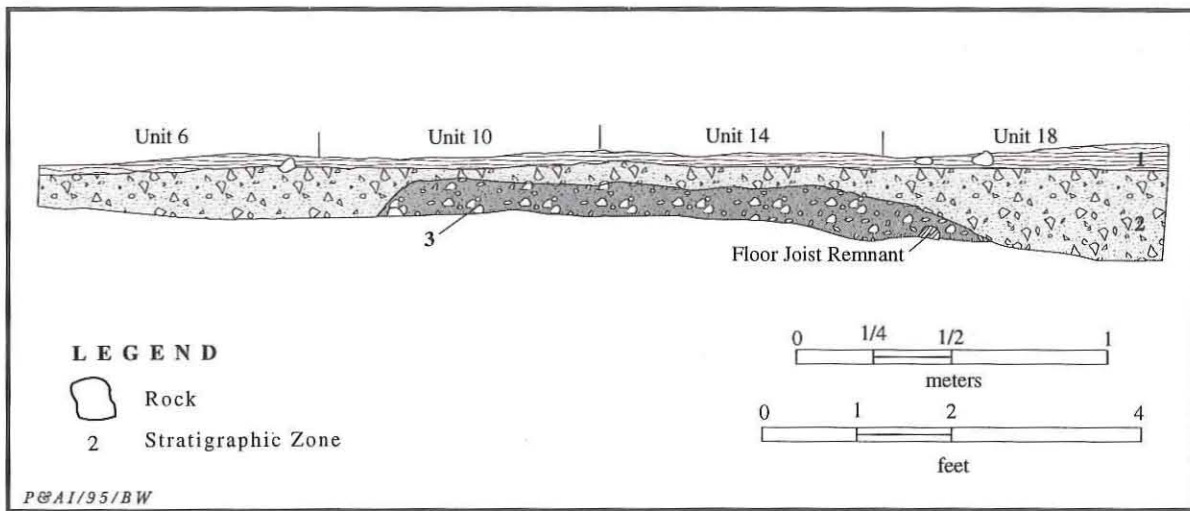
Figure 21. Profiles of Room 1 of Officers' Quarters 4. View to the east of the west walls of Units 6, 10, 14, and 18 (unexcavated).

brown to brownish gray sandy silt loam to clayey silt with few to moderate amounts of mortar and few to moderate limestone rubble fragments and pebbles (Figure 21). Most artifacts were contained within this layer. The origins of this layer were eolian, wall deterioration, and trash disposal. This layer was absent in the east balk profile of Unit 6 and the northern foot of Unit 10, which contained a high density of angular rubble fragments as well as stream cobbles and pebbles that appear to represent a mixture of two to three strata. In the north end of the room near the fireplace were two 1–2-ft rubble blocks that may have originated from the west wall or fireplace dismantling. The top layer was mixed with limestone gravels, pebbles, and cobbles in the east wall repair area in the southeast corner of the room, where the sandy silt loam underlay mortar from recent wall repair and a lens of wood (shingles?) fragments. Similar evidence of wall repair was found in the Units 15 and 16 south balk and Unit 18 east and west balk

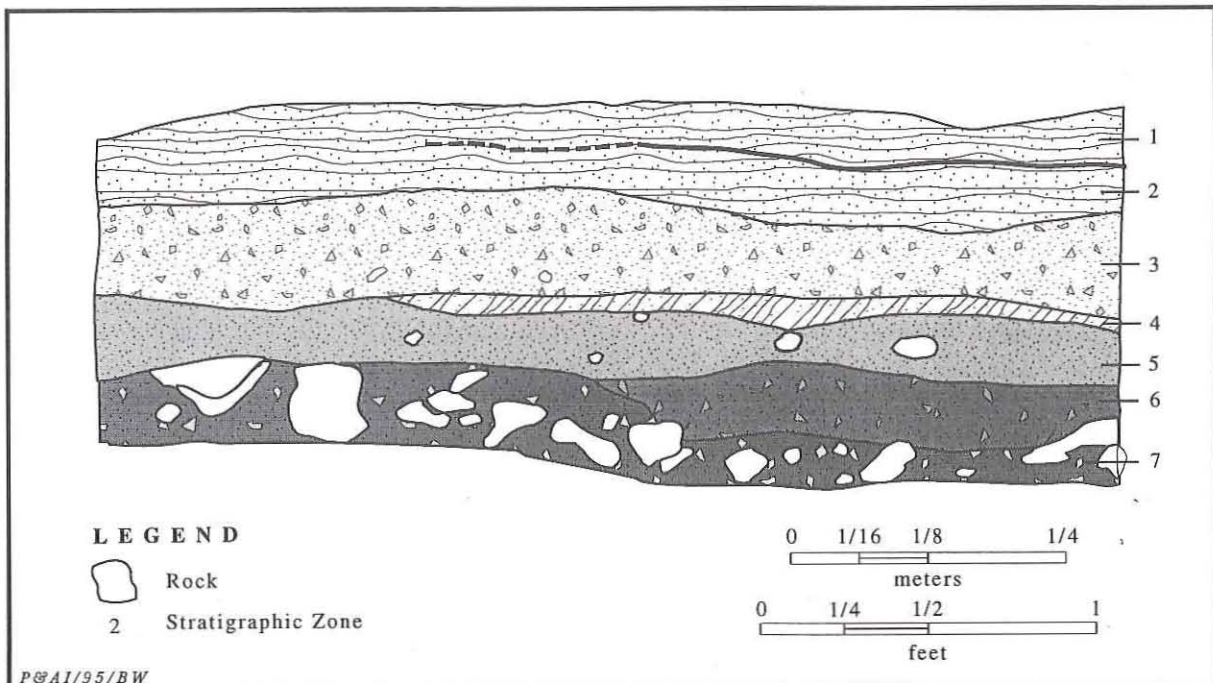
Figure 23. West wall profile of Unit 6, Room 2, in Officers' Quarters 4.

The west wall profile of Unit 6 (Figure 23) contained three upper layers of pale brown to gray sandy silt to silty loam showing possible soil development (Strata 1-3). Below was a pale gray mortar lens (Stratum 4), and mortar also occurred in the top layer. Gray sand, limestone chips, mortar, river gravels, and sterile black clay were

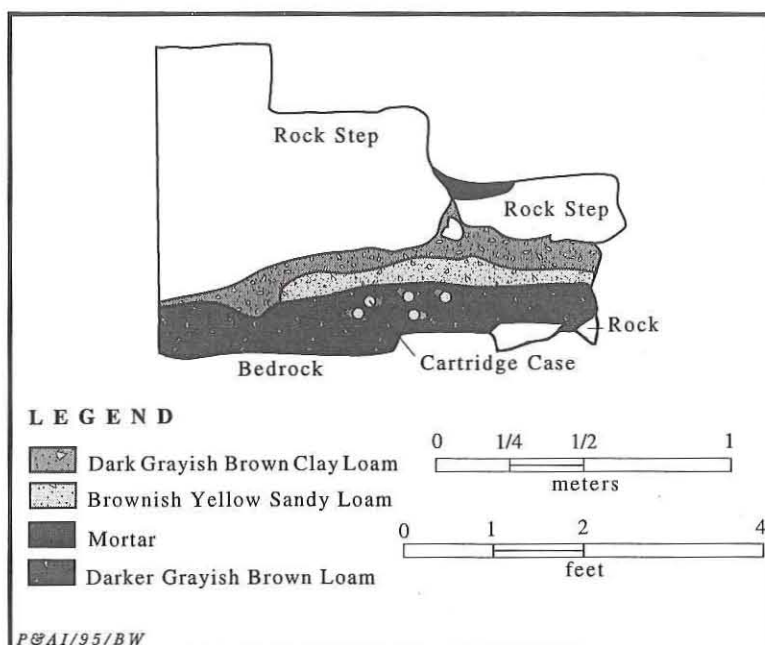
Figure 32. South profile of exterior doorsteps of Room 3 in Officers' Quarters 8.

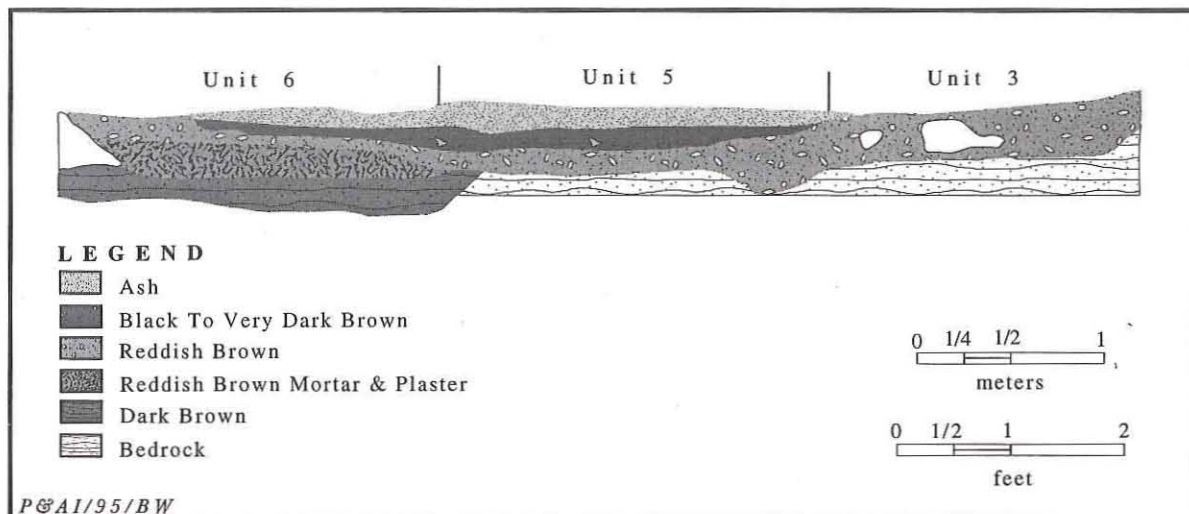
Figure 41. North profile of commissary storehouse, Units 6, 5, and 3.

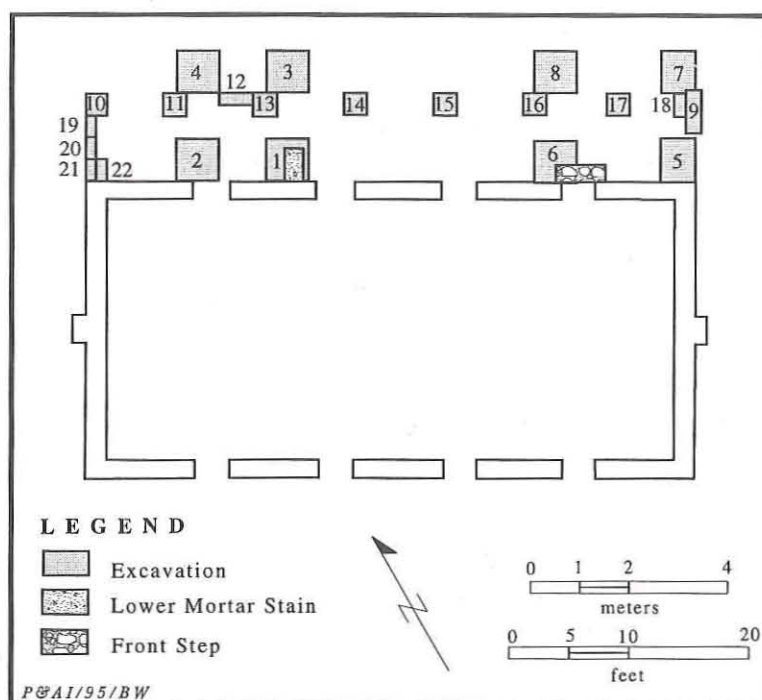
Figure 44. Plan of excavations on the north side of the schoolhouse.
