FINAL Cultural Resources Survey Report

PROPOSED HORSEPEN BAYOU CONVEYANCE IMPROVEMENTS

CITY OF HOUSTON, HARRIS COUNTY, TEXAS

Terracon Project No. 92187794
HCFCF Project ID: B104-00-00-E002

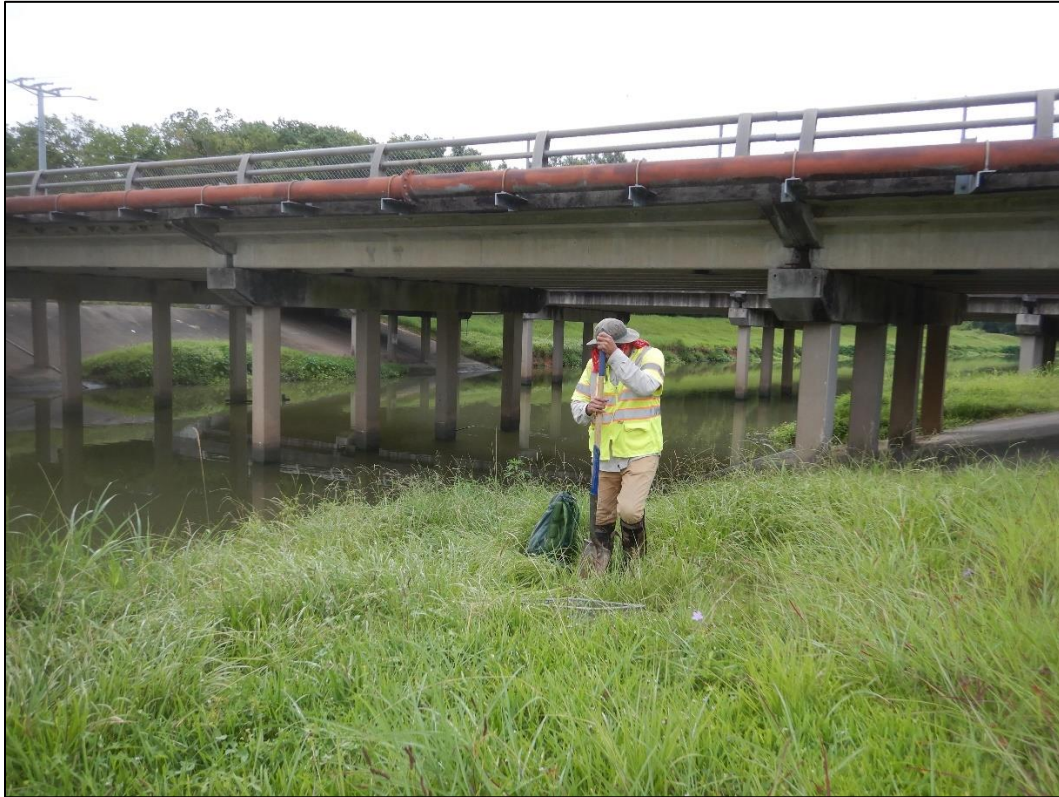
Figure 7. First shovel test near Bay Area Boulevard (facing east).

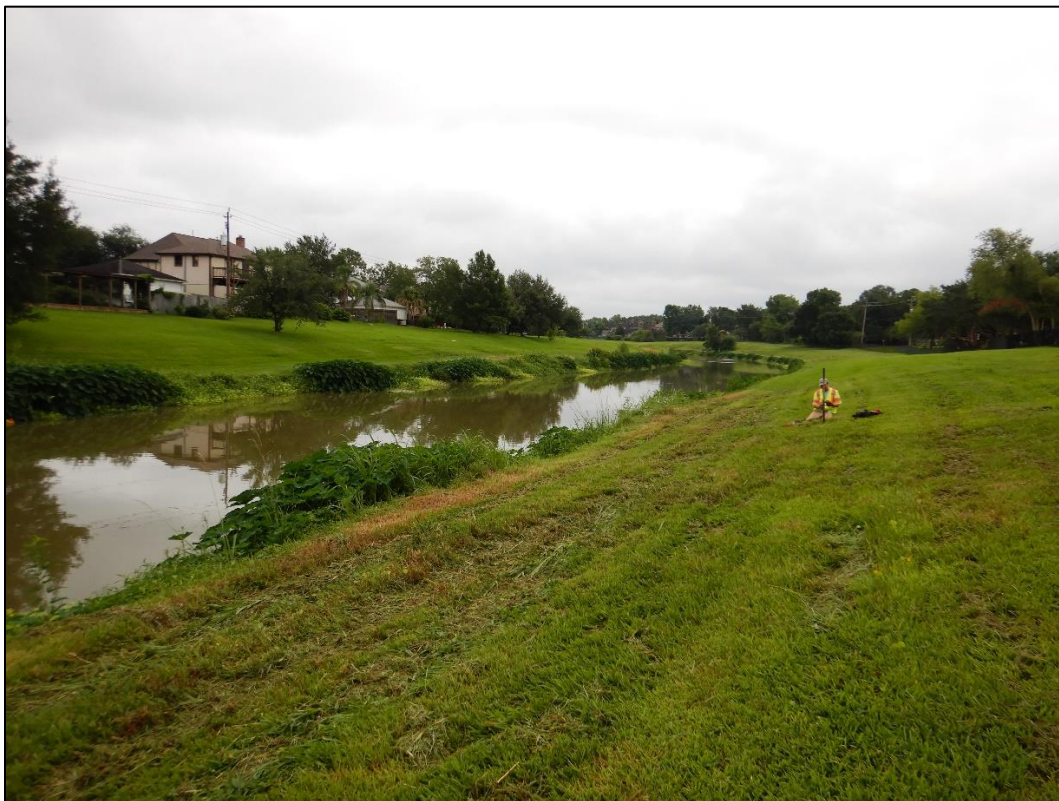
Figure 8. Project area along Horsepen Bayou (facing east).

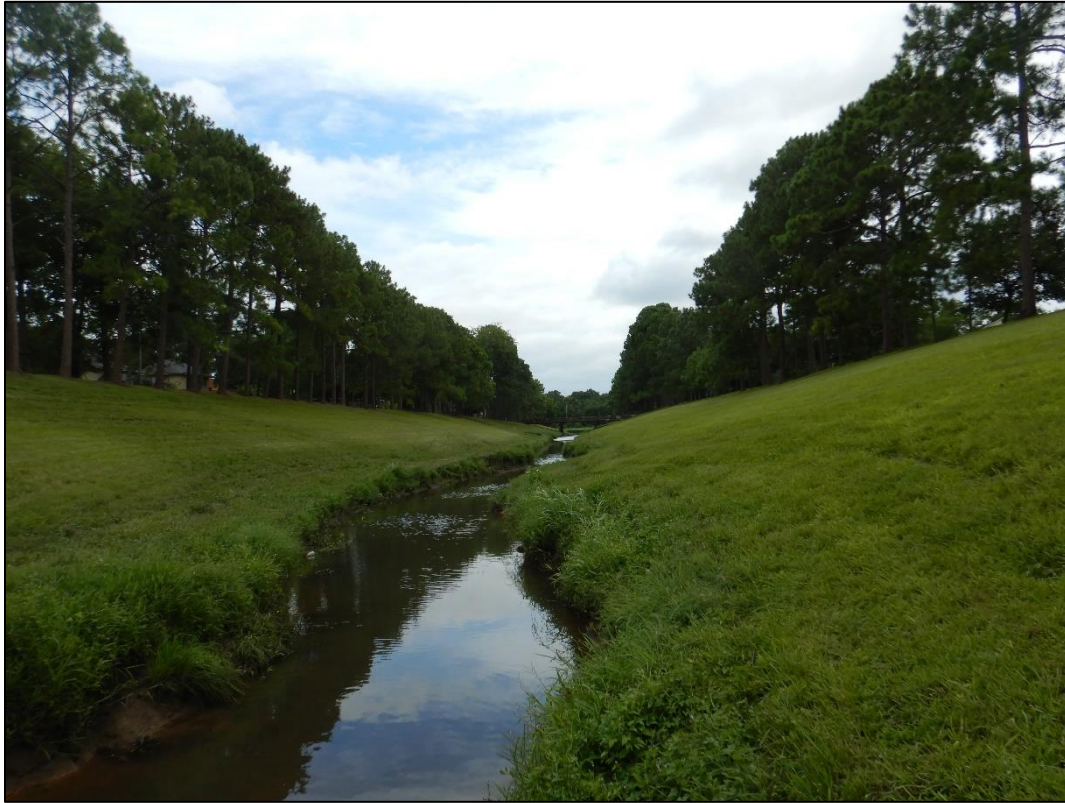
Figure 9. Project area along channelized stream from Spring Forest Drive to Brook Forest Drive (facing south).
