## **Intensive Cultural Resources Survey of the Brushy Creek Sewer Line Phase 3 Project in the City of Ingram, Kerr County, Texas**

FINAL: INTENSIVE CULTURAL  
RESOURCES SURVEY OF THE  
BRUSHY CREEK SEWER LINE  
PHASE 3 PROJECT IN THE CITY  
OF INGRAM, KERR COUNTY,  
TEXAS

TEXAS ANTIQUITIES PERMIT NO. 9243

PREPARED BY  
**SWCA Environmental Consultants**

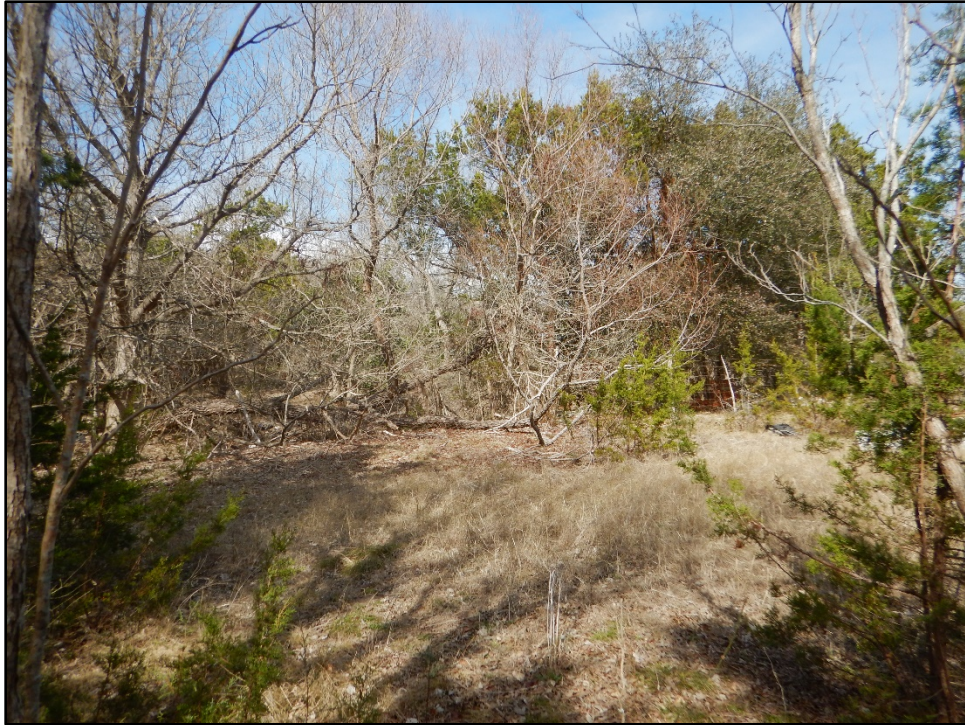
**Figure 6. Typical vegetation within the Project area, facing north.**

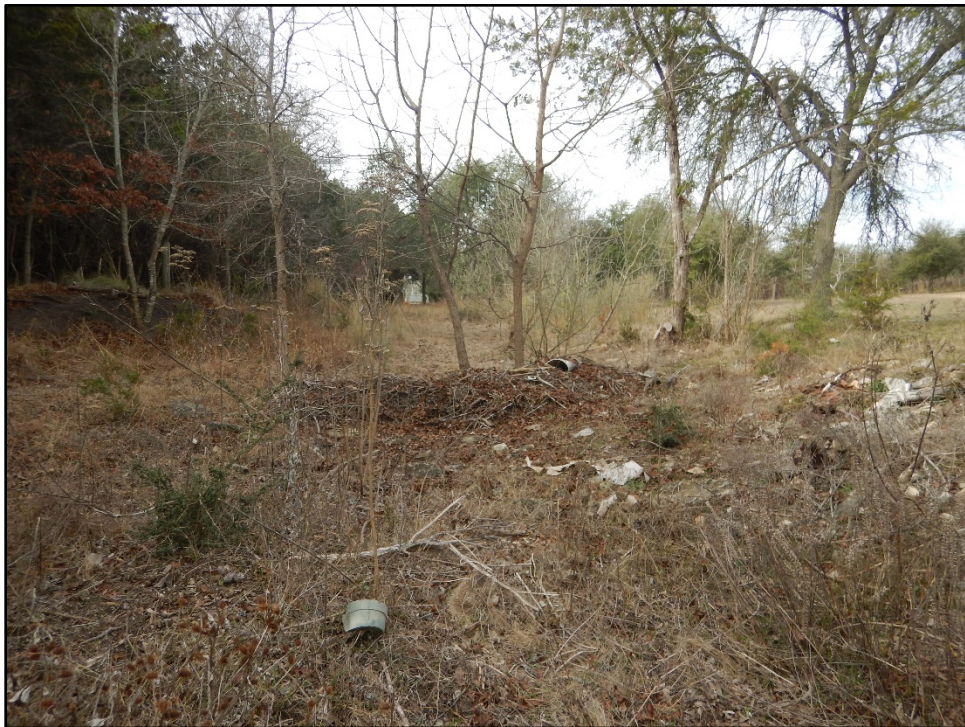
Although the Project occurs within the Ingram city limits, the Project corridor consists largely of undeveloped land. Ground surface visibility varied greatly, ranging from 0 to 100 percent, but averaged near 0 percent across the Project due to the presence of tall grasses and leaf litter (Figure 6). The majority of the Project is located within a riparian wooded zone, as the alignment parallels two unnamed tributaries which feed into Johnson Creek, located approximately 280 m west of the southern terminus. The small strips of wooded lands are bounded on either side by residential developments. Modern trash and debris were observed over much of the surface throughout the Project area, although, no historic or prehistoric artifacts were encountered (Figure 7). Common disturbances within the Project area include roadways, powerline and telephone poles, as well as backyard improvements, such as gardens (Figure 8).

**Figure 7. Example of modern trash and vegetation debris within the Project area, facing west.**

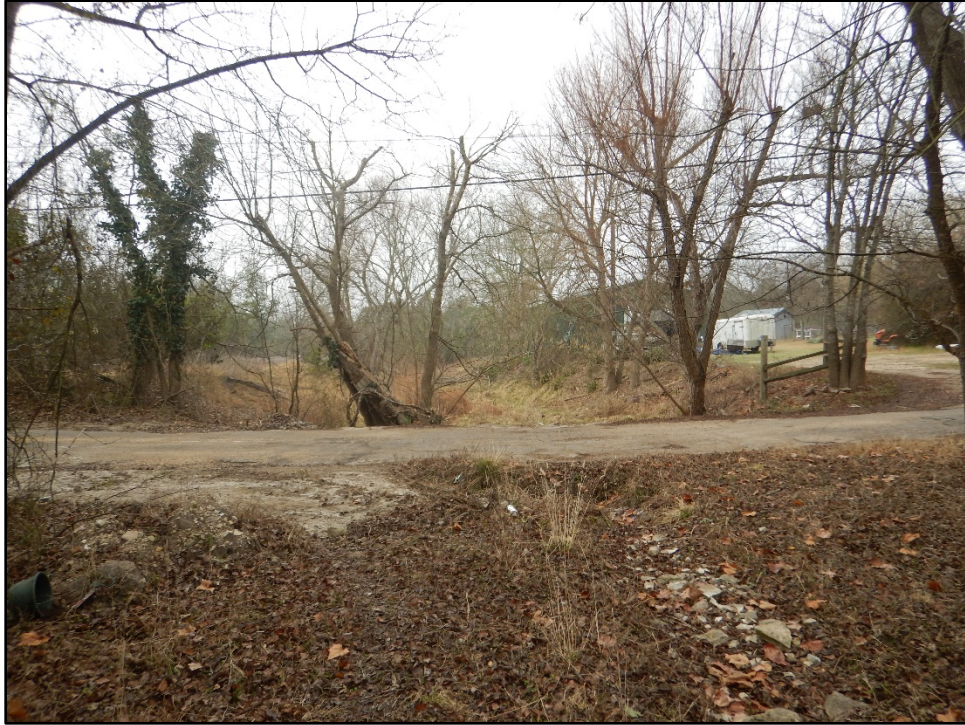
**Figure 8. Overview of Velma Street crossing the Project area, facing south.**

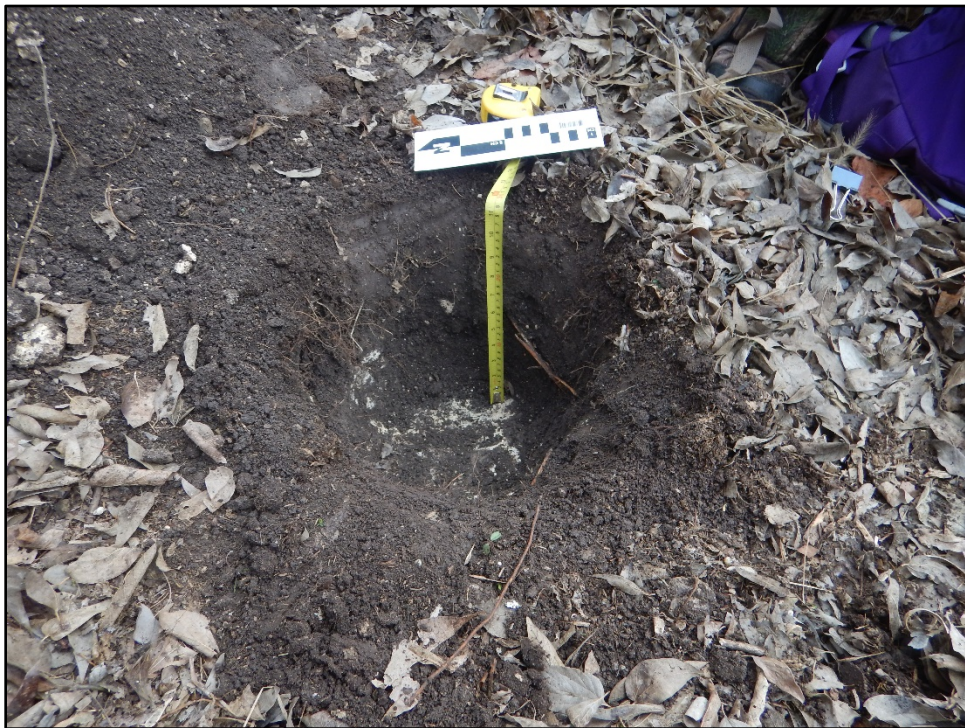
**Figure 9. Shovel test LV02, an example of a typical shovel test within the Project area.**
