## Archaeological Investigations of Sections of the San Pedro (41BX337) and Upper Labor (41BX1273) Acequias in San Antonio, Bexar County, Texas

Texas Antiquities Permit No. 9229

*Prepared by:*  
Center for Archaeological Research  
The University of Texas at San Antonio  
One UTSA Circle  
San Antonio, Texas 78249  
Archaeological Report, No. 481

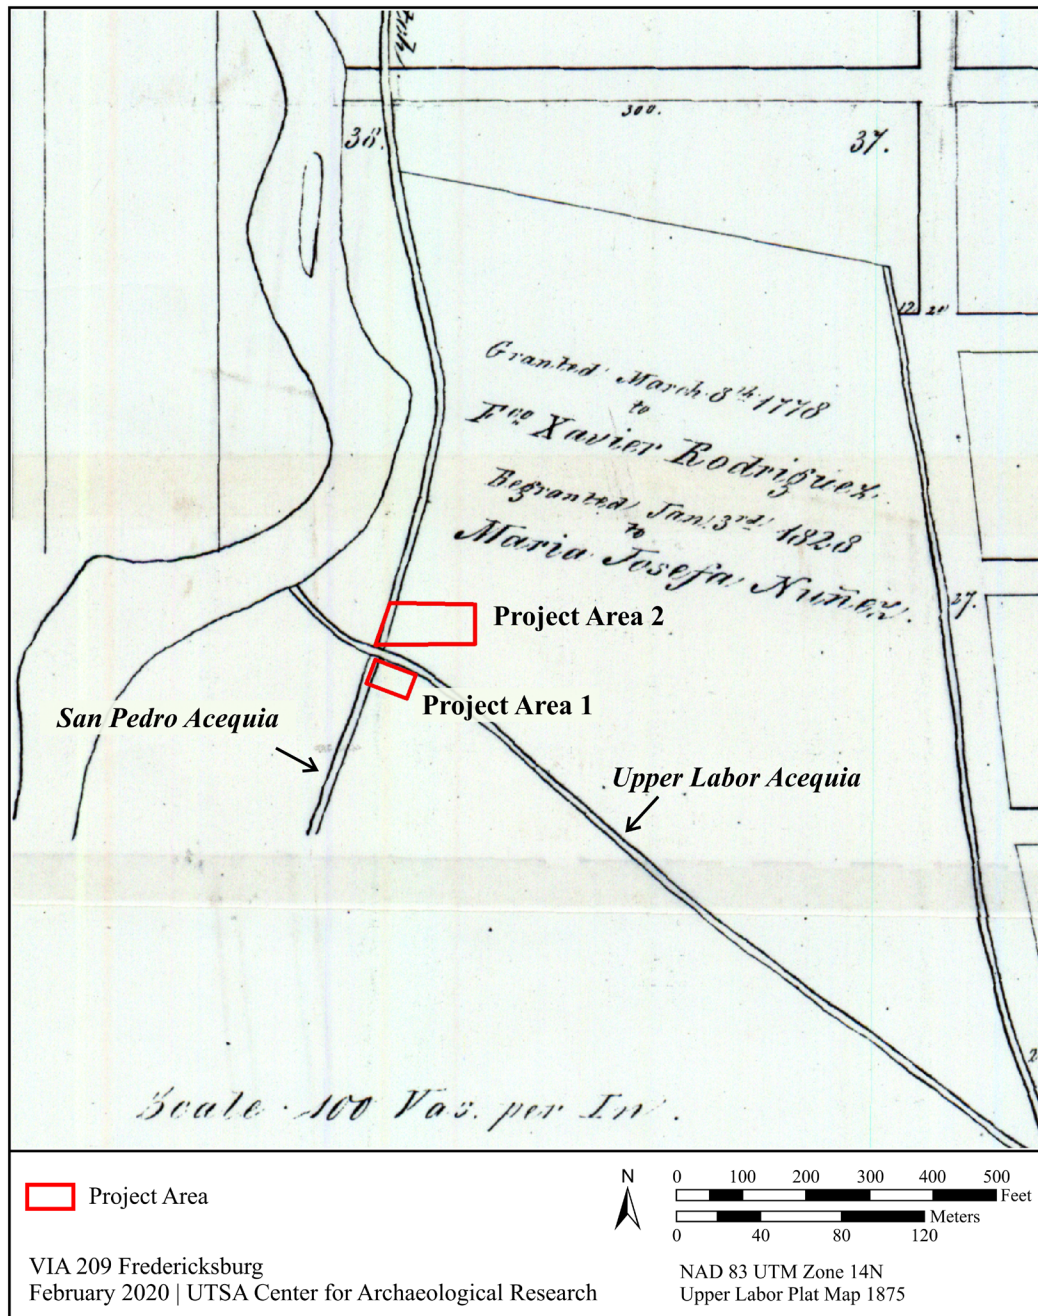
Figure 2-1. Project Areas 1 and 2 overlain on the Freisleben 1875 map (Freisleben 1875). Note the intersection of the San Pedro (north-south) and the Upper Labor (east-west) acequias.

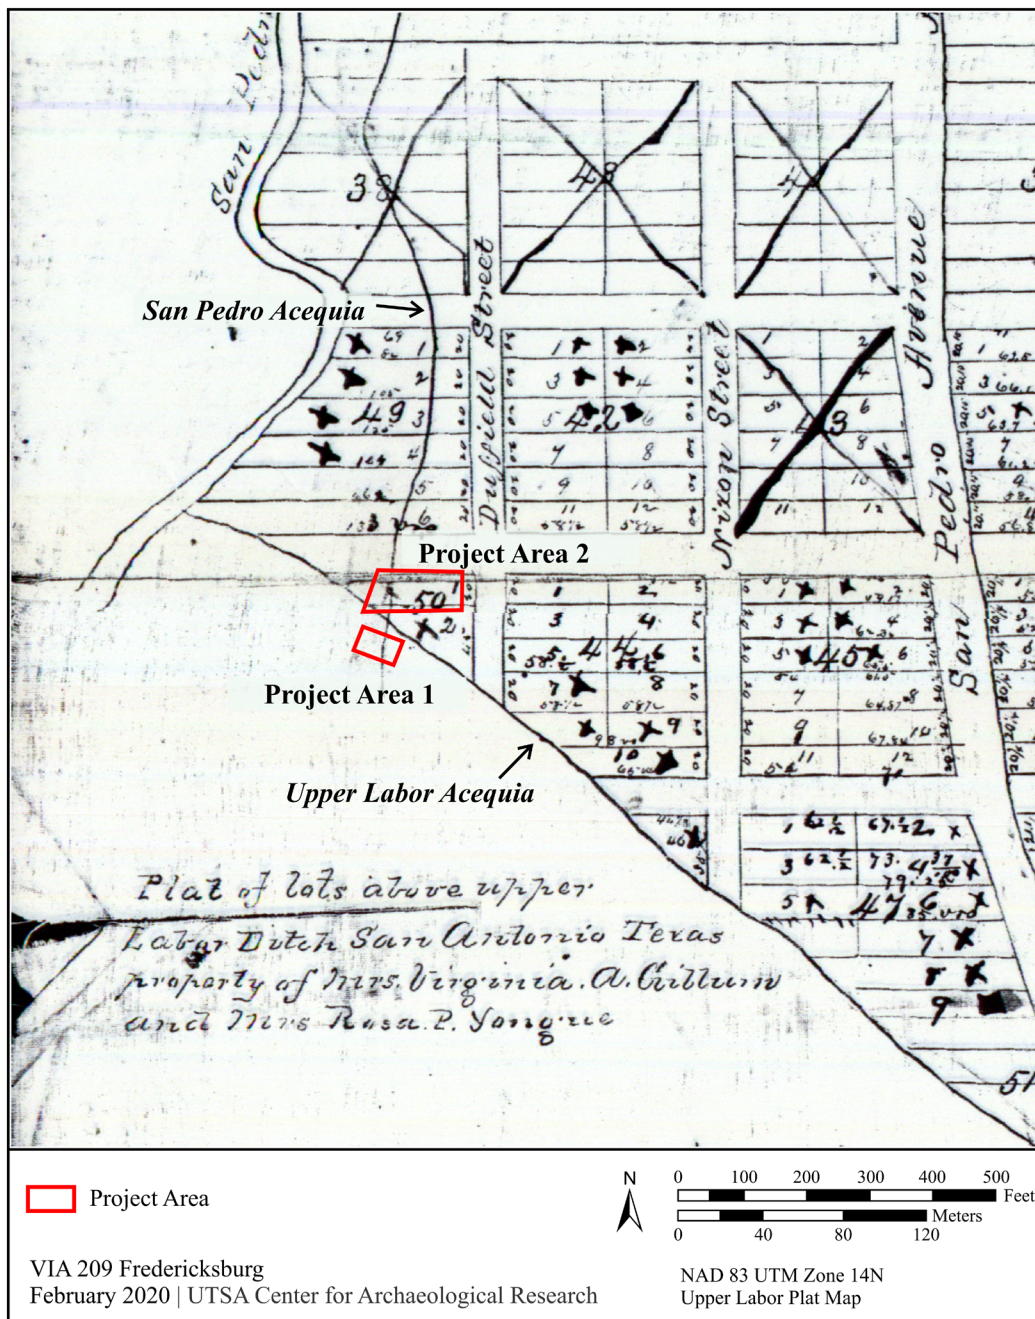
Figure 2-2. Project Areas 1 and 2 overlain on an 1877 plat map (Bexar County Deed Records V6:565). Note the intersection of the San Pedro and Upper Labor acequias.

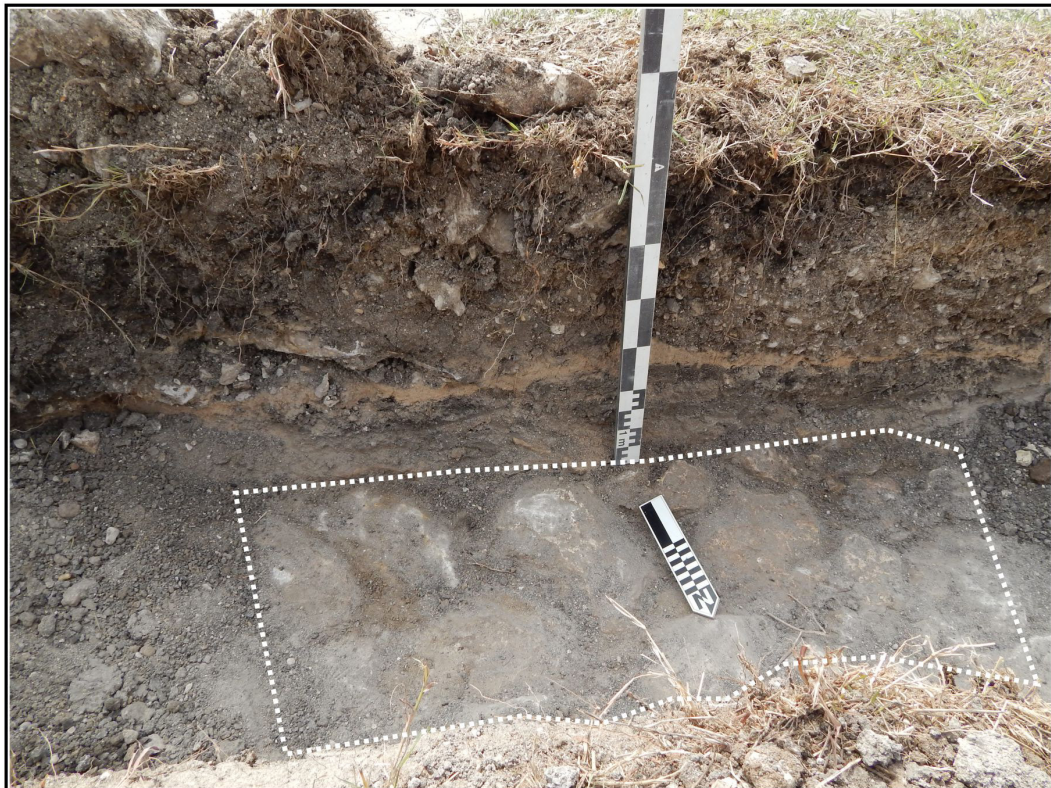
*Figure 4-4. South profile of BHT 1. Feature 1 in foreground in dashed white outline.*

silty clay containing gravels and, in the south profile, cobbles (Figure 4-5). Below this layer, the south profile contained evidence of multiple fill episodes with distinct layers of sand and gravel (see Figure 4-4). Layer 2 of the north profile contained a blocky black (10YR 2/1) clay with carbonates and limestone cobbles from 35-75 cm (13.8-29.5 in.). A 1-2 cm (0.39-0.79 in.) wide intrusion of very pale brown (10YR 8/4) sand was noted in the north profile from 40-75 cm (15.75-29.5 in) below the surface. No artifacts were observed in either the backdirt or the profiles. The feature is discussed in the subsequent section.

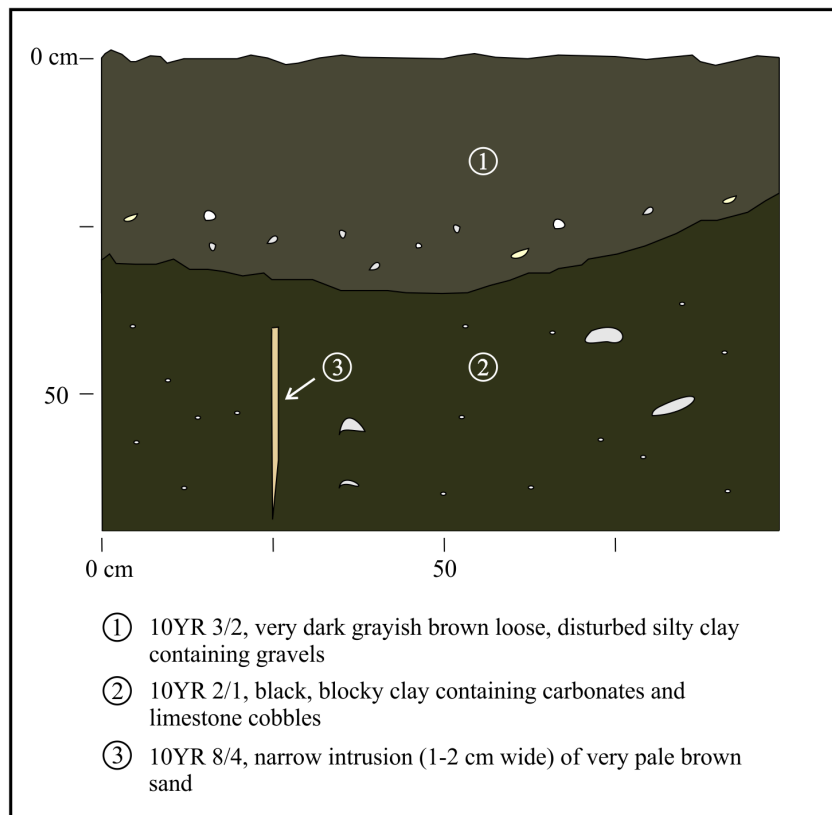
Figure 4-5. North profile drawing of BHT 1, 1 m segment.

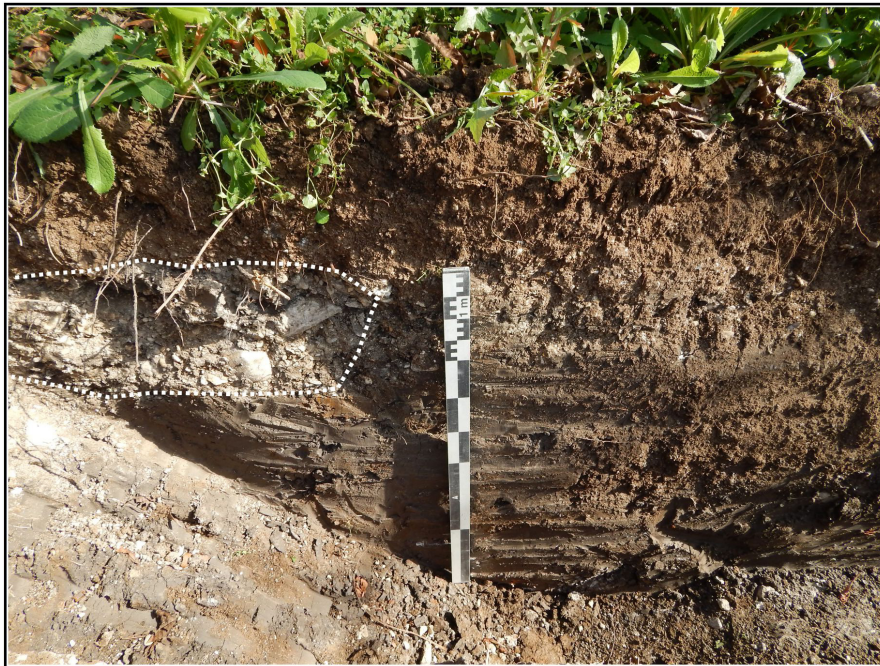
Figure 4-6. East profile of BHT 2. Feature 2 (left) demarcated by dashed white outline.

BHT 2 extended 4.3 m (14.1 ft.) and was terminated at 1.45 m (4.76 ft.) below the surface. In both trench profiles, Feature 2, a shallow, basin-shaped concentration of concrete,

tile, and large amounts of rock and gravel, was documented from 30-60 cm (11.8-23.6 in.) below the surface near the northern edge of the trench. The feature spanned more than 1 m (3.3 ft.) in the eastern profile but narrowed in the west, disappearing into the northwest corner (Figure 4-6). The feature, dominated by construction material, is likely recent. Four layers were recorded in the trench profile (Figure 4-7). Layer 1 was similar to Layer 1 in BHT 1 and contained loose, dark brown (10YR 3/3) silty clay with roots. This layer appeared disturbed and extended from 30-35 cm (11.8-13.8 in.) below the surface. Layer 2 extended from 30-50 cm (11.8-19.7 in.) below the surface and contained dark brown (10YR 3/3) gravelly clay. Layer 3, from 50-110 cm (19.7-43.3 in.) below the surface, contained blocky, very dark gray (10YR 3/1) clay. Below 110 cm (43.3 in.) to the trench floor, Layer 4 was distinguished from Layer 3 by a significant increase in carbonates. One piece of debitage and one fragment of clear glass were observed in the backdirt but not collected. No artifacts, aside from the construction debris in Feature 2, were observed in either profile.

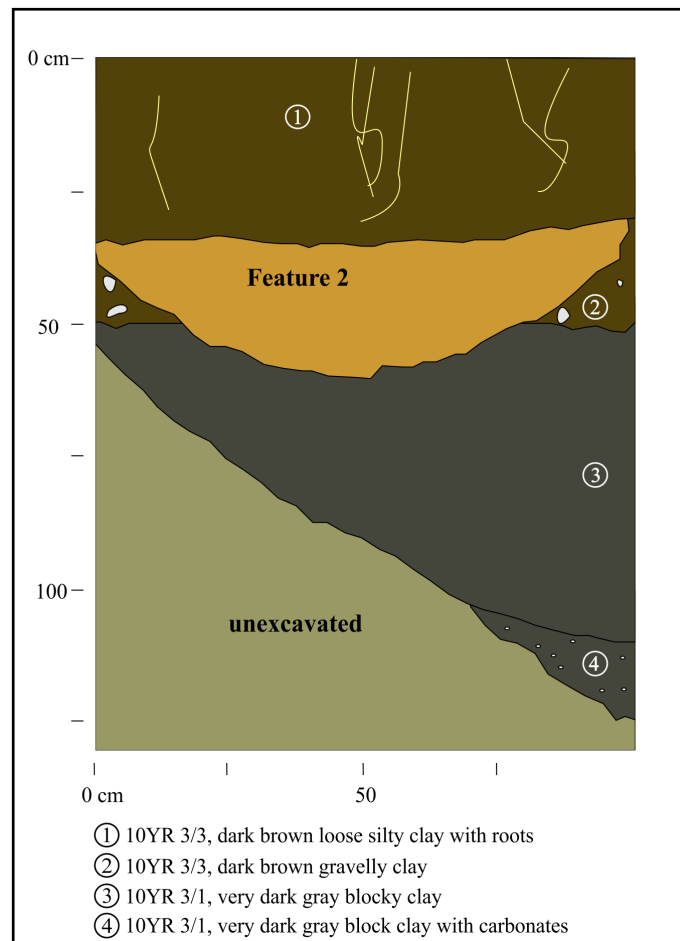
Figure 4-7. East profile of BHT 2, 1 m segment. Roots are shown as yellow lines.

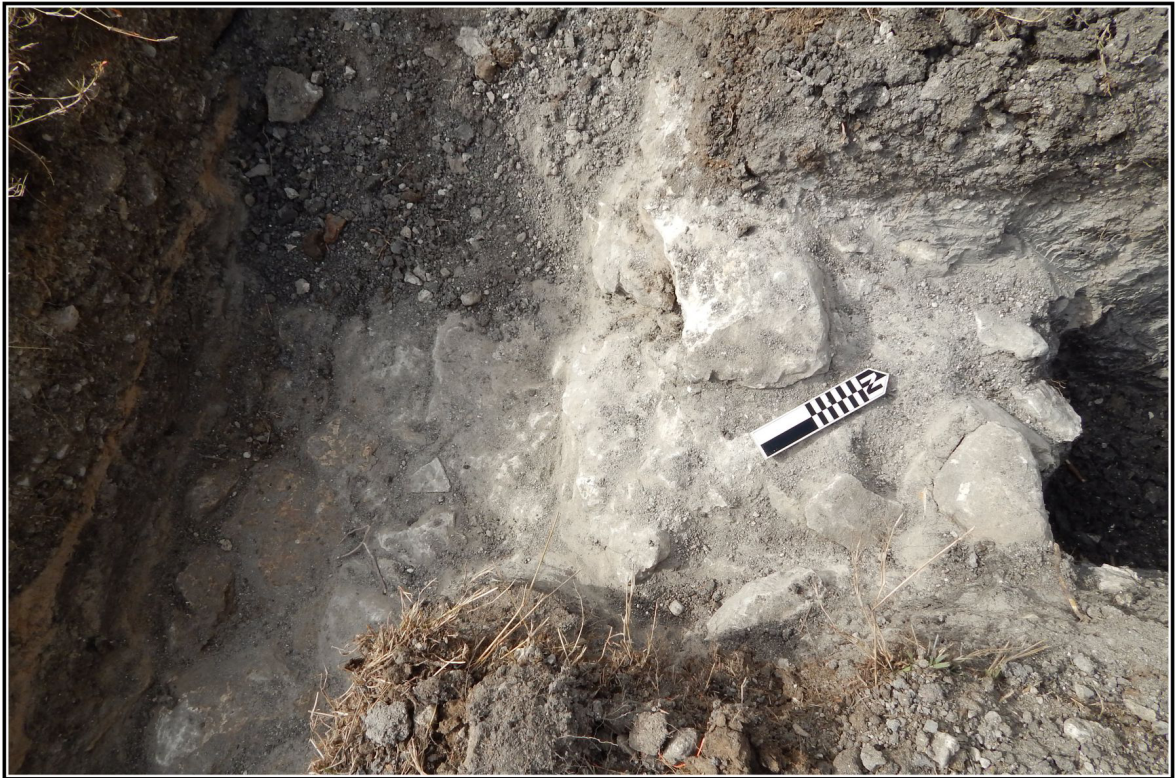
Figure 4-9. Feature 1 facing west. Wall to the right and cobble floor to the left.

Feature 1 was documented in BHTs 1 and 3, spanning the entirety of BHT 1. The feature consisted of a relatively flat floor of rough limestone cobbles, articulated with a wall constructed of rough-cut limestone blocks (Figures 4-9 and 4-10). A layer of sandy soil above the floor was noted (Figure 4-11). To the south, the layers of the soil profile indicate

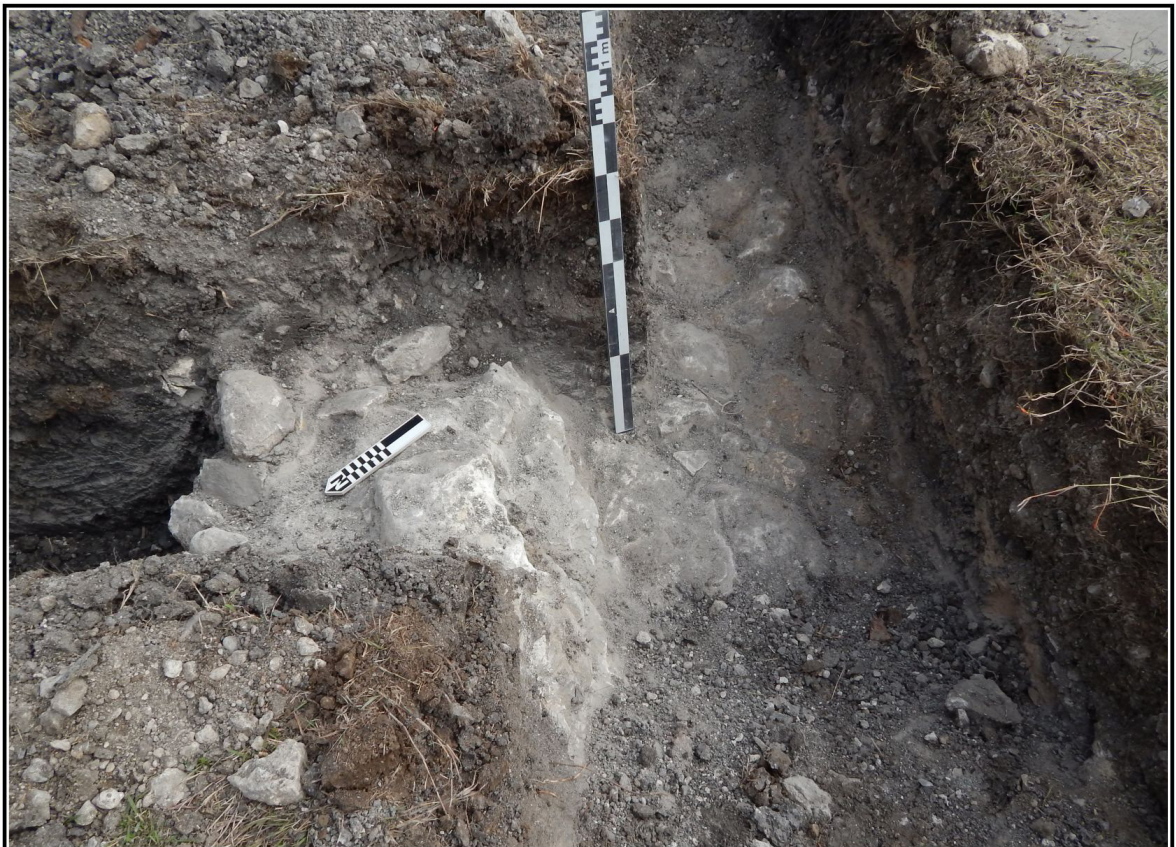
Figure 4-10. Feature 1 facing east. Wall to the left and cobble floor to the right.

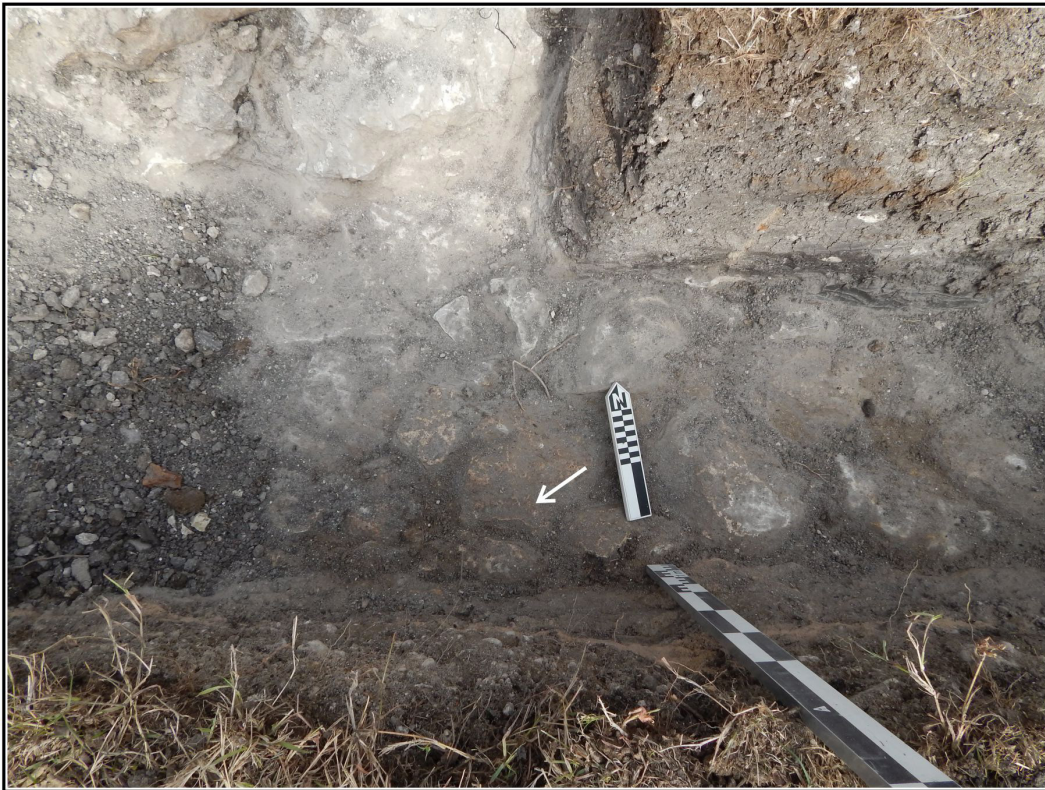
Figure 4-11. Feature 1. Note sandy layer above cobble floor.

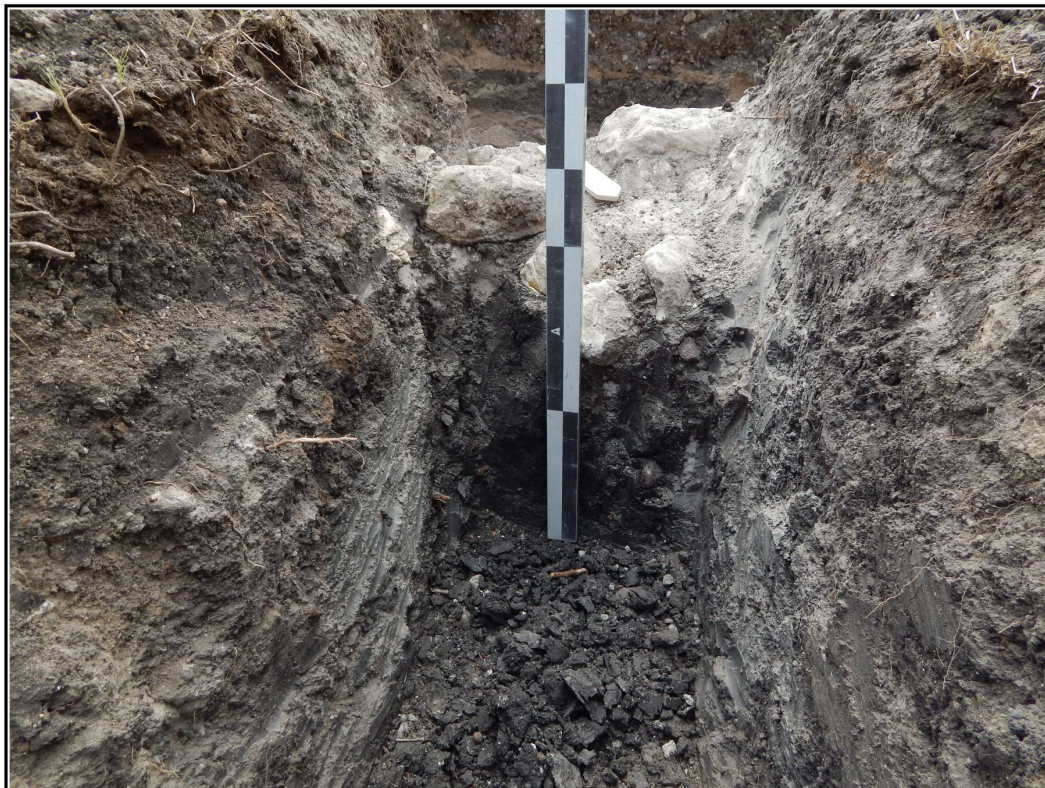
Figure 4-12. Northern profile of Feature 1 within BHT 3 (facing south). Note partial wall collapse.

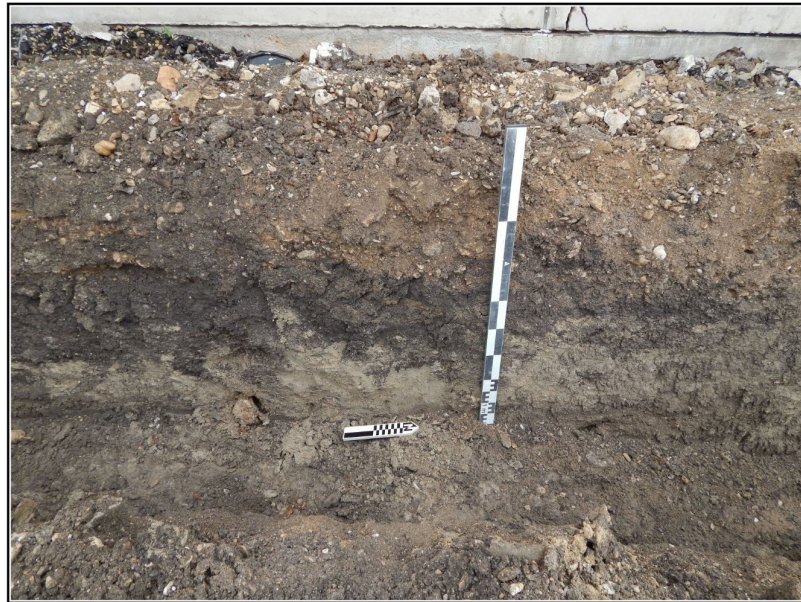
Figure 4-15. Western profile of BHT 4.

The soil profile documented within the trench included three layers with borders that were somewhat irregular (Figures 4-15, 4-16, and 4-17). Layer 1 was 0-47 cm (0-18.5 in.) below the surface and consisted of gravelly clay mottled very dark grayish brown (10YR 3/2) and yellowish brown (10YR 5/6). Layer 2 was 47-75 cm (18.5-29.5 in.) below the surface and consisted of very dark grayish brown (10YR 3/2) blocky clay. Layer 3 was 75-105 cm (29.5-41.3 in.) below

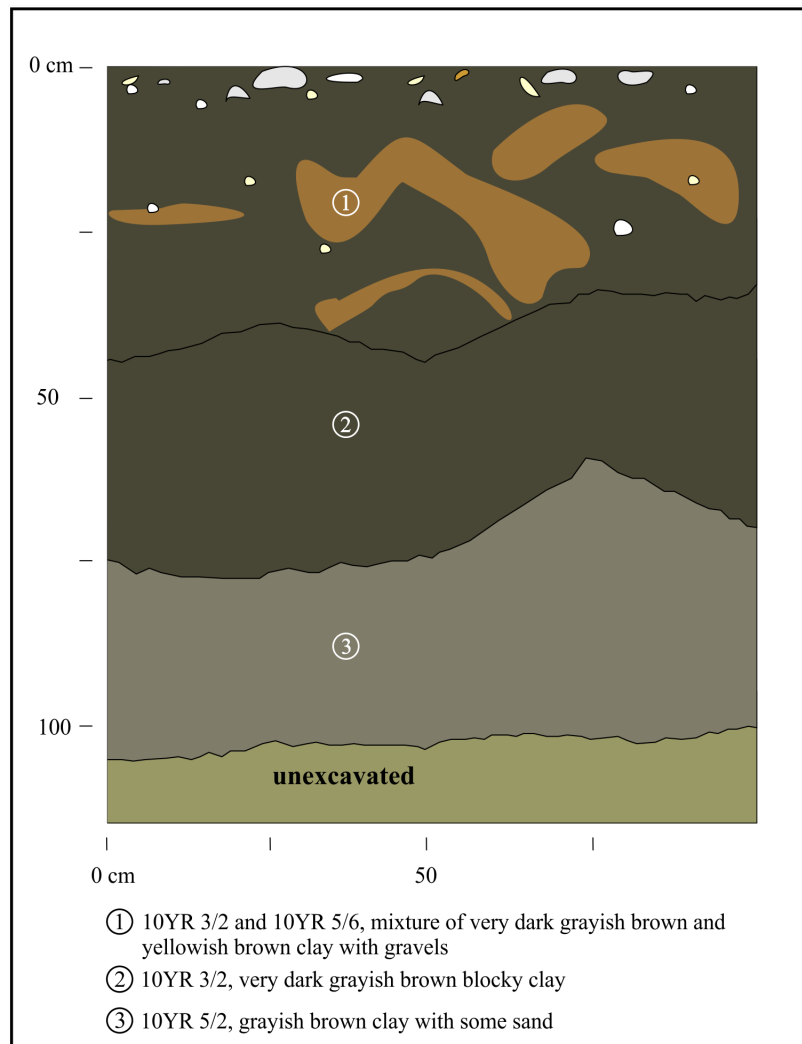
Figure 4-16. West profile of BHT 4, 1 m segment.

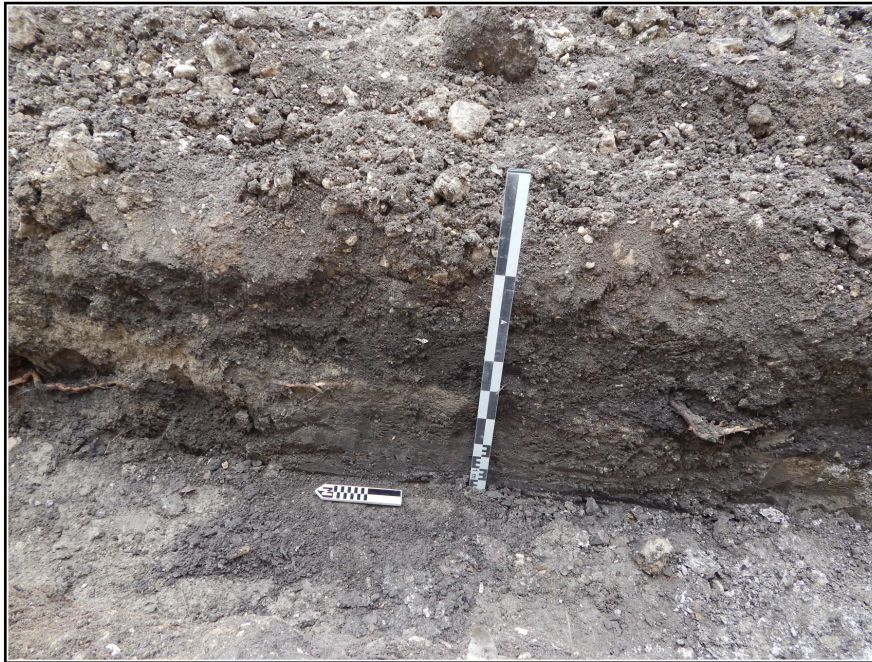
Figure 4-17. Eastern profile of BHT 4.

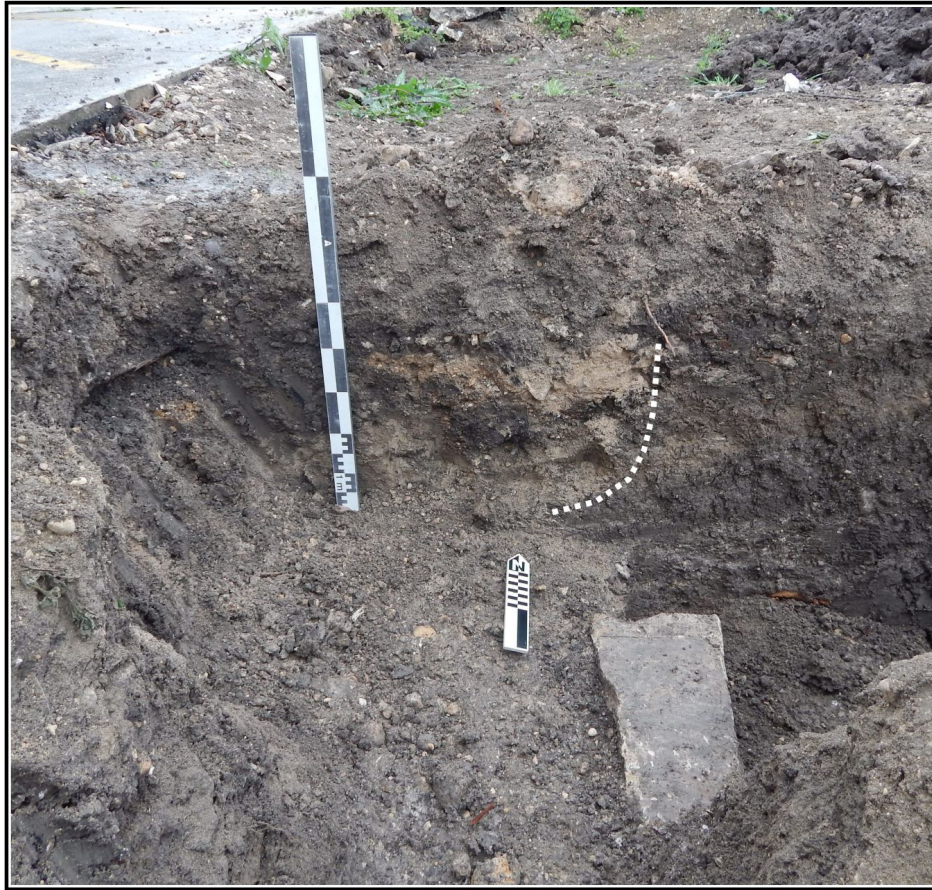
*Figure 4-18. Northern profile of BHT 5. Dashed white line demarcates soil change associated with Feature 3.*

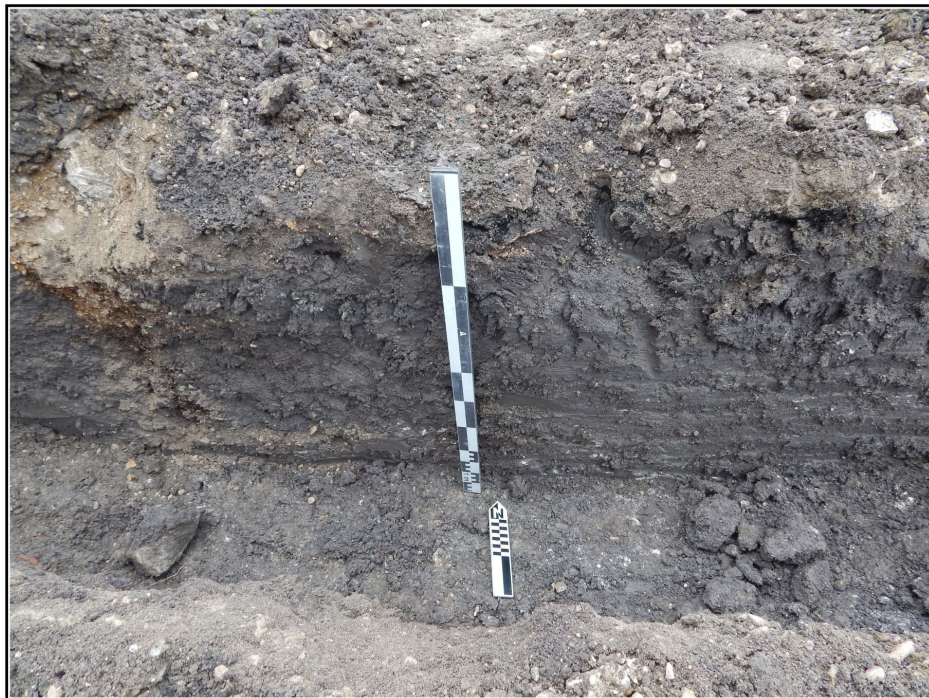
*Figure 4-19. Northern profile of BHT 5, east of Feature 3.*

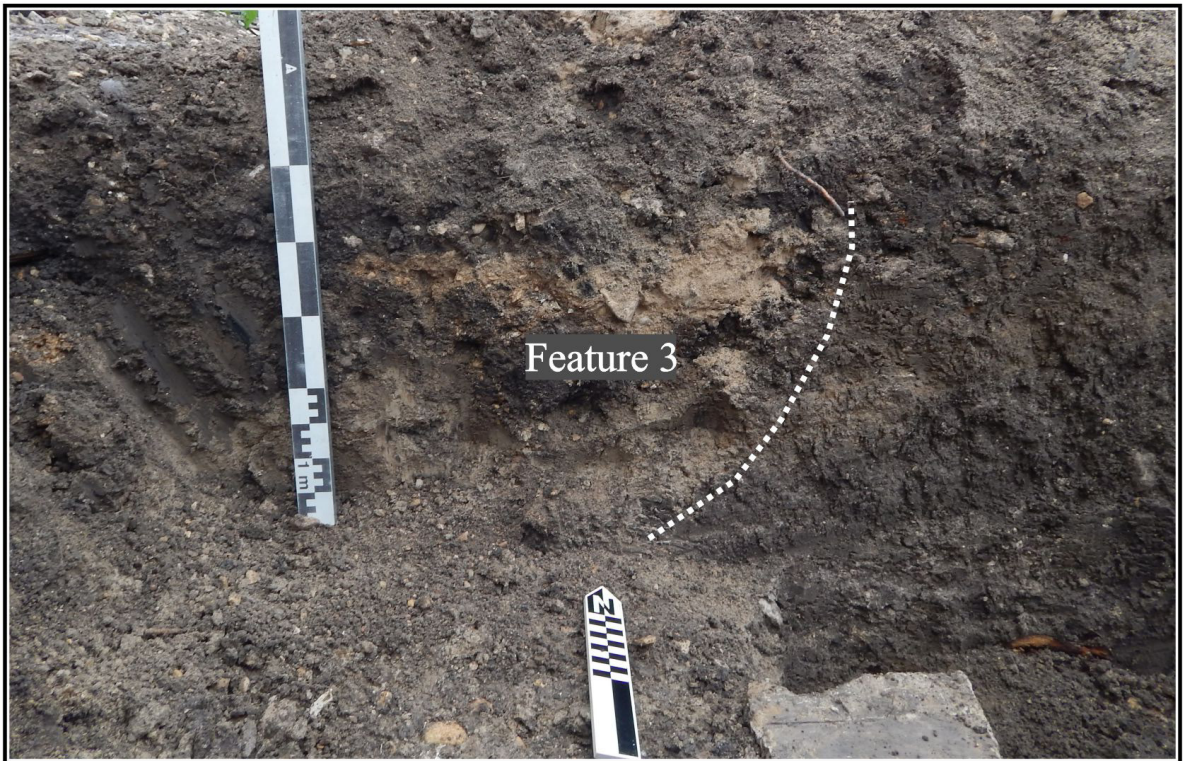
*Figure 4-21. Feature 3. Note soil change west of limestone block (facing north). Dashed white line demarcates shift in soil profile.*

present, is likely west of the Project Area 2 on VIA-MTA property. The highly finished nature of the stone (see Figures 4-21, 4-22, and Appendix A) suggests that it may have been a later modification, prior to the closing of the *acequia* in 1912 (Cox 2005). If this is the case, it is likely that this segment of the *acequia* was originally unlined. The construction of Feature 3 is significantly different than the limestone cobble construction of Feature 1 in Project Area 1.

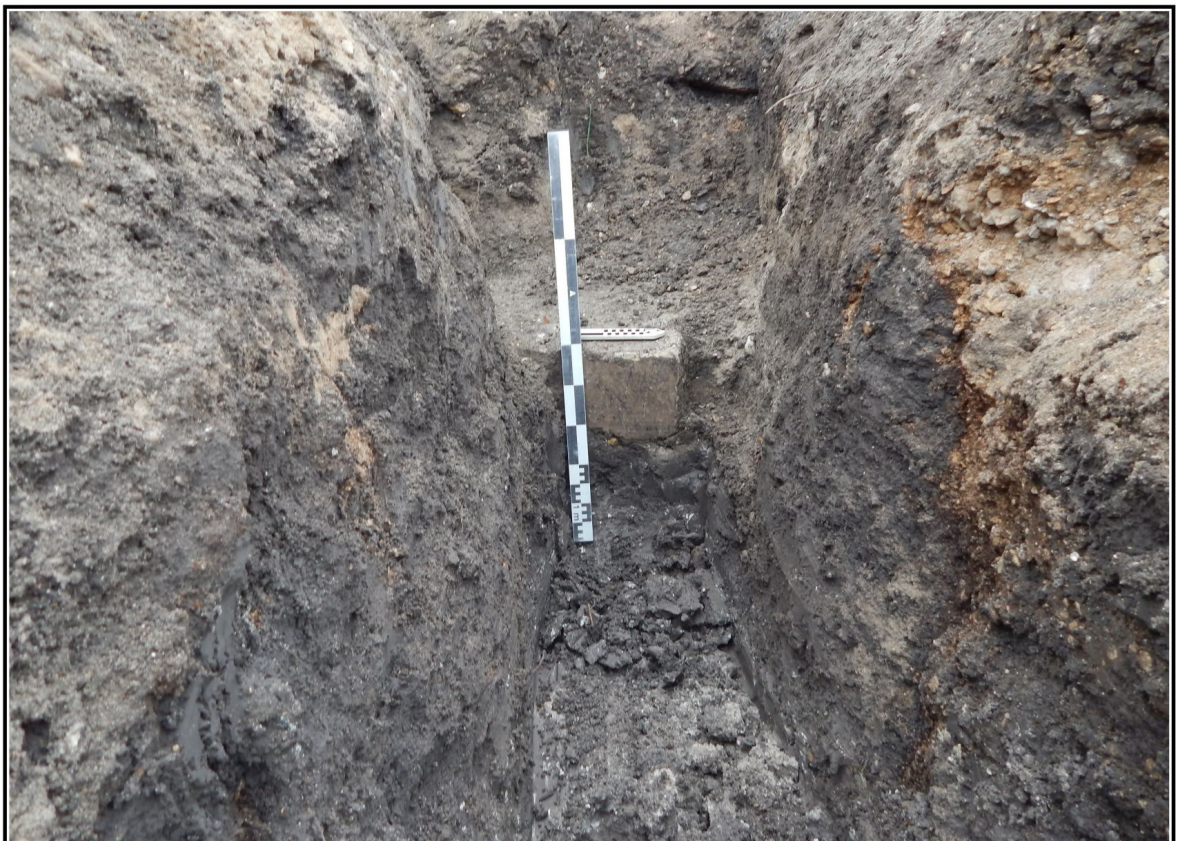
*Figure 4-22. East profile of Feature 3. Note single course of stone.*

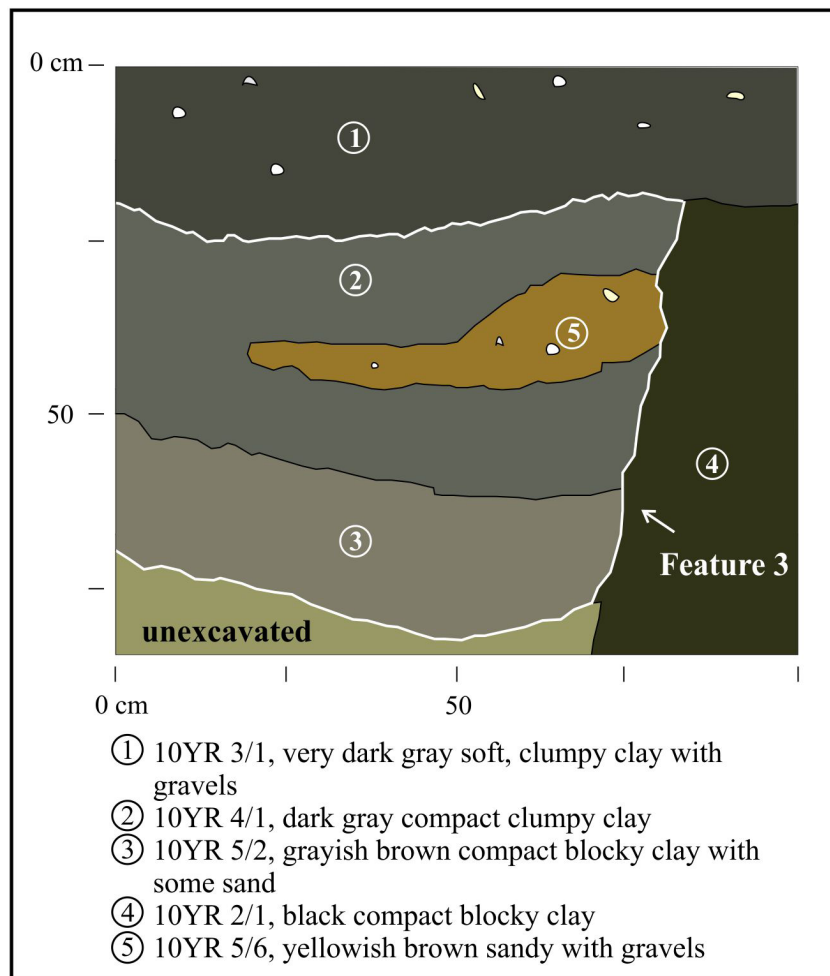
Figure 4-23. Northern profile of BHT 5 showing Feature 3 (outlined in white).

Five layers were recorded in the north trench profile that contained Feature 3 (Figure 4-23). Layer 1 was 0-25 cm (0-9.8 in.) below the surface and consisted of very dark gray (10YR 3/1) soft, gravelly, clumpy clay. Layer 2 was 25-62 cm (9.8-24.4 in.) below the surface and consisted of dark gray (10YR 4/1) compact clumpy clay. Layer 3 was 62-82 cm (24.4-32.3 in.) below the surface and consisted of grayish brown (10YR 5/2) compact, blocky clay with some sand.

Layer 4 was 25-90 cm (9.8-35.4 in.) below the surface and consisted of black (10YR 2/1) compact, blocky clay. Layer 5 was 30-45 cm (11.8-17.7 in.) below the surface and consisted of a yellowish brown (10YR 5/8) sandy intrusion with gravels. The boundaries between Layer 2, within the feature, and Layer 4, outside the feature, were not well defined, and it is possible that the soil color difference is primarily due to soil mixing between layers within the feature.

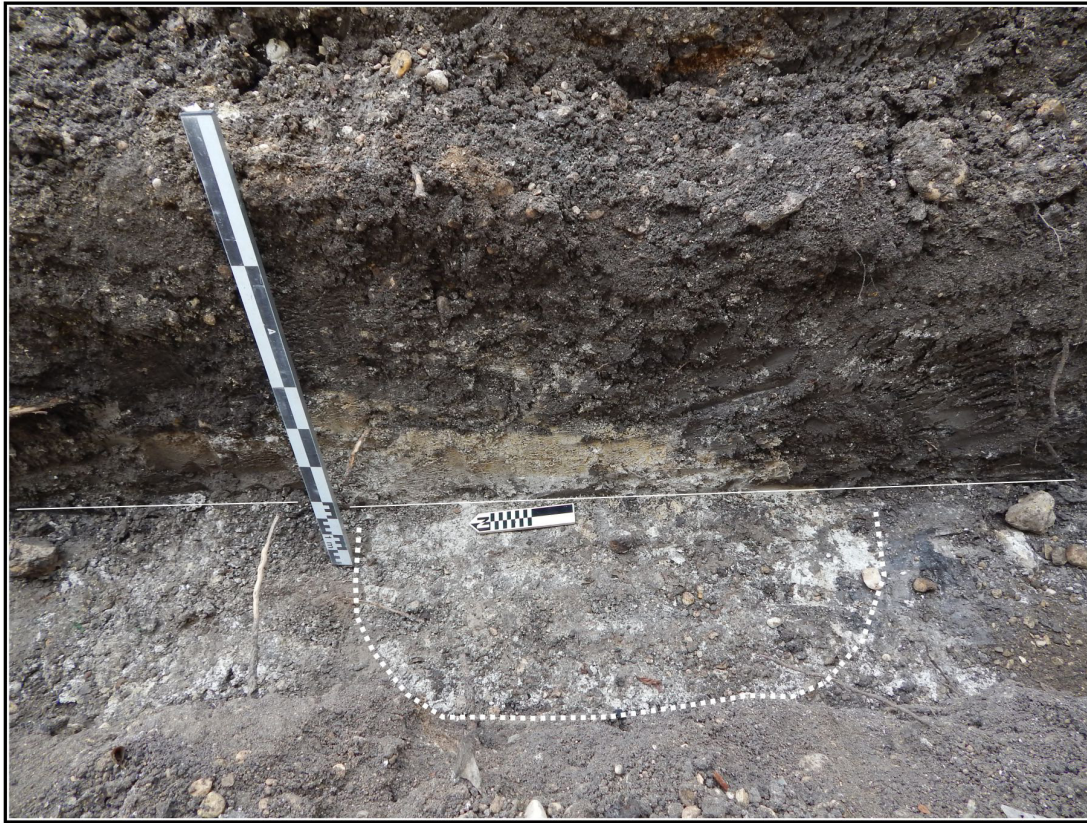
Figure 4-24. Feature 4 within BHT 4 (facing east). Dashed white line demarcates feature boundary, and solid white line separates trench wall from trench floor.

Feature 4 is a white clay stain documented within the *acequia* channel (Feature 3) near the bottom of BHT 4 (Figure 4-24; see also Figure 4-20). This may represent the use of the area as some sort of dump before the *acequia* was closed. The feature was irregular in shape with defined edges. It was defined at 70 cm (27.6 in.) below the surface and reached a depth of at least 115 cm (45.3 in.) below the surface. The feature was 118 cm (46.5 in.) in length and 55 cm (21.65 in.) in width. The feature contained no artifacts.

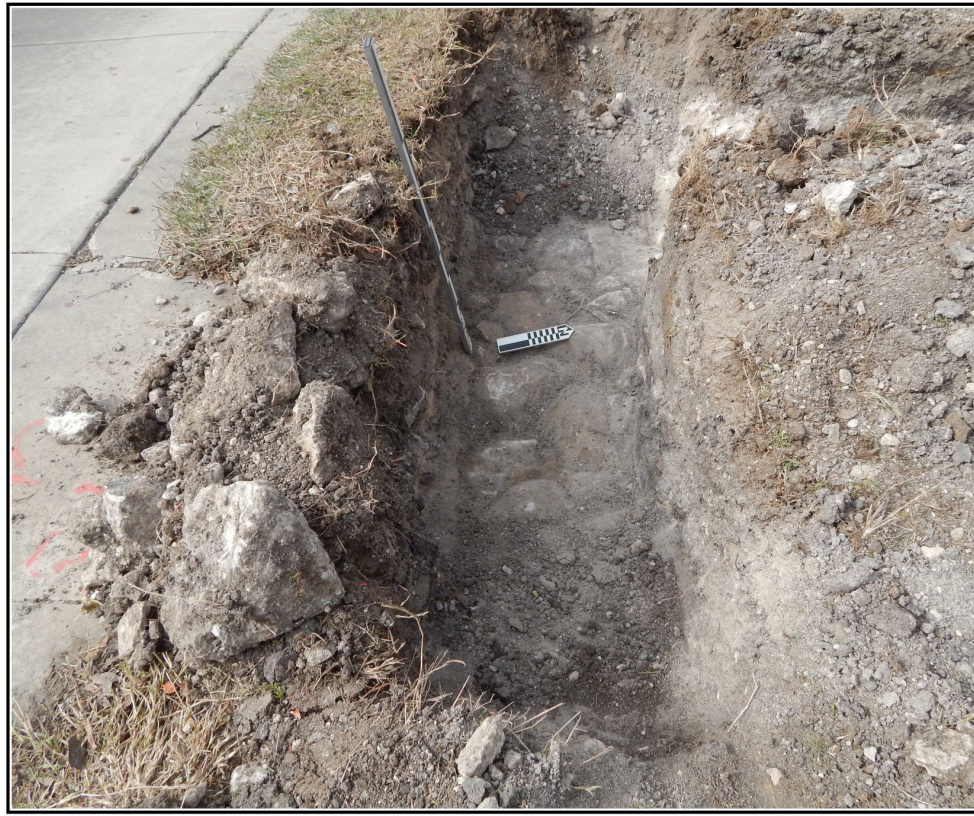
*Figure A-1. Feature 1, floor, in BHT 1.*

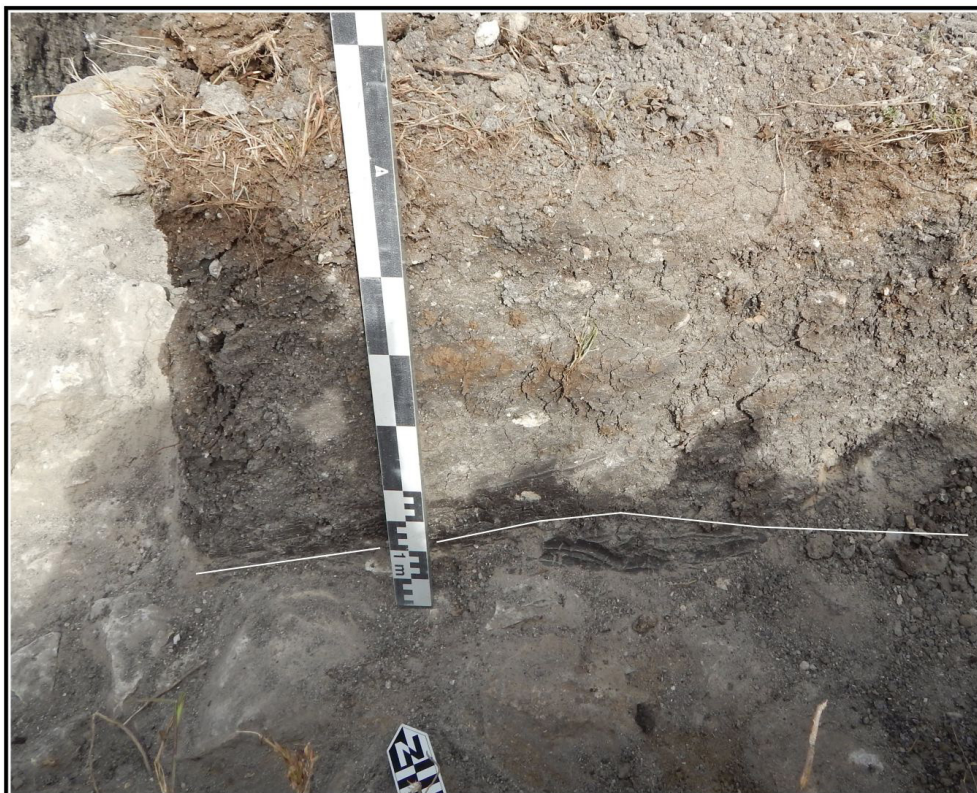
*Figure A-2. North profile of BHT 1, Feature 1 to the left and foreground. Solid white line demarcates trench wall from floor.*

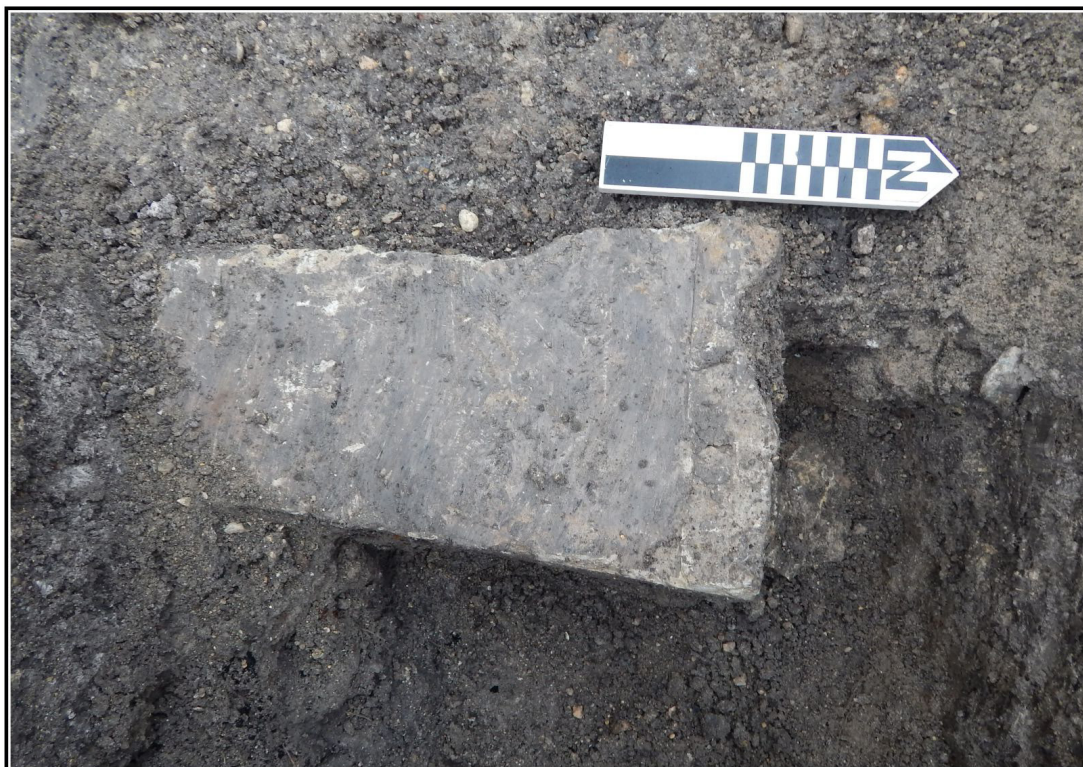
*Figure A-4. Limestone block in Feature 3.*
