Archaeological Documentation at Kallison Square, San Antonio, Bexar County, Texas

Prepared by:
Center for Archaeological Research
The University of Texas at San Antonio
One UTSA Circle
San Antonio, Texas 78249
Technical Report, No. 84

On June 4, 2019, the Center for Archaeological Research (CAR) at The University of Texas at San Antonio (UTSA) conducted an archaeological assessment of four excavation pits located at the south side, or rear, of three historic buildings that are owned by GrayStreet Partners and are being rehabilitated. The buildings are part of a group of historic buildings located at the southwest corner of Dolorosa and S. Flores streets known as Kallison Square. Since it is a privately funded project on privately owned property, the project is not subject to regulatory review by the Texas Historical Commission (THC). The three properties, however, are located within the Main and Military Plaza Historic District; therefore, the project is subject to regulatory review by the City of San Antonio (COSA) Office of Historic Preservation (OHP) under the COSA Unified Development Code (Article 6 35-630 to 35-634). Dr. Paul Shawn Marceaux served as the Principal Investigat

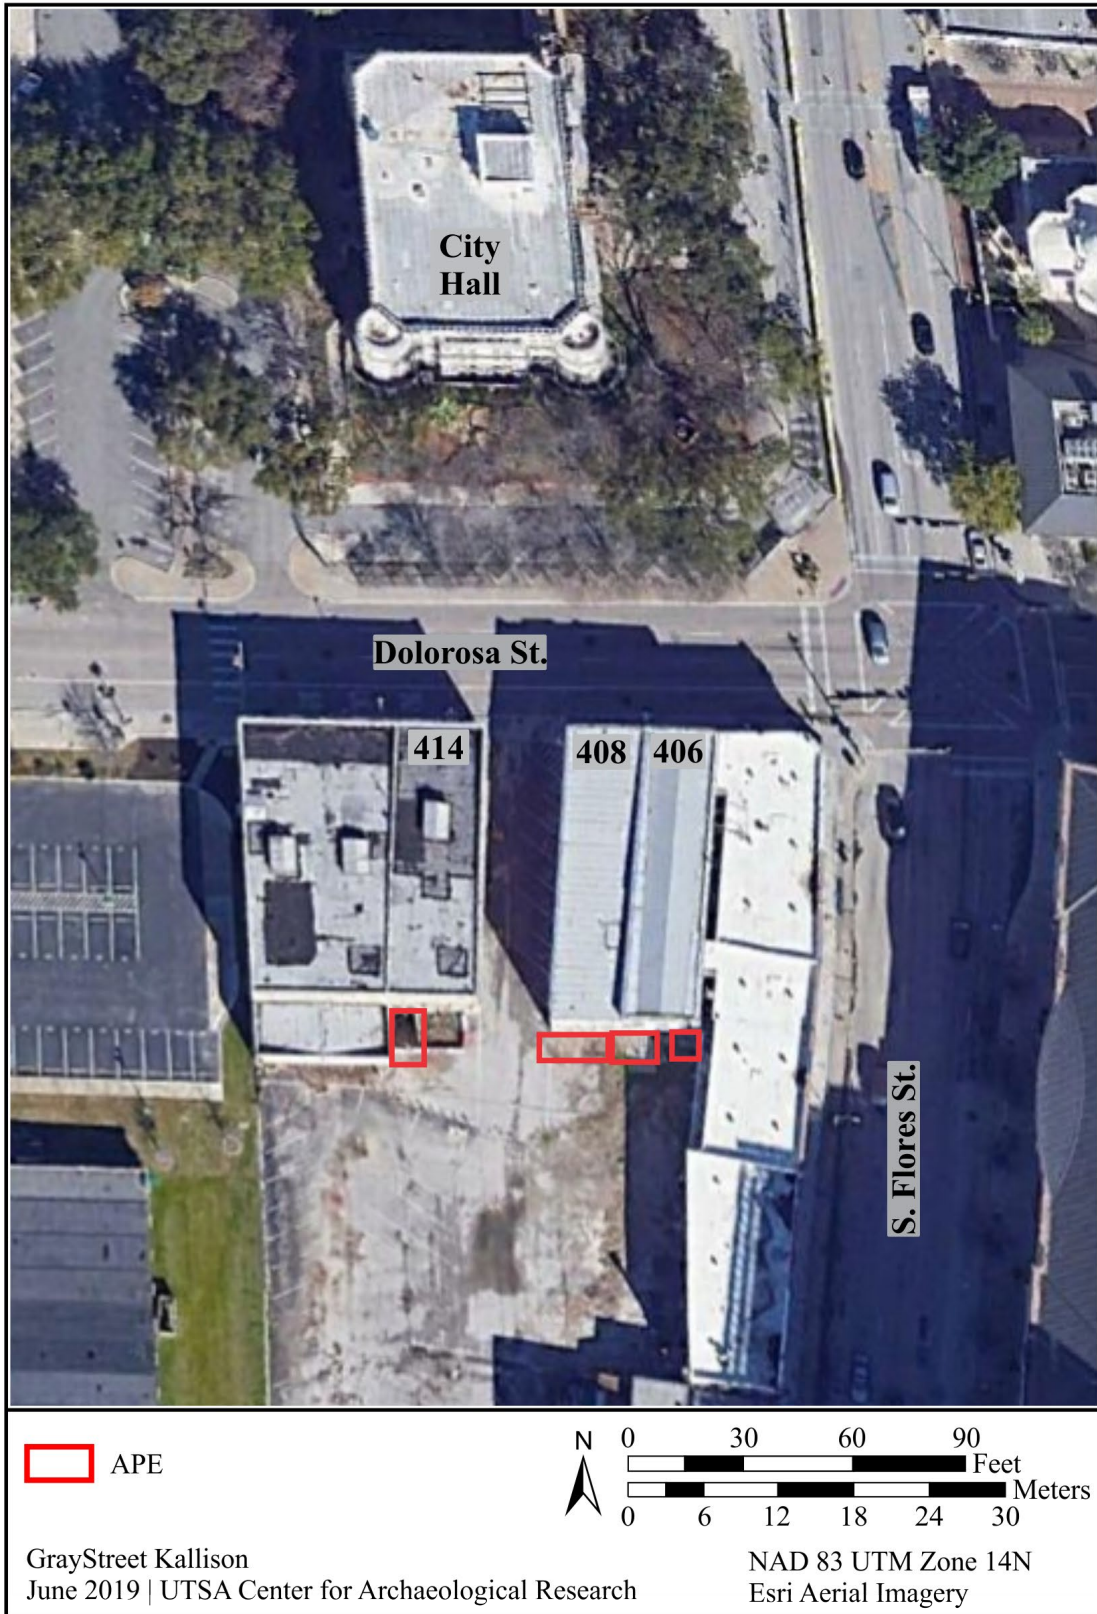
Figure 1-1. Satellite image of the project area with the APE identified.

The Area of Potential Effect (APE) consists of the four excavation pits that were located at the rear of the three buildings scheduled for rehabilitation (Figure 1-1). The pits were excavated as an attempt to correct a water seepage problem. The purpose of the assessment was to determine if any cultural features and/or material had been inadvertently compromised as a result of the mechanical excavations. The mechanical excavations partially exposed the below-grade construction along the rear of all three buildings. During the assessment, CAR determined that a significant amount of disturbance was present. Undiagnostic glass, ferrous metal, and construction debris were observed within the exposed stratigraphy of several of the pits, but none of the material was collected. A review of multiple Sanborn Fire Insurance Maps indicated that the area had been previously disturbed by recurring building construction dating to at least 1877. This construction was especially pronounced between 1896 and 1904, when earlier stone structures were replaced by brick-constructed structures (Sanborn Map Company [Sanborn] 1896, 1904). Given the level of disturbance, the building rehabilitation project was allowed to proceed. However, CAR recommends that any additional mechanical excavations by the property owner in this area include an archaeological component.

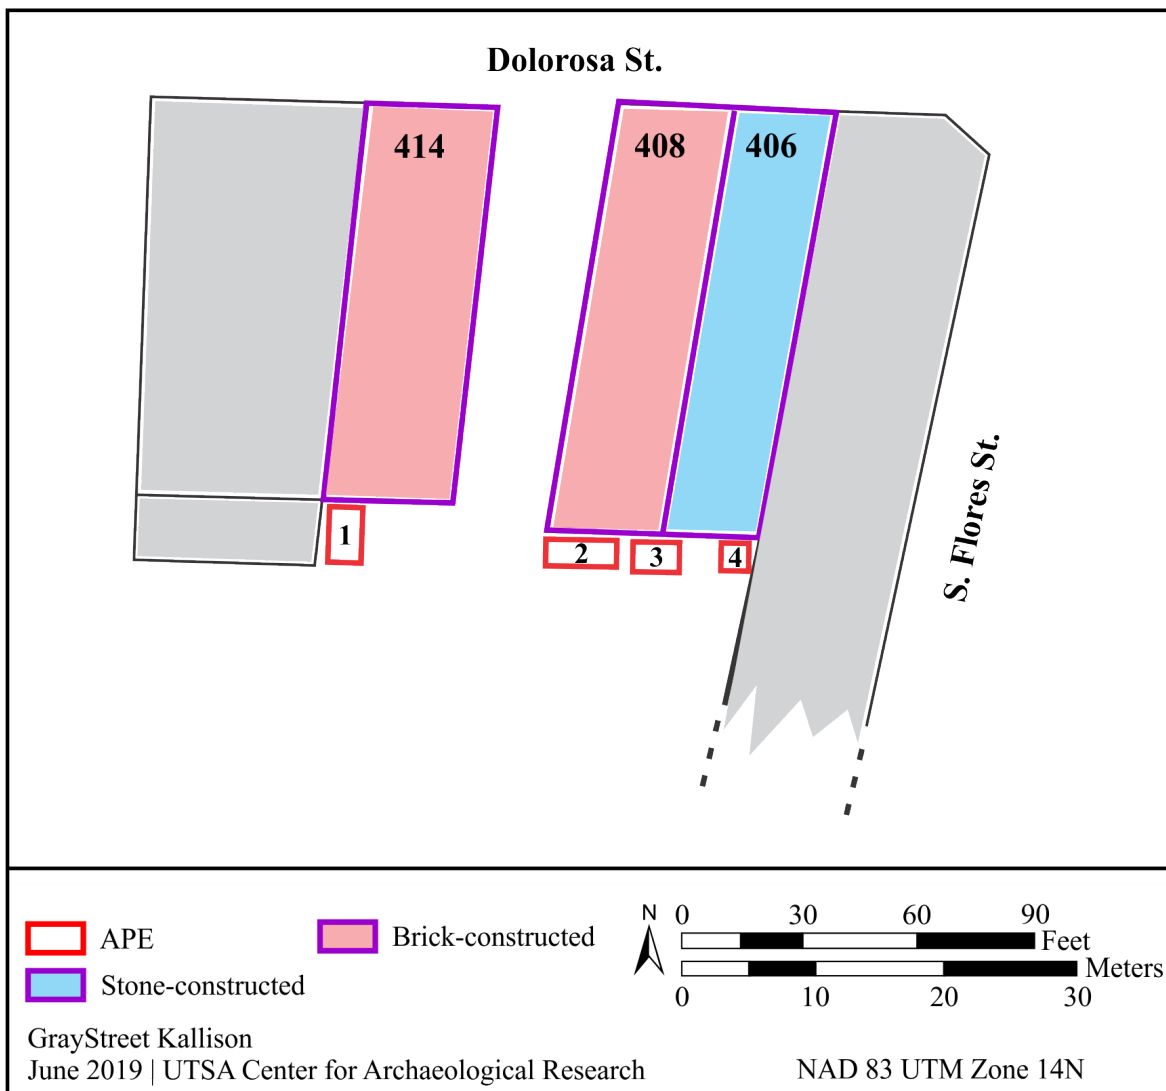
Figure 4-1. Plan view of the four excavation pits.

On June 4, 2019, CAR staff arrived on site and located four irregularly excavated pits at the rear of 406, 408, and 414 Dolorosa Street (Figure 4-1). The excavated soils had been removed from the site prior to the arrival of CAR staff. The depth of the excavation pits varied between 1.9 m and 3.0 m (6.2 ft. and 9.8 ft.). Excavation Pits 1, 2, and 3 were wide enough and sloped to allow safe access, while Excavation Pit 4 was too deep and access was prohibited (Figure 4-2). Extensive construction rubble was observed in the exposed stratigraphy of all pits, and it is likely the rubble was related to earlier construction episodes.

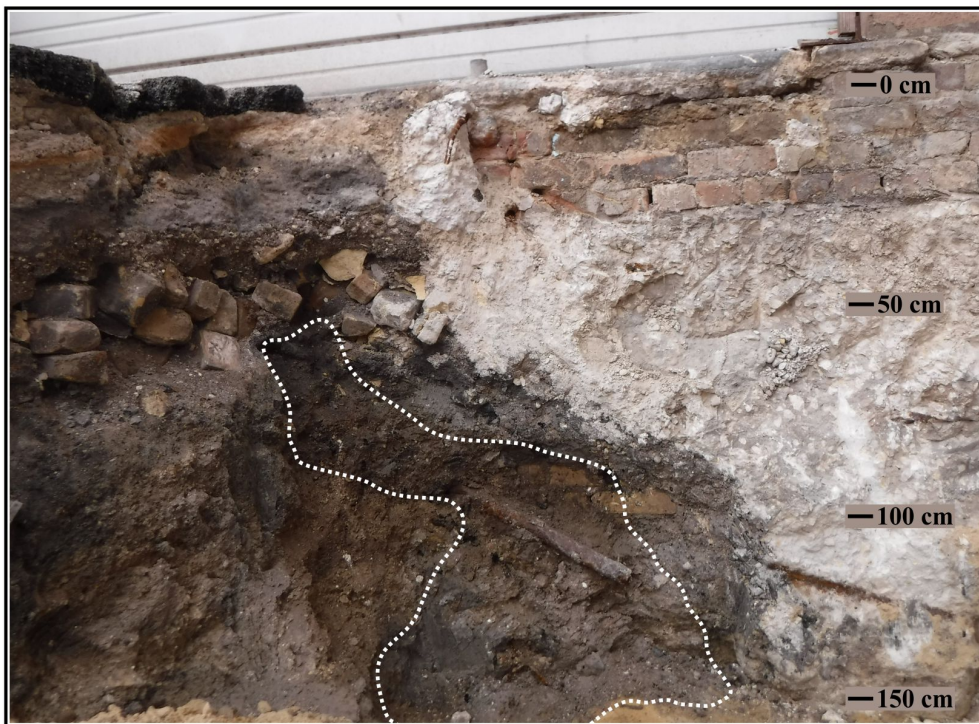
Excavation Pit 1 was located at the rear of 414 Dolorosa Street along the southwest corner of the building. The dimensions of the pit were irregular, but it was approximately 3.3 m (10.8 ft.) wide, 5.0 m (16.4 ft.) long, and 2.0 m (6.5 ft.) deep. CAR staff documented the west wall profile of a section of masonry wall exposed below-grade (Figure 4-3). This area was of interest due to a concentration of burnt material and ashy soils. Small fragments of charcoal and unidentifiable fragments of ferrous metal were observed. The area lacked a definite outline, and it was determined to likely be residual from a structural fire. The 1896 Sanborn map indicates that the building on this lot was in ruins due to a fire. No diagnostic artifacts were observed.

Figure 4-3. West wall profile of Excavation Pit 1 at rear of 414 Dolorosa Street; note brick (construction fill) to the left of the outlined charcoal and ashy deposit.

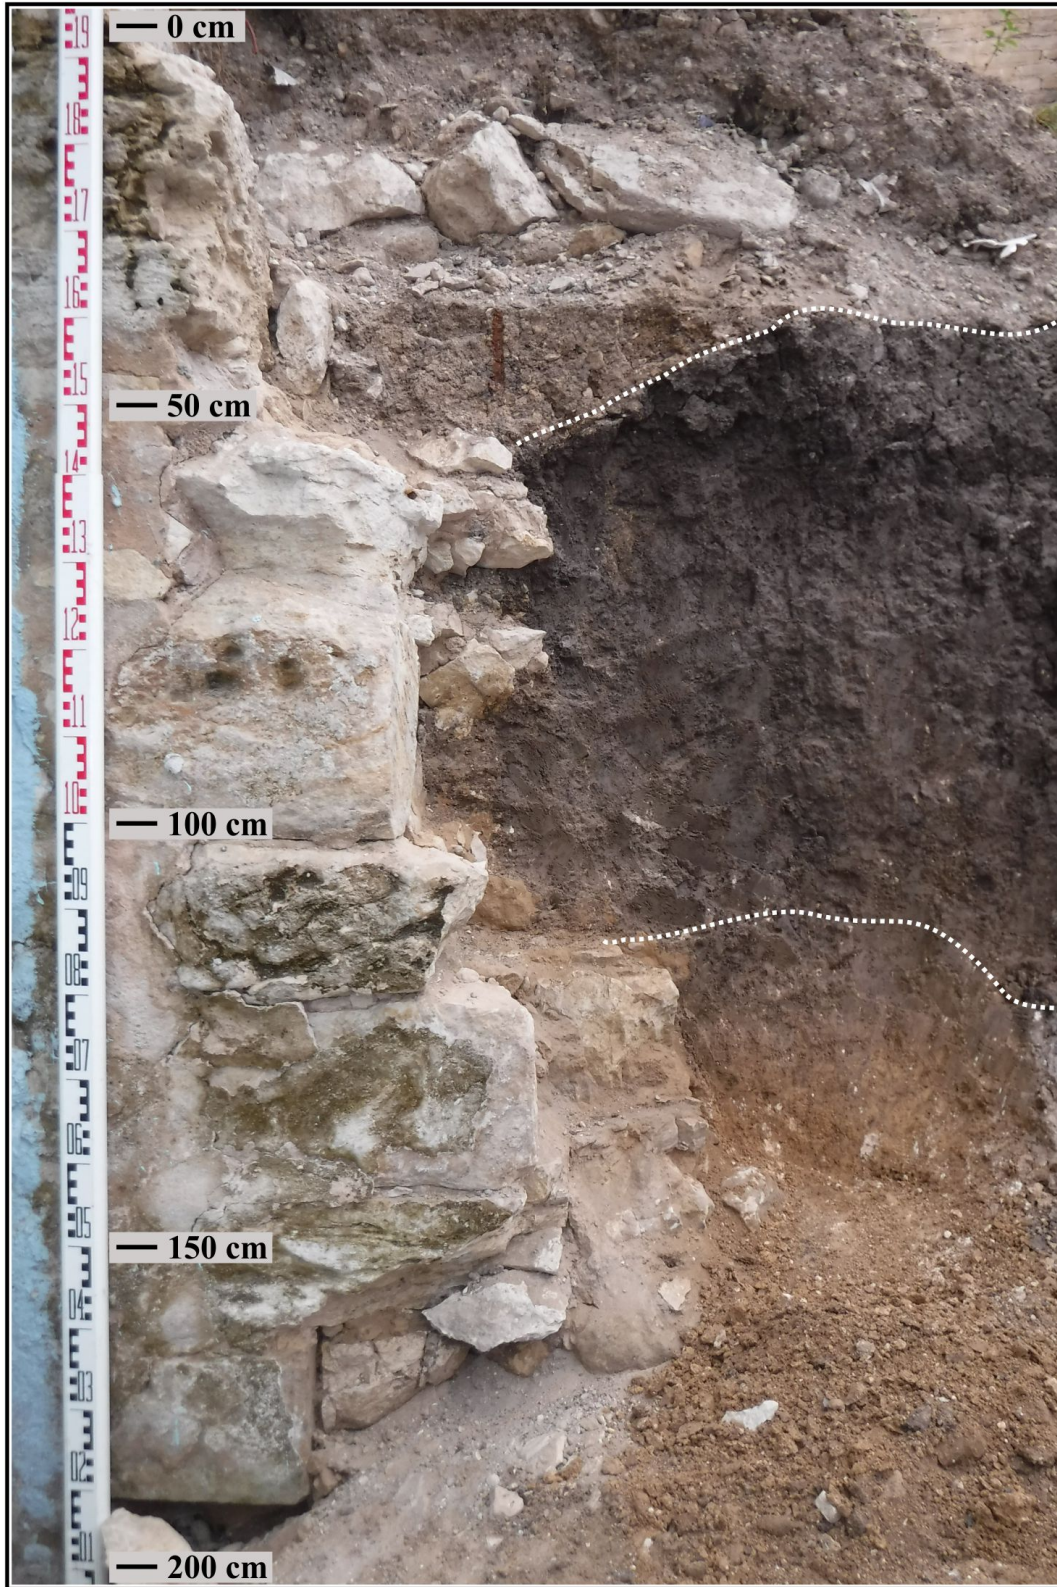
Excavation Pit 3 abutted the rear of 406 Dolorosa Street toward the west edge of the building, although most of the excavation was at the rear of 408 Dolorosa Street. This pit was also irregular, but it was approximately 2.7 m (8.8 ft.) wide, 4.2 m (13.7 ft.) long, and 2.7 m (8.8 ft.) deep. CAR staff documented the east wall profile of the pit (Figure 4-5). The remnants of a limestone-constructed wall can be seen in Figure 4-5.

Figure 4-5. East wall profile of Excavation Pit 3 at rear of 406-408 Dolorosa Street; note that the consistent clay strata between 50 and 150 cm are likely natural sediments.

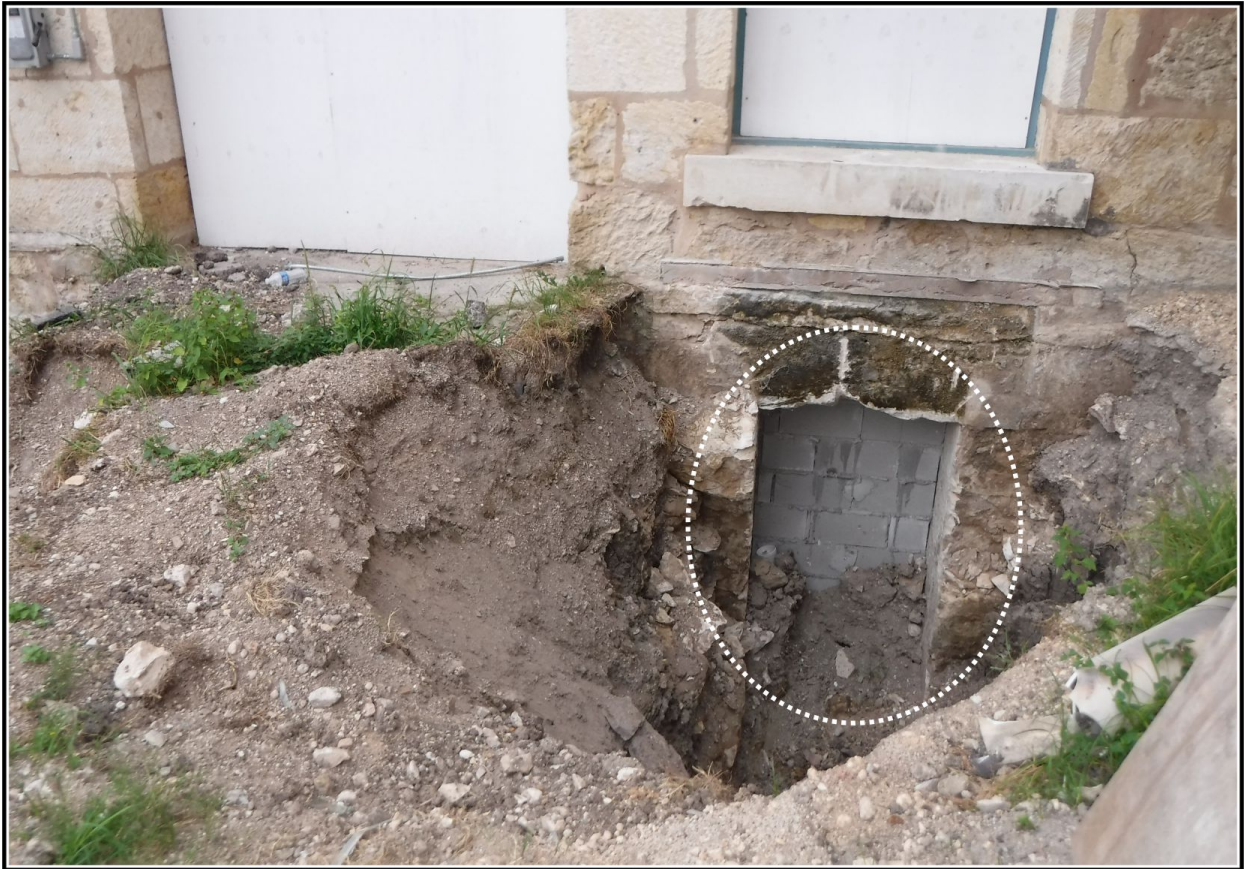
Excavation Pit 4 was located at the rear of 406 Dolorosa Street (4-6). The pit was approximately 2.5 m (8.2 ft.) north-south by 2 m (6.6 ft.) east-west. Depth estimates were not made as entrance to the pit was not possible given safety concerns. CAR staff were limited to a visual assessment of the pit and its contents. A blocked-off doorway is noticeable in the below-grade exposure of the building's southern elevation.

Figure 4-6. Excavation Pit 4 at rear 406 Dolorosa Street; note blocked-off doorway inside pit.

CAR staff determined that the area had been previously disturbed by recurring building construction dating to at least 1877. This was especially pronounced between 1896 and 1904, when earlier stone structures were replaced by brick structures (Sanborn 1896, 1904). Based on the significant amount of disturbance and related construction debris in the excavated pits noted by CAR staff, it was determined to be unlikely that the mechanical excavation of the pits had damaged any earlier features. The building rehabilitation project was allowed to proceed. However, CAR recommends that any additional mechanical excavations planned by the property owner in this area be coordinated with COSA-OHP.
