## **Cultural Resources Survey for the Granbury East Wastewater Treatment Plant, City of Granbury, Hood County, Texas (TWDB Project No. 73813)**

Cultural Resources Survey for the Granbury East Wastewater Treatment Plant, City of Granbury, Hood County, Texas (TWDB Project No. 73813)

June 2020

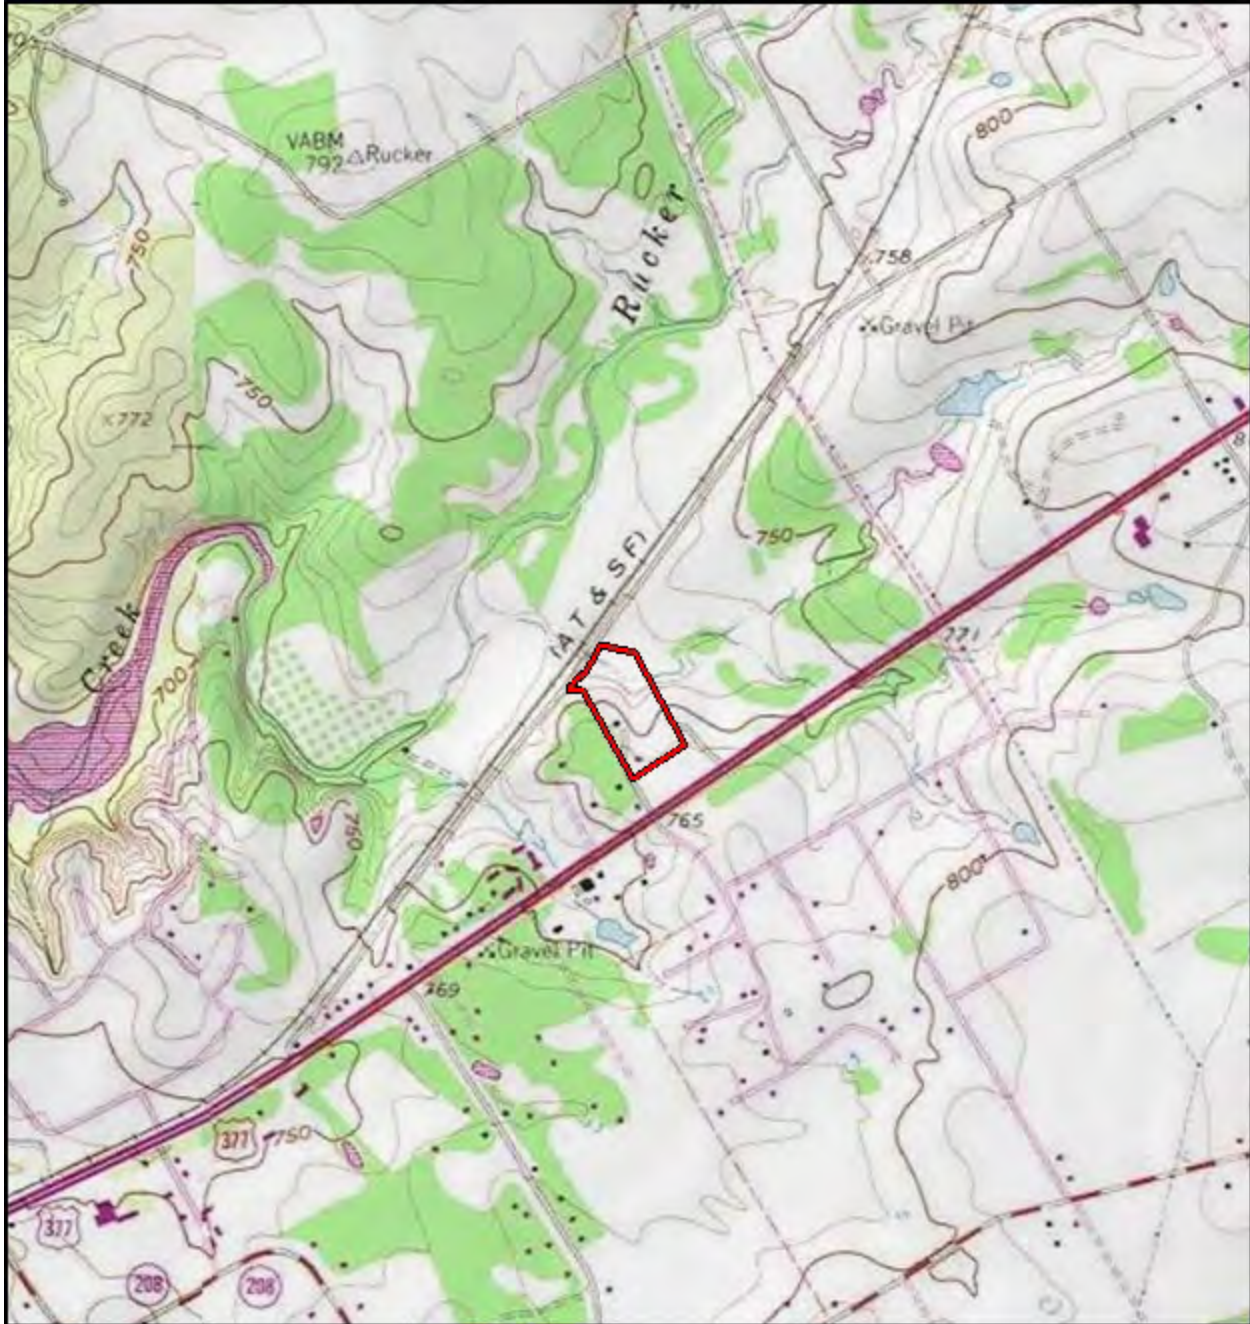
Figure 2.1  
Topographic Setting

The USGS Acton 7.5-minute topographic quadrangle map illustrates that the APE is located within a dissected upland terrace bordering the Brazos River floodplain. An unnamed tributary of Rucker Creek flowed west crossing the northeastern corner of the APE. Overall, the project area slopes toward the tributary that crosses the APE and features an elevation range of approximately 727 to 772 ft above mean sea level (amsl; **Figure 2.1**).

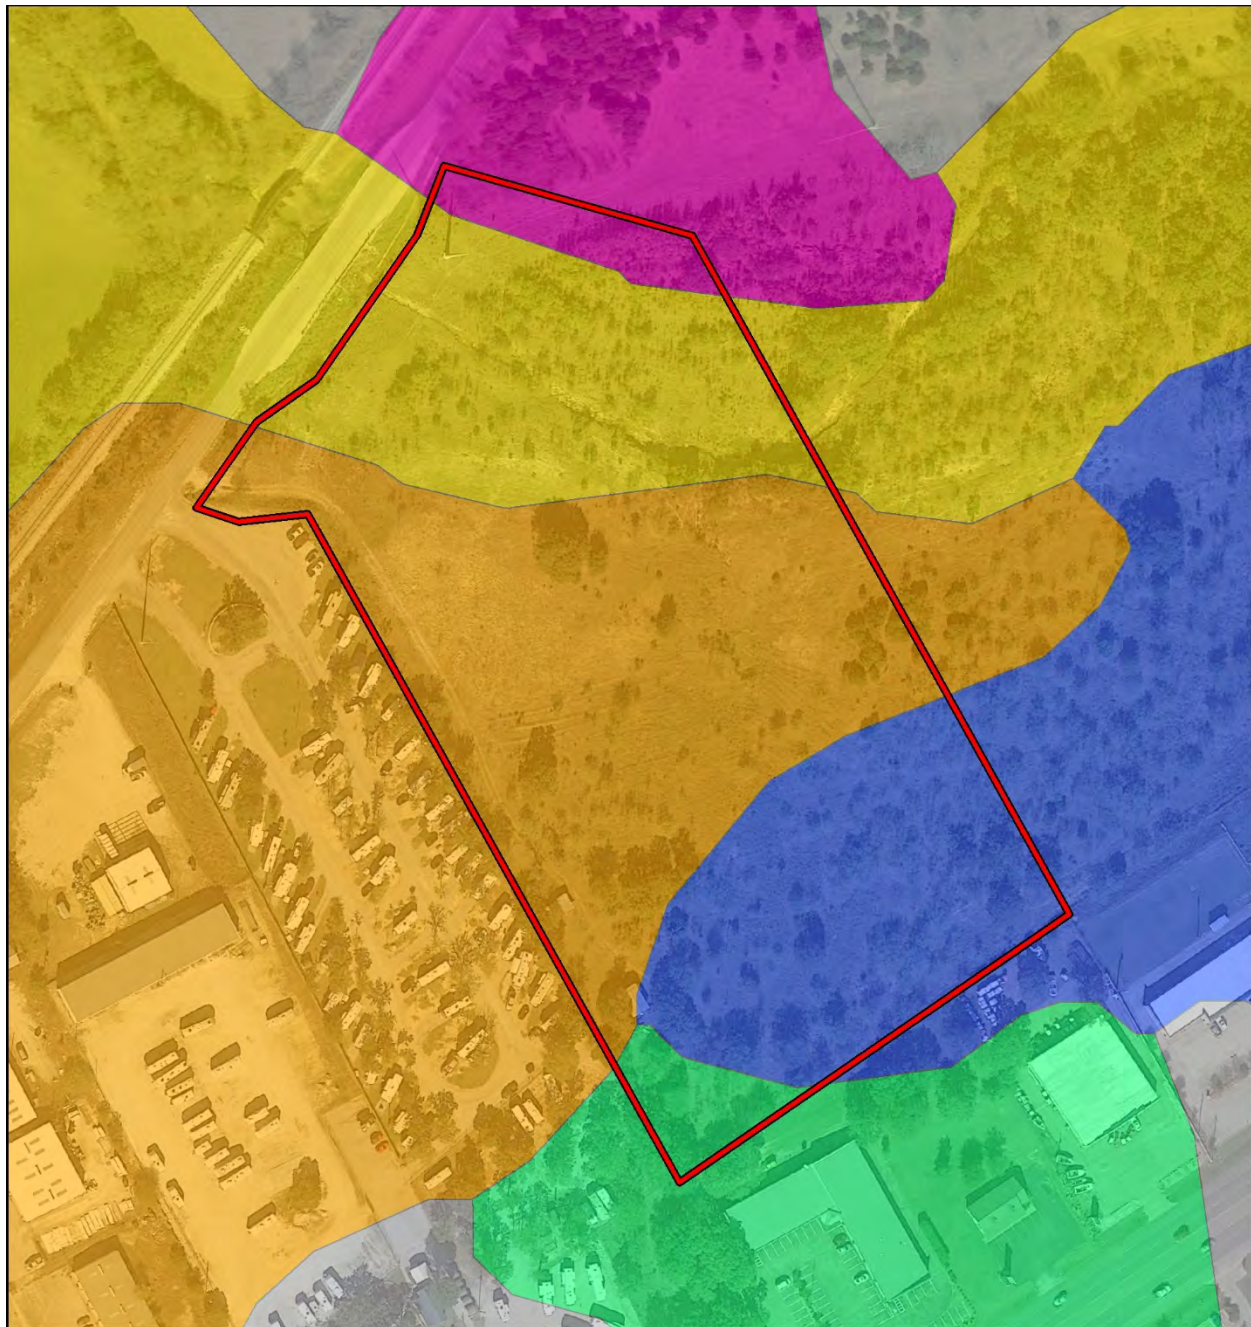
**Figure 2.3**  
**Soil Map Units Located Within**  
**and Adjacent to the APE**

As shown by the *Soil Survey of Hood and Somervell Counties, Texas*, there are five mapped soil units within the project area (Coburn 1978; **Figure 2.3; Table 2.1**). Approximately 75.81 percent of the project area contains soils typical of the Grand Prairie ecoregion. The remaining 24.19 percent of the APE contains occasionally flooded soils. Soils data were viewed from the U.S. Department of Agriculture (USDA) Natural Resource Conservation Service (NRCS) Web Soil Survey (Web Soil Survey 2020).

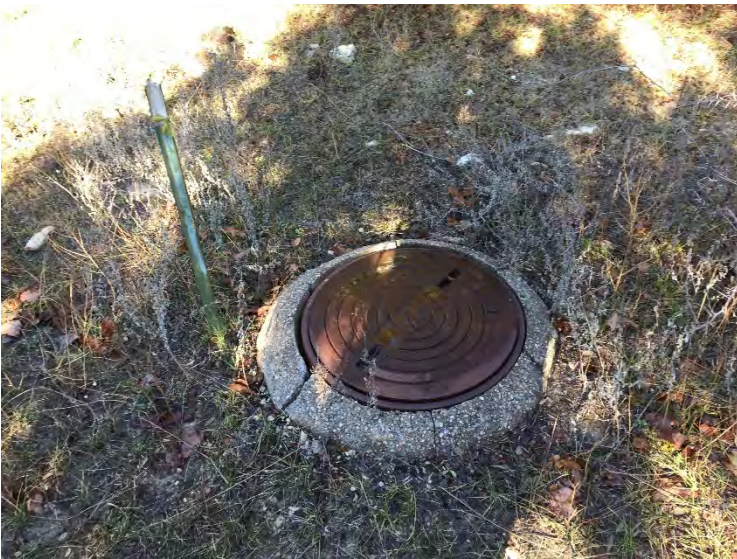
Photograph 15: Modern manhole cover, facing North.

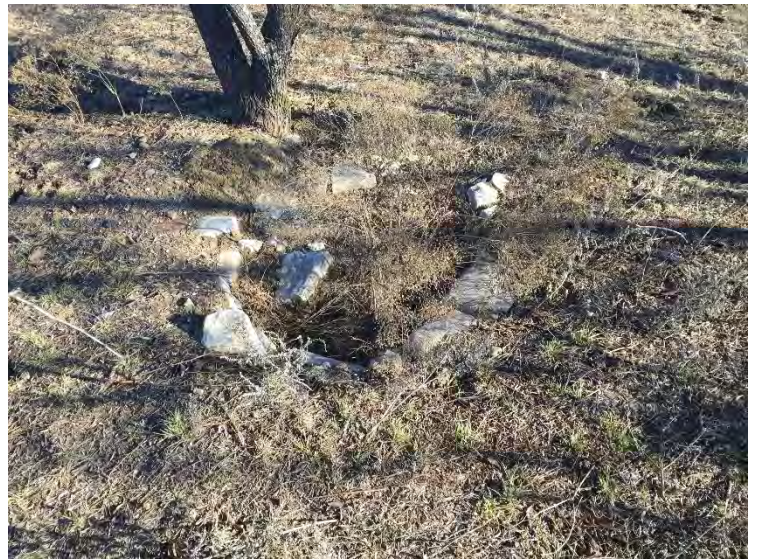
Photograph 16: Site 41HD96, Original Feature 1, well, facing Northeast.

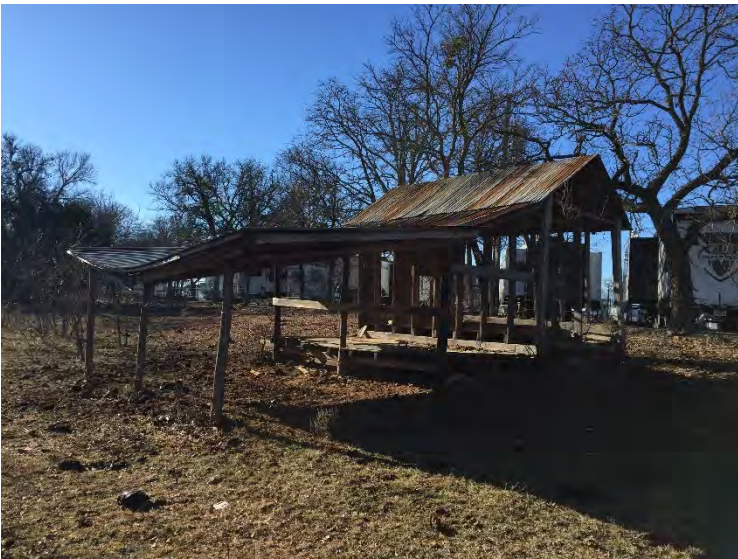
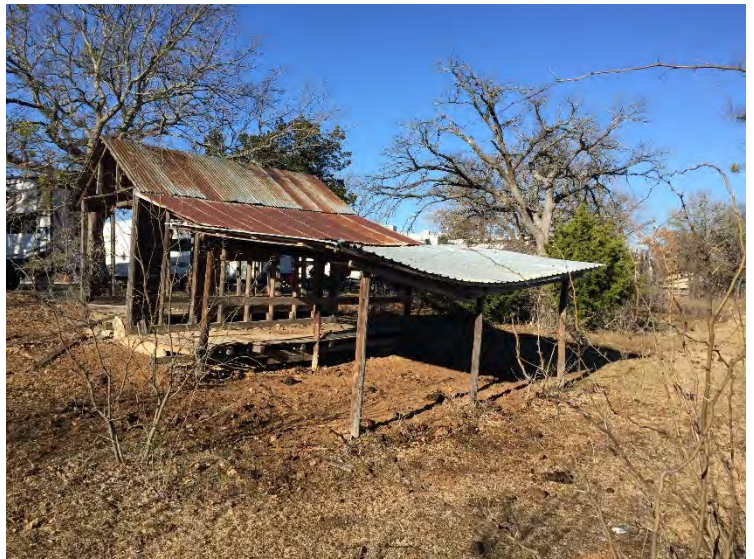
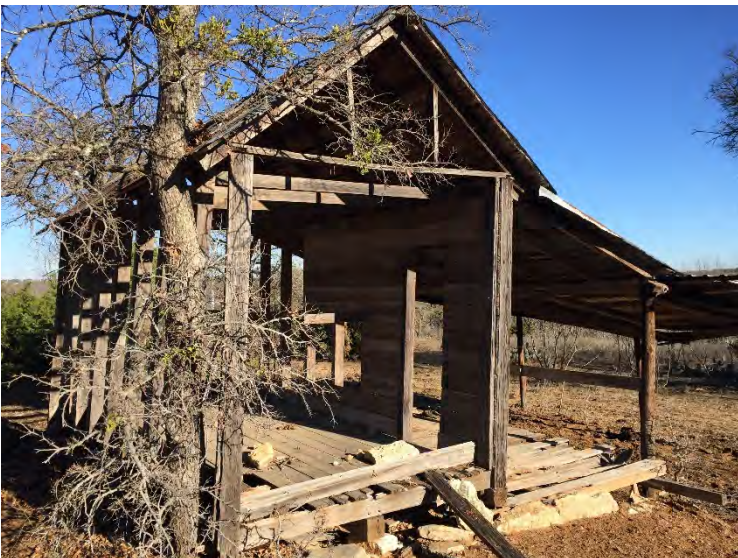
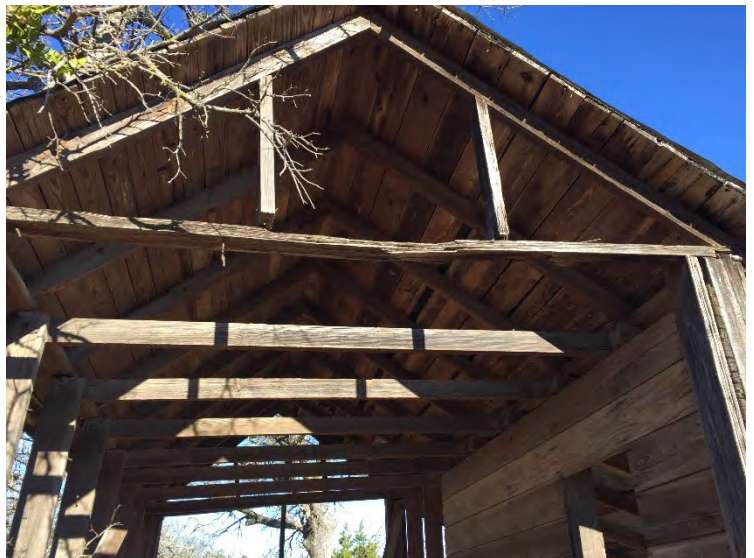
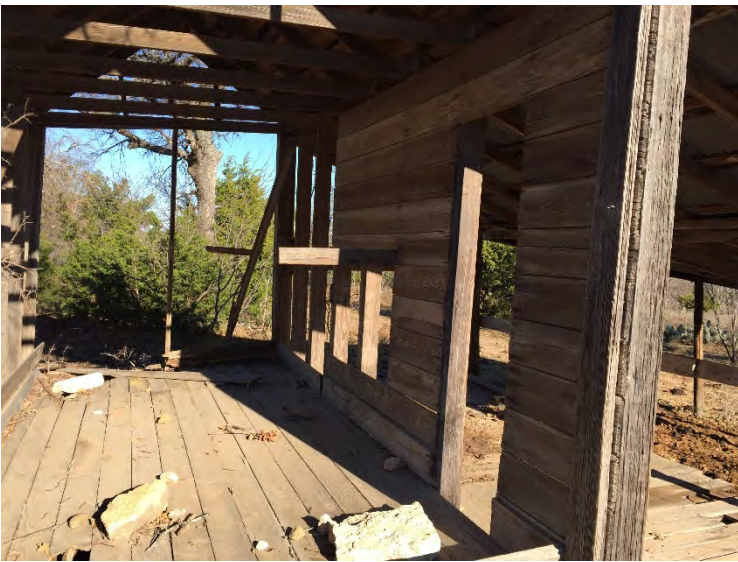
**Feature 2** was a typical example of a side-gabled cabin comprised of a single room that was constructed using balloon frame constructions methods (**Appendix A, Photographs 21 through 25**). The building's foundation was comprised of pier and beam resting on the ground's surface or limestone rock. The majority of the walls contained exposed studs, but a section of wall illustrated the cabin was once clad in horizontal milled wood boards. The roof was comprised of milled wood clad in iron sheets rolled in a simple 2 ½-in x ½-in wavy profile. At some point in modern times, the original shed extension covering the front porch was extended off the front porch to provide additional storage space. This modern shed extension was supported by round wooden poles and a galvanized tin roof pressed in a "U"-shaped profile. At the time of field survey, Feature 2 was dilapidated and considered an archeological ruin.

Photograph 21: 41HD96, Feature 2, barn exterior, facing Southeast.

Photograph 22: 41HD96, Feature 2, barn exterior, facing Northwest.

Photograph 23: 41HD96, Feature 2, barn interior, facing North.

Photograph 24: 41HD96, Feature 2, barn interior, facing North.

Photograph 25: 41HD96, Feature 2, barn interior, facing North.

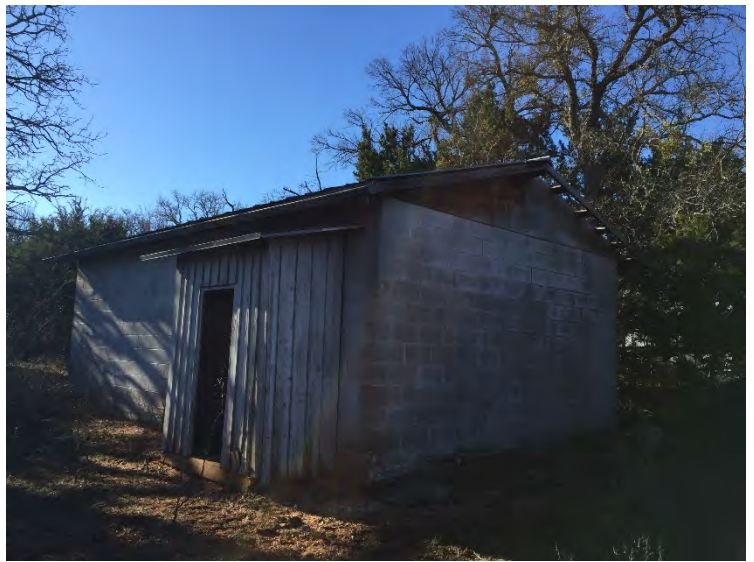
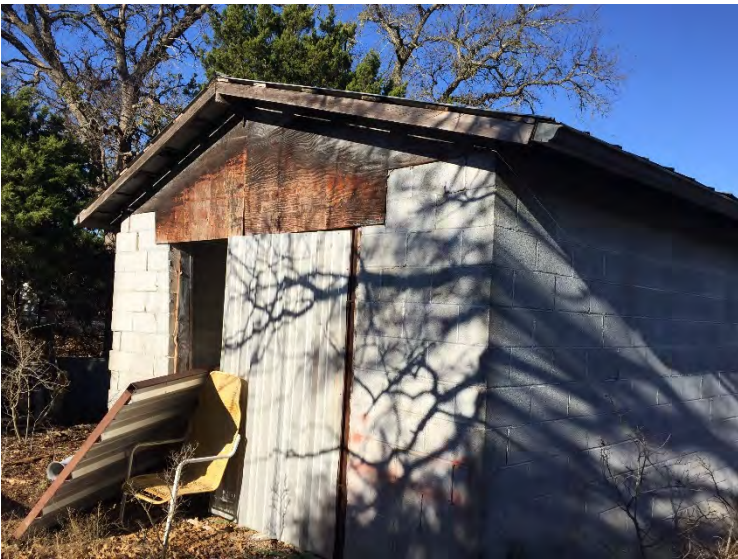
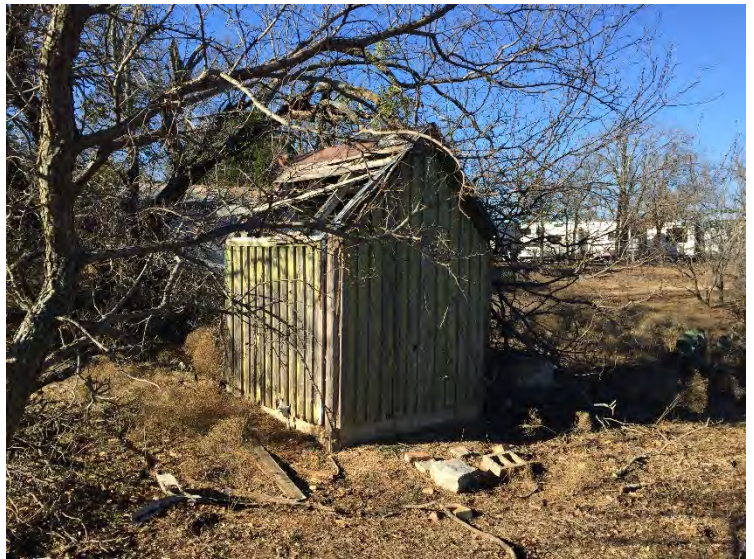
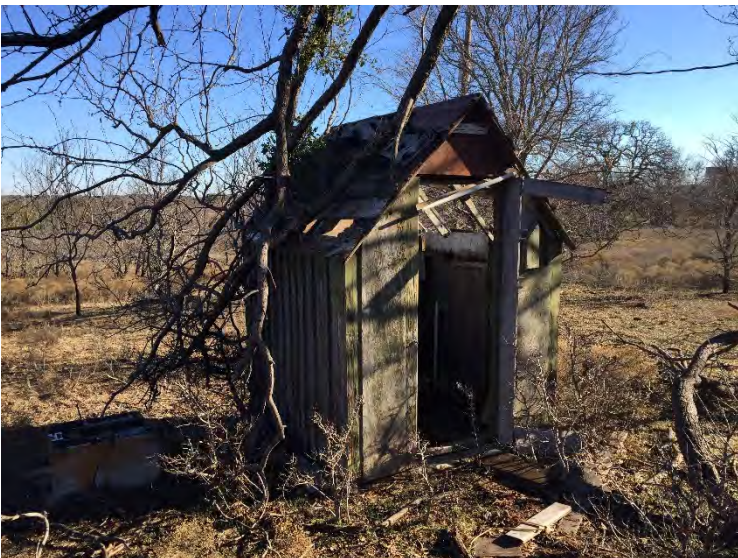
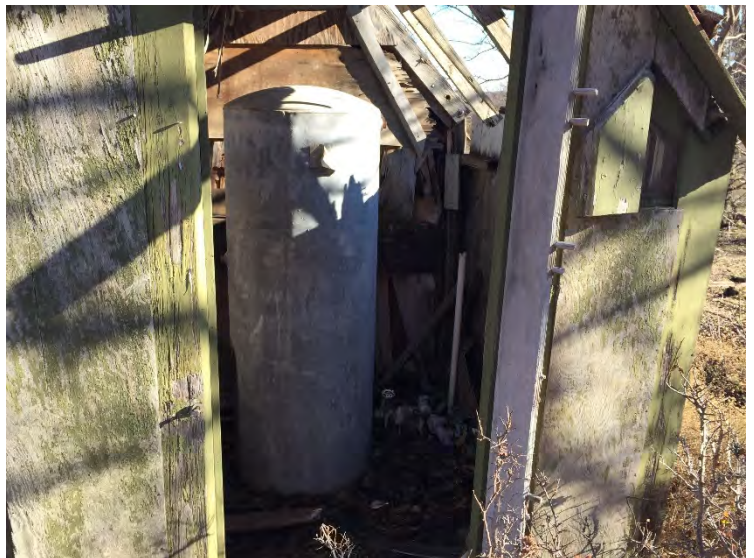
The southern building consisted of a modern, front gabled storage building constructed from cinderblocks. A variety of furniture debris was observed within the shed, which included tables, cabinets, and a refrigerator (**Appendix A, Photographs 26 and 27**). As detailed in *Section 3.2.2.3* of this report, this building was constructed between 1976 and 1981. A modern outbuilding was located to the south of the modern storage building and consisted of a small utility shed constructed using milled wood framing and roofing. The shed contained a modern water heater and piping (**Appendix A, Photographs 29 through 30**).

Photograph 26: 41HD96, modern structure, facing Southwest.

Photograph 27: 41HD96, modern structure, facing Northwest.

Photograph 28: 41HD96, modern structure, facing West.

Photograph 29: 41HD96, modern structure, facing Northeast.

Photograph 30: 41HD96, modern structure, facing Northeast.
