Cultural Resources Survey of the Proposed Franklin 1A Elevated Storage Tank and Access Road, El Paso County, Texas

Texas Antiquities Permit No. 8114

September 2017_Final Report

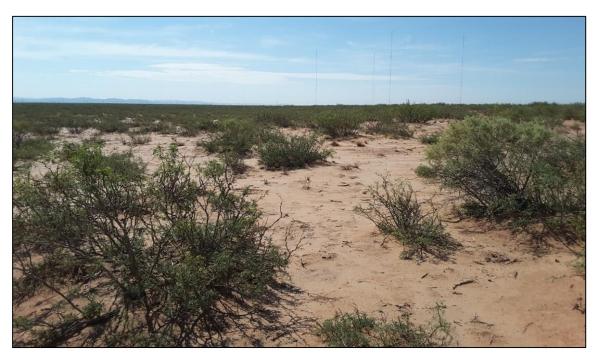
Figure 2-1. Photograph showing the general environmental condition of the project area, looking east.

Current landforms consist of poorly-developed mesquite-stabilized dune fields, areas of interdunal deflation, and shallow sand sheets characterized by gravelly alluvium (Figure 2-1). Impacts to the parcel currently noted result from ongoing eolian and erosional deflation and previous highway development; a graded easement parallels the current survey corridor. The soils throughout the project area consist of unconsolidated eolian sediments, light tan sandy loams, and low to moderate amounts of alluvium-related gravels and cobbles.

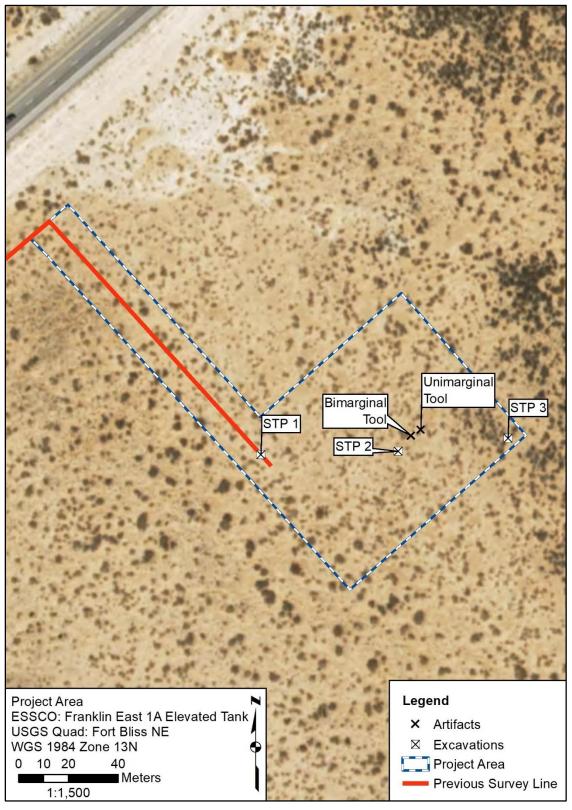
Figure 4-1. Map of project area, shovel test pits, and isolated occurrences.

This project entailed an intensive pedestrian survey of a 3.0-acre parcel in El Paso County, Texas. The survey was confined to the access road corridor and water tank footprint, which run perpendicular to U.S. Highway 54 (Figure 4-1). The condition of the project area appeared to be generally intact; however, the far western margins of the access road corridor closest to the highway exhibited a higher level of disturbance. In these areas, disturbance from road expansion, drainage, and maintenance were clearly evident (Figure 4-2 and Figure 4-3). Moreover, eolian deflation and alluvial action has, over time, removed and redistributed sediments, creating deflation basins and gravel deposits throughout the project area. Low-to-medium sized mesquite-stabilized coppice dunes anchor sediments in the parcel. Ephemeral rills and several shallow arroyos have impacted the landscape. Dune margins and exposed dune facies were closely examined for evidence of buried cultural deposits. No archaeological sites were identified; two isolated occurrences were encountered.

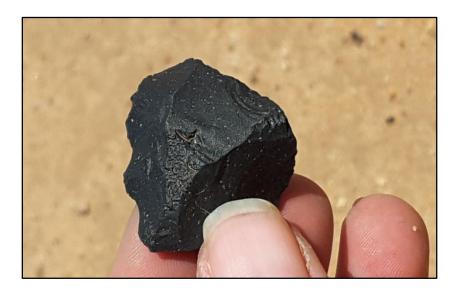
Figure 4-4. Isolated Occurrence 1, a unimarginal black chert tool.

Two isolated finds were documented during the survey, both located in the central portion of the proposed water tank footprint, each within 5-m of the other. The first isolated occurrence is a black chert unimarginal tool (Figure 4-4). This tool was exhibited non-overlapping flake scars and was produced from a piece of angular debris. It measured 4.5 cm in size and was expediently produced.

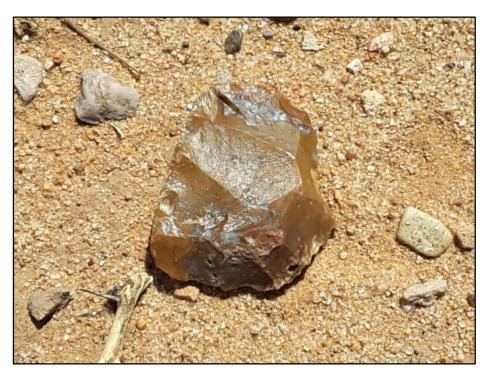
Figure 4-5. Isolated Occurrence 2, a tan-brown bimarginal chert tool.

The second isolated occurrence was a bimarginal chert tool (Figure 4-5). This tool was made from a more homogenous, less coarse tan-brown chert and measured approximately 8-cm in length. Platform preparation is visible along the proximal end; several extending flake scars are also present. The edge preparation and overlapping flake scars suggest, that prior to detachment, this piece was one edge of a core. Post-detachment modification resulted in the shaping of the distal end as evidenced by the sharp edge angle and supporting flake scars. No other artifacts were encountered during the survey. Both artifacts were thoroughly documented in-field and no further action is recommended.

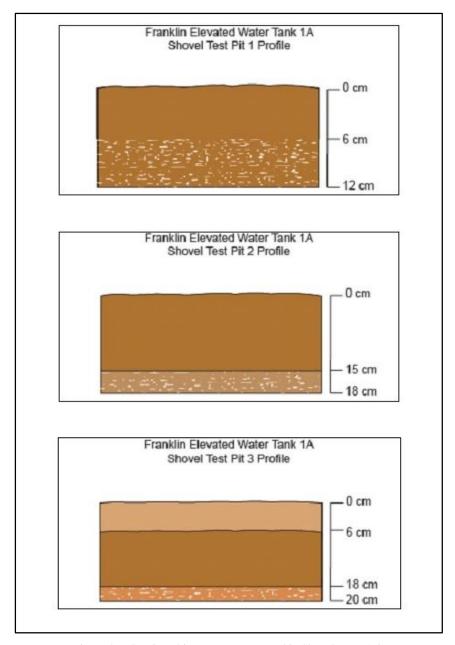
Figure 4-6. Stratigraphic sequences exposed in Shovel Tests 1-3.

Finally, in order to assess the potential for buried archaeological deposits and examine the contextual integrity of the project area, three shovel tests were excavated within the proposed footprint of the Franklin 1A elevated water tank (Figure 4-6). All sediments removed from the shovel tests were screened through 1/8th-inch hardware mesh. The shovel tests did not reveal any buried archaeological remains. The stratigraphic data are presented below.

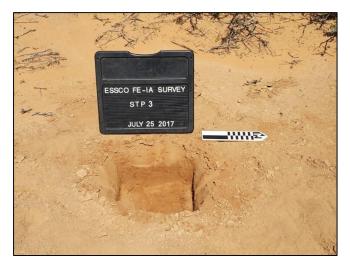
Figure 4-8. Image showing Shovel Test 3, looking west.

Shovel Test 3 was placed in the southeastern corner of the project area in an area with increased vegetation at the base of a small dune (Figure 4-8). Maximum depth was 20-cm, with the first 6-cm consisting of light brown loose sands, followed by12-cm of dark brown, more consolidated sand, with the last 2-cm characterized by a semi-compact calcic stratum of light red, silty sand. No cultural materials were encountered.
