Archeological Survey of Frontera Road from 109 Linear Feet South of the Union Pacific Railroad Tracks to Alderete Lane, Del Rio, Val Verde County, Texas

Frontera Road Improvements: from 109 Linear Feet South of the Union Pacific Railroad Tracks to Alderete Lane, Del Rio, Val Verde County, Texas

TxDOT, Laredo District CSJ: 0922-11-032 Texas Antiquities No. 8733

Technical Report No. 267

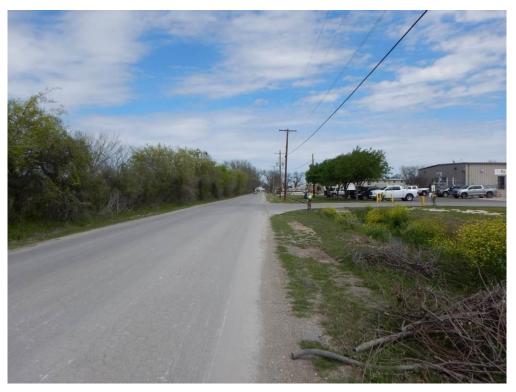
Figure 9. Typical conditions throughout the northern half of the APE: buried utilities within a narrow ROW corridor, paved business entries, and a gravel shoulder, facing north.

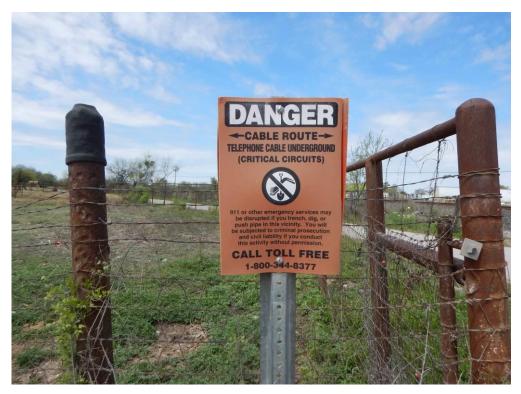
Figure 10. Buried phone line present on the western side of Frontera Road's northern half and buried along the northern side of Frontera Road in the southern half of the APE, facing east.

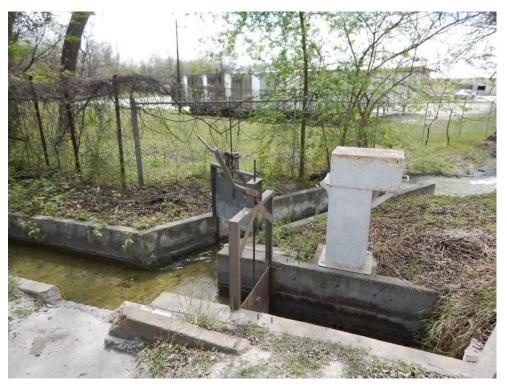
Figure 11. Historical irrigation structures adjacent to the project APE, facing northeast.

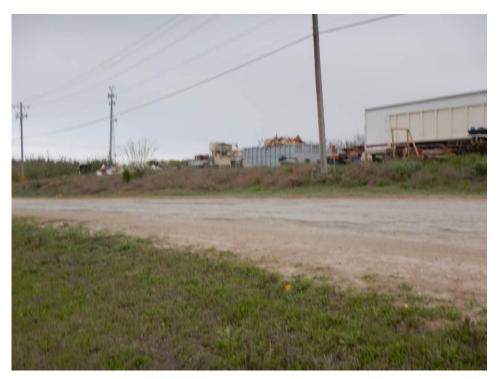
Figure 12. Typical conditions in the southern half of the APE along the northern side of Frontera Road: buried utilities and industrial complexes, facing north.

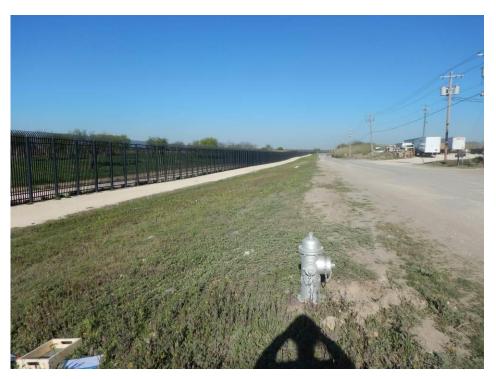
Figure 13. Typical conditions in the southern half of the APE along the southern side of Frontera Road: buried water line and landscaped slope, punctuated by pull-throughs, revetment cobbles, and a storm drain, facing west.

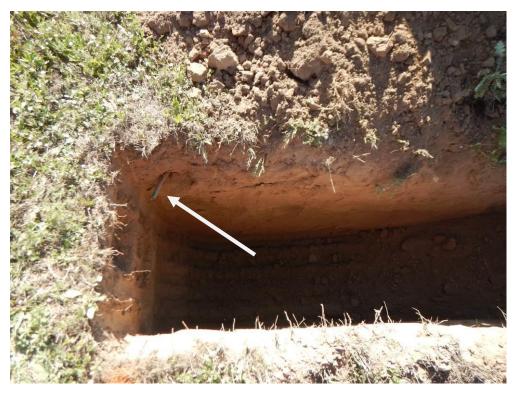
Figure 14. Buried PVC pipe within backhoe trench #4 (BH4)

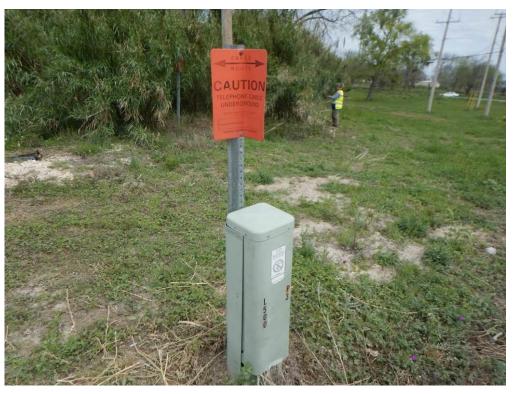
Figure 15. Phone line buried along the north side of Frontera Road in the southern half of the APE, facing east.

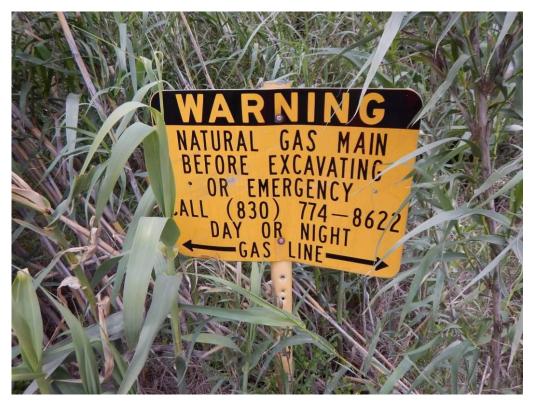
Figure 16. Buried gas line along the north side of Frontera Road in the southern half of the APE, facing north.

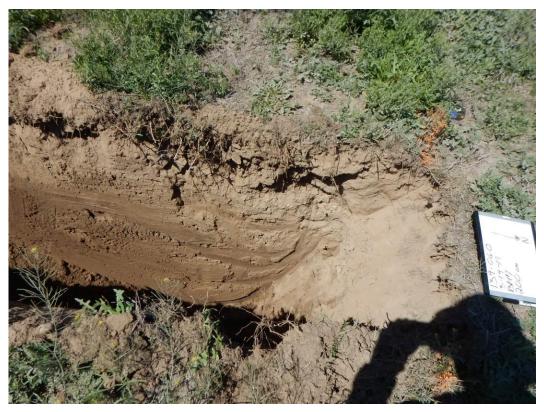
Typical shovel tests revealed disturbed and compact soils, comprised of mostly silt, backfill gravel, and trash. Shovel tests were excavated to a maximum of 80cmbs; on average, the 17 shovel tests were excavated to a depth of 38cmbs. Shovel tests were placed approximately every 100 meters within the southern APE in areas that appeared undisturbed. Backhoe trenches were excavated every 300 meters to a depth of 150-200cmbs. Typical trenches included disturbed soils to a minimum depth of 100cmbs, and included modern trash such as Styrofoam, plastic sheeting, glass beer bottles, and aluminum beer cans (Figure 17). One atypical trench included a layer of river rocks from a previous drainage culvert (Figure 18).

Figure 17. Profile of a typical trench (BH7).

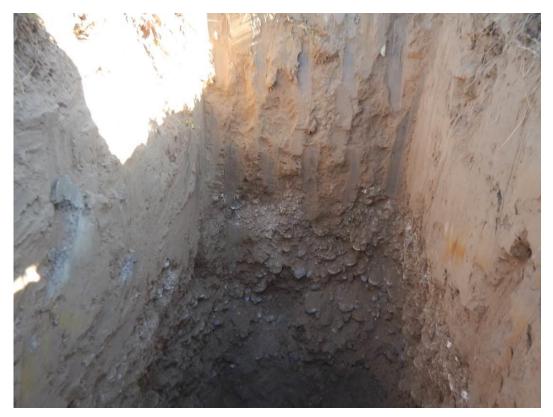
Figure 18. Profile of a typical trench (BH1) with deeply buried road gravels.

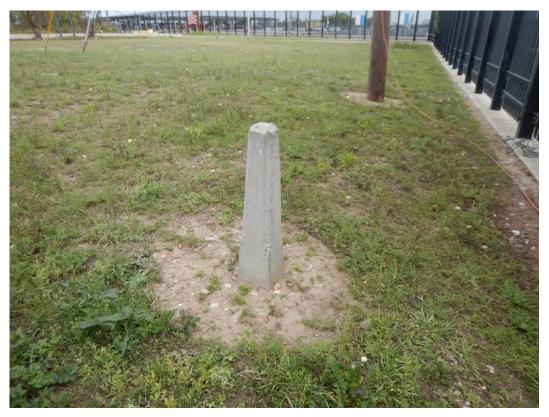
At the terminus of Frontera Road at State Loop 239 (the easternmost edge of the APE), one potentially historic monument was located (**Figure 19**).

From 1891-1894, 276 official concrete obelisks were established along the US-Mexico border. After the initial 276 concrete obelisks were constructed, smaller concrete markers were erected along the border in order to further delineate the boundary, particularly in high-traffic areas like cities and river-crossings. By 1984, 493 additional markers had been added along the border in urban places like Del Rio (Dear 2005). Based on its appearance, condition, and location, this marker likely belongs to that family of historic border markers. Due its close proximity to the border fence, it is unlikely to be impacted by the roadway improvements to Frontera Road, but we recommend avoiding disturbance during construction.

Figure 19. Concrete marker located during archeological survey, facing east.

The project was conducted under the ACT (Permit 8733) and Section 106 of the NHPA and all work conformed to the guidelines for implementation of these regulations under 13 TAC Chapter 26 as well as 36 CFR 800. No prehistoric or historic-age artifacts or archeological sites were discovered during field investigations. However, it is recommended that the concrete obelisk be avoided during construction.
