**CULTURAL RESOURCES SURVEY FOR THE  
FORT WORTH-HASLET-TRINITY RIVER AUTHORITY  
(FW-HASLET-TRA) SEWER PROJECT**

Tarrant County, Texas

Final Report  
February 2019

aci Project No.: 05-18-040

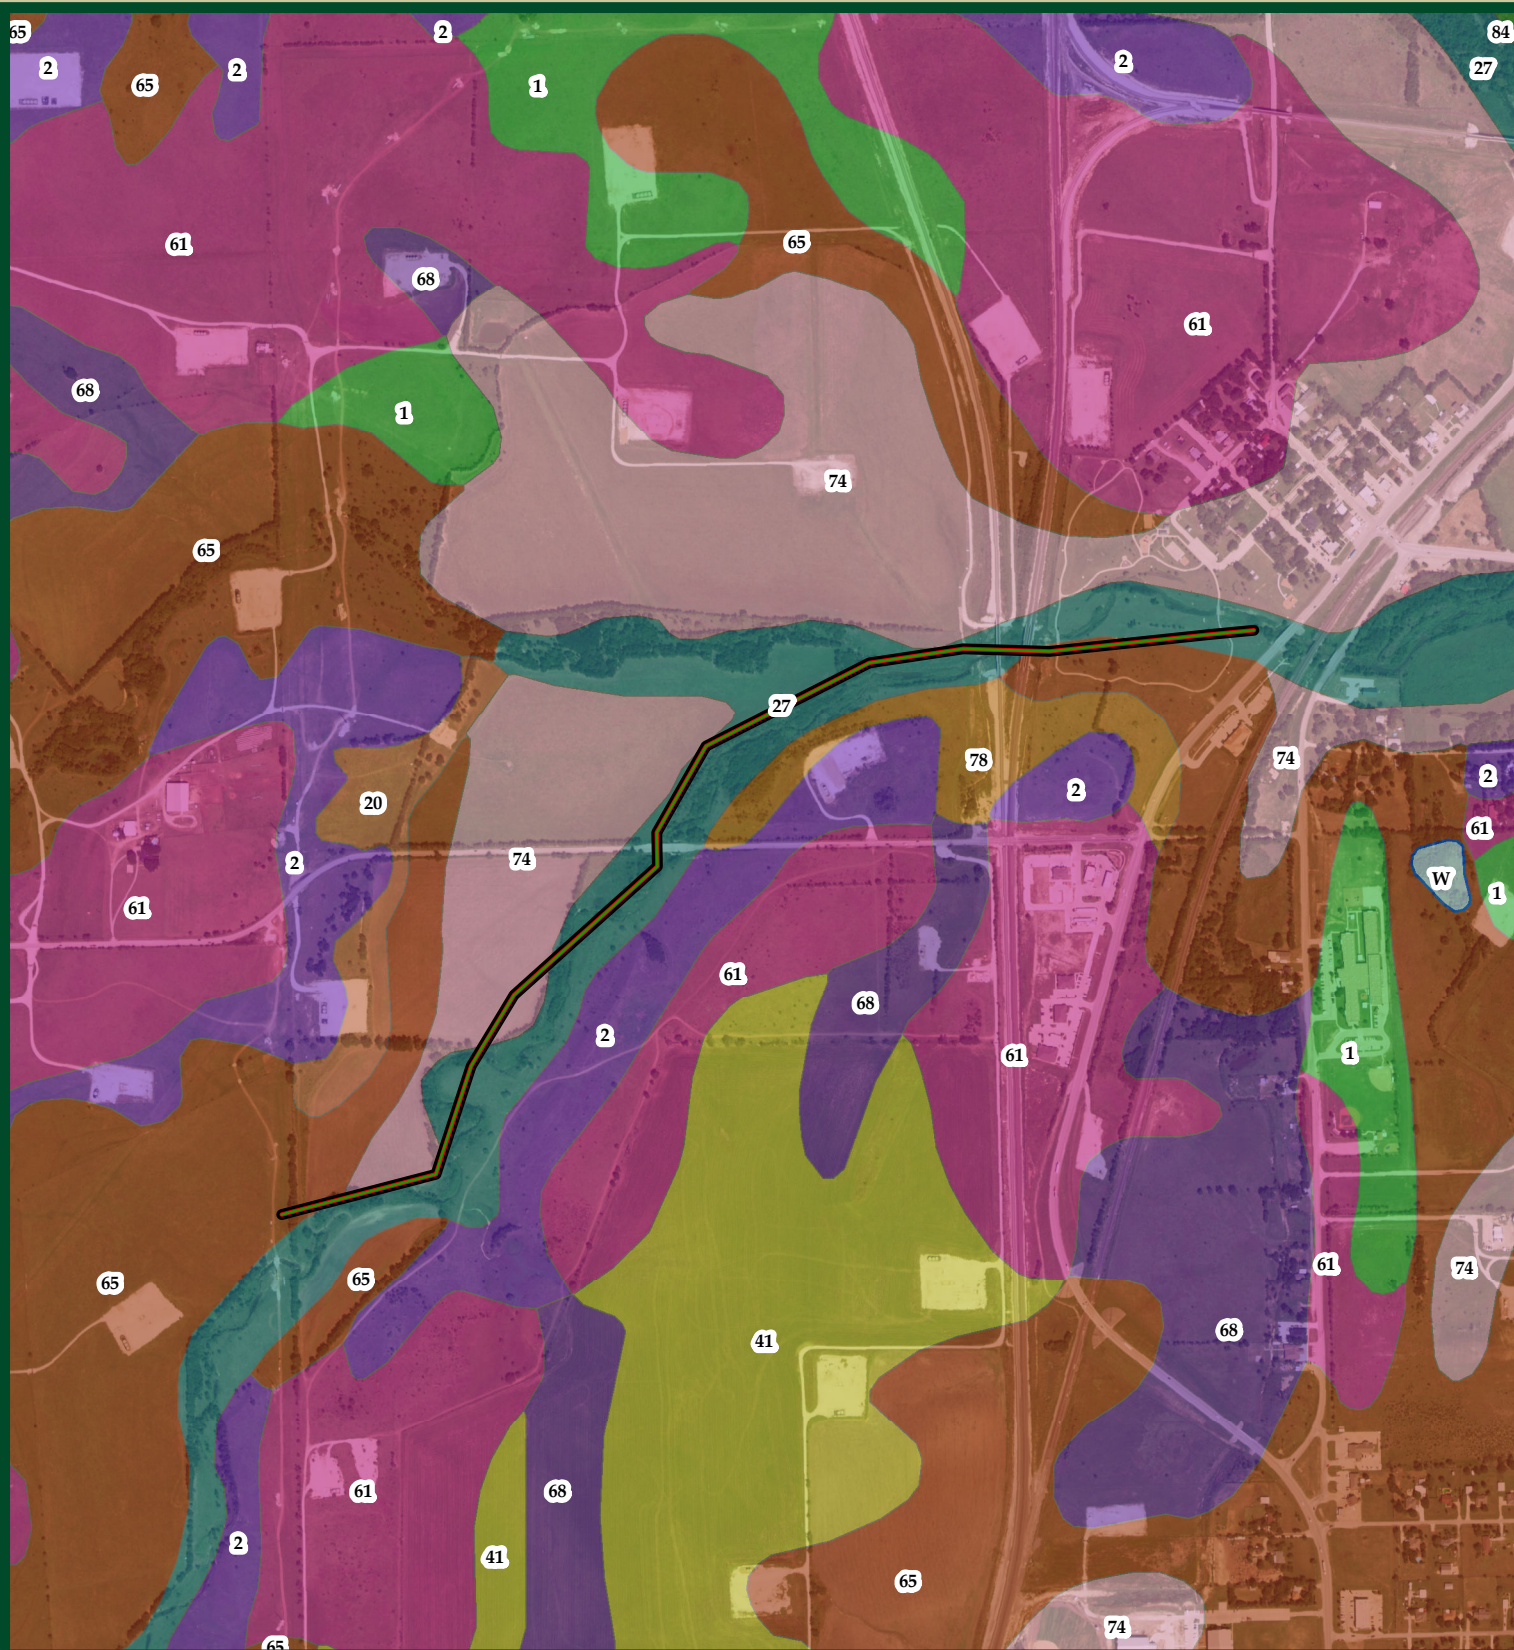
Three soil series are mapped along the APE (Figure 3). The soils are mapped as Frio silty clay, Sanger clay, and Slidell clay (NRCS 2018). While Sanger and Slidell have been previously determined to have a low probability to contain archeological sites according to the Potential Archeological Liability Maps

(PALM) model created by TxDOT ENV for highway projects in the Fort Worth District, Frio soil series has been determined to have a very high probability (Abbott 2013). Frio silty clay is mapped as 71.5% of the APE.

- *Frio silty clay, frequently flooded (27)* - The Frio series consists of very deep, well drained, moderately slowly permeable soils that formed in calcareous loamy and clayey alluvium. These nearly level to very gently sloping soils occur on flood plains.
- *Sanger clay, 1 to 3 percent slopes (65)* - The Sanger series consists of very deep, well drained, very slowly permeable soils that formed in clayey marine sediments. These gently sloping to strongly sloping soils are on broad uplands.
- *Slidell clay, 1 to 3 percent slopes (74)* - The Sanger series consists of very deep, well drained, very slowly permeable soils that formed in clayey marine sediments. These gently sloping to strongly sloping soils are on broad uplands.

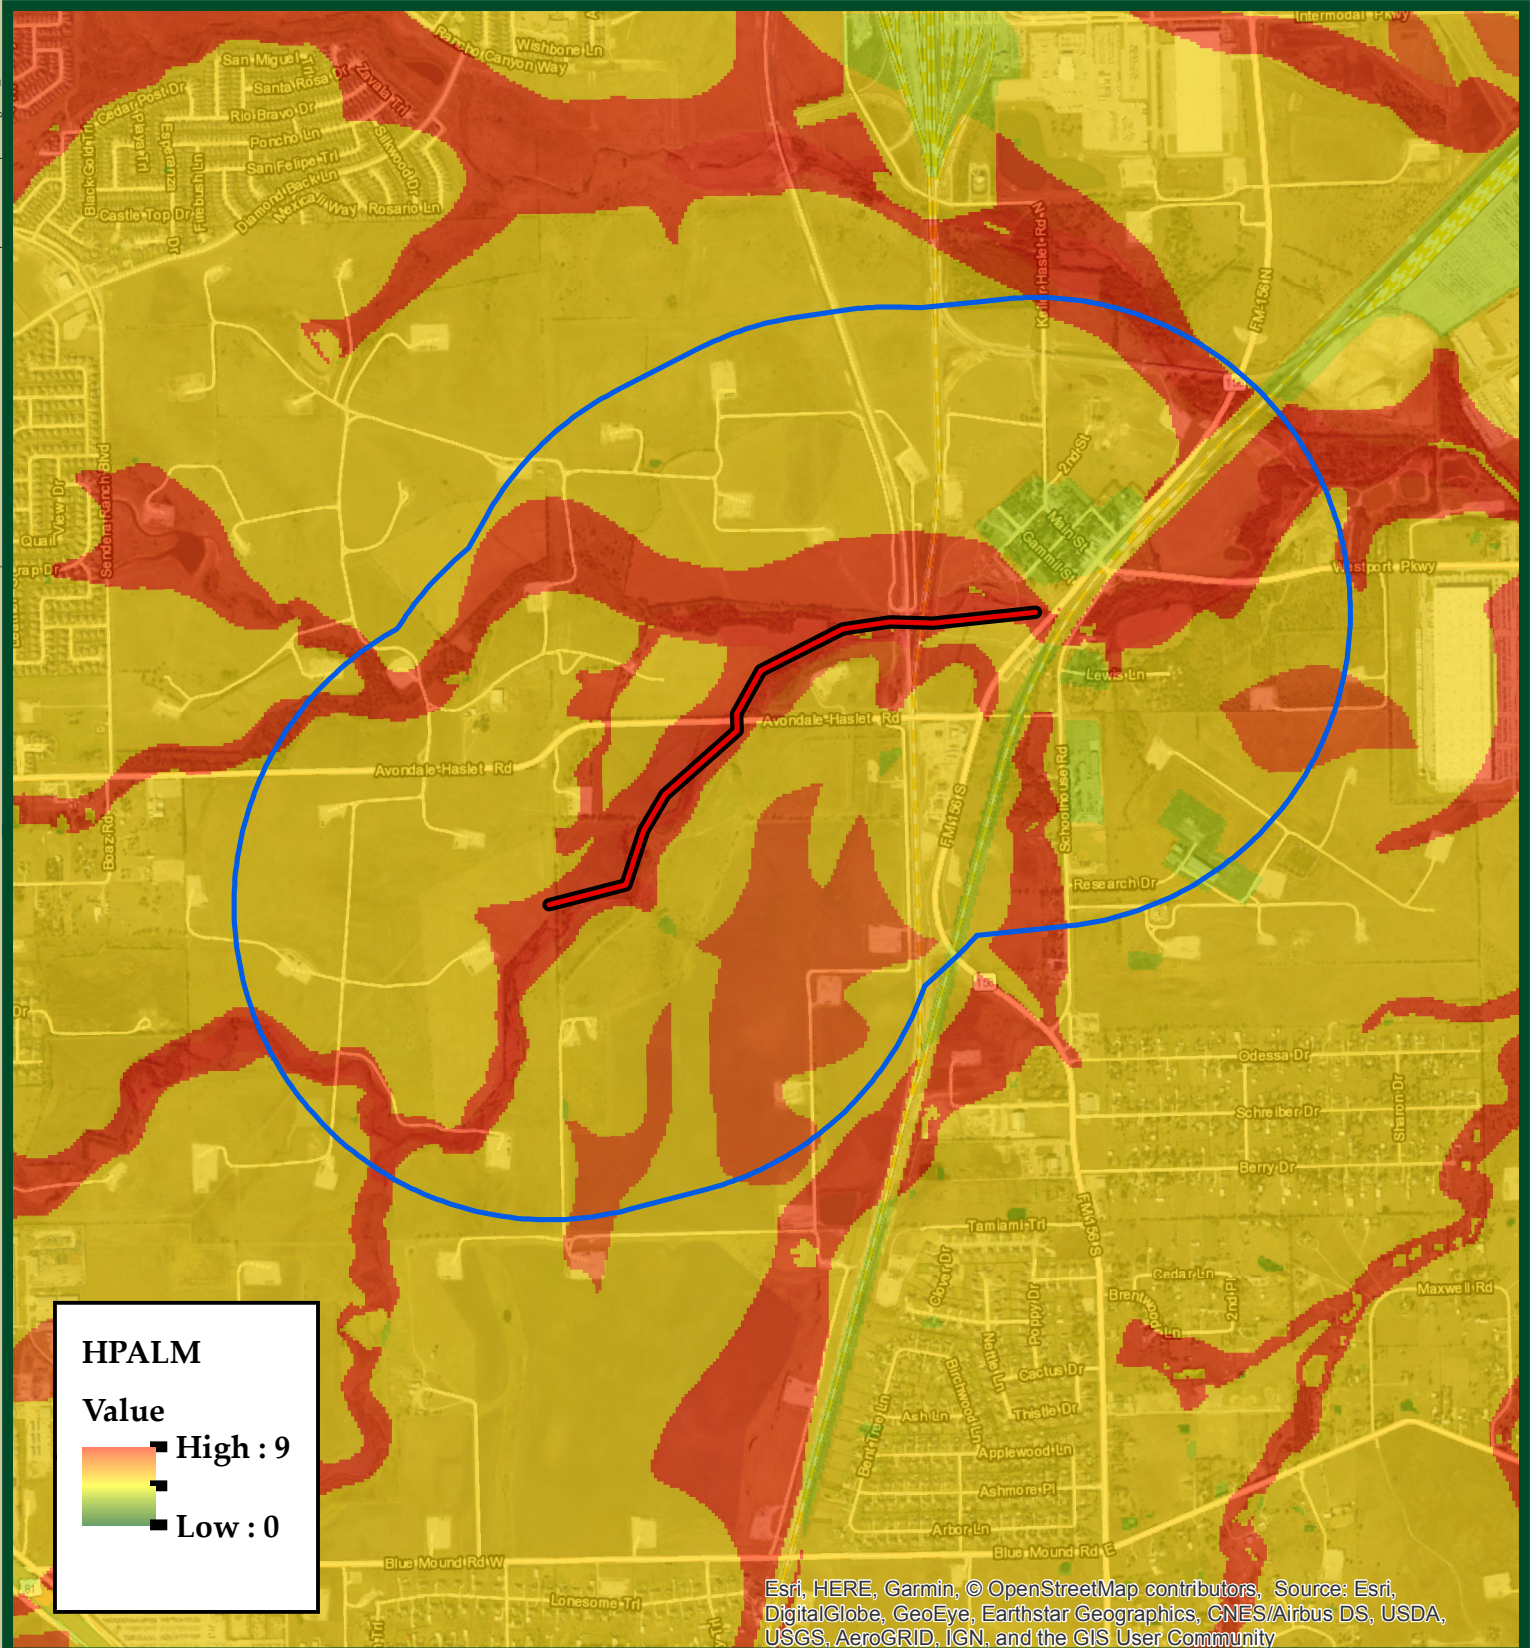
A literature review of the THC Archeological Sites Database (the Atlas) revealed that no previously recorded sites are within the APE nor within 1 kilometer of the APE (Figure 5). Furthermore, only one previously conducted survey intersects the APE. The survey was conducted in 2009 by URS for the City of Fort Worth and the Federal Aviation Administration for the Realignment of BNSF Railway and John Day Road, Alliance Airport Expansion Project (Turner-Pearson *et al* 2009). The survey only crosses the proposed APE for 36 meters (118 feet) parallel to the BNSF Railway. No cemeteries or historical markers are within the APE or 1 kilometer of the APE.

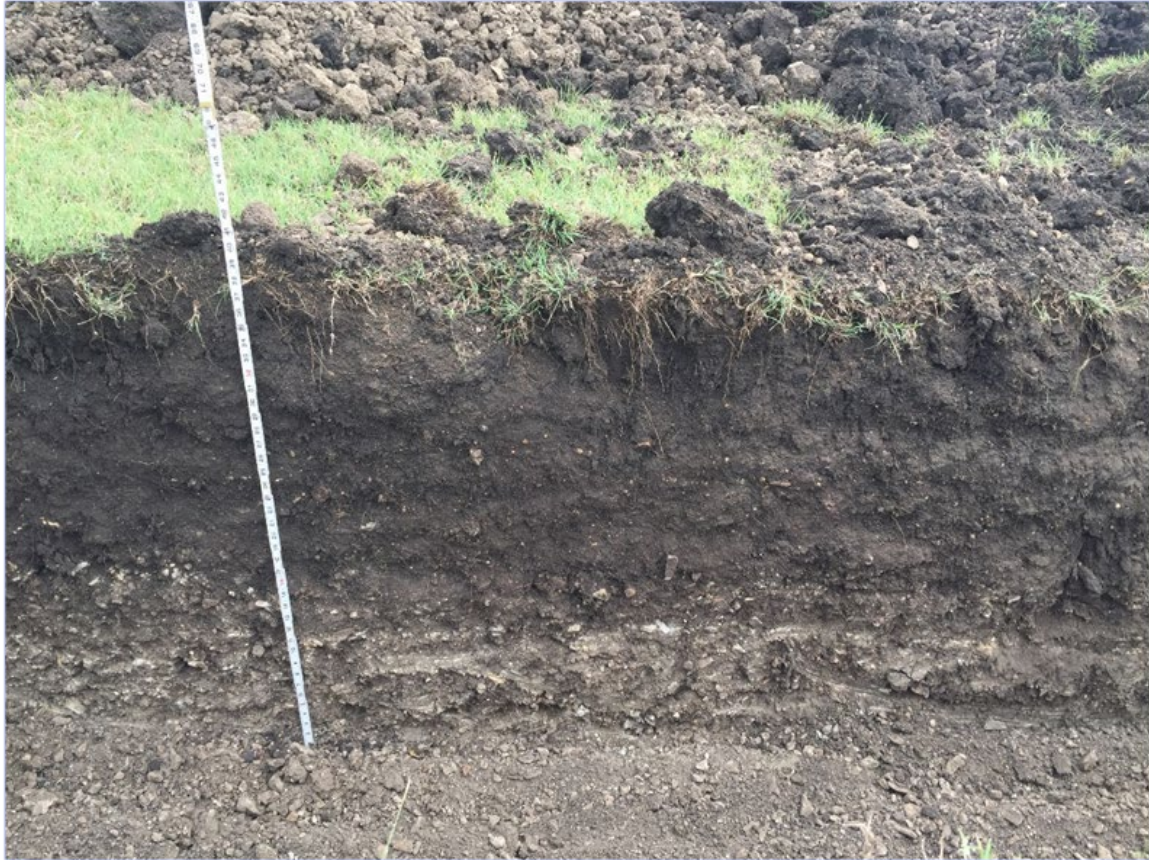
**BHT 1**

Zone	Depth (cmbs)	Description – Northeast Wall
I	0-70	10YR3/1 very dark gray clay loam; clear, smooth boundary; moderate fine structure; hard, firm; moderately sticky, moderately plastic; many fine, medium, few coarse roots; A horizon.
II	70-110	10YR 6/2 light brownish gray clay; boundary unknown; moderate medium and coarse prismatic structure; hard, firm; moderately sticky, moderately plastic; few fine, medium, and coarse roots; many fine films and threads and a few soft masses of calcium carbonate; Bk horizon.

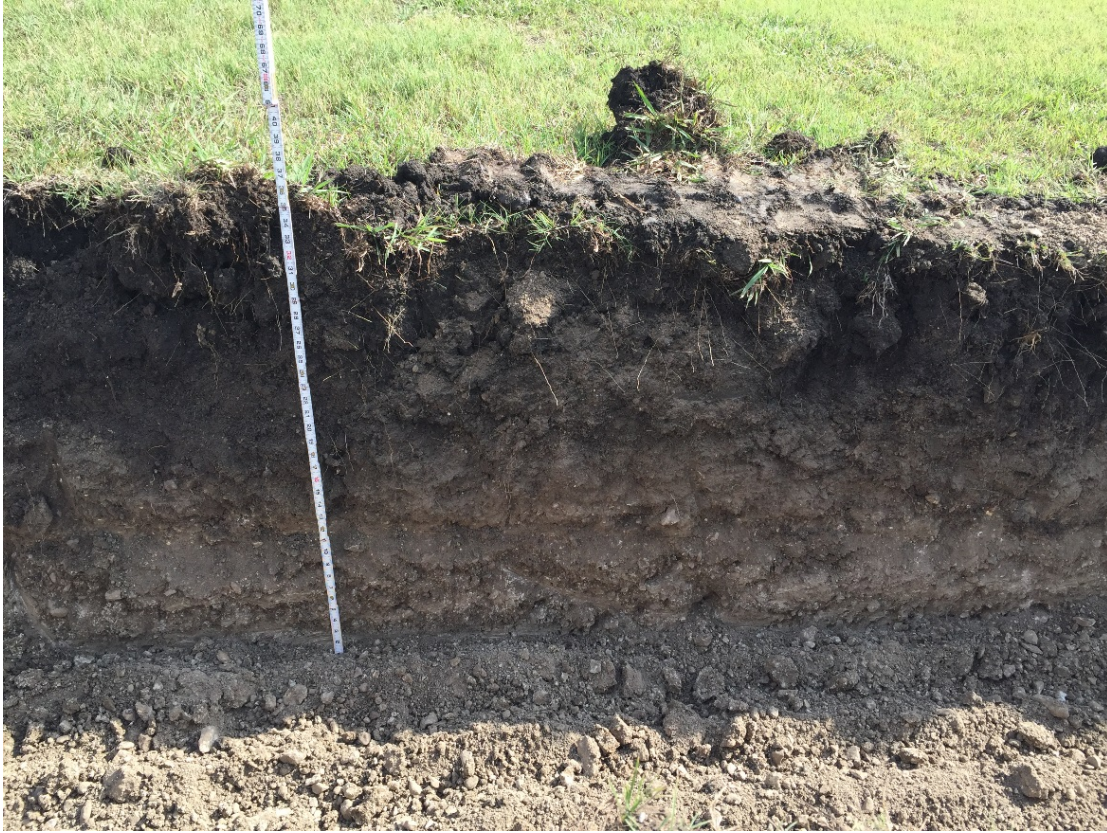
## BHT 2

Zone	Depth (cmbs)	Description – North Wall
I	0-30	10YR3/1 very dark gray clay loam; wavy boundary; moderate fine structure; hard, firm; moderately sticky, moderately plastic; many fine, medium, few coarse roots; A horizon.
II	30-100	10YR 6/2 light brownish gray clay; boundary unknown; coarse prismatic structure; hard, firm; moderately sticky, moderately plastic; few fine, medium, and coarse roots; many fine films and threads and a few soft masses of calcium carbonate; Bk horizon.

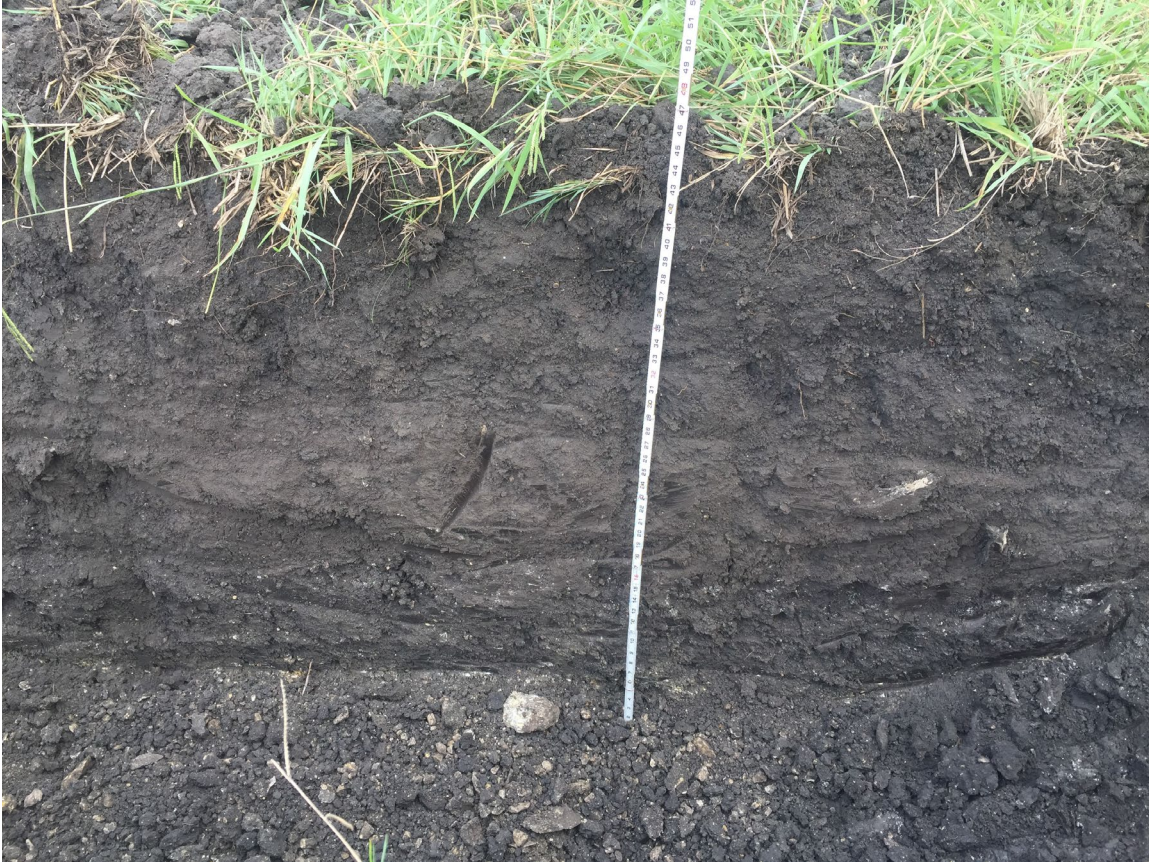
### BHT 3

Zone	Depth (cmbs)	Description – North Wall
I	0-40	10YR2/1 very dark gray clay loam; wavy boundary; moderate fine structure; hard, firm; moderately sticky, moderately plastic; many fine, medium, few coarse roots; A1 horizon.
II	40-80	10YR 3/1 very dark gray clay; wavy boundary; moderate fine structure; hard, firm; moderately sticky, moderately plastic; many fine, medium, few coarse roots; A2 horizon.
III	80-120	10YR 6/2 light brownish gray clay; boundary unknown; coarse prismatic structure; hard, firm; moderately sticky, moderately plastic; few fine, medium, and coarse roots; many fine films and threads and a few soft masses of calcium carbonate; Bk horizon.

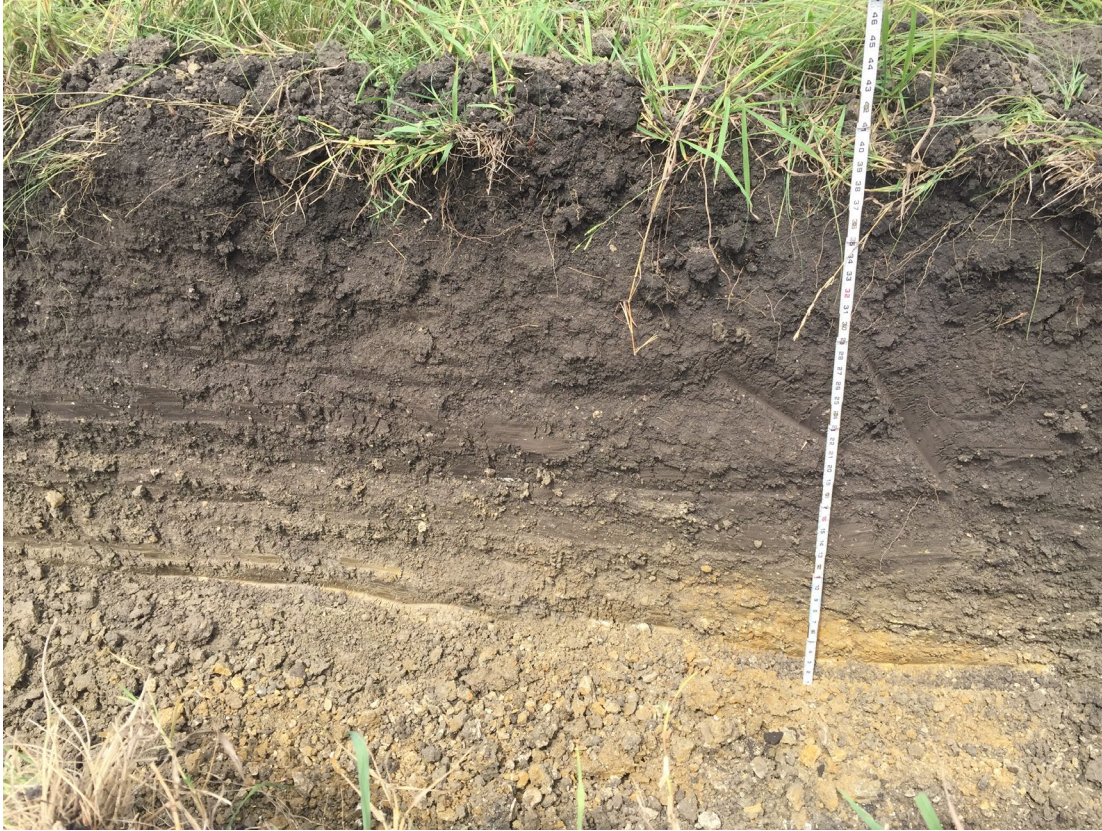
## BHT 4

Zone	Depth (cmbs)	Description – North Wall
I	0-40	10YR3/1 very dark gray clay loam; wavy boundary; moderate fine structure; hard, firm; moderately sticky, moderately plastic; many fine, medium, few coarse roots; A1 horizon.
II	40-80	10YR 6/2 light brownish gray clay; wavy boundary; moderate fine structure; hard, firm; moderately sticky, moderately plastic; many fine, medium, few coarse roots; Bk1 horizon.
III	80-120	10YR 6/2 light brownish gray clay; 10YR3/3 common distinct mottles; boundary unknown; coarse prismatic structure; hard, firm; moderately sticky, moderately plastic; few fine, medium, and coarse roots; many fine films and threads and a few soft masses of calcium carbonate; Bk2 horizon.

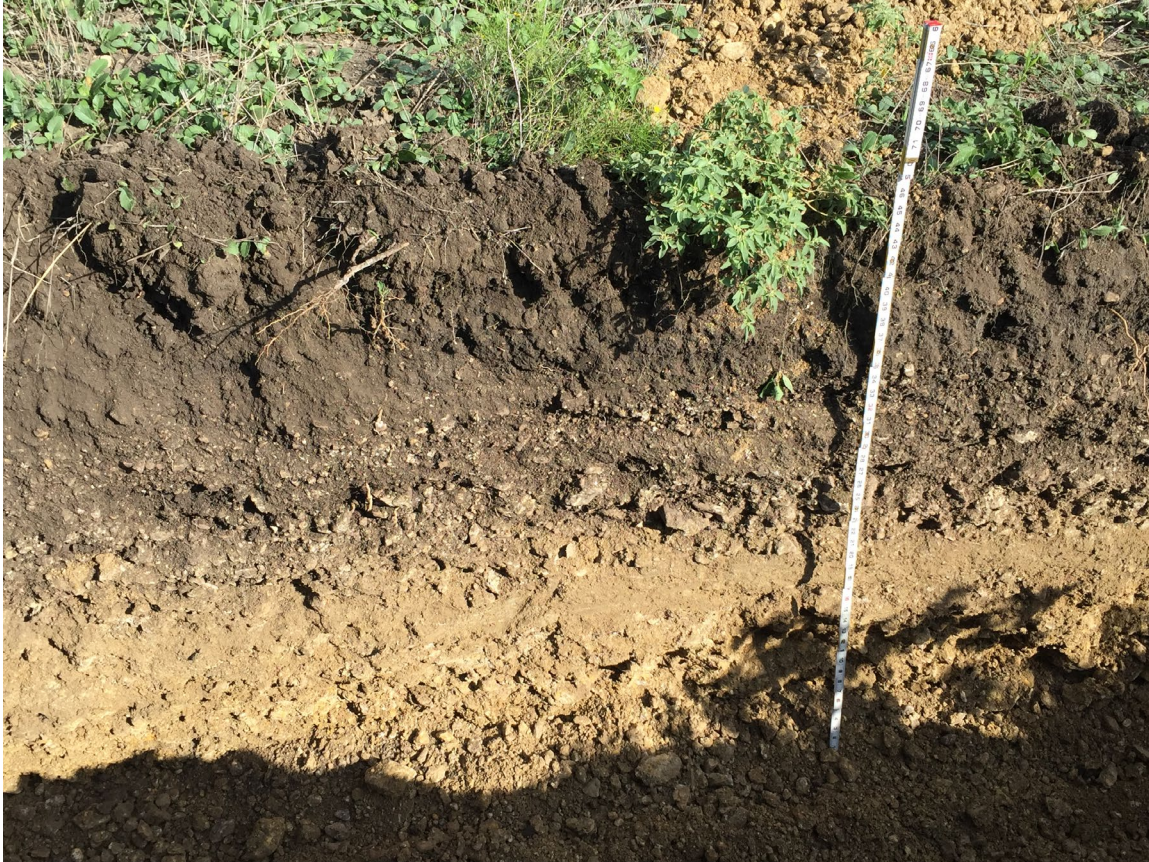
**BHT 5**

Zone	Depth (cmbs)	Description – North Wall
I	0-60	10YR2/1 very dark gray clay loam; wavy boundary; moderate fine structure; hard, firm; moderately sticky, moderately plastic; many fine, medium, few coarse roots; A1 horizon.
II	60-90	10YR 3/1 very dark gray clay; wavy boundary; moderate fine structure; hard, firm; moderately sticky, moderately plastic; many fine, medium, few coarse roots; A2 horizon.
III	90-110	10YR 5/2 grayish brown silty clay; boundary unknown; moderate medium and coarse prismatic structure parting to weak coarse blocky; hard, firm; moderately sticky, moderately plastic; few fine, medium, and coarse roots; many fine films and threads and a few soft masses of calcium carbonate; Bk horizon.

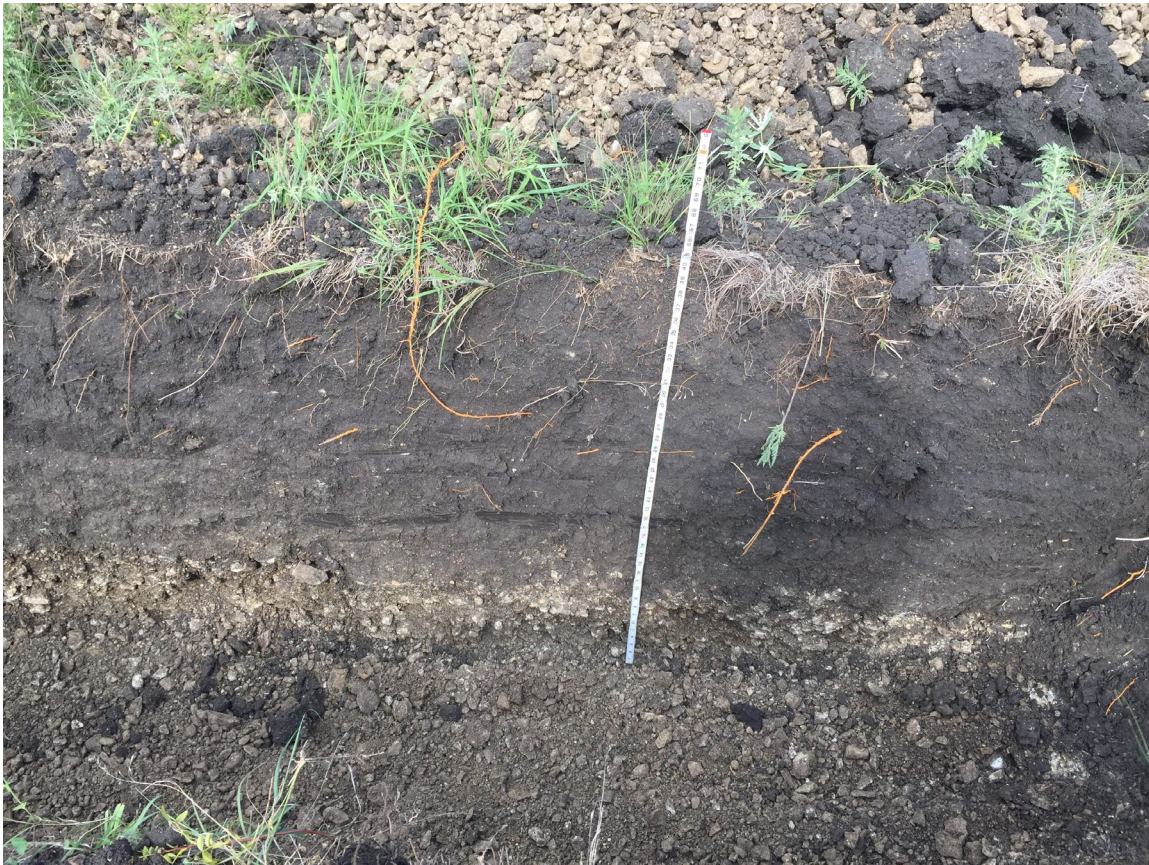
**BHT 6**

Zone	Depth (cmbs)	Description – West Wall
I	0-80	10YR2/1 very dark gray clay loam; wavy boundary; moderate fine structure; hard, firm; moderately sticky, moderately plastic; many fine, medium, few coarse roots; A horizon.
II	80-100	10YR 5/2 grayish brown silty clay; boundary unknown; moderate medium and coarse prismatic structure parting to weak coarse blocky; hard, firm; moderately sticky, moderately plastic; few fine, medium, and coarse roots; many fine films and threads and a few soft masses of calcium carbonate; Bk horizon.

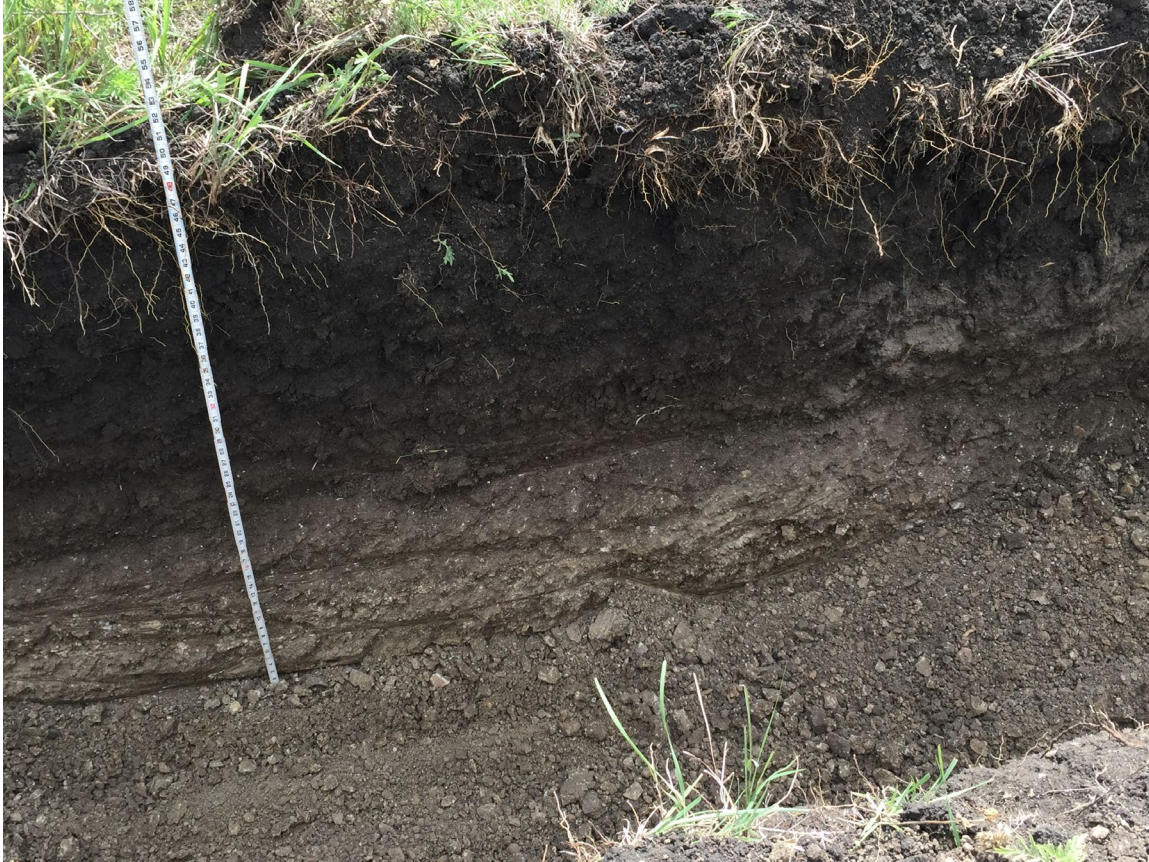
## BHT 7

Zone	Depth (cmbs)	Description – East Wall
I	0-40	10YR2/1 very dark gray clay loam; wavy boundary; moderate fine structure; hard, firm; moderately sticky, moderately plastic; many fine, medium, few coarse roots; A1 horizon.
II	40-70	10YR 4/2 dark grayish brown clay loam; moderate medium and coarse subangular blocky structure parting to moderate fine subangular blocky; hard, firm; moderately sticky, moderately plastic; many fine, medium, and few coarse roots; moderately alkaline; clear smooth boundary; A2 horizon.
III	70-120	10YR 6/2 light brownish gray clay; boundary unknown; coarse prismatic structure; hard, firm; moderately sticky, moderately plastic; few fine, medium, and coarse roots; many fine films and threads and a few soft masses of calcium carbonate; Bk horizon.

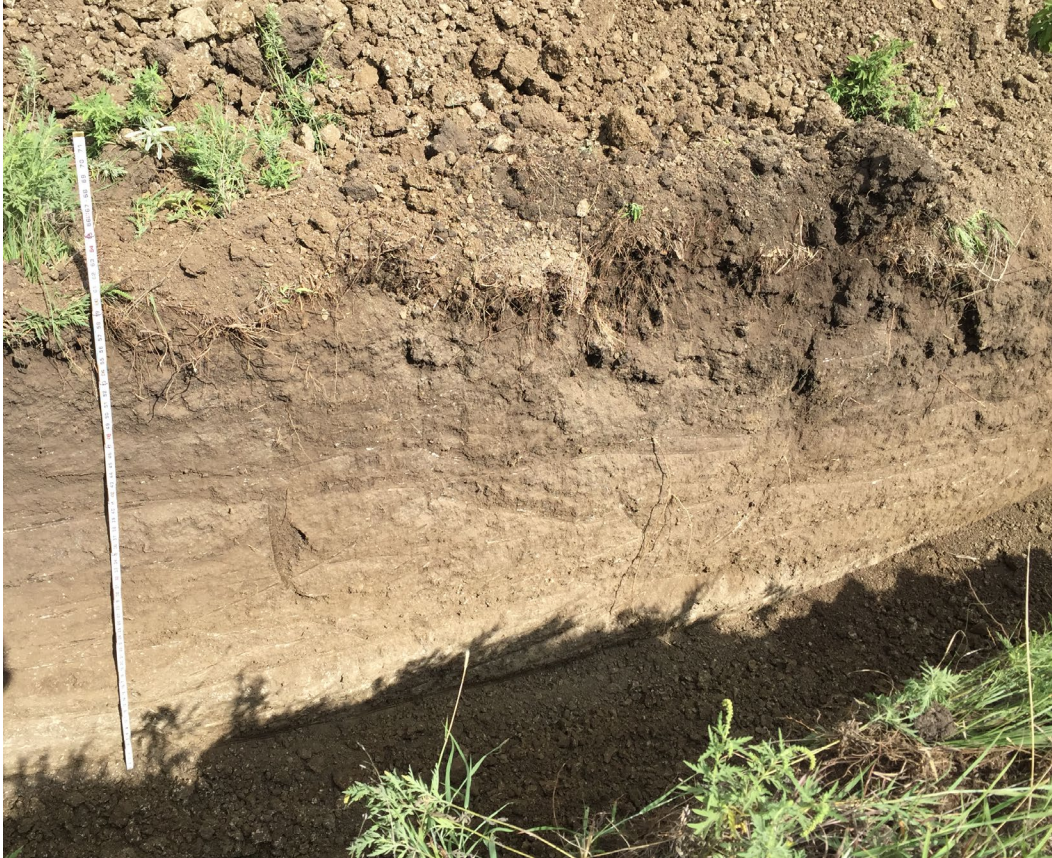
**BHT 8**

Zone	Depth (cmbs)	Description – West Wall
I	0-80	10YR2/1 very dark gray clay loam; wavy boundary; moderate fine structure; hard, firm; moderately sticky, moderately plastic; many fine, medium, few coarse roots; A1 horizon.
II	80-150	10YR 6/2 light brownish gray clay; boundary unknown; moderate medium and coarse prismatic structure; hard, firm; moderately sticky, moderately plastic; few fine, medium, and coarse roots; many fine films and threads and a few soft masses of calcium carbonate; Bk horizon.

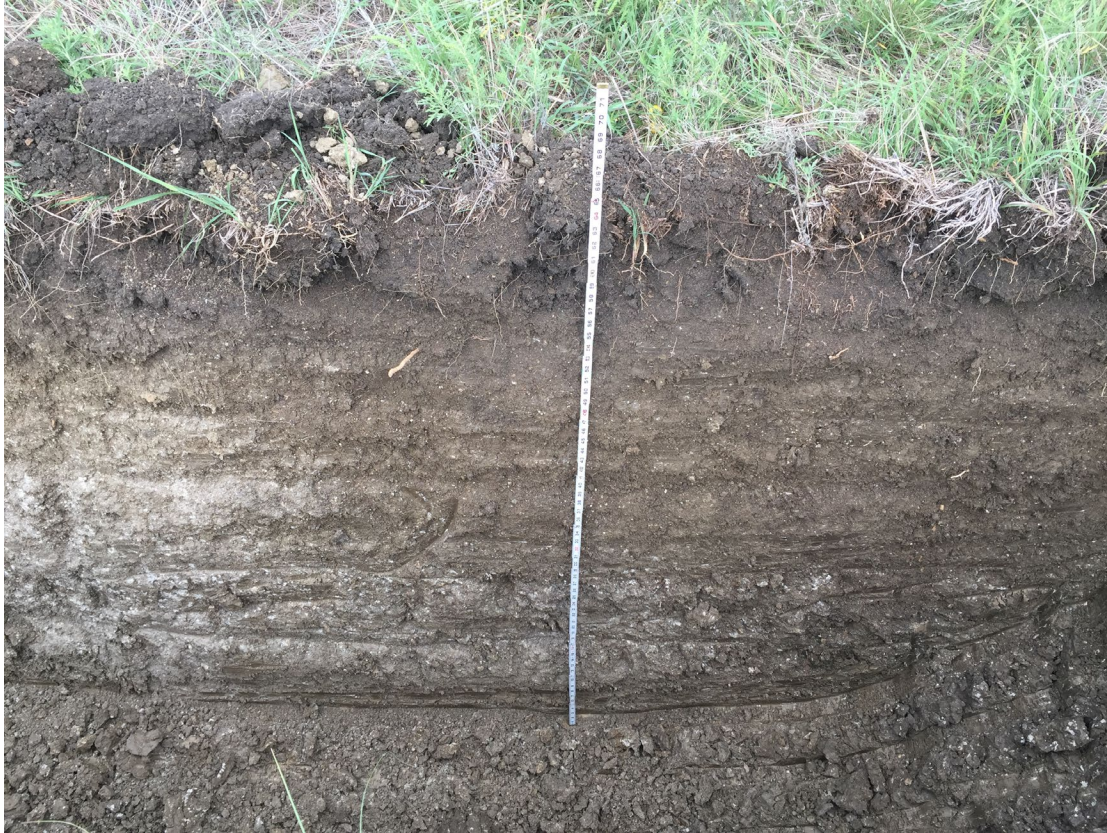
**BHT 9**

Zone	Depth (cmbs)	Description – Northwest Wall
I	0-40	10YR3/1 very dark gray clay loam; wavy boundary; moderate fine structure; hard, firm; moderately sticky, moderately plastic; many fine, medium, few coarse roots; A1 horizon.
II	40-70	10YR 4/2 dark grayish brown clay loam; moderate medium and coarse subangular blocky structure parting to moderate fine subangular blocky; hard, firm; moderately sticky, moderately plastic; many fine, medium, and few coarse roots; moderately alkaline; clear smooth boundary; A2 horizon.
III	70-120	10YR 6/2 light brownish gray clay; 10YR3/3 common distinct mottles; boundary unknown; coarse prismatic structure; hard, firm; moderately sticky, moderately plastic; few fine, medium, and coarse roots; many fine films and threads and a few soft masses of calcium carbonate; Bk2 horizon.

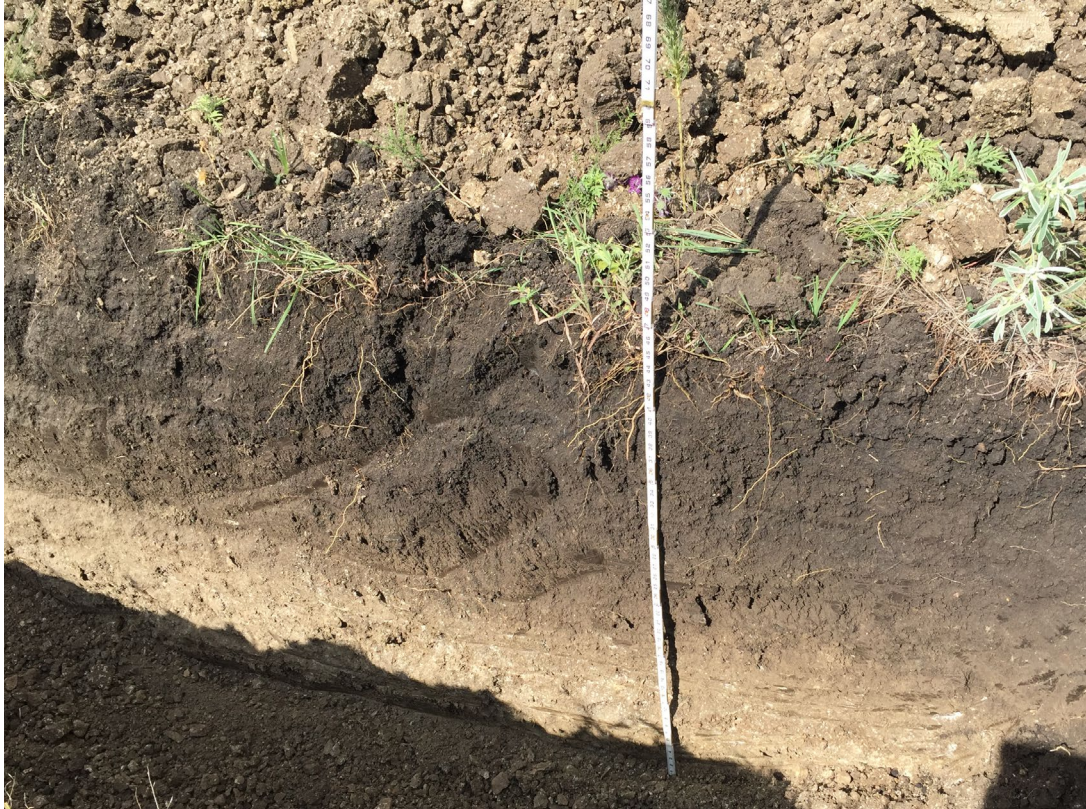
**BHT 10**

Zone	Depth (cmbs)	Description
I	0-80	10YR3/1 very dark gray clay loam; clear, smooth boundary; moderate fine structure; hard, firm; moderately sticky, moderately plastic; many fine, medium, few coarse roots; A horizon.
II	80-120	10YR 6/2 light brownish gray clay; boundary unknown; moderate medium and coarse prismatic structure; hard, firm; moderately sticky, moderately plastic; few fine, medium, and coarse roots; many fine films and threads and a few soft masses of calcium carbonate; Bk horizon.
