Document No. 140027

**ARCHEOLOGICAL INVESTIGATIONS OF THE
PROPOSED LEON CREEK EMERGENCY
BANK STABILIZATION PROJECT
SAN ANTONIO, BEXAR COUNTY, TEXAS**

TEXAS ANTIQUITIES PERMIT No. 6518

June 2014

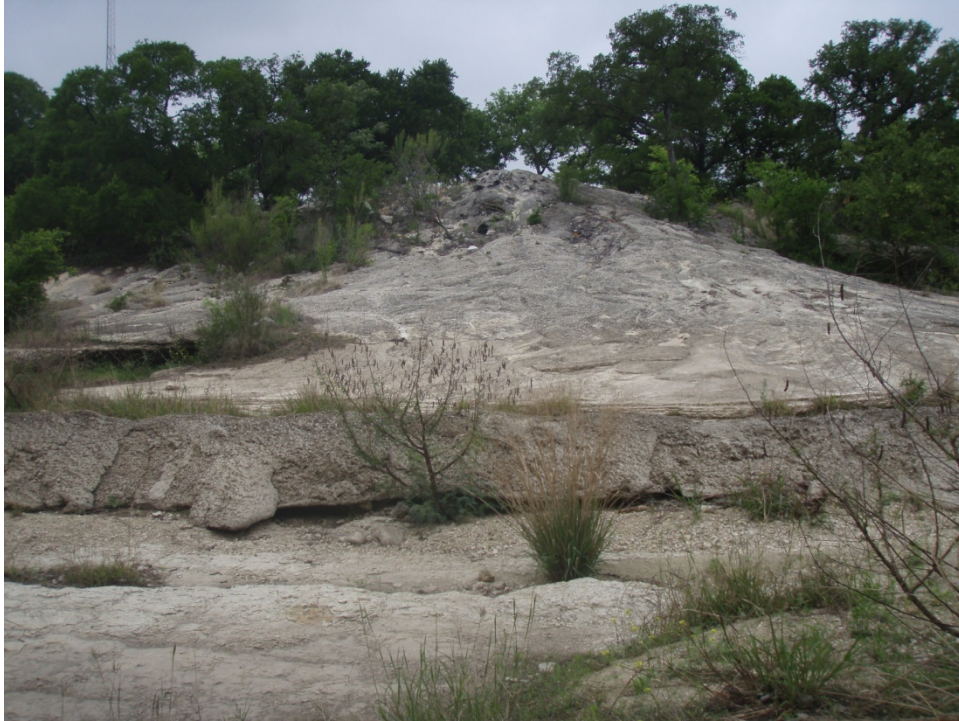
Figure 2: Concrete that has been dumped along the north bank of Leon Creek, facing northwest

Atkins' archeological survey of the project area found the Leon Creek channel to have been significantly impacted by the dumping of concrete (see Figure 2) down the face of the north channel wall. As a result of the dumping, the natural course of the waterway has shifted to the south, and the flow of water has begun to undercut the south wall of the Leon Creek channel. This severe erosional activity has led to large areas where underlying limestone cobbles and gravels (Figure 4) have eroded out from the south bank. A pedestrian inspection of the project area including the large piles of loose sediment along the base of the south channel wall identified no surface remains of prehistoric or historic affiliation.

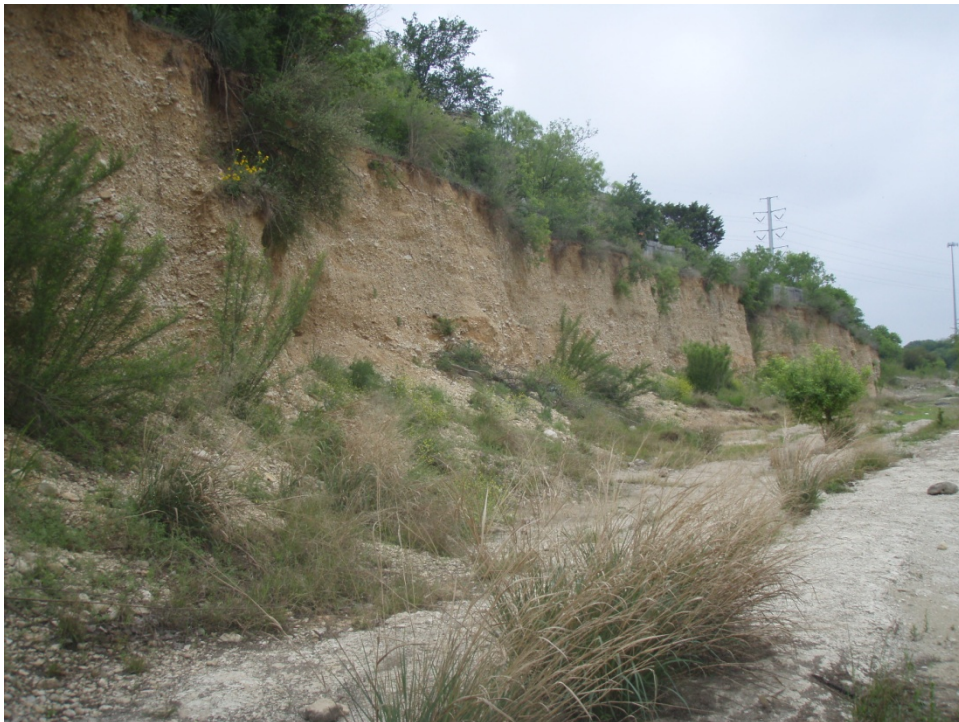
Figure 3: Overview of project area showing the severe erosion along the south bank of Leon Creek, facing southwest

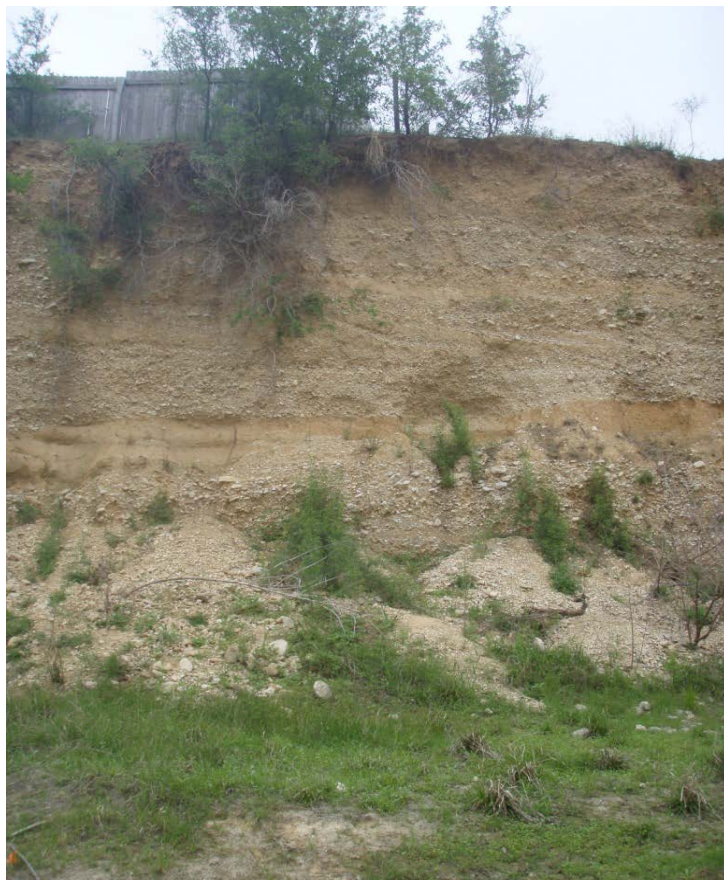
Figure 4: Large piles of loose cobbles and gravels that have eroded out from the south bank wall of Leon Creek, facing southeast
