## **Cultural Resources Survey of Two Atascosa County Bridges, Atascosa County, Texas**

SWCA Cultural Resource Report No. 07-67

January 2015

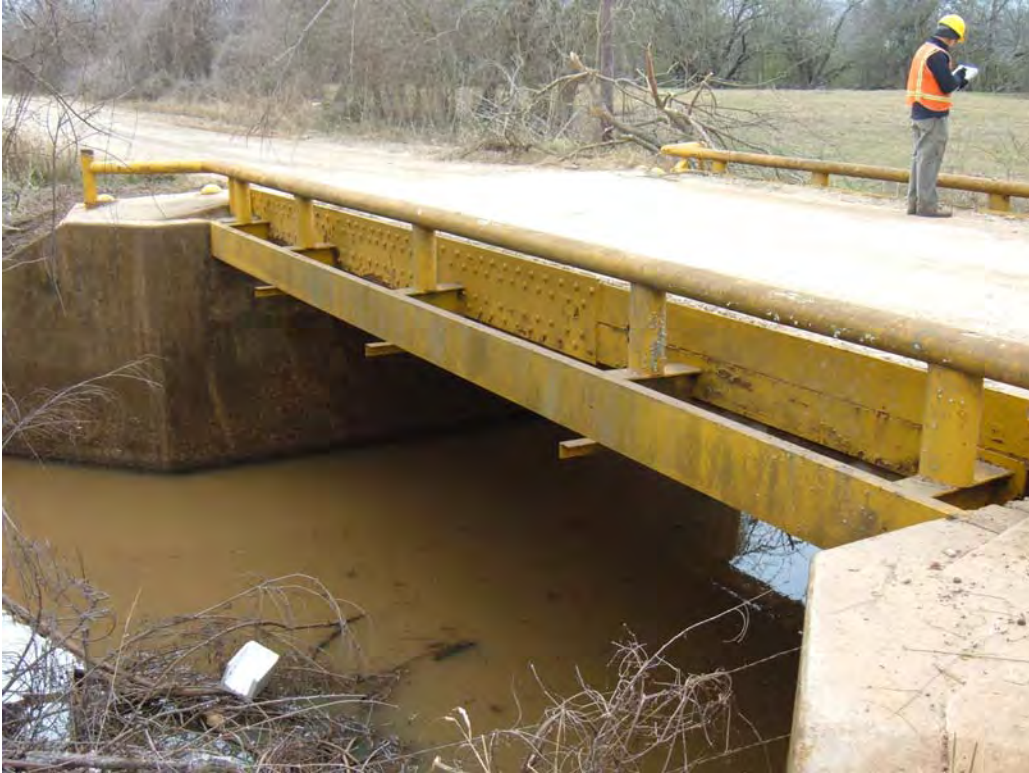
The existing bridge consists of a single span steel stringer bridge that is 50-feet long and 16.5-feet wide and supported by concrete abutments at the drainage banks (Figure 4). The Byrd Road roadway runs north to south and consists of a 20-foot wide gravel road with no shoulders. The Lucas Creek drainage, at this crossing, trends northwest to southeast and is roughly 22-feet wide and exhibits 4-foot high cutbanks. At the time of evaluation, the drainage contained over a foot of water and had a low-energy flow.

Figure 4. Overview of Byrd Road at Lucas Creek bridge; facing southwest.

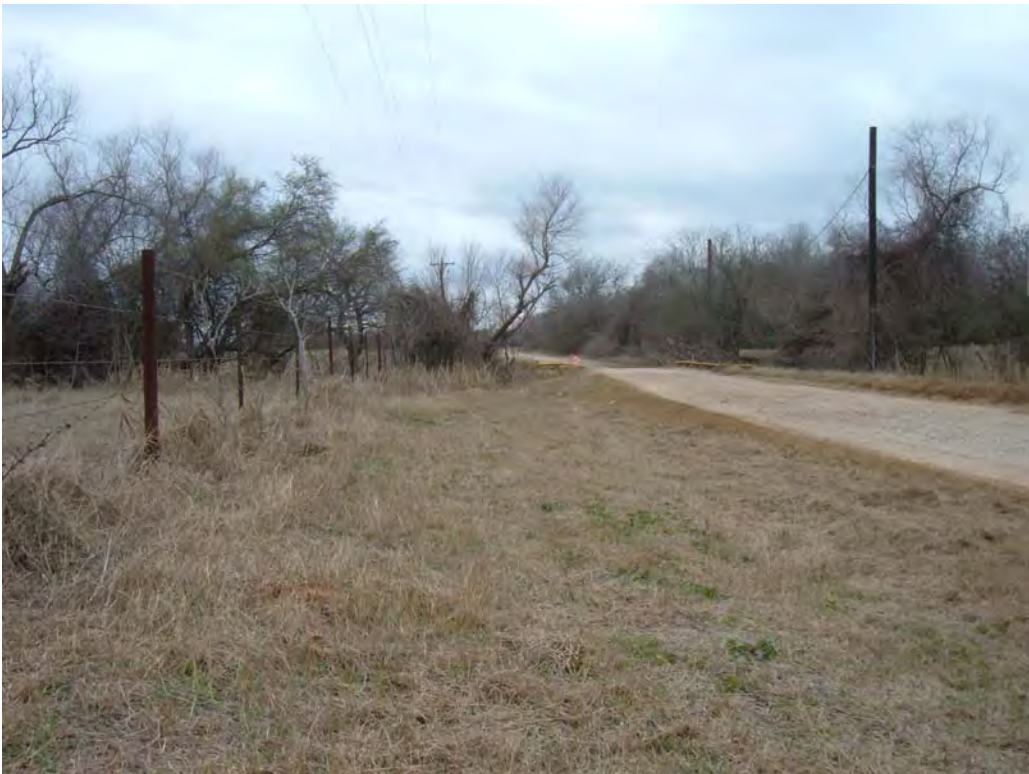
The project area has been significantly impacted by road construction, utilities, and fence lines. Specifically, both approaches along Byrd Road have been cut roughly 2–4 feet below grade (Figure 5). The road cut extends from the drainage to beyond 350 feet from each end of the bridge. Also, at the drainage banks, Byrd Road is underlain with a 2-foot thick fill section that extends 15 feet from the road centerline, which tapers to grade about 60 feet from the end of the bridge.

Figure 5. Overview of typical cut below grade along Byrd Road; facing south.

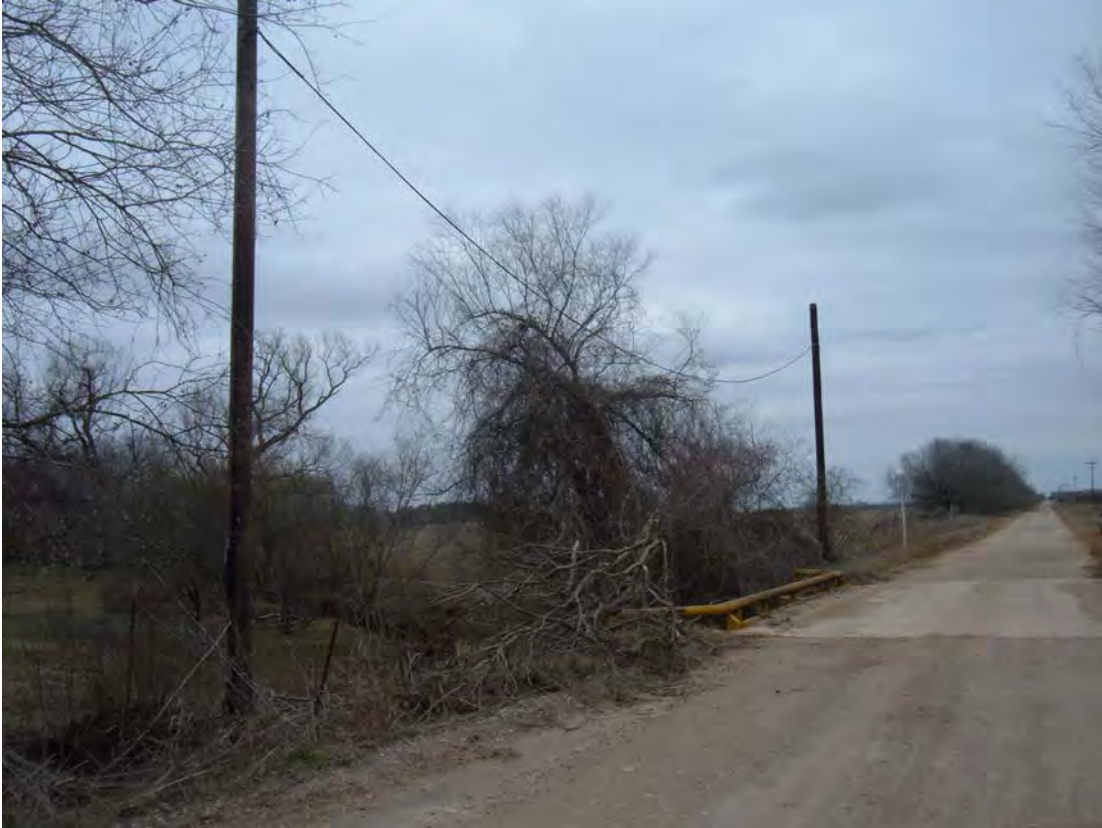
Furthermore, the project area has been disturbed by a buried telephone cable that runs along the western side of Byrd Road up both approaches. The buried cable parallels the road between 18–24 feet from centerline down the approaches until about 50 feet from the end of the bridge where it becomes an overhead utility that crosses the drainage (Figure 6). Similarly, an overhead power line parallels the eastern side of Byrd Road along both

Figure 6. Overview of buried and overhead utility along Byrd Road; facing northwest.

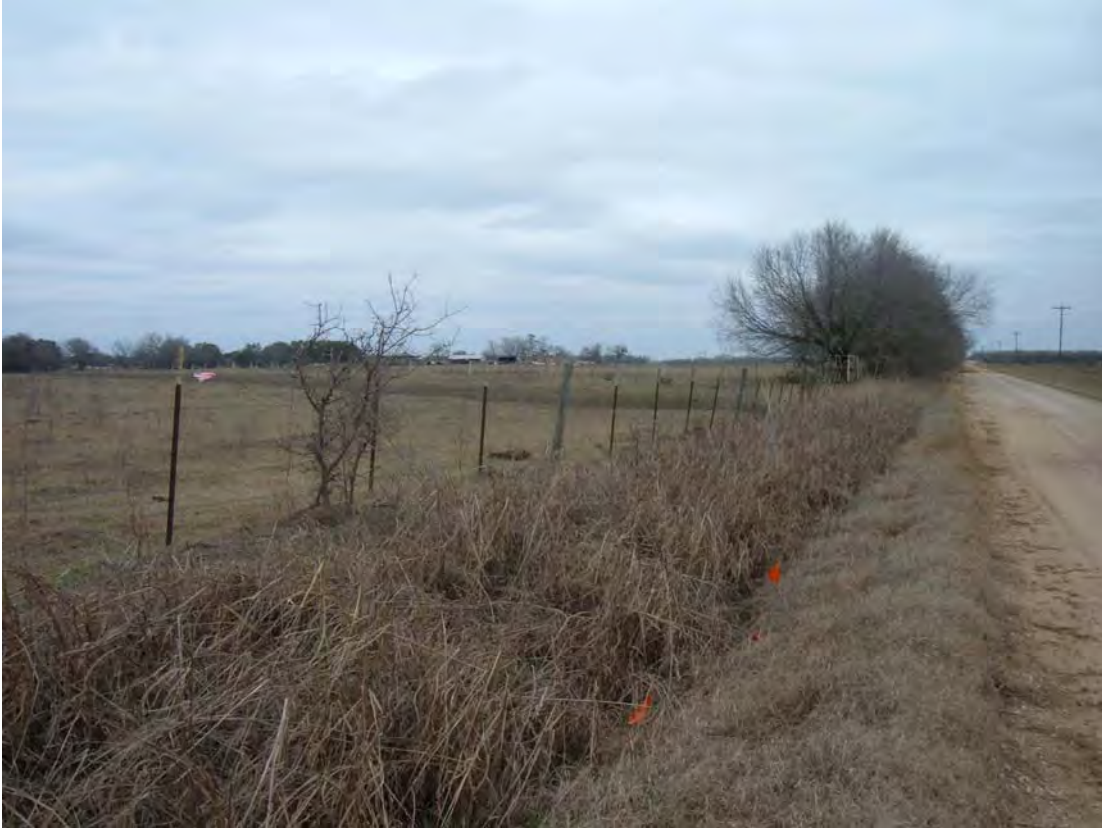
approaches about 30 feet from centerline. Finally, barbed wire fence lines align both sides of the road generally 24 feet from the road centerline (Figure 7).

Figure 7. Overview of fence line and buried utility along Byrd Road; facing north.

Due to the extensive disturbances and fill sections observed within the narrow ROW, no subsurface investigations were conducted at this project area. However, the entire project area was examined and all available cut bank exposures were inspected. No cultural materials were observed on the surface or in the cut banks of Lucas Creek.

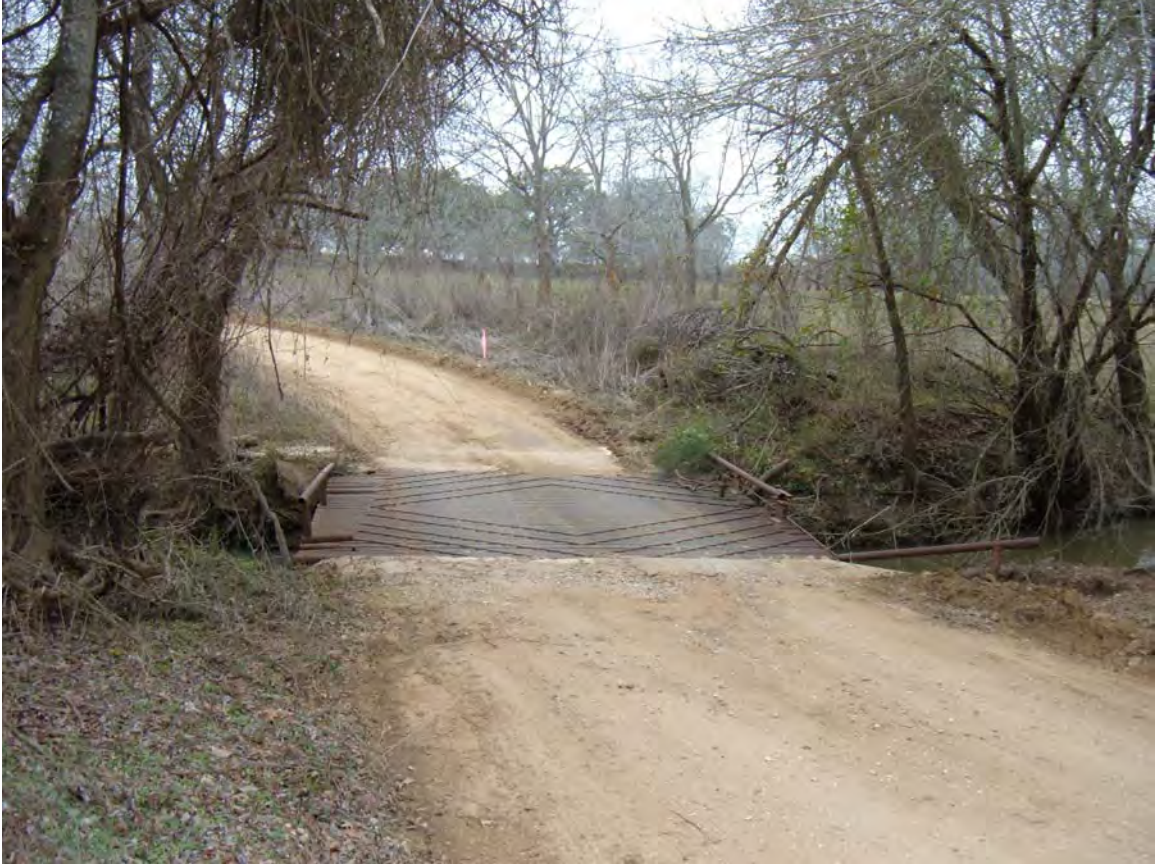
The existing bridge consists of a single span welded steel pipe deck with steel I-beam cross pieces. The bridge is 50-feet long and roughly 14.5-feet wide and supported by concrete abutments at the drainage banks (Figure 8). The Jim Brite Road roadway generally runs west to east and consists of a 12-foot wide gravel road with no shoulders. The Atascosa River, at this crossing, trends northeast to southwest and is roughly 12-feet wide and exhibits 5-foot high cutbanks. At the time of evaluation, the drainage contained over 2 feet of water and had a medium-energy flow.

Figure 8. Overview of Jim Brite Road at the Atascosa River crossing; facing northwest.

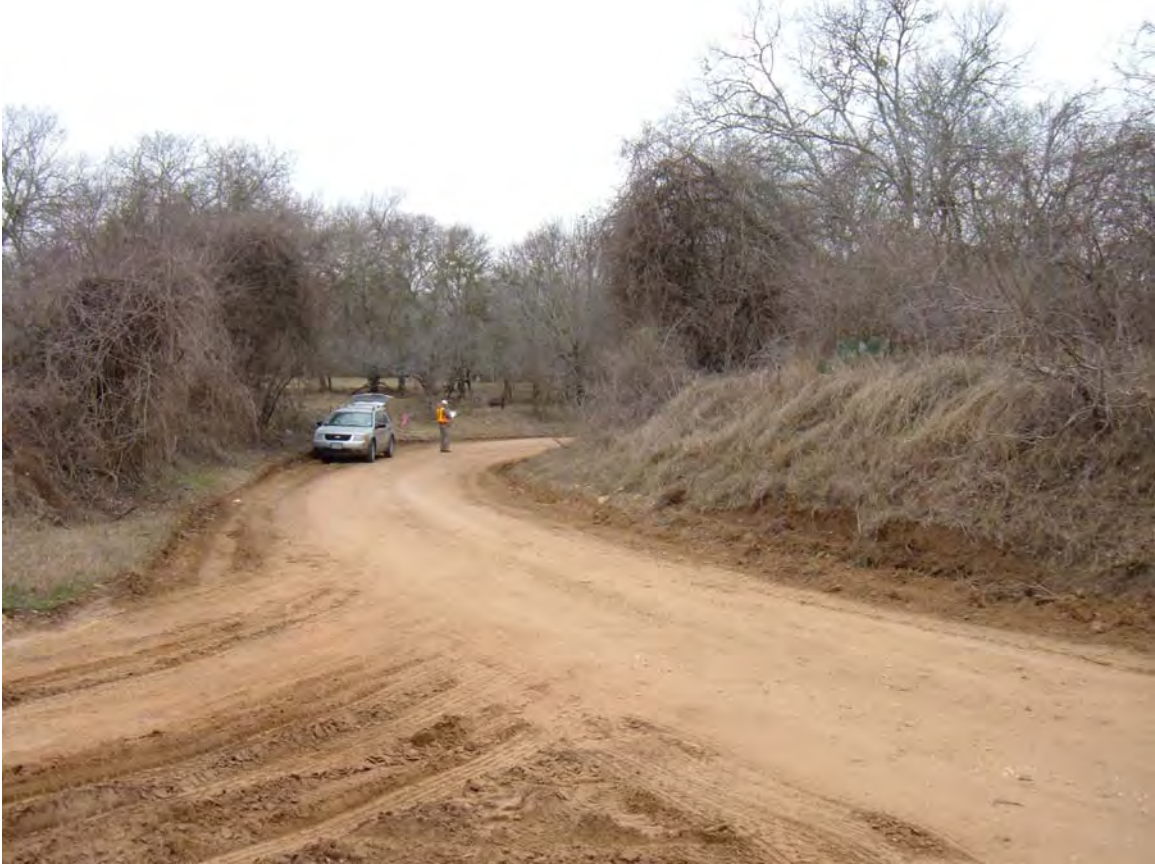
The project area has been significantly impacted by road construction, utilities, and fence lines. Specifically, both approaches along Jim Brite Road have been cut below grade from the drainage to beyond 350 feet from the end of the bridge. The cut below grade on the western approach ranges from 2–4 feet below grade. The road cut along the eastern approach, which crosses the first and second terraces, ranges from 2–6 feet below grade (Figures 9 and 10). Also, several roadside field entrances along Jim Brite Road have impacted the ROW. Two roadside entrances intersect the Jim Brite ROW about 300 feet from the end of the bridge on the western approach while one roadside entrance is along the eastern approach roughly 200 feet from the end of the bridge.

Figure 9. Overview of road cut below grade along eastern approach of project area; facing south.

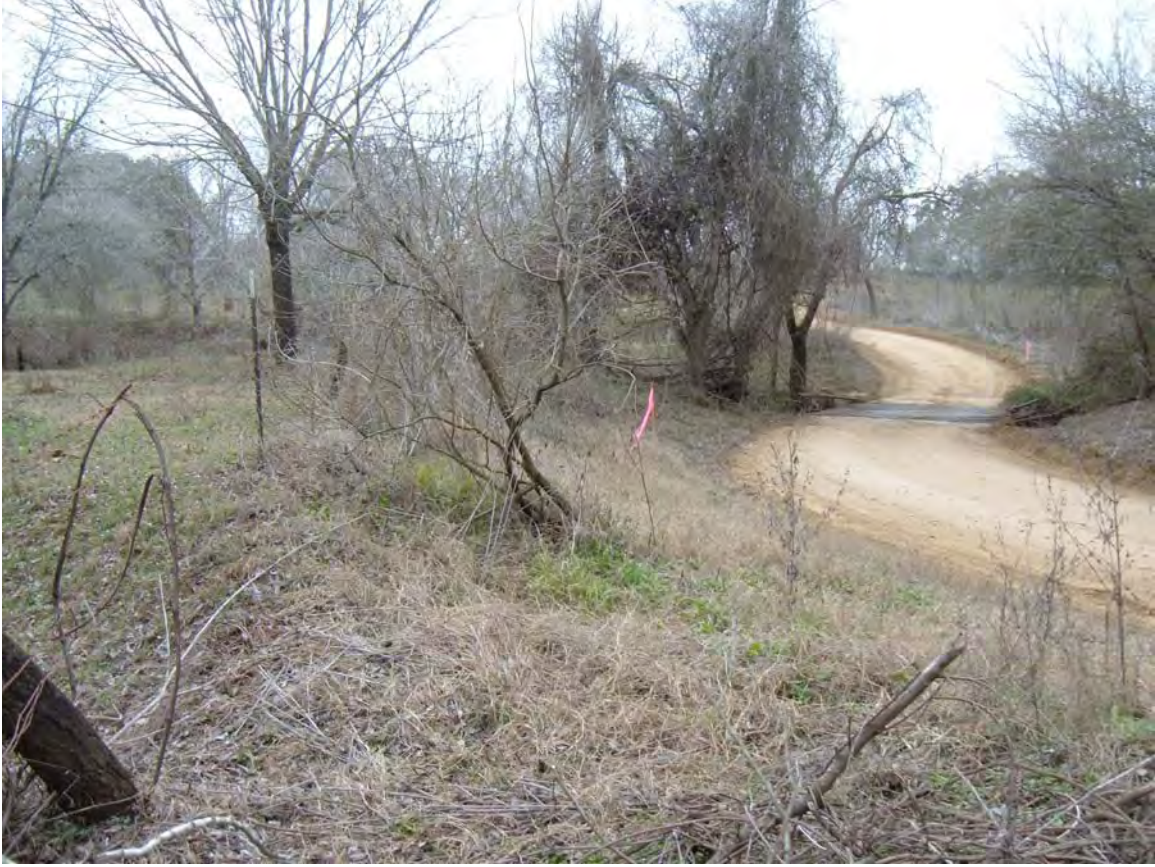
Figure 10. Overview of road cut below grade along eastern approach; facing west.

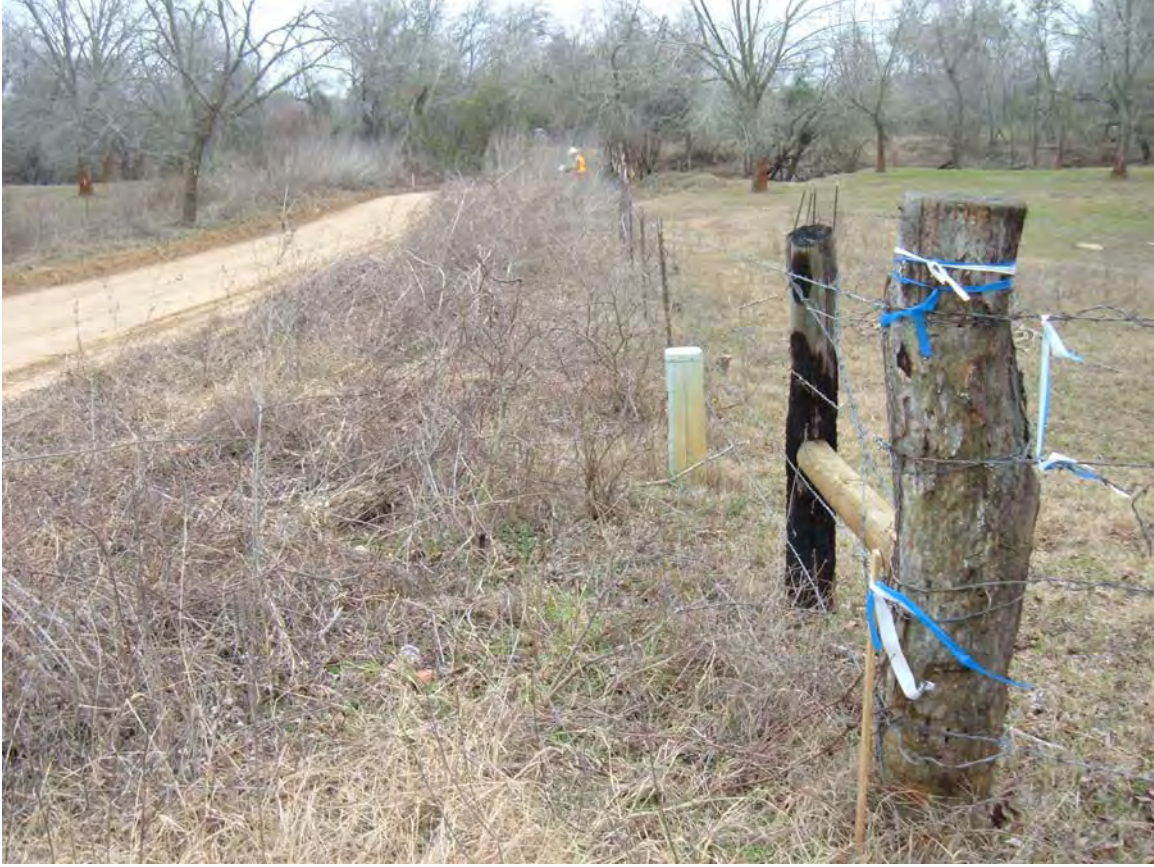
along the southern (down stream) side of Jim Brite Road up both approaches. The buried cable parallels the road between 18–30 feet from centerline down the approaches (Figure 11). Finally, barbed wire fence lines align both sides of the road, generally 21–25 feet from the road centerline (Figure 12).

Figure 11. Overview of buried utility along fence line along western approach; facing east.

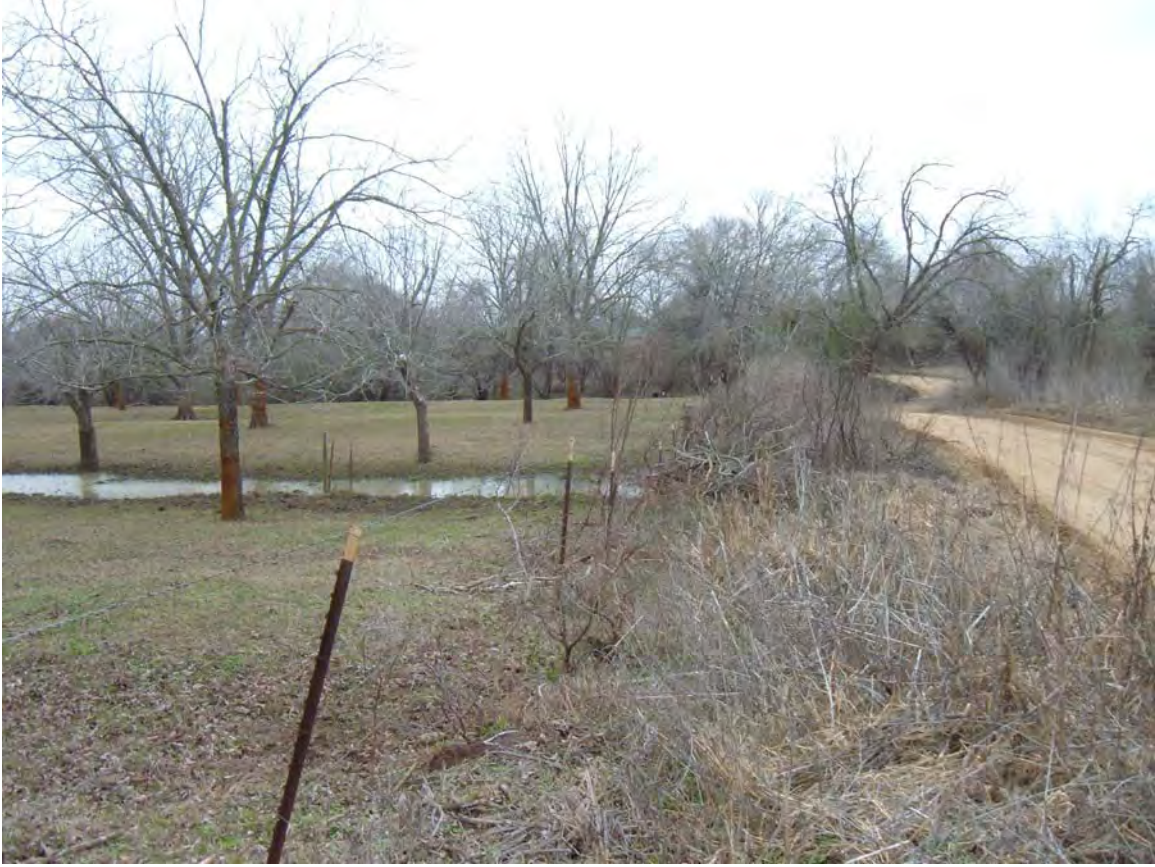
Figure 12. Overview of fence lines and orchard along western approach; facing east.

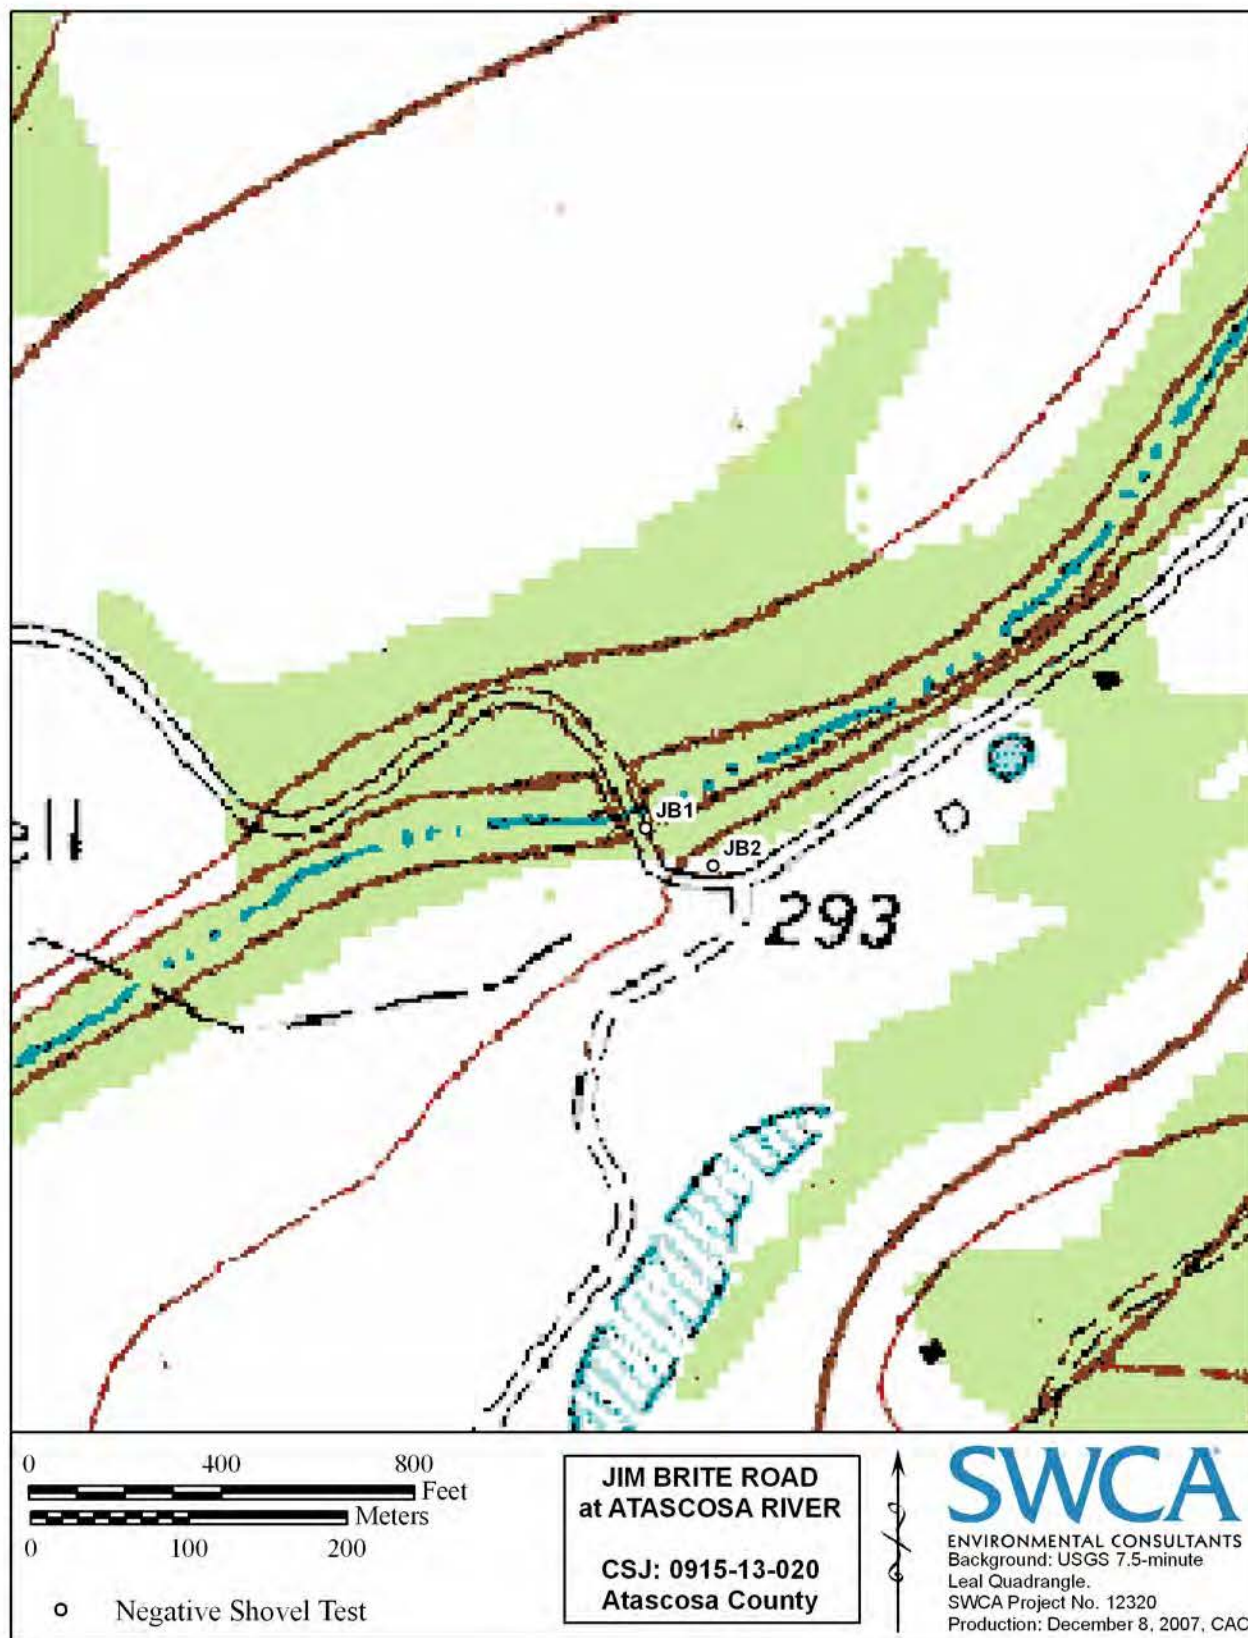
Originally, this crossing was scheduled for subsurface investigations with backhoe trench excavations. However, upon evaluation of the project area it was determined that the ROW is too narrow and disturbed for backhoe trench excavation. A reasonably intact area was observed along the eastern approach that was investigated with two shovel test investigations (ST JB-1 and JB-2). The shovel tests were placed along the edge of the ROW within the narrow (5 feet) strip between the fence line and the cut below grade (Figure 13). One shovel test (JB-1) was placed on the first terrace of the Atascosa River while the second shovel test (JB-2) was placed on the second terrace of the drainage. Shovel test JB-1 was excavated to a depth of 80 cm below surface (bs) before terminating at impassible tree roots. Shovel test JB-1 encountered a 20-cm thick horizon of very dark grayish brown (10YR3/2) silty loam overlying a yellowish brown (10YR5/4) clay loam that graded into fine sand, which extends below 80 cmbs (Table 1). Shovel test JB-2 located on the second terrace encountered deep very dark grayish brown to brown (10YR3/2–4/3) sands that extended below 120 cmbs (Table 1). Of note, some of the examined road cuts in this area exhibited a brown (10YR4/3) clay horizon below the very dark grayish brown to brown sand horizon, which began about 135 cmbs and extends below 140 cmbs. No cultural materials were observed during the shovel test excavations or during the road cut profile examinations (Figure 14).

Figure 13. Shovel test locations at Jim Brite Road bridge.

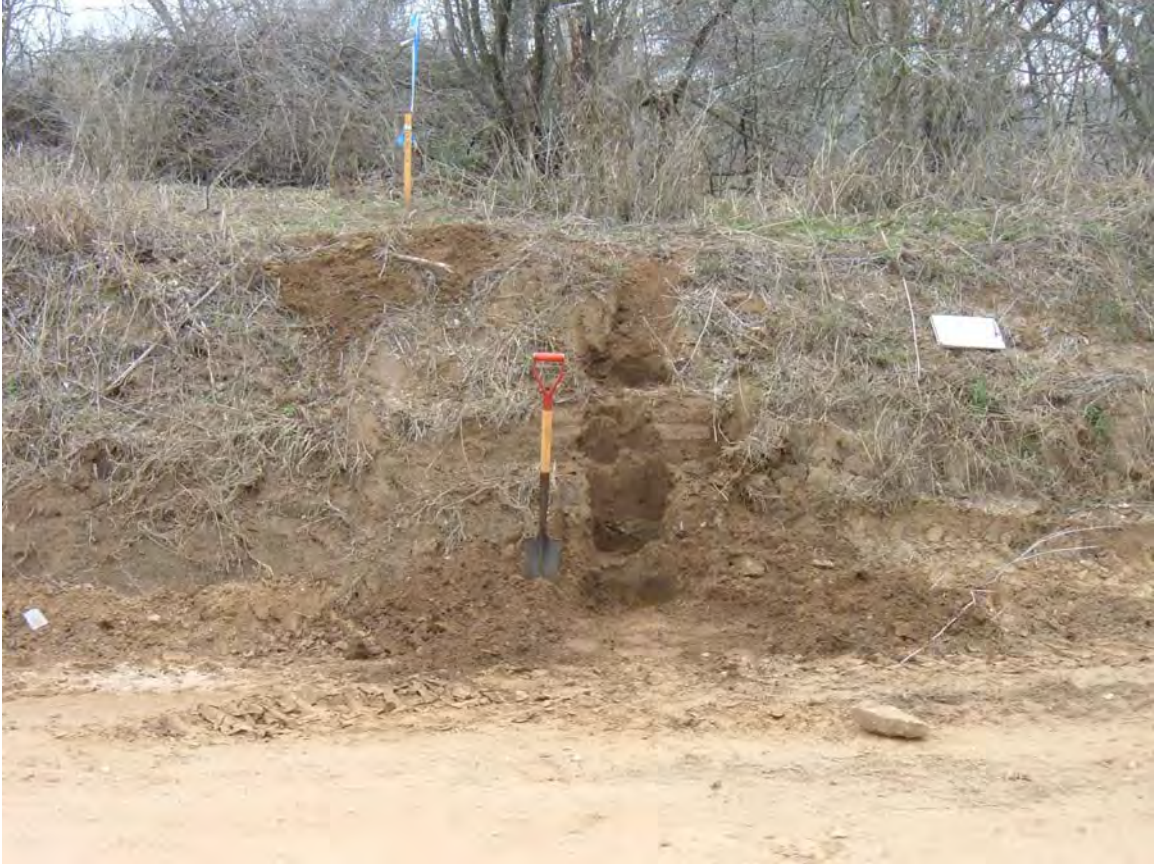
Figure 14. Overview of road cut profile along eastern approach near shovel test JB-2; facing northwest.
