Archeological Survey for the Trinity Skyline Trail Phase II Project, City of Dallas, Dallas County, Texas

ARCHEOLOGICAL SURVEY REPORT

Prepared for:
Texas Historical Commission
Texas Antiquities Permit #8865

September 2019

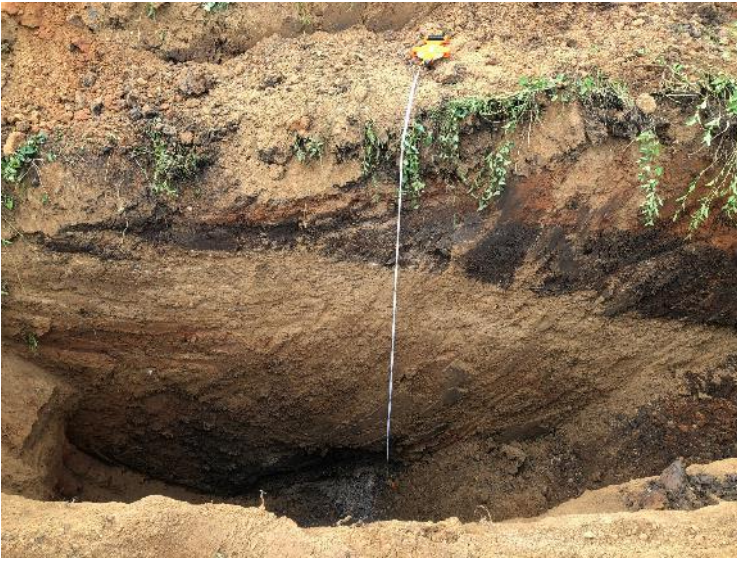
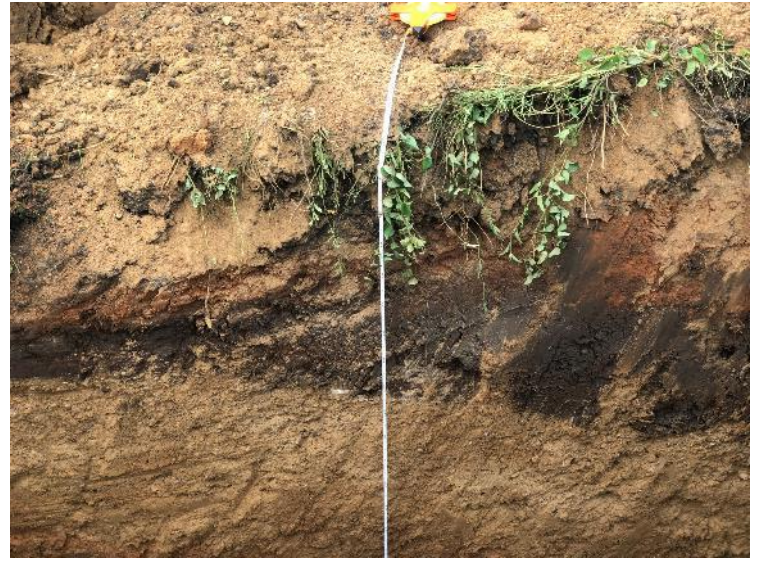
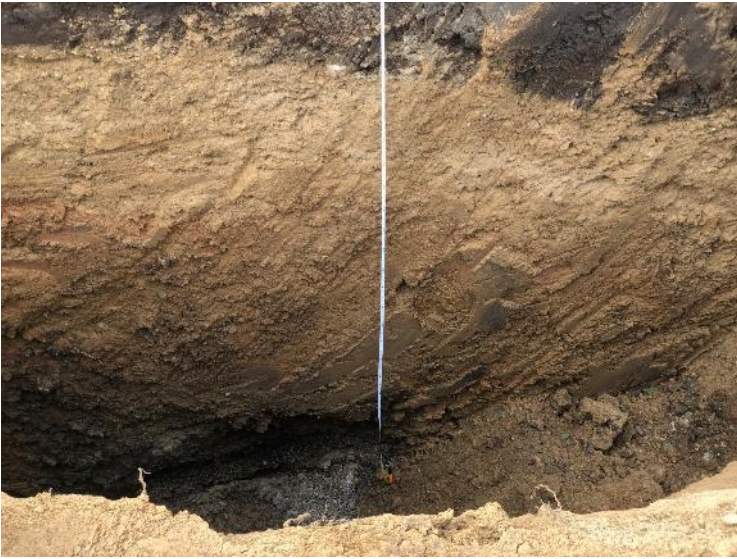
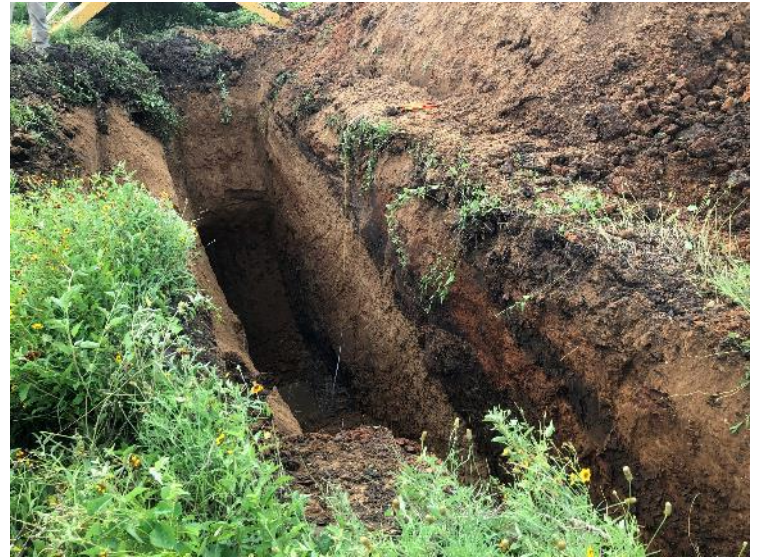
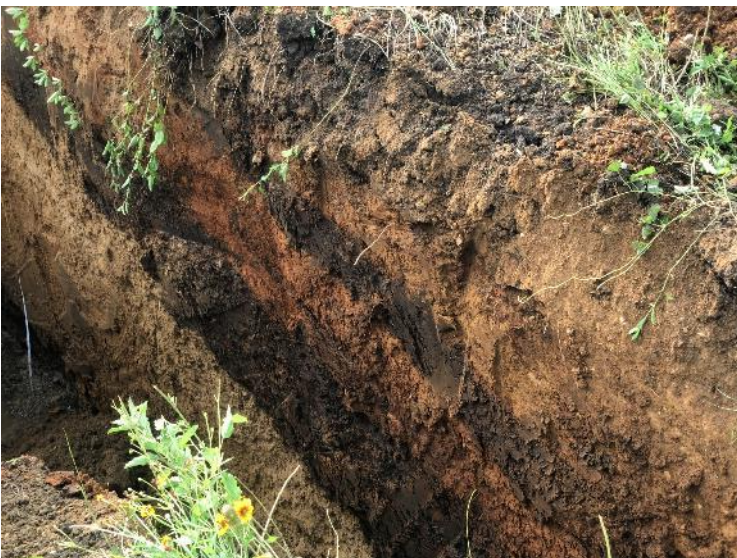
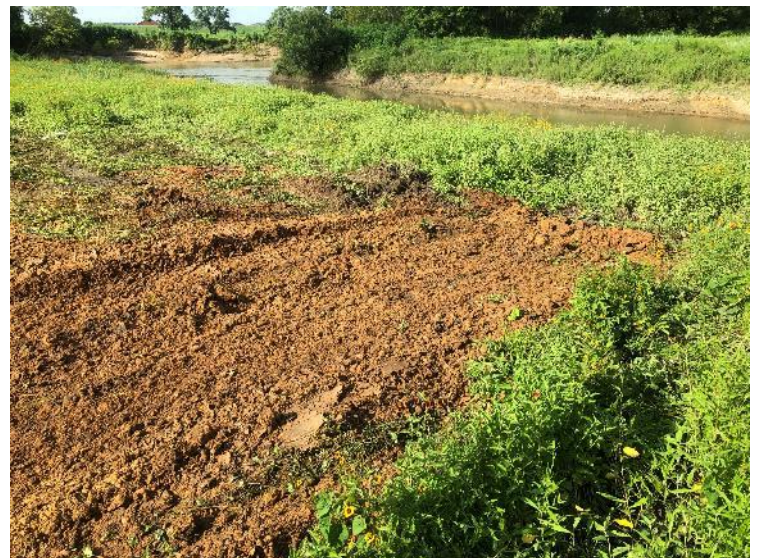
Trench 1 was excavated approximately 13 m east of a channelized drainage feeding into the Trinity River (**Appendix A, Photographs 1 through 6**). The soil profile exposed within Trench 1 consisted of a thin layer of very dark grayish brown (10YR 3/2) clay loam overlying a series of sediments to depths exceeding 120 cm below surface (cmbs) deposited during construction of the channel. At a depth of 120 cmbs, pale brown (10YR 6/3) loamy sand with a loose granular structure was encountered. This stratum gradually transitioned to a dark grayish brown (10YR 4/2) loamy sand with frequent gravel inclusions at depths exceeding 350 cmbs. The final stratum likely represents pre-Holocene alluvial deposits and is unlikely to contain or overlie prehistoric cultural deposits. The water table was encountered at 350 cmbs.

Photograph 1 – Trench 1, view to the south.

Photograph 2 - Trench 1, view to the south.

Photograph 3 - Trench 1, view to the south.

Photograph 4 - Trench 1, view to the east.

Photograph 5 - Trench 1, view to the southeast.

Photograph 6 - Trench 1, view to the south.

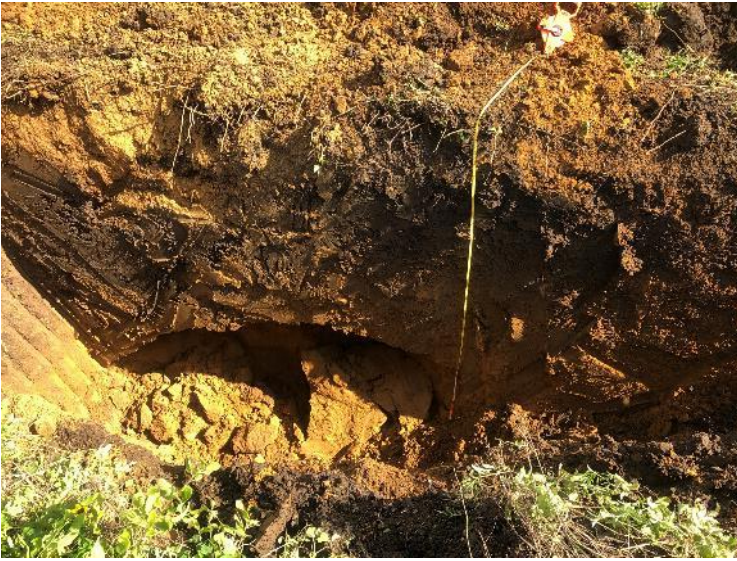
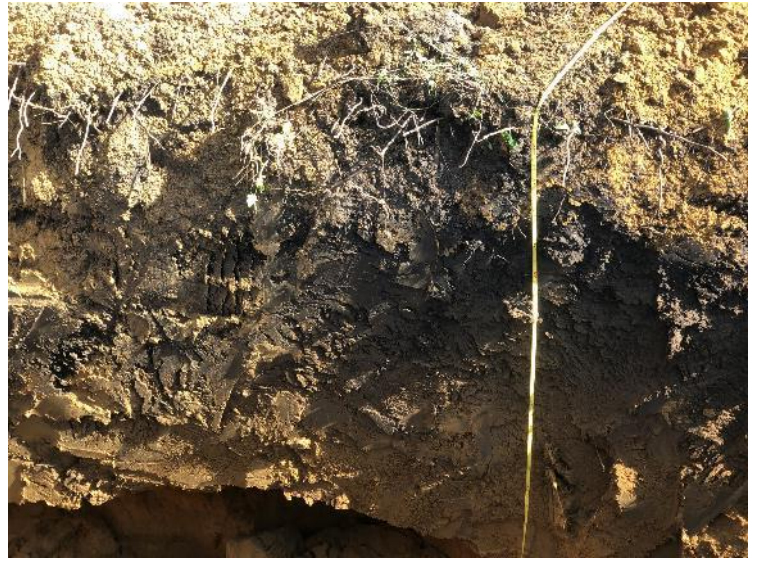
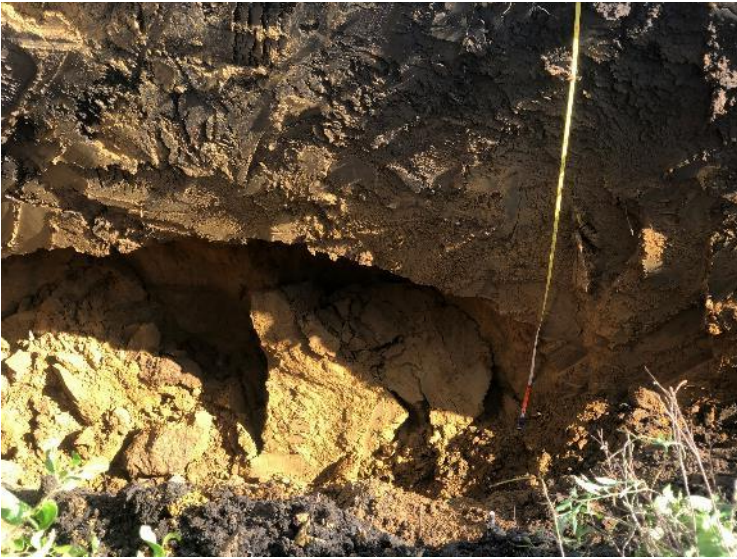
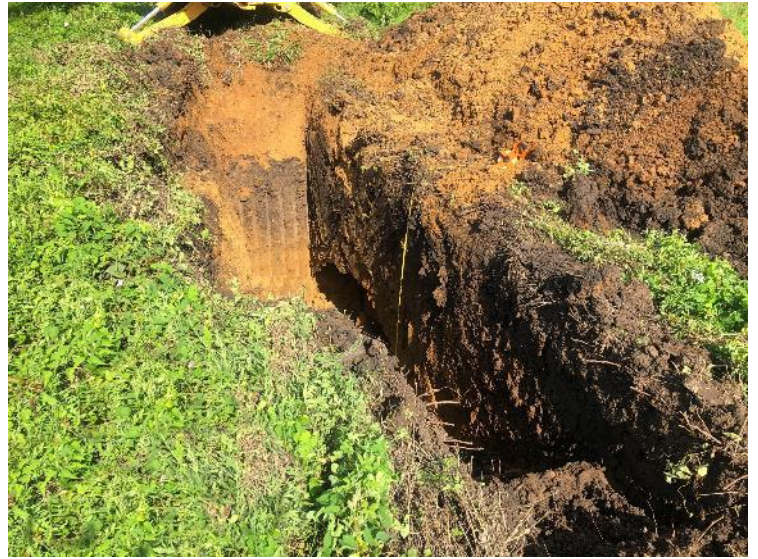
Trench 2 was excavated approximately 8 m west of a channelized drainage feeding into the Trinity River (**Appendix A, Photographs 7 through 10**). The soil profile exposed within Trench 2 were dissimilar to those of Trench 1 (approximately 32 m east). Trench 2 consisted of a thin layer of dark gray (10YR 4/1) loam that transitioned to a very dark gray (10YR 3/1) clay loam at a depth of 50 cmbs. Beneath that layer, the soil profile consisted of loamy sands that transitioned from dark yellowish brown (10YR 4/4) to yellowish brown (10YR 5/6). At depths exceeding 310 cmbs, gravel inclusions significantly increased. The water table was encountered at 360 cmbs.

Photograph 7 - Trench 2, view to the north.

Photograph 8 - Trench 2, view to the northwest.

Photograph 9 - Trench 2, view to the north.

Photograph 10 - Trench 2, view to the west.

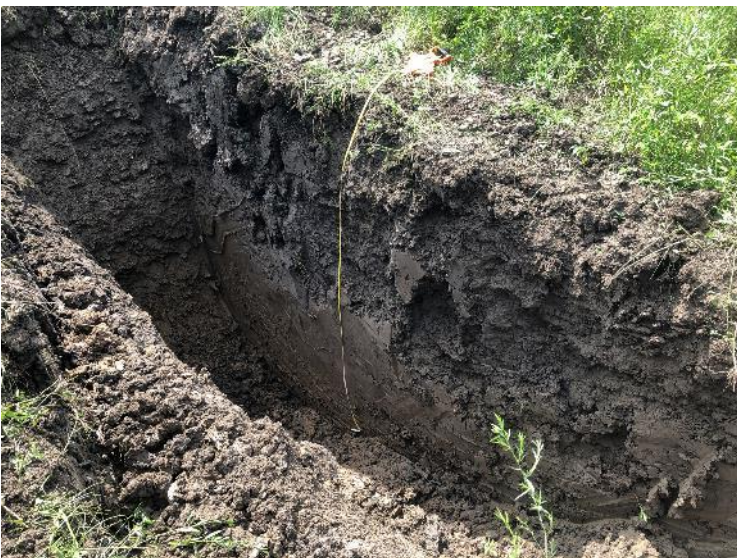
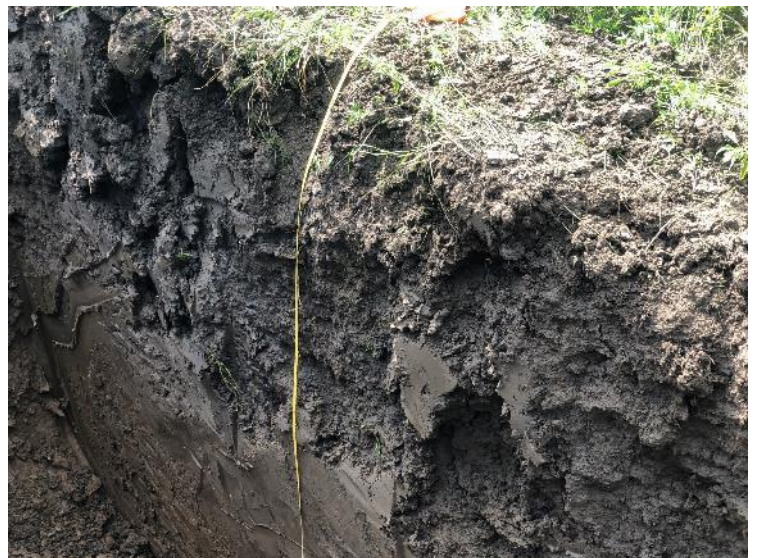
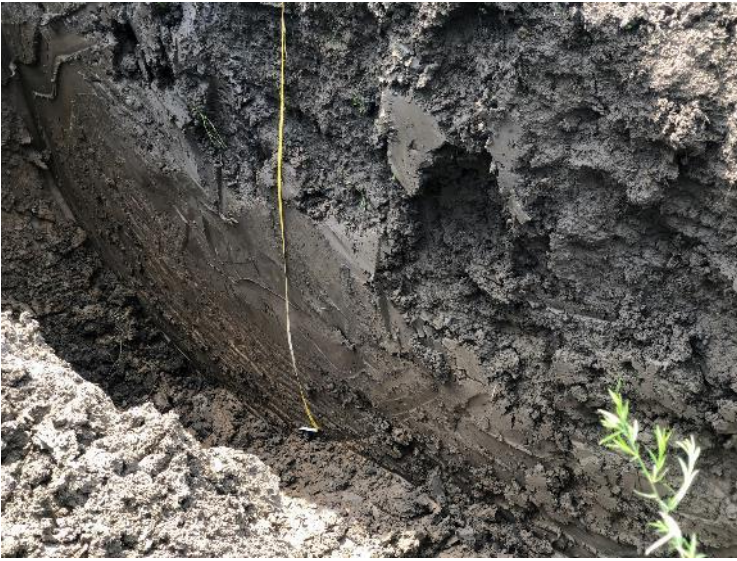
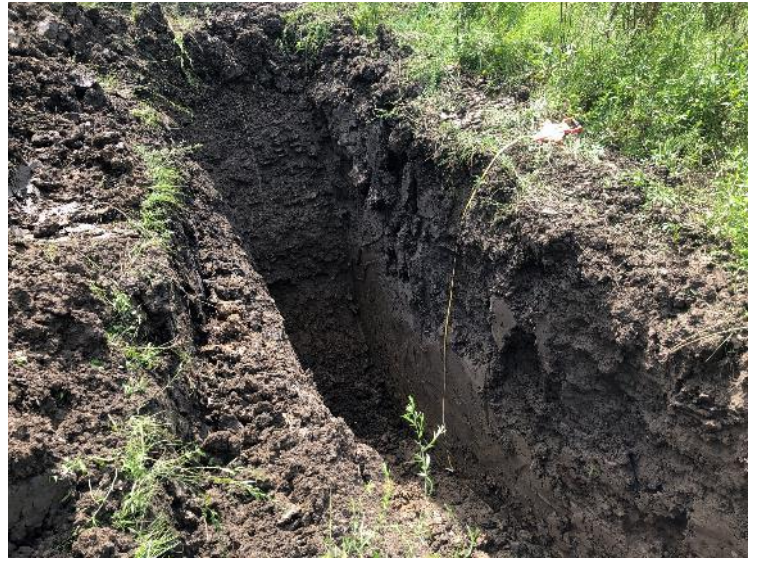
Trench 3 was excavated approximately 20 m east of the Elm Fork Trinity River channel (**Appendix A, Photographs 11 through 14**). The soil profile exposed within Trench 3 consisted of a thick layer of dark gray (10YR 4/1) loam with a medium subangular blocky structure. The soil profile gradually transitioned to a very dark brown (10YR 2/2) subangular blocky clay loam to a depth of 225 cmbs. The clay content significantly increased below this stratum, which consisted of dark brown (10YR 3/3) clay with frequent gravel inclusions. The water table was encountered at 310 cmbs in Trench 3.

Photograph 11 - Trench 3, view to the southeast.

Photograph 12 - Trench 3, view to the southeast.

Photograph 13 - Trench 3, view to the southeast.

Photograph 14 - Trench 3, view to the east.

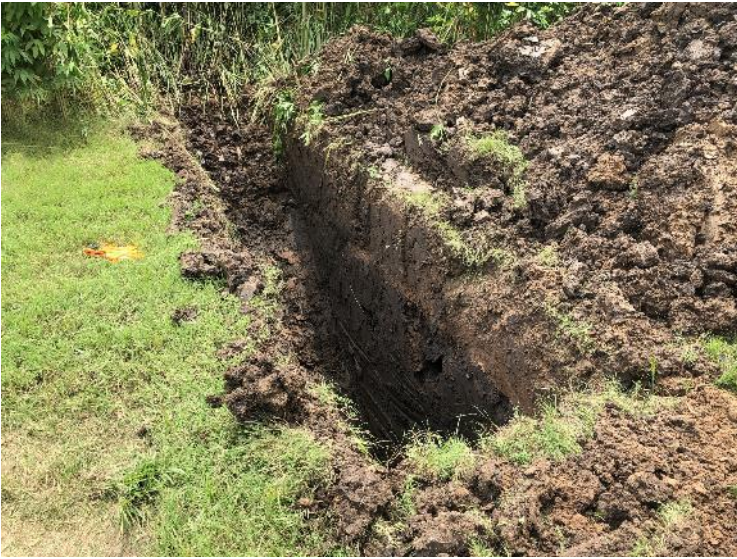
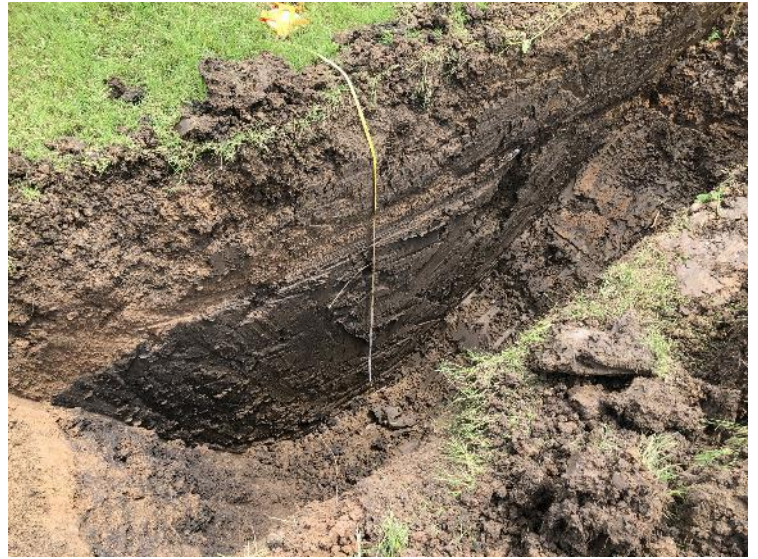
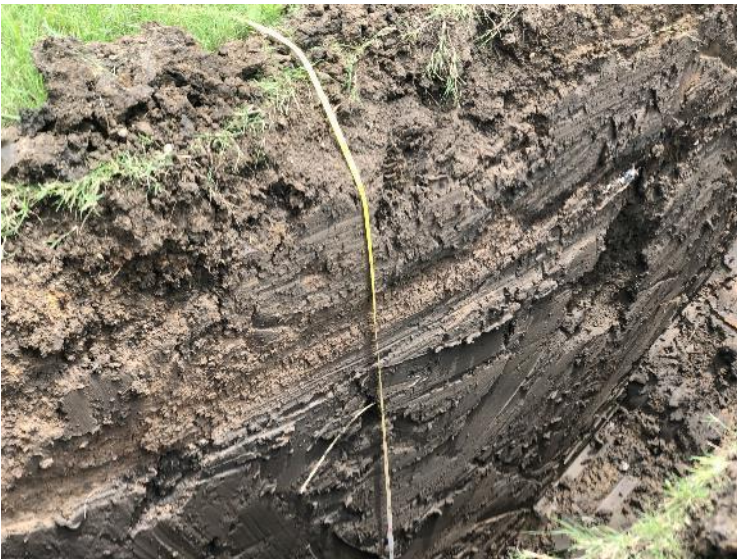
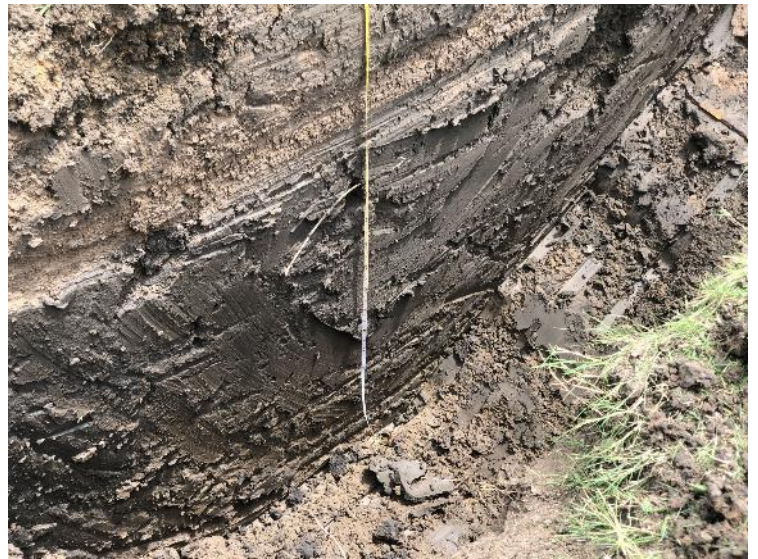
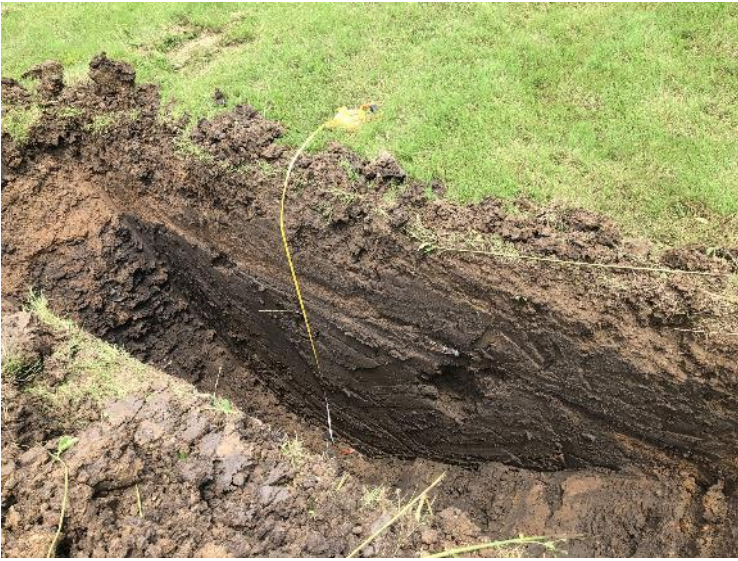
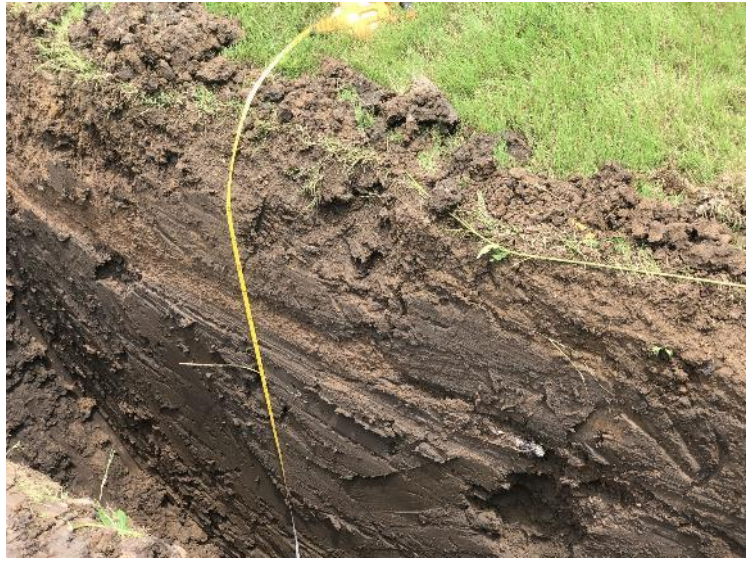
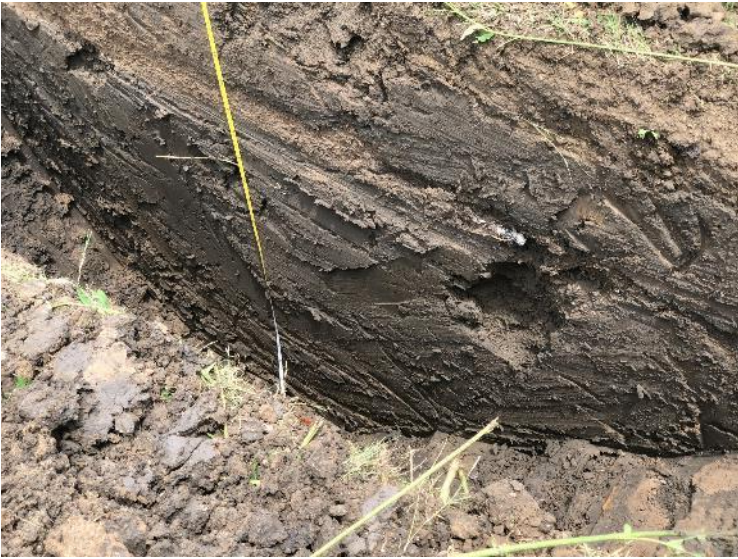
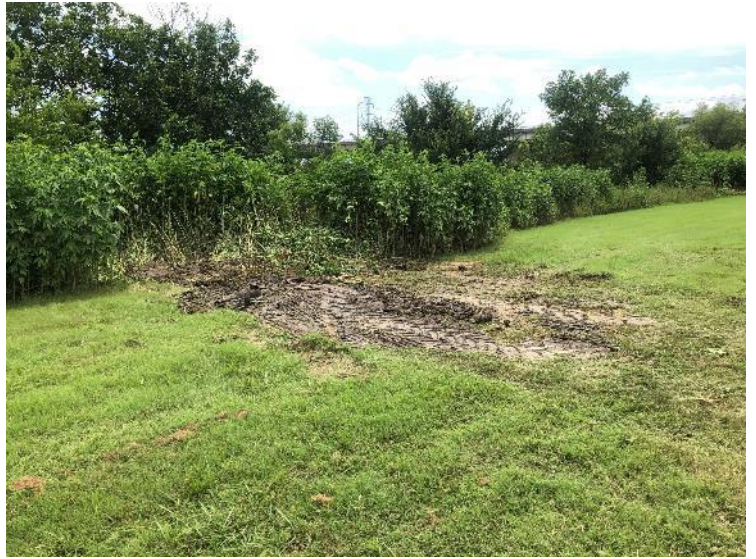
Trench 4 was excavated approximately 25 m west of the Elm Fork Trinity River, near the eastern margin of Trinity View Park. The soil profile exposed within Trench 4 was generally similar to Trench 3; however, a thick layer of modern fill from construction and grading of the park capped Trench 4 (**Appendix A, Photographs 15 through 22**). The fill layer was approximately 50 cm thick and consisted of pale brown (10YR 6/3) loam covered with manicured turf grass. The fill layer was underlain by a thick deposit of very dark grayish brown (10YR 3/2) clay loam that featured pockets of mottled black (10YR 2/1) and dark yellowish brown (10YR 4/4) clay. The water table was encountered at 330 cmbs.

Photograph 15 - Trench 4, view to the southeast.

Photograph 16 - Trench 4, view to the northeast.

Photograph 17 - Trench 4, view to the northeast.

Photograph 18 - Trench 4, view to the northeast.

Photograph 19 - Trench 4, view to the northwest.

Photograph 20 - Trench 4, view to the northwest.

Photograph 21 - Trench 4, view to the northwest.

Photograph 22 – Trench 4, view to the southeast.
