Intensive Archeological Survey for the Bridge Replacement on County Road 279 at Kings Creek, Kaufman County, Texas

Report for Archeological Survey

CSJ: 0918-11-093

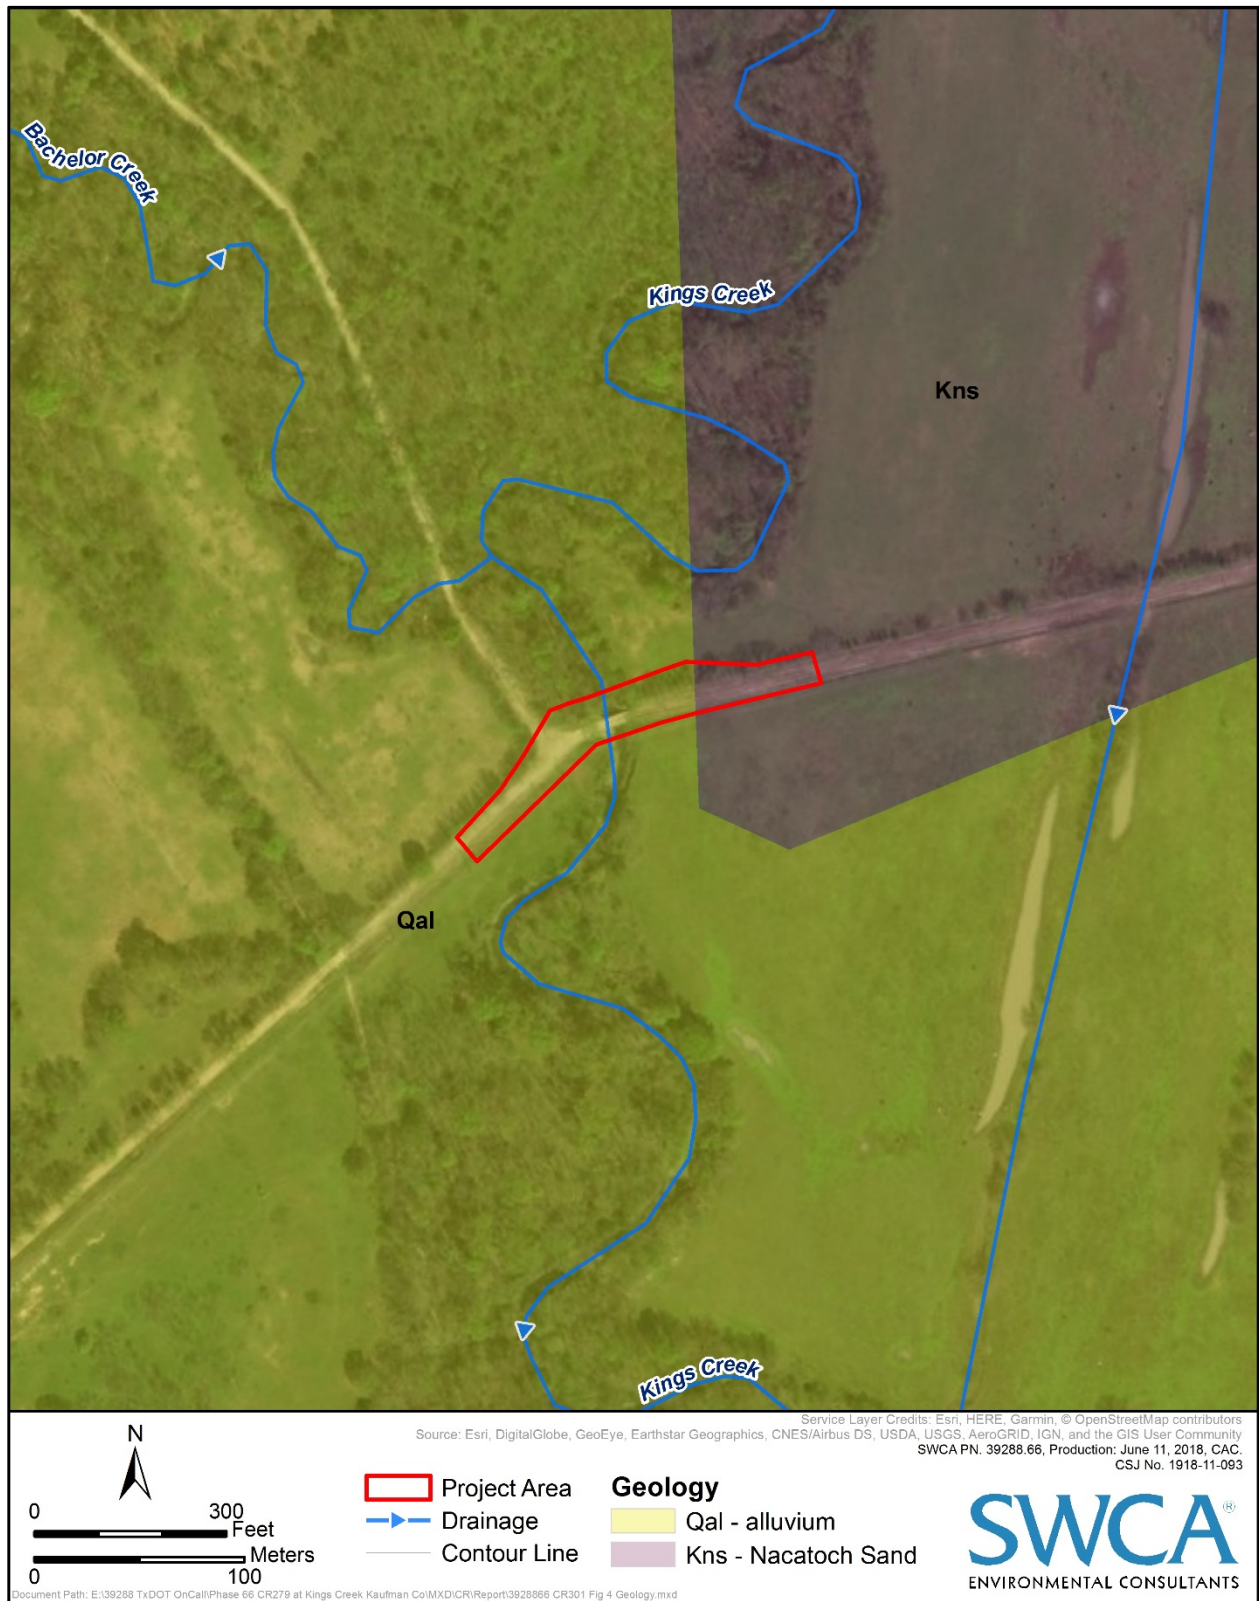
Figure 3. Project area geology.

Geology: Due to the project's floodplain location, its underlying geology is primarily (73 percent) Holocene alluvium (Figure 3). These soils are low terrace deposits of clay, silt, and sand. These sediments have historically demonstrated potential for the presence of buried, intact archeological deposits. Therefore, the APE does possess the potential for the presence of buried intact archeological deposits (Barnes 1967).

Additionally, the Nacatoch Sands encompass approximately 27 percent of the project area (see Figure 3). This formation is composed of Late Cretaceous age fine-grained quartz sand with local lenses of compact silty clay (Barnes 1967).

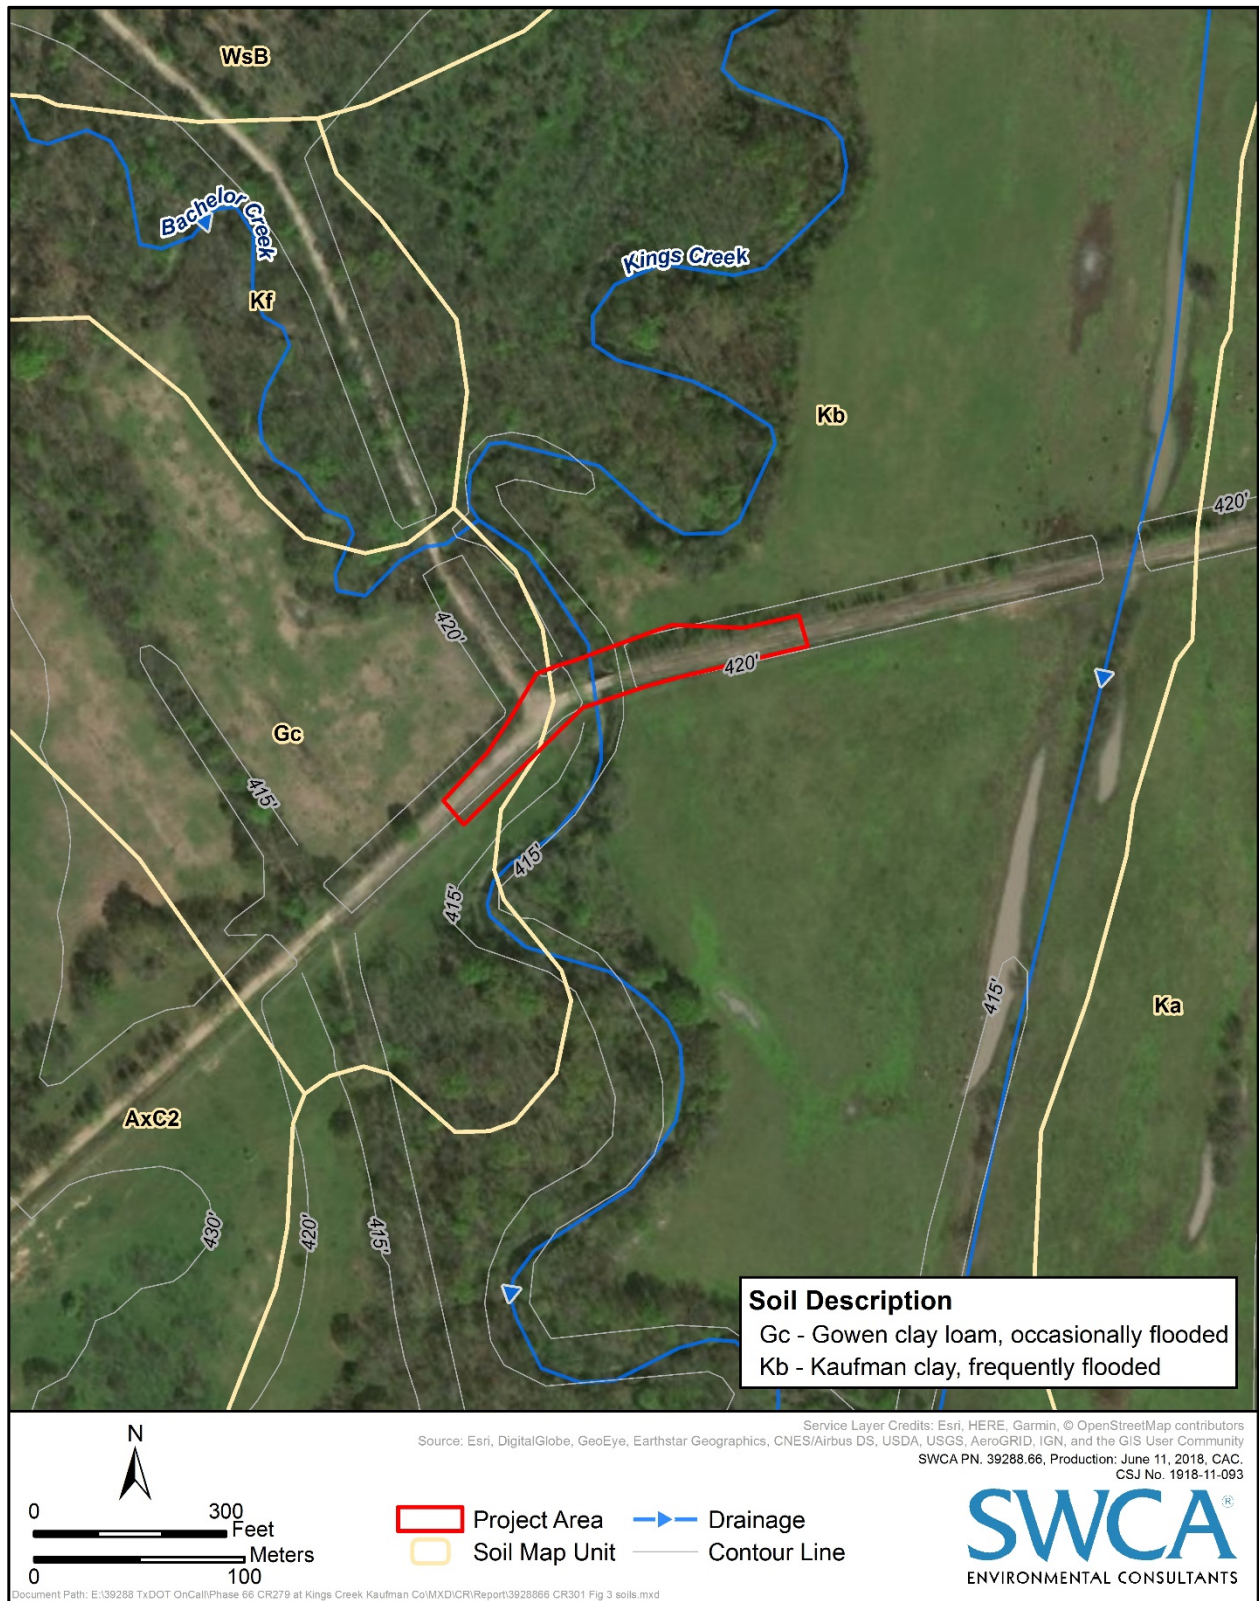
Figure 4. Project area soils.

Soils: According to the U.S. Department of Agriculture Natural Resources Conservation Service (NRCS) Web Soil Survey, the APE is located within the Kaufman clay and Gowen clay loam soil series (Figure 4).

The Kaufman clay consists of very deep, moderately well drained, very slowly permeable soils that formed in clayey alluvium derived from mudstone. Occurring on floodplains, river valleys, and dissected plains, these soils are nearly level with slopes typically less than 1 percent but range up to 2 percent. This soil series belongs to the Vertisol order of soil taxonomy (NRCS 2018).

The Gowen clay loam consists of very deep, well drained, moderately permeable soils that formed in loamy alluvium of Holocene age. Located on nearly level floodplains, these soils are located on slopes that are predominantly less than 1 percent but range up to 2 percent. This soil series belongs to the Mollisol order of soil taxonomy (NRCS 2018).

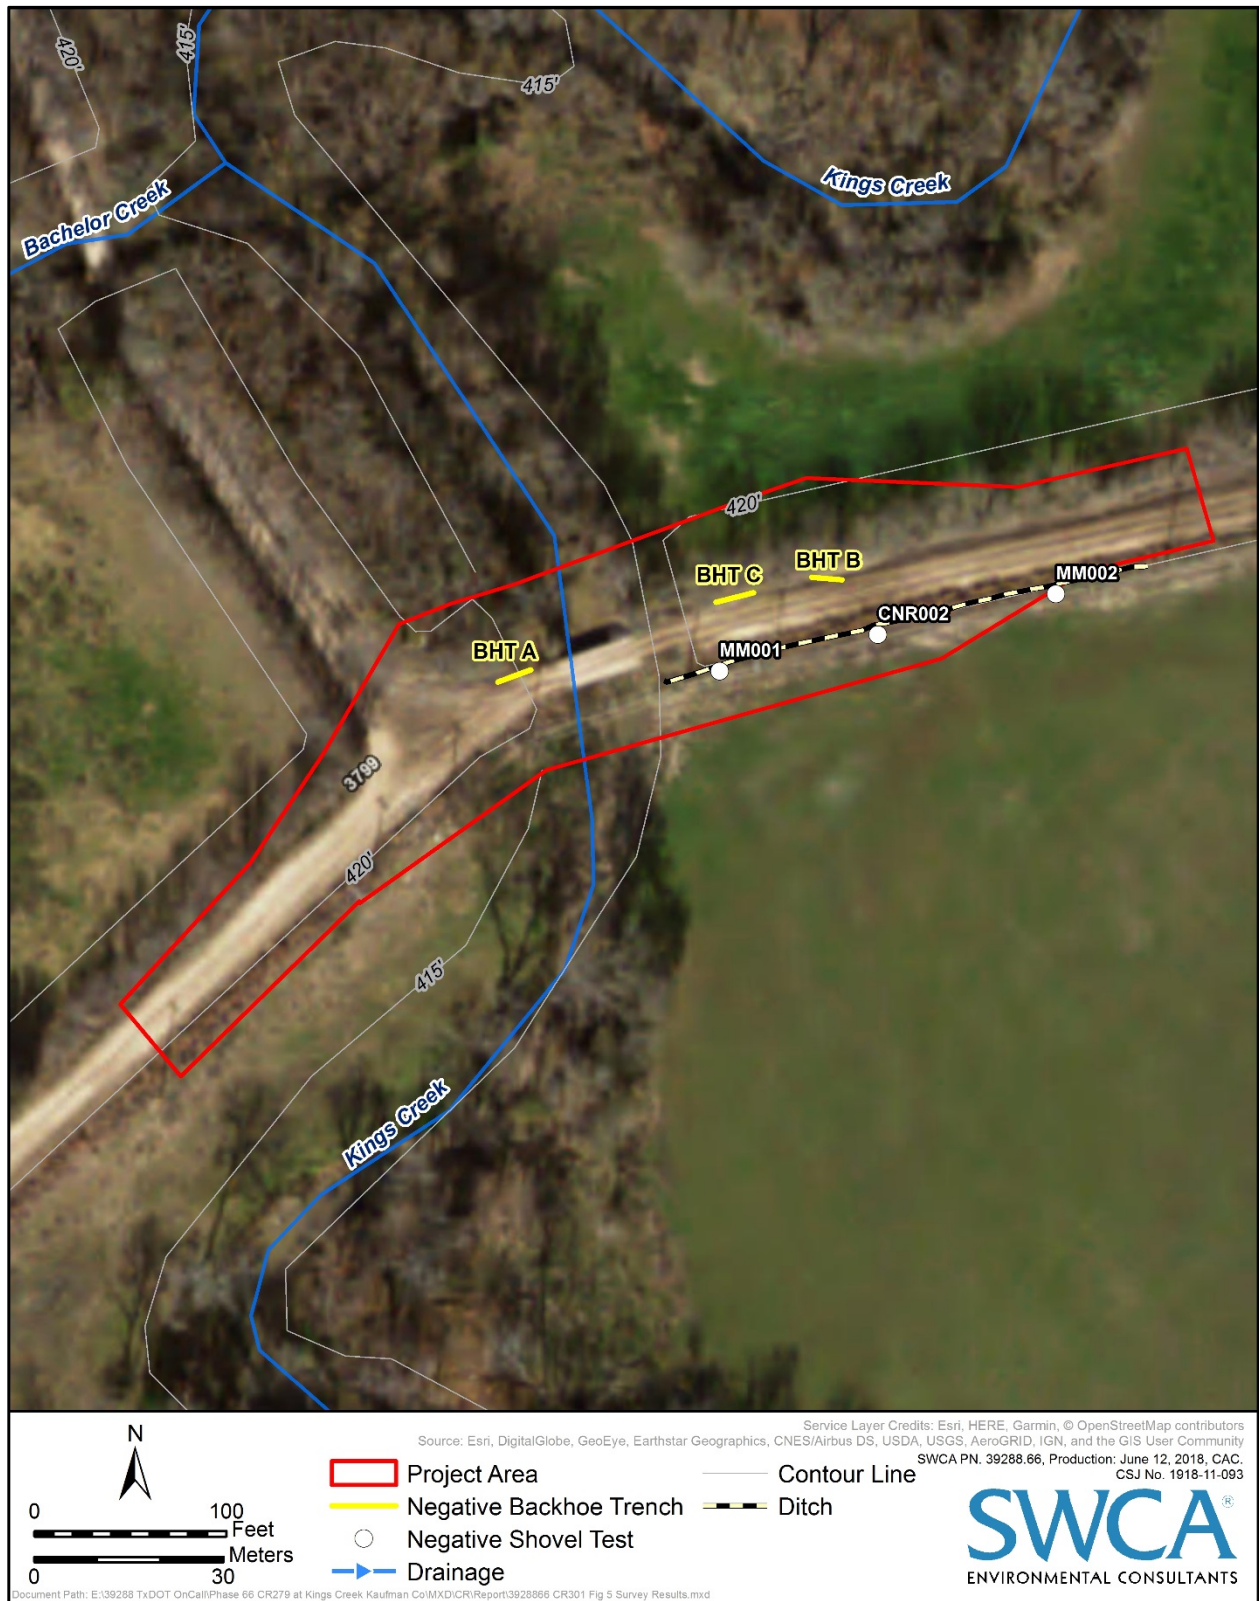
Figure 5. Results map.

Project Area Description: SWCA archeologists conducted pedestrian survey with shovel testing and backhoe trenching within the 2.0-acre APE (Figure 5; Tables 3 and 4). The project consists of existing and new ROW within the Kings Creek floodplain and associated terraces (see Figure 5). No right of entry was granted for the new ROW and easement; consequently, all excavations were limited to the existing ROW, using any available exposures to assess the inaccessible areas. The existing ROW has been disturbed by road and bridge construction, maintenance (including grading, fill, and runoff culverts), and buried utilities (Figures 6 and 7).

Shovel Testing: SWCA archeologists excavated three STs (i.e., MM001–MM002 and CNR002) on the eastern side of Kings Creek and the southern side of CR 279 (see Table 3 and Figure 5). The STs encountered a very dark brown or very dark gray (10YR 2/2 or 10YR 3/1) clay, terminating at approximately 40 cm below surface (cmb) due to compact soils (Figure 8). No cultural materials were identified within any of the three STs.

Backhoe Trenching: SWCA archeologists excavated three BHTs (i.e., A, B, and C) on the northern side of CR 279 (see Table 4 and Figure 5). BHT A was located on the western side of Kings Creek, while BHTs B and C were located on the eastern side of Kings Creek. All trenches were approximately 10 feet (3 m) long, 3 feet (0.9 m) wide, and ranged in depth from 4.6 feet (1.4 m) to 11.7 feet (3.6 m).

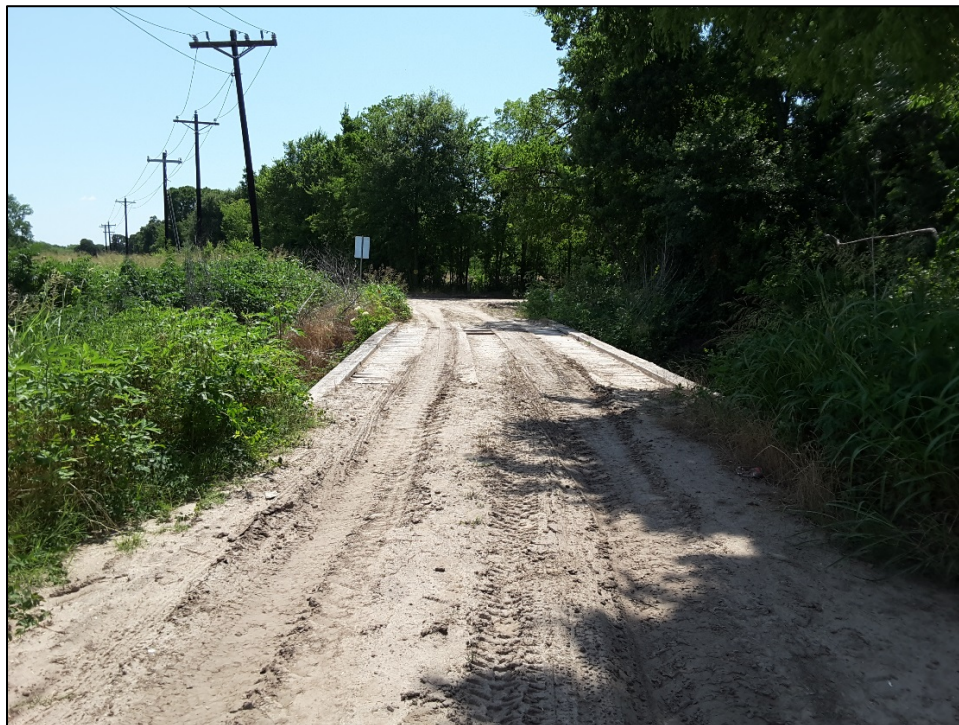
Project Description and Impacts: The proposed project would replace the existing bridge and approaches on CR 279 in Kaufman County, Texas (Figures 1 and 2). The existing, one-lane, timber deck bridge, built in 1982, measures 54 feet in length and 16.2 feet in width. The proposed new structure would measure 70 feet in length and 36 feet in width. The approaches would be widened to match the wider structure. The vertical alignment would be raised by approximately 2 feet. Approximately 1.0 acre of proposed new ROW and 0.3 acre of new, permanent easement would be required.

Figure 6. Overview of CR 279 showing bridge to be replaced, facing west

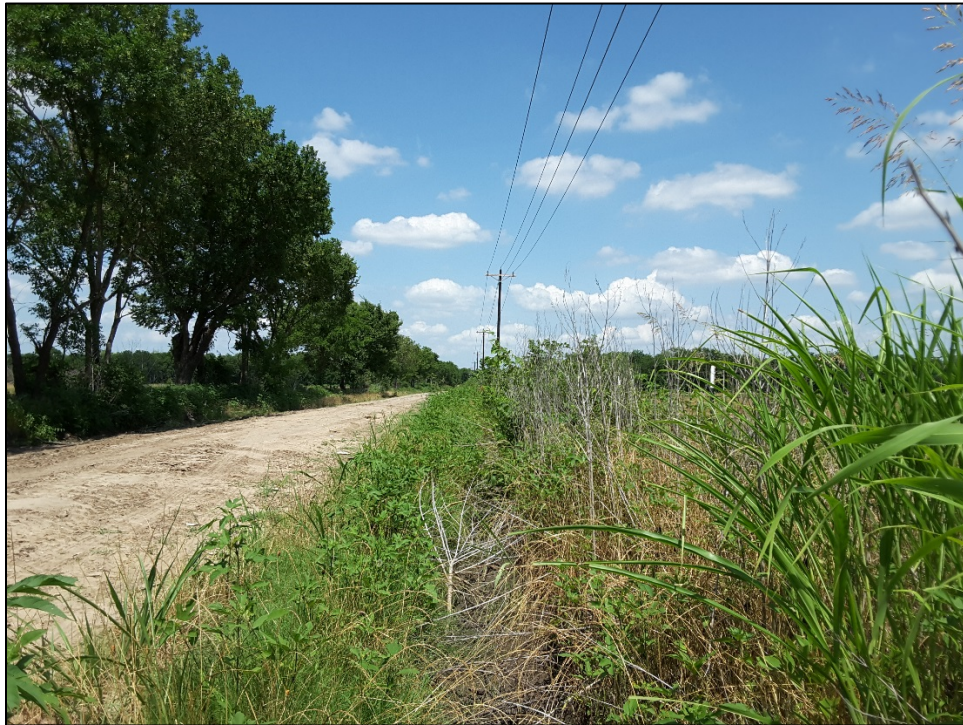
Comments on Project Setting: The APE within the existing ROW has been extensively modified by previous roadway and bridge construction and maintenance. In addition, an existing transmission line runs east to west along the southern side of CR 279.

Figure 7. Overview of CR 279 showing disturbances from transmission line and road construction, facing east.

APE Integrity: The proposed APE exhibits evidence of prior disturbance caused by buried utilities and road and bridge construction and maintenance, which has compromised the integrity of the APE.

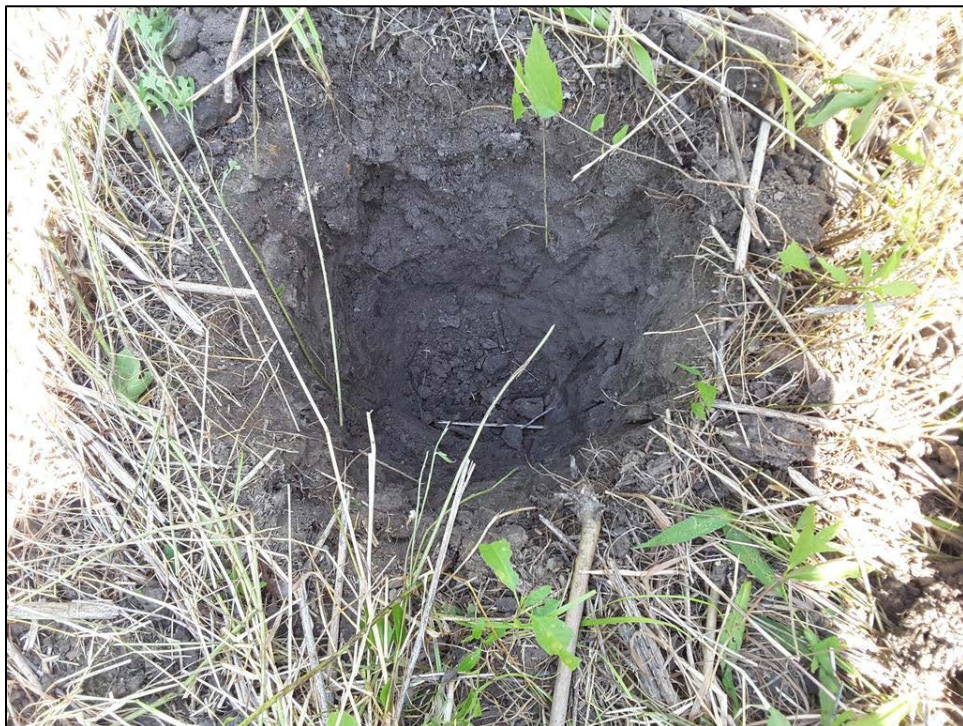
Figure 8. Shovel test CNR002 showing compact clay soils.

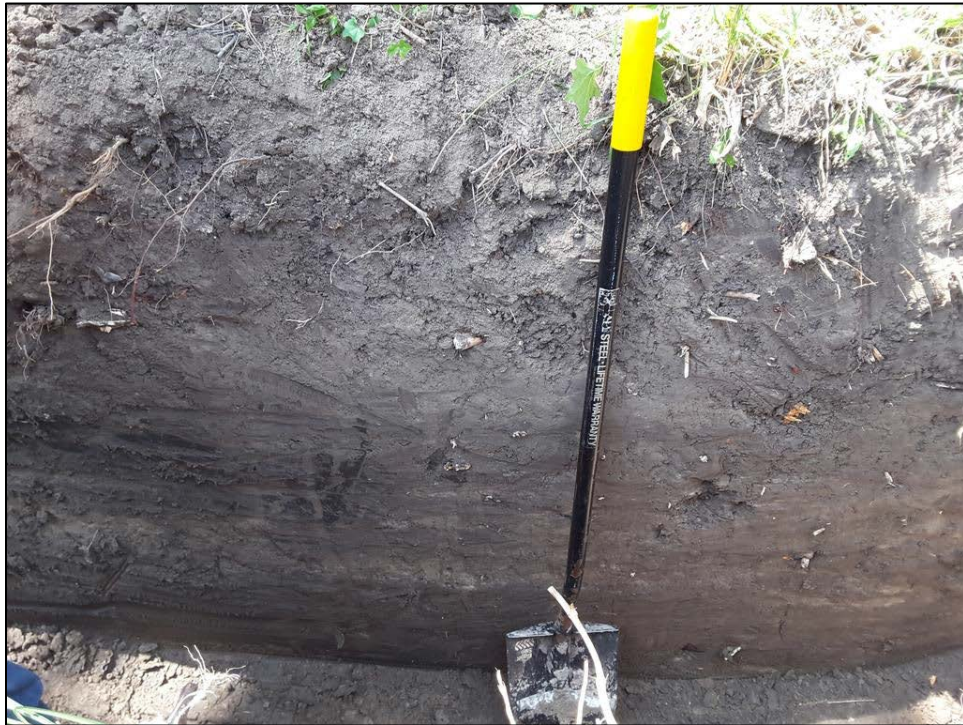
BHT A was located on the western side of Kings Creek and north of CR 279. It measured approximately 10 feet (3 m) long, 3 feet (0.9 m) wide, and 4.6 feet (1.4 m) deep (Figure 9; see Table 3). Soils in the BHT exhibited a grayish brown (10YR 5/2) sandy clay loam over a dark grayish brown (10YR 4/2) sandy clay. The third stratigraphic layer consisted of a dark grayish brown (10YR 4/2) clay. No cultural materials were identified within the BHT and inclusions were limited to modern trash, roots, rootlets, and pebbles.

Figure 9. BHT A northern wall profile from approximately 0–140 cmbs, facing north.

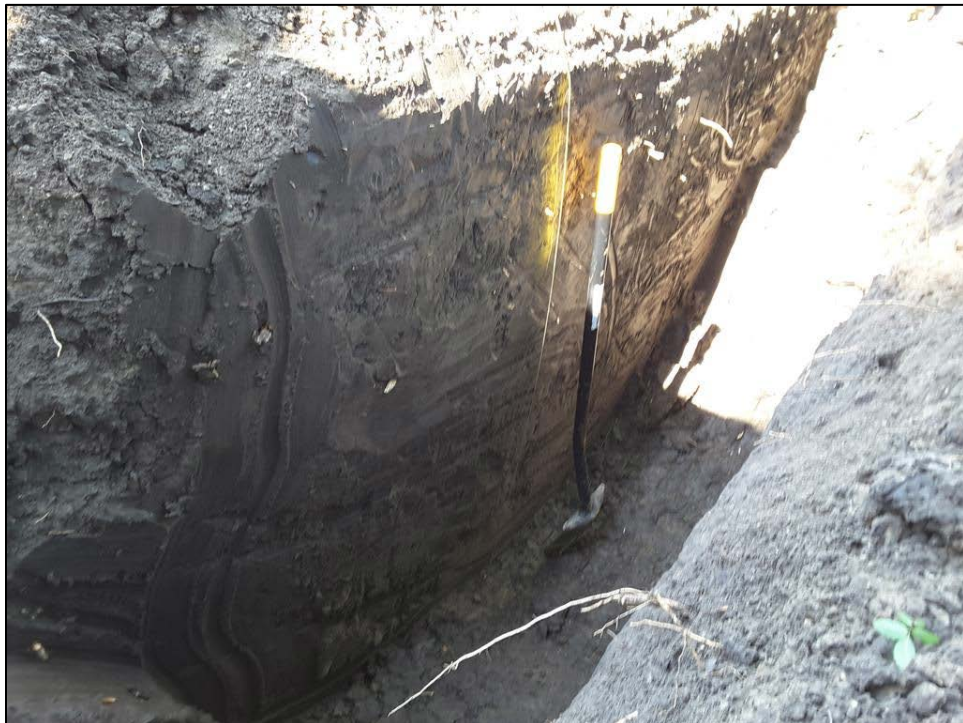
BHT B was located on the eastern side of Kings Creek and north of CR 279. It measured approximately 10 feet (3 m) long, 3 feet (0.9 m) wide, and 11.7 feet (3.6 m) deep (Figure 10; see Table 3). Soils in the BHT exhibited a very dark brown (10YR 2/2) clay over a dark gray (10YR 4/1) silty clay. The third stratigraphic layer consisted of a reddish brown (2.5YR 5/4) silty clay. An additional level was excavated to assess the potential for deeply buried cultural material. The soils observed in the fourth stratigraphic layer consisted of a light yellowish brown (2.5YR 6/4) clay. No cultural materials were identified within the BHT and inclusions were limited to roots and rootlets.

Figure 10. BHT B northern wall profile from approximately 0–170 cmbs, facing northeast.

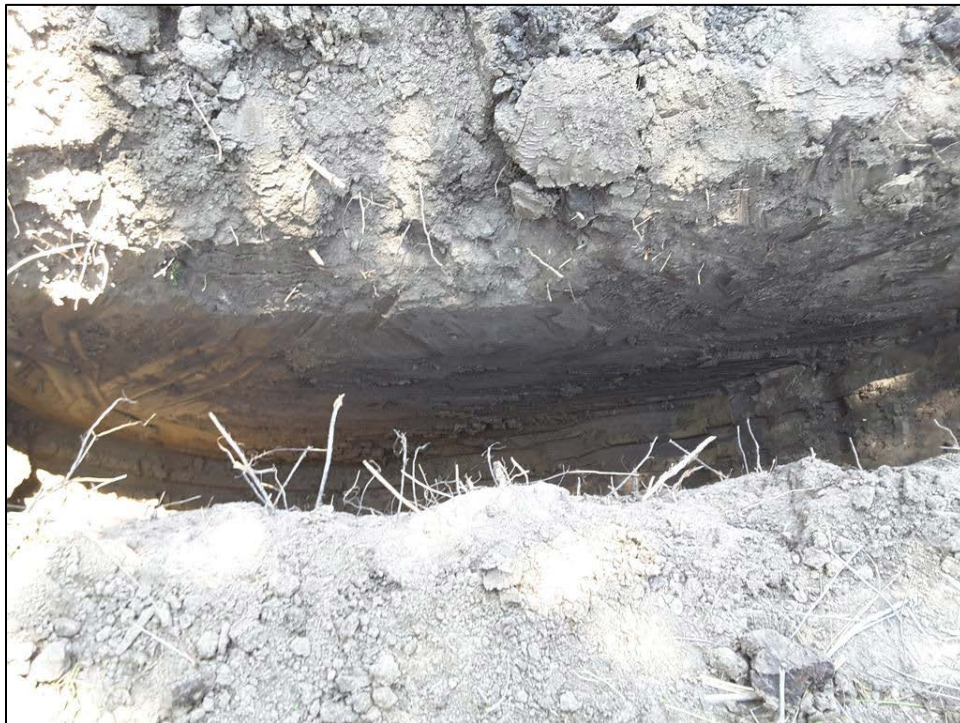
BHT C was located on the eastern side of Kings Creek and north of CR 279. It measured approximately 10 feet (3 m) long, 2 feet (0.6 m) wide, and 10 feet (3 m) deep (Figure 11; see Table 3). Soils in the BHT exhibited a very dark grayish brown (10YR 3/2) sandy clay loam over a dark gray (10YR 4/1) clay loam. An additional level was excavated to assess the potential for deeply buried cultural materials. The third stratigraphic layer consisted of an olive brown (2.5YR 4/4) silty clay. No cultural materials were identified within the BHT and inclusions were limited to roots, rootlets, and pebbles.

Figure 11. BHT C southern wall profile showing deep testing from approximately 0–300 cmbs, facing south.
