## **Intensive Cultural Resources Survey For The Proposed Farm-To-Market 1625 Realignment Project, Travis County, Texas**

INTENSIVE CULTURAL RESOURCES SURVEY  
FOR THE PROPOSED FARM-TO-MARKET 1625  
REALIGNMENT PROJECT, TRAVIS COUNTY,  
TEXAS

TEXAS ANTIQUITIES PERMIT NO. 7975  
CSJ: 1535-01-012  
MAY 2018

PREPARED BY  
**SWCA Environmental Consultants**

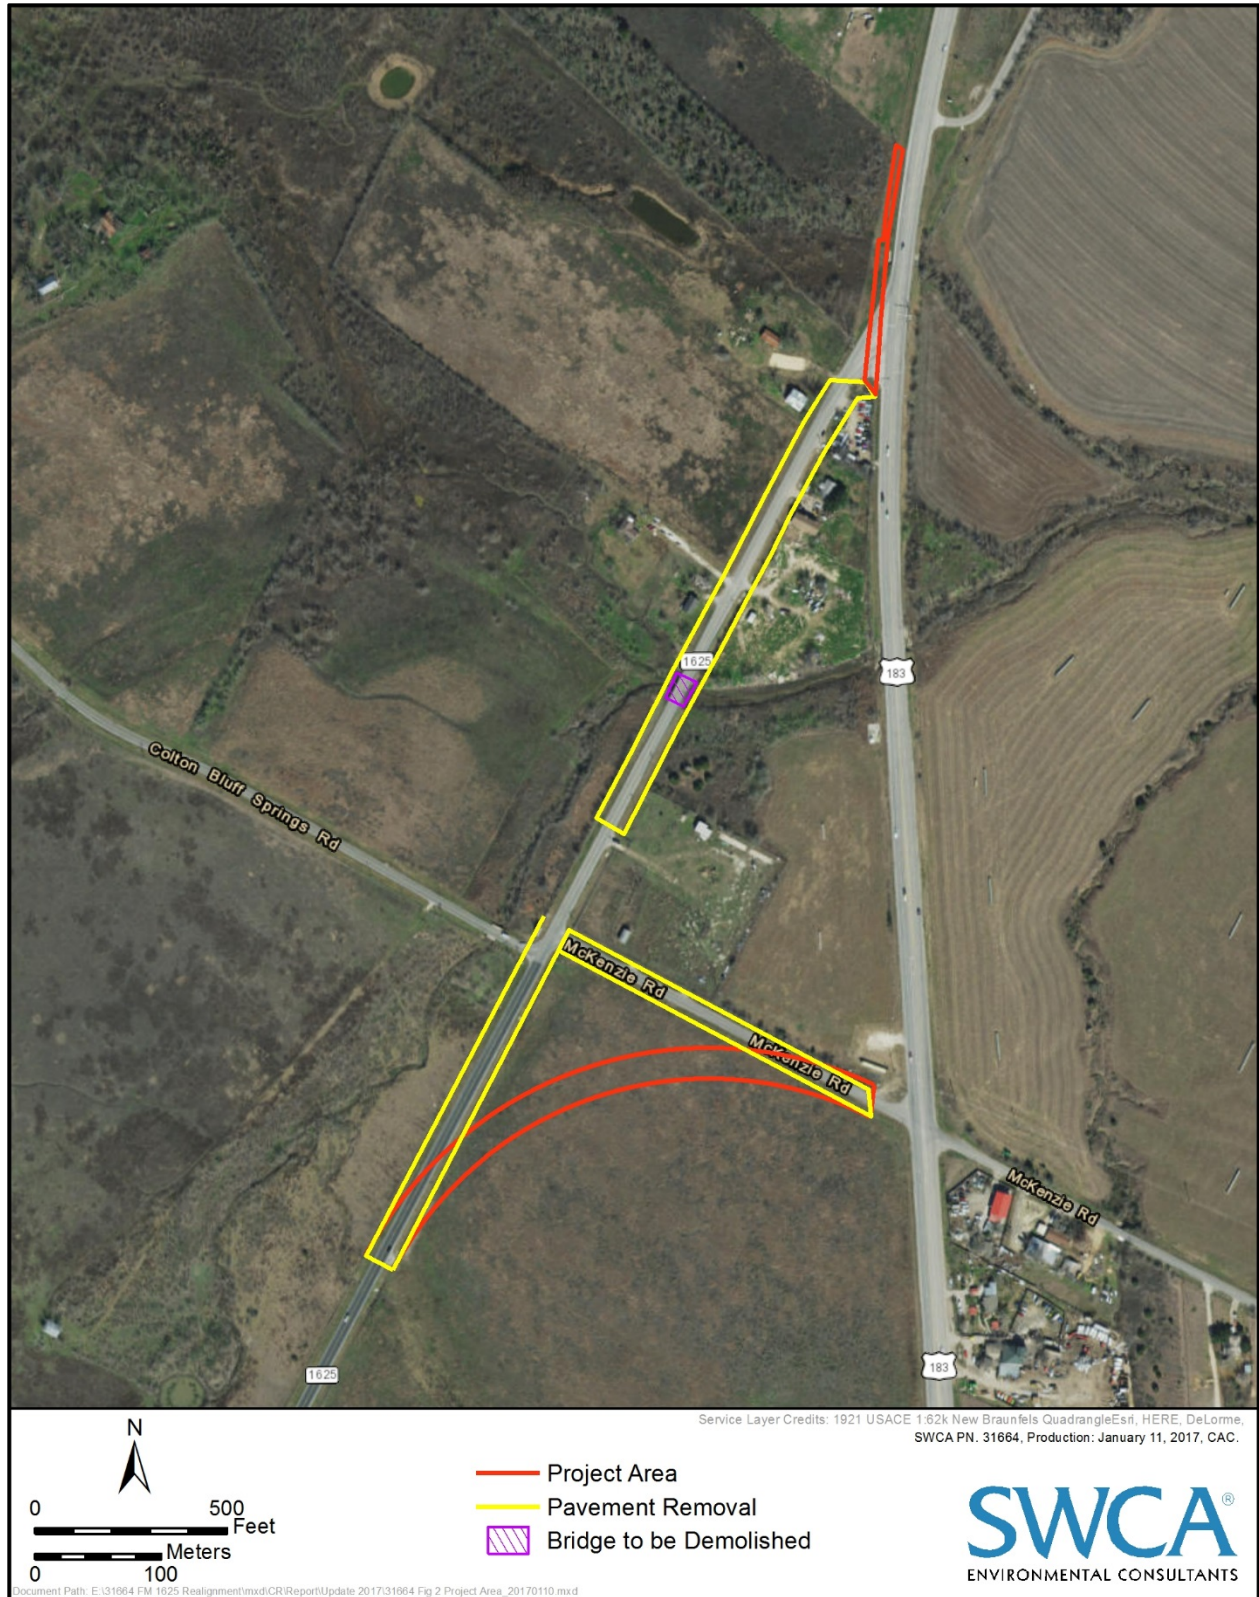
Figure 2. Project APE.

The area of potential effects (APE) is in southeastern Travis County in a semi-rural setting surrounded by open pastures and scattered residential housing. The western terminus of the approximately 0.3-mile long proposed FM 1625 realignment begins 0.15 mile (790 feet) south of the intersection of McKenzie Road and FM 1625. The alignment then trends northeast for approximately 0.3 mile (1,555 feet) to its eastern terminus near the intersection of FM 1625 and US 183, and continues for another 300 feet on the west side of US 183. The majority of the ROW is approximately 60 feet in width; however, at the eastern terminus, the ROW widens to approximately 260 feet. The depths of impacts are not known at this time, but are expected not to exceed 5 feet below ground surface. In addition, portions of a 970-foot-long section (0.18 mile) of McKenzie Road, 2,270-foot-long section (0.42 mile) of FM 1625 pavement, and a bridge spanning the North Fork Dry Creek will be removed during the realignment efforts. The project area is defined as the 0.3-mile-long corridor (2.74 acres) and 0.6-mile-long (3,240 feet) potential pavement removal area (2.9 acres) along McKenzie and FM 1625, culminating in the 5.64 acre APE (see Figure 2).

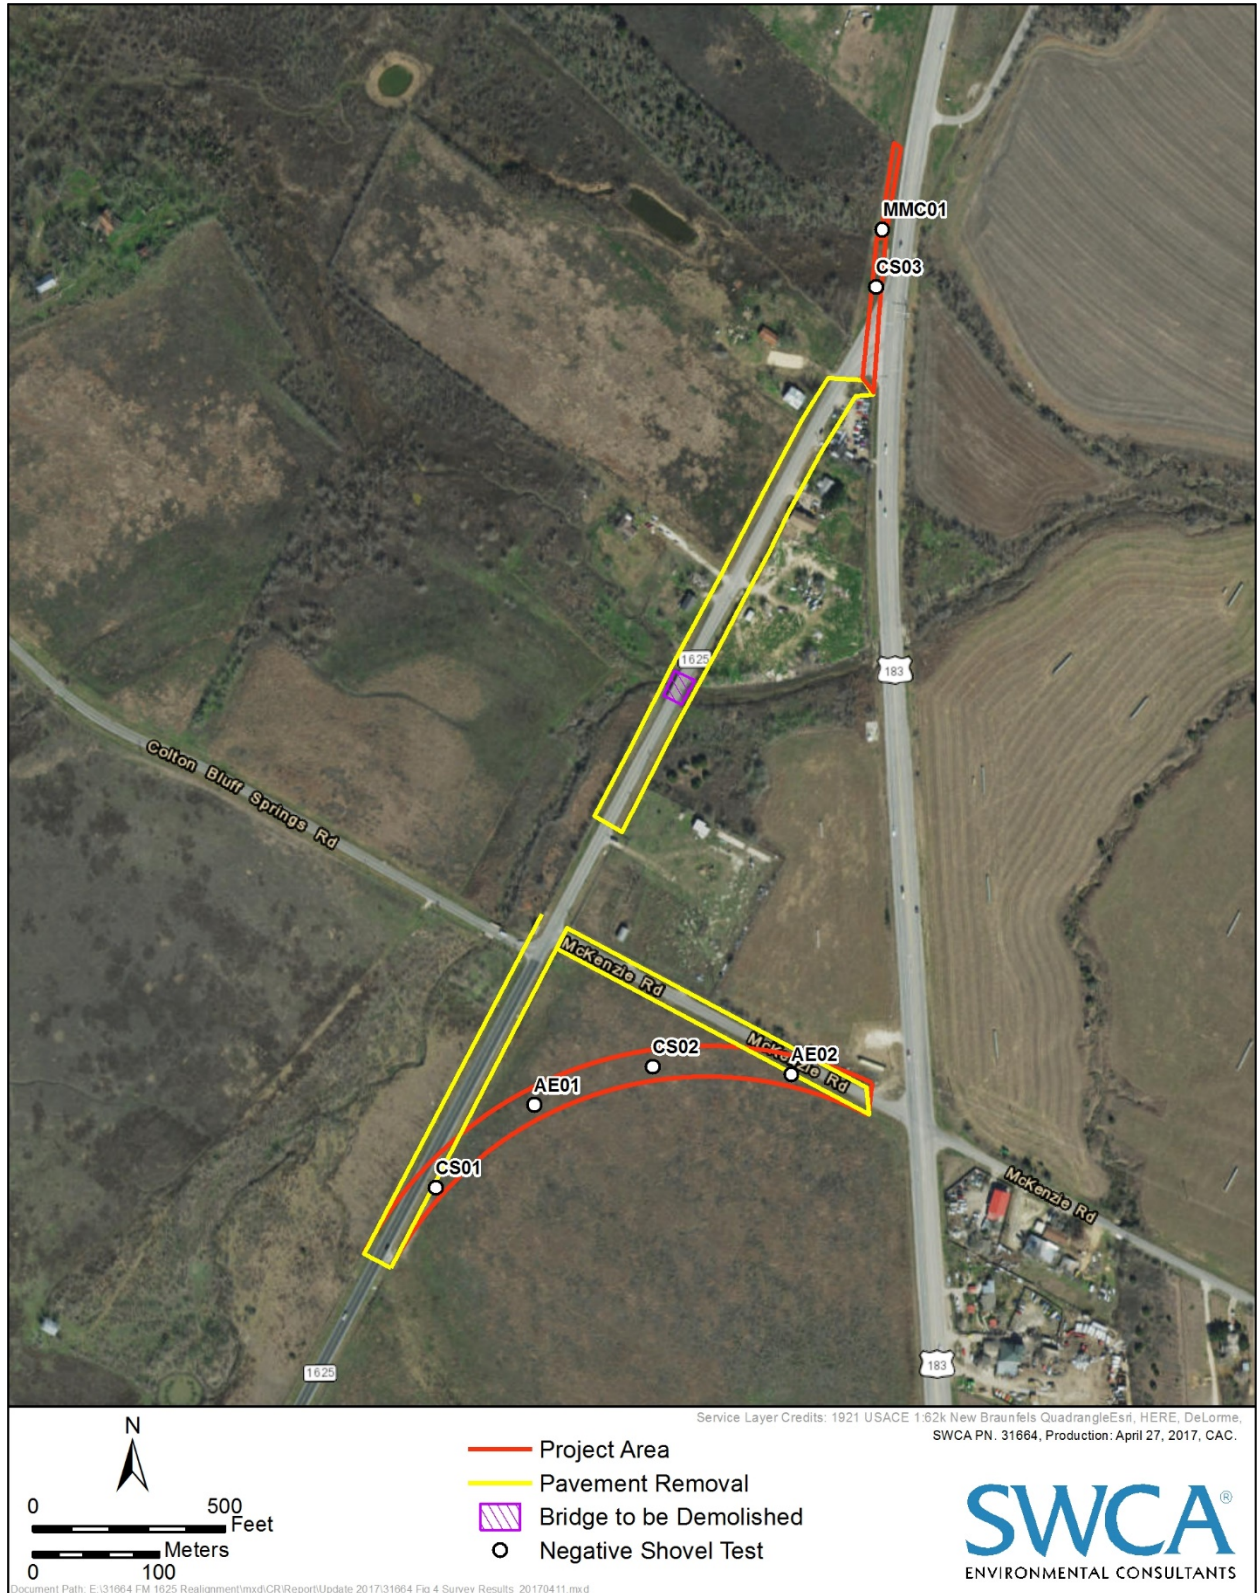
Figure 4. Survey results.

On April 11, 2017, two SWCA archaeologists conducted an intensive pedestrian survey with shovel testing of the proposed approximately 1,555-foot-long (0.3-mile) alignment for the realignment of FM 1625. Additionally, archaeologists visually inspected the 970-foot-long section (0.18 mile) of McKenzie Road and the 2,270-foot-long sections (0.42 mile) of FM 1625 scheduled for pavement removal to ensure impacts from the pavement removal would be restricted to the previously disturbed areas. The bridge spanning North Fork Dry Creek, scheduled to be removed, was visually inspected to ensure the bridge is not of historic age construction and to assess the potential for the surrounding deposits to contain intact, buried cultural materials (Figure 4).

Visual examination of the project area revealed a primarily semi-rural setting surrounded with open pastures and scattered residential housing. Vegetation throughout the 0.3-mile FM 1625 realignment project area consists of tall, dense grasses and short scrub, which reduced the estimated surface visibility to a range between 0 and 10 percent (Figure 5). SWCA archaeologists excavated a total of six shovel tests within the project area (Table 1). The encountered soils consisted of a dark gray to very dark gray (10YR 4/1 to 10YR 3/1) dense clay at the surface. The density of the clay impeded manual excavation beyond a depth of 40 cmbs, and reduced the likelihood of deeply buried archaeological deposits. Neither the surface, nor the subsurface investigations identified any historic or prehistoric cultural material.

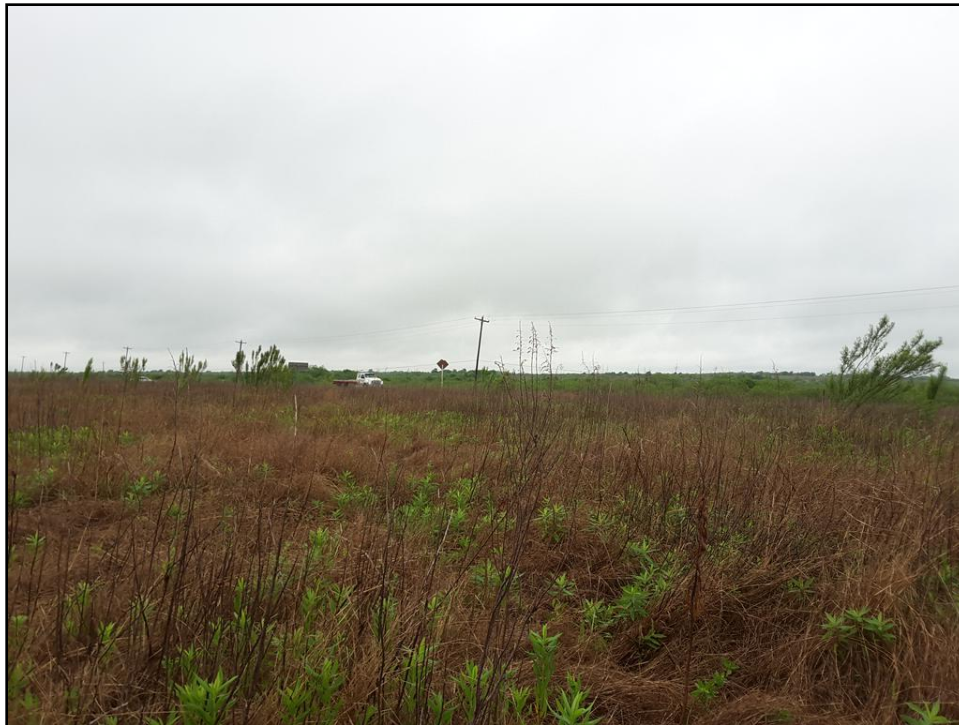
**Figure 5.** Overview of vegetation in project area from shovel test AE01, facing south.

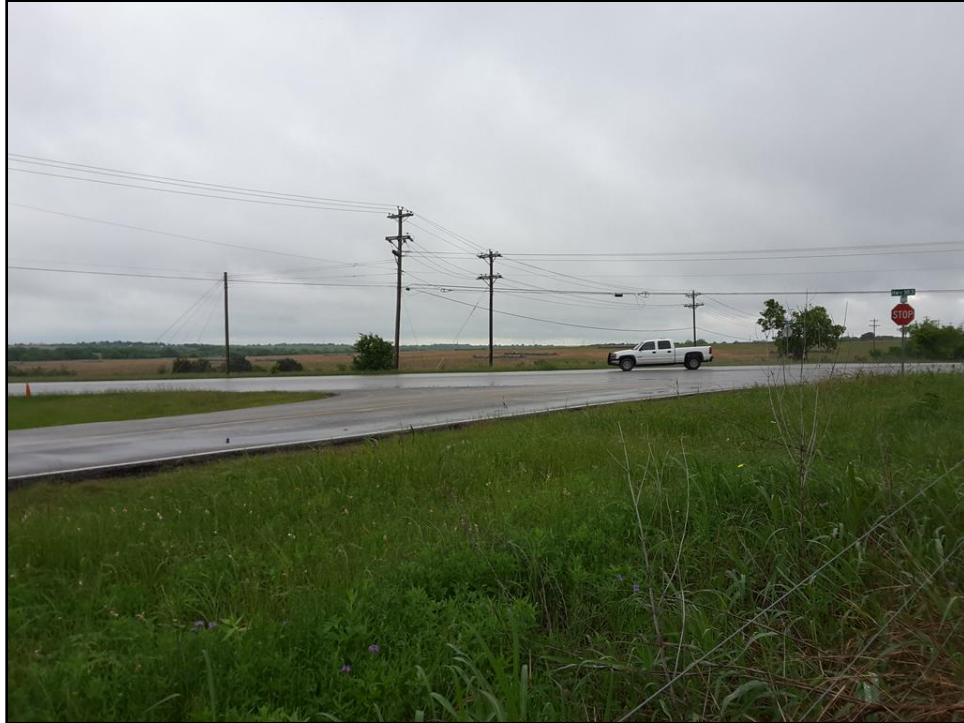
An examination of the 970-foot-long section (0.18 mile) of McKenzie Road and the 2,270-foot-long sections (0.42 mile) of FM 1625 scheduled for pavement removal revealed that the area of impact would be entirely within a pre-existing paved road (Figures 6 and 7); the pavement removal would not generate any additional disturbance to potential cultural resources in the area. Additionally, the examination of the bridge spanning North Fork Dry Creek determined that the disturbance produced by the initial bridge construction was at such an extent that the removal of the bridge would not impact any potentially remaining, intact cultural features (Figures 8 and 9). Further, the drainage and surrounding soils are not conducive to the preservation of deeply buried, intact cultural deposits. Specifically, the North Fork Dry Creek at this crossing is a relatively shallow incised drainage with shallow (less than 4 feet) cut banks. The drainage is incised into the Tinn clay and bracketed by the Houston Black clay series that contribute to the Tinn clays (NRCS 2017). The dense clays at the crossing are derived from clayey residuum from calcareous mudstone of Cretaceous Age (Houston Black) or calcareous clayey alluvium from the Blackland Prairies (Tinn) and not typically associated with deeply buried stratified archaeological sites. Similarly, the floodplain at this crossing is slightly sloping within a narrow (about 100-m-wide) valley. Considered together, the crossing appears more erosive than depositional and does not have the potential for deeply buried, intact cultural deposits. Further, the presence of shallow calcium carbonate encountered in the shovel tests excavated approximately 750 feet from the bridge, suggest the deposits aligning the drainage may be of considerable age.

**Figure 6.** Intersection of US 183 and FM 1625, facing northwest.

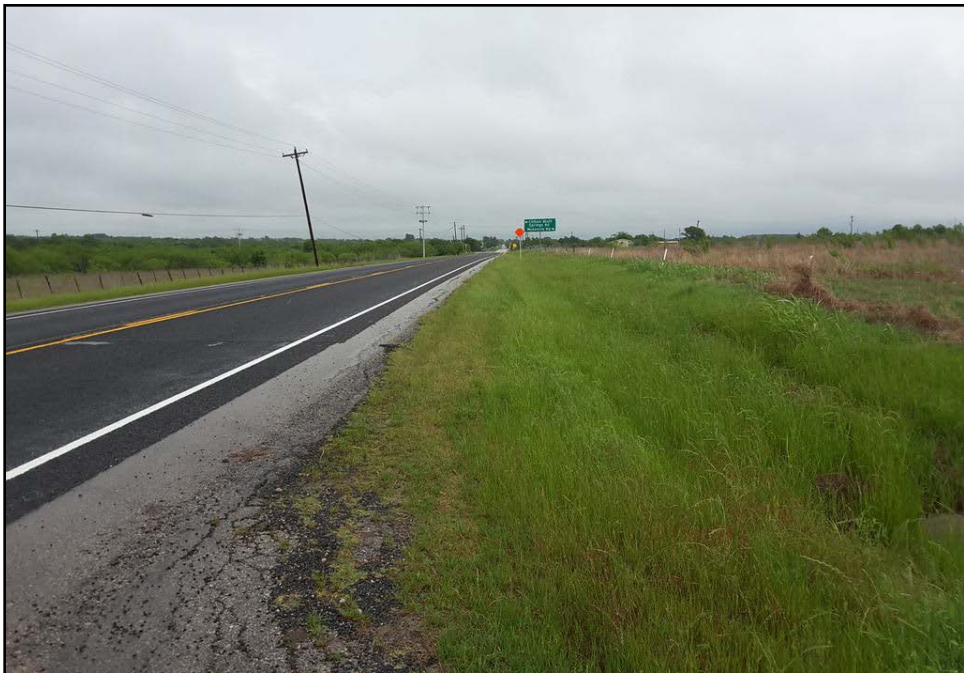
**Figure 7.** Overview of proposed pavement removal area on FM 1625, facing north.

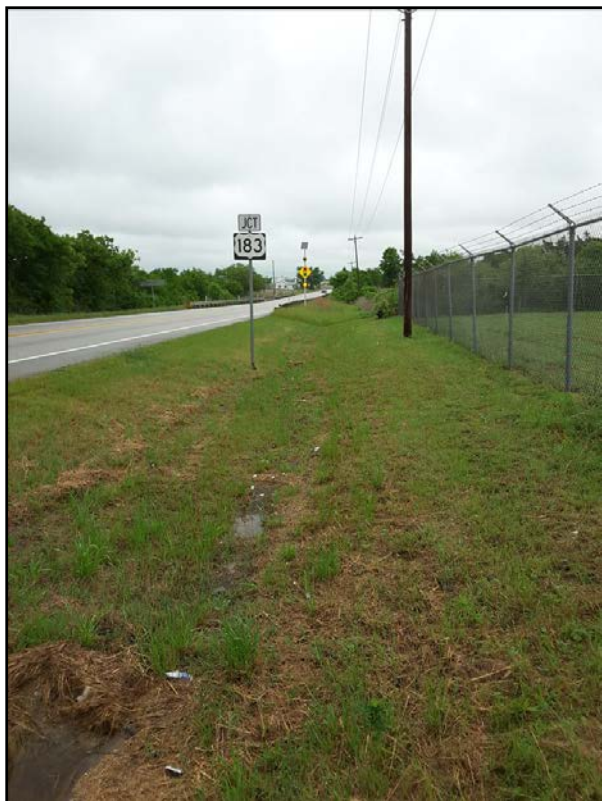
**Figure 8.** Overview of approach along FM 1625 to bridge spanning North Fork Dry Creek, facing northwest.

The soils surrounding the bridge crossing at the North Fork Dry Creek have been significantly impacted by previous construction. The road bed approaching the bridge has been artificially raised about 3 feet, and road side ditches have been cut below grade roughly 3 to 4 feet on each side to channel runoff into the drainage. Concrete and steel pilings have been driven into the drainage for bridge support. Concrete retaining walls extend for approximately 12 feet at a diagonal angle from the bridge on both banks and on each side. Guard rails have been placed on both sides of the bridge in each direction and are held in place by a series of large, wood posts. The direct impacts from construction of the road leading to the bridge, as well as the indirect impacts from the heavy machinery used in construction, have significantly disturbed the deposits in and around the drainage. Further, roadside utilities, such as the telephone poles located on the east side of the bridge, will have further disturbed the surrounding area. Given the seemingly erosive nature of this setting and the low potential for buried cultural deposits, combined with the high degree of disturbance from previous construction and maintenance, any potential, intact cultural deposits will have already been destroyed and the removal of the bridge will not have any further impacts.

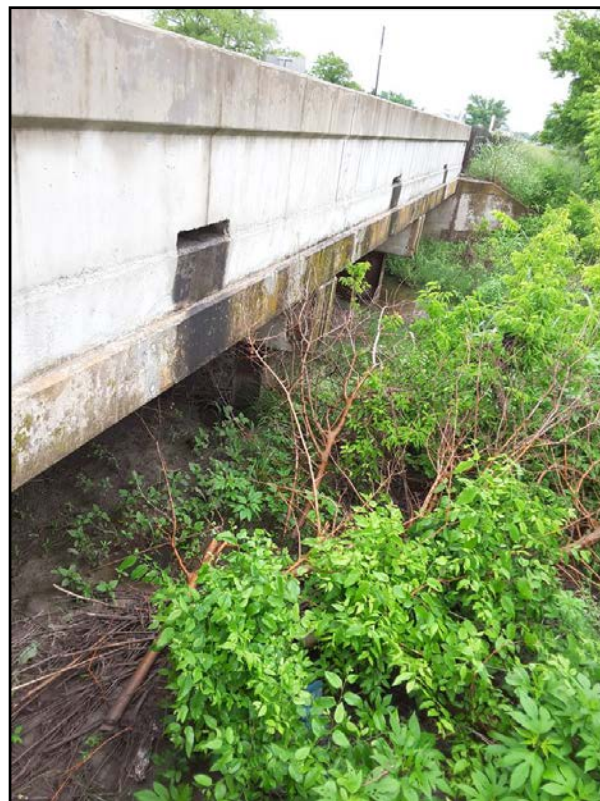
**Figure 9.** Overview of FM 1625 bridge at North Fork Dry Creek, drainage, and pilings; facing northwest.

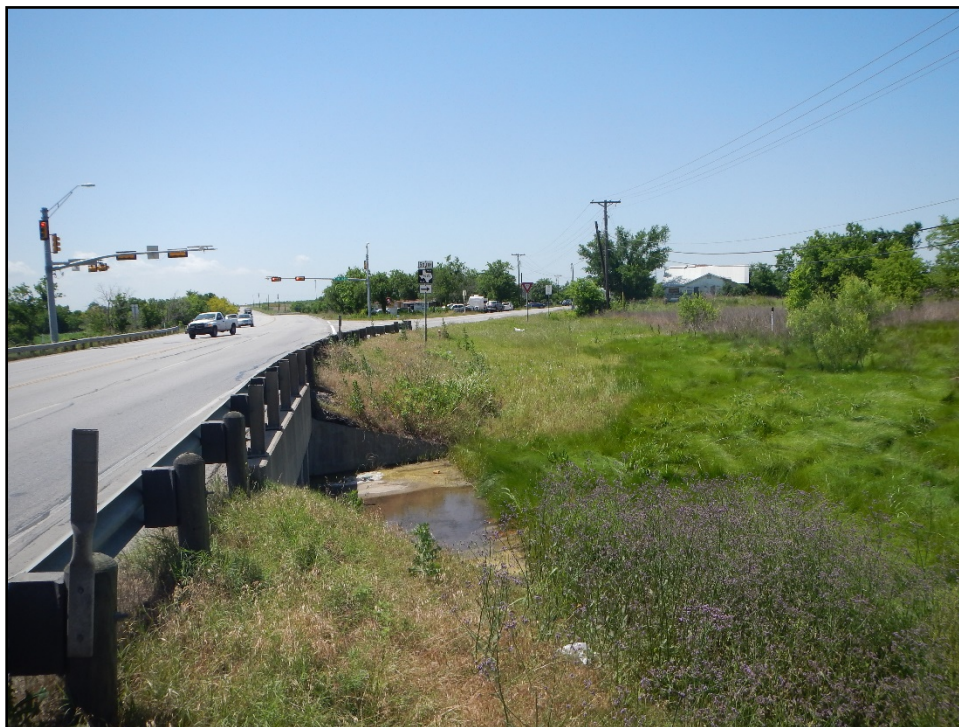
Additionally, SWCA evaluated a roughly 300-foot-long by 30-foot-wide area along the west side of US 183 (Figure 10). This area, within TxDOT ROW is situated north of the US 183 and FM 1625 intersection and crosses a small tributary of the North Fork Dry Creek. The soils within this small section and surrounding the drainage has been significantly impacted by previous construction (e.g., berm) and utilities. The road bed approaching the bridge on US 183 has been artificially raised approximately 2 feet, and the road side ditch has been cut roughly 2 feet below grade. The bridge spanning the drainage has been constructed with concrete pilings, a concrete floor, concrete retainer walls, and wooden guard rail posts that

have been driven into the ground. Utilities in the area include telephone poles, a buried gas pipeline, and a buried fiber optic cable. SWCA archaeologists excavated a total of two shovel tests within this area (CS03 and MCC01; see Table 1). The shovel tests contained dense clay at the surface, and appeared to be quite disturbed with road gravels in MCC01 and a mixture of soils in CS03.

Similar to the North Fork Dry Creek crossing, the tributary crossing US 183 is small (approximately 4 feet wide and 1 foot deep) and incised into Tinn Clay and is bracketed by Houston Black clay. The dense clays at the crossing are derived from clayey residuum from calcareous mudstone of Cretaceous Age (Houston Black) or calcareous clayey alluvium from the Blackland Prairies (Tinn) and not typically associated with deeply buried stratified archaeological sites. Considered together, the crossing appears more erosive than depositional and does not have the potential for deeply buried, intact cultural deposits. Further, shovel testing in the project area provides further evidence for the high degree of disturbance present in the project area and the lack of potential for intact cultural materials.

**Figure 10.** Overview of US 183 bridge at the tributary of North Fork Dry Creek and project area, facing south.
