## INTENSIVE ARCHEOLOGICAL SURVEY OF POISON OAK ROAD REALIGNMENT CITY OF TEMPLE, BELL COUNTY, TEXAS

April 12, 2018

Terracon Project No. 96177272C

Antiquities Permit No. 8263

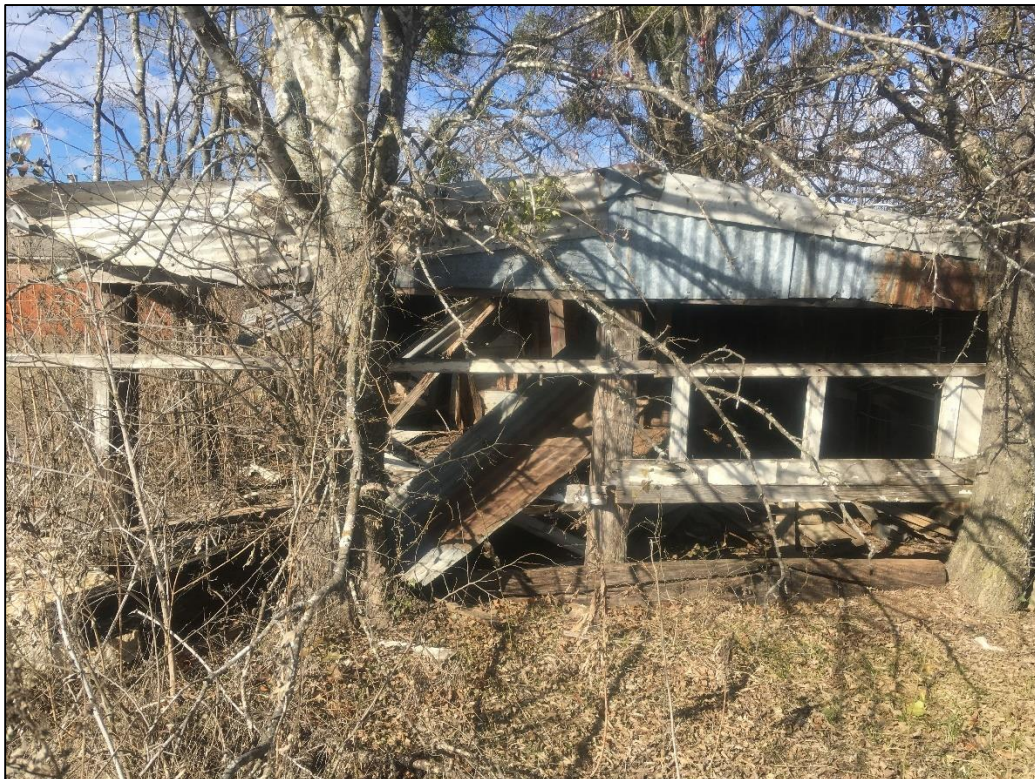
One isolated feature was observed during the course of the survey (see Appendix A, Exhibit 4). This feature consists of an outbuilding structure located on the southern edge of the project APE. The structure is roughly 15 feet by 30 feet, and made from wood and sheet metal (Appendix B, Photos 12 and 13). Historic aerial photographs indicate that this outbuilding was built between 1952 and 1964. No historic-age cultural materials were observed in the vicinity of the outbuilding. Given the isolated nature of the structure, its recent age, and the lack of associated artifacts, it was not recorded as an archaeological site.

**Photo 12. Historic-age outbuilding in the eastern portion of the project APE. View to the west.**

Photo 13. Historic-age outbuilding in the eastern portion of the project area APE. View to the northeast.

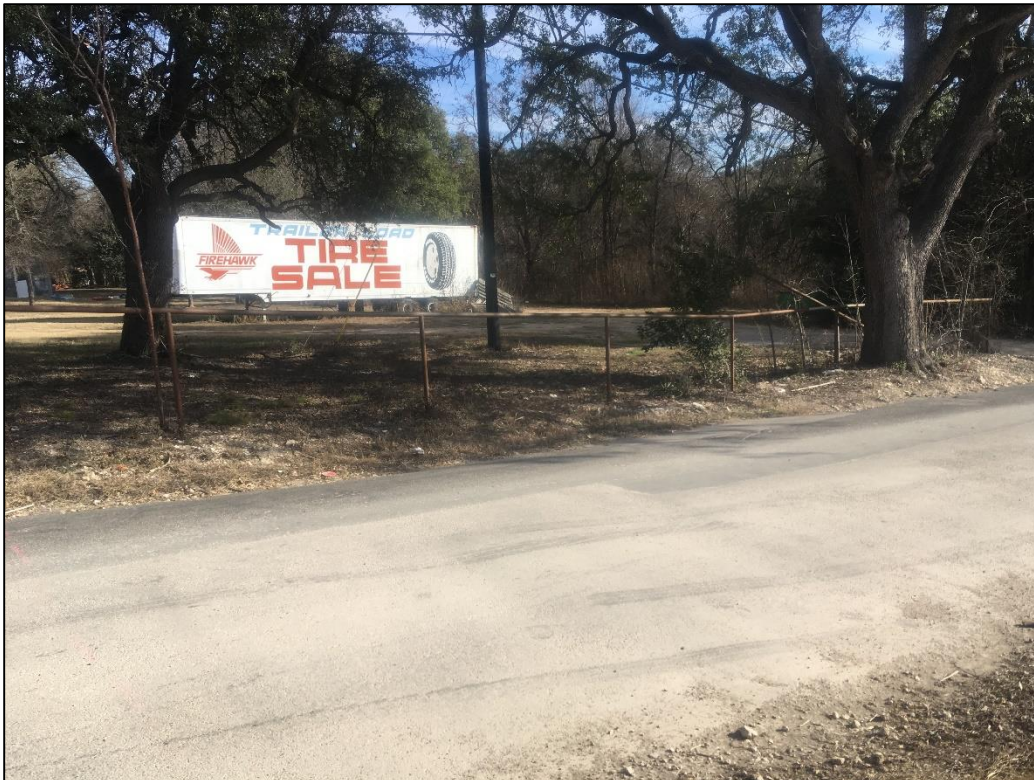
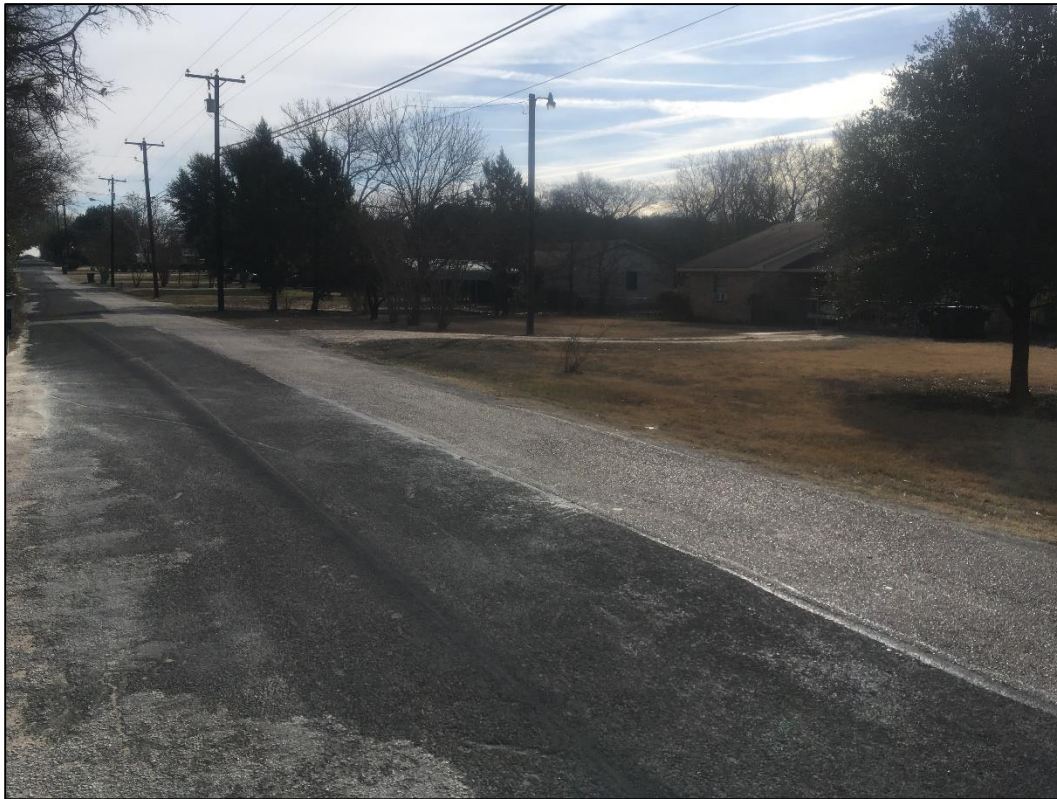
In the western portion of the project alignment, several parcels could not be surveyed due to lack of Right of Entry (ROE) (see Appendix A, Exhibit 4). In total, the parcels which could not be surveyed added up to 1,070 linear feet. However, this was not deemed to be detrimental to the survey as the parcels are not entirely adjoining and do not constitute the entire width of the alignment. When the parcels without ROE were examined from adjoining parcels with ROE, it was observed that they had been heavily disturbed by utilities and landscaping activities (Appendix B, Photos 14 and 15). It is unlikely that the parcels without ROE contain intact cultural resources.

Photo 14. Parcel without ROE near intersection of FM 317 and Poison Oak Road. Note landscaping disturbances. View to the northeast.

**Photo 15. Parcels without ROE west of intersection of Poison Oak Road and Ridgeway Drive. Note disturbances from utilities and landscaping. View to the southeast.**
