## **Intensive Cultural Resources Survey Of The Proposed City Of Llano West Ranch Road 152 Pedestrian Sidewalk Improvement Project, Llano County, Texas**

TEXAS ANTIQUITIES PERMIT NO. 7989

CSJ: 0396-09-021

SWCA Cultural Resources Report No. 17-217

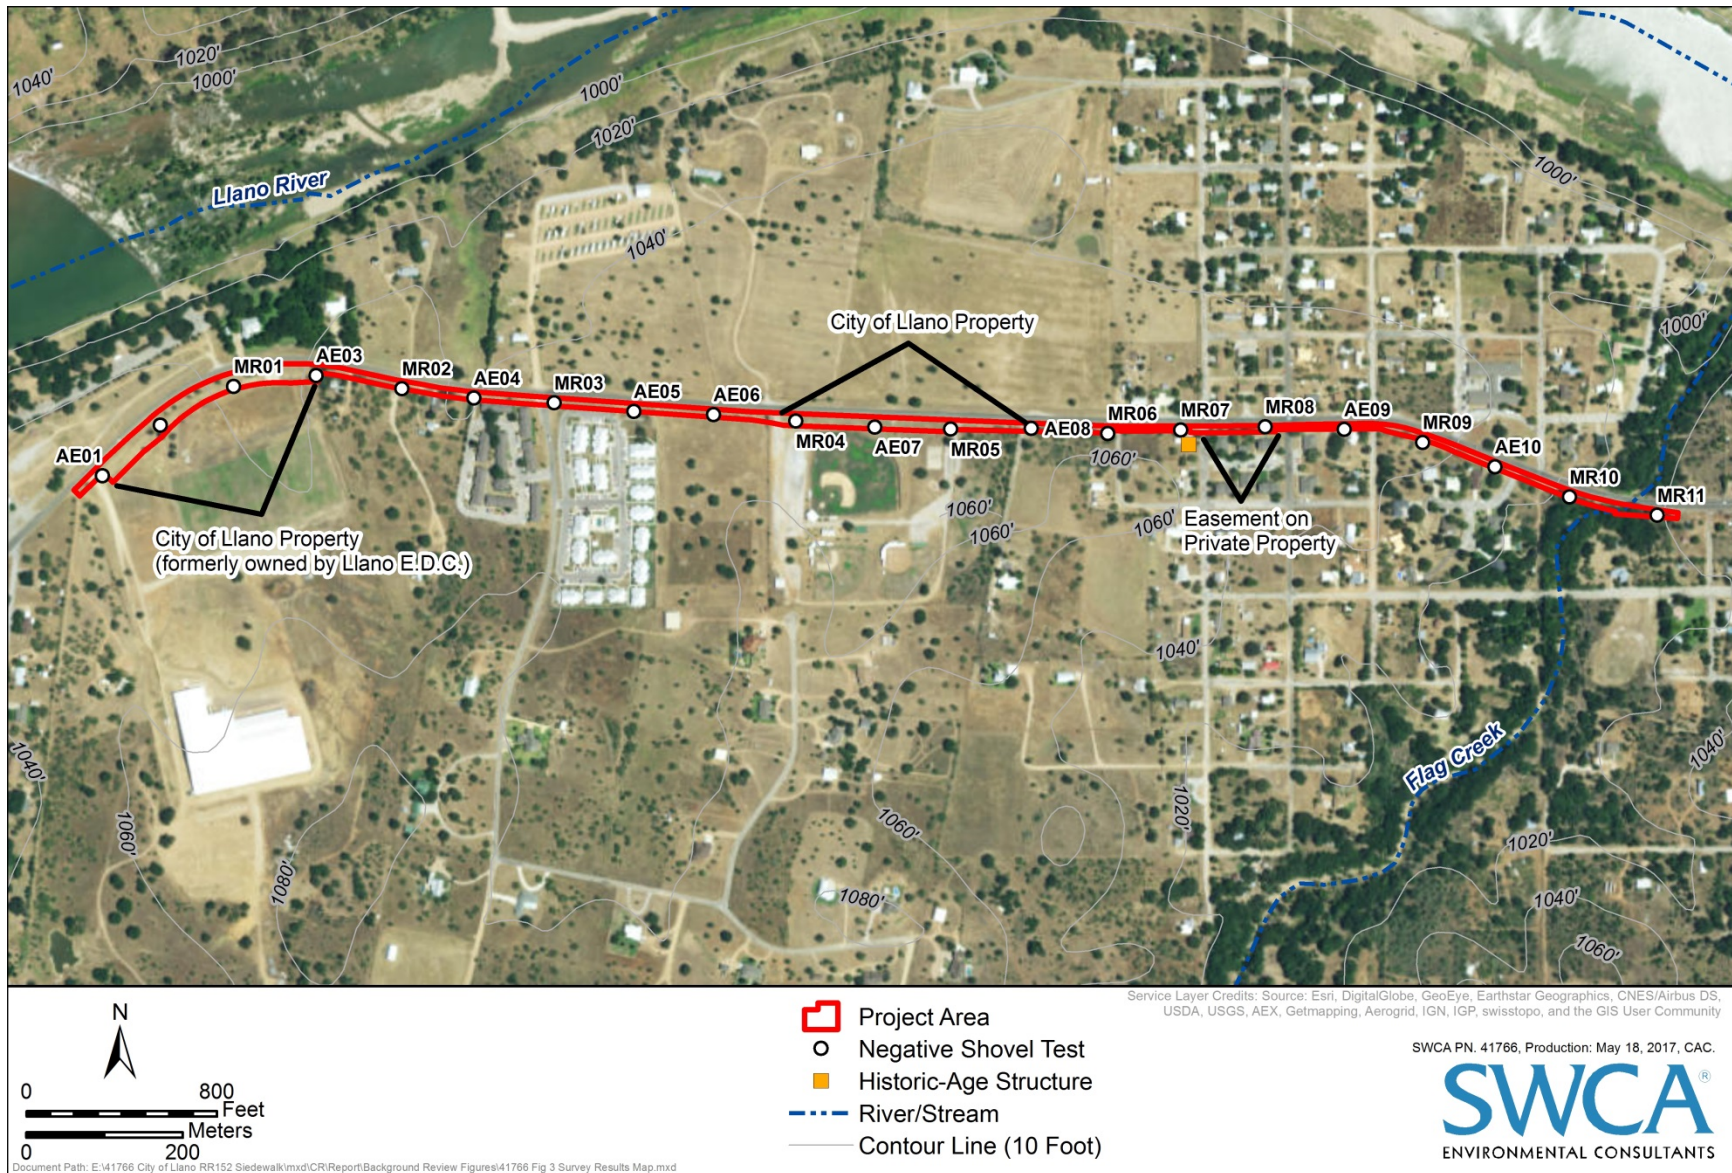
Figure 5. Survey Results.

Archaeologists excavated 21 shovel tests within the APE (Table 1; Figure 5). Excavated soils consisted of a light brown to dark reddish brown (7.5YR 4/6 to 5YR 3/4) loamy sands with dense eroding bedrock gravels. Shovel tests were typically terminated at 30 cmbs with only two reaching a maximum depth of 50 cmbs, due to a high density of gravels and eroded bedrock at depth. The density and shallowness of eroding quartz-rich schist reduced the likelihood of deeply buried archaeological deposits being represented. Archaeologists identified modern brown bottle glass and plastic trash along RR 152 and within some shovel tests. Neither the surface, nor the subsurface investigations identified any prehistoric or historic cultural materials.

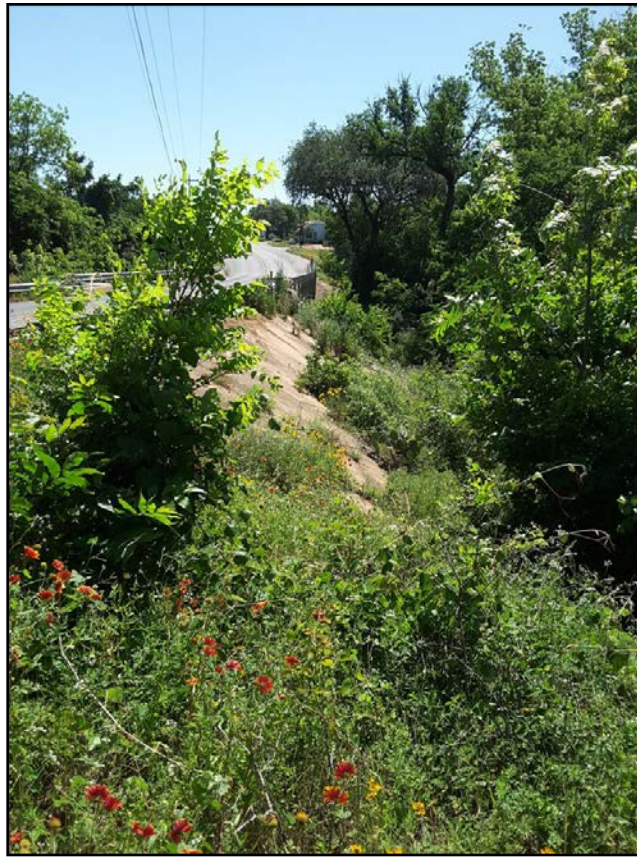
On April 26, 2017, SWCA archaeologists conducted an intensive pedestrian survey with shovel testing of the proposed approximately 6,970-foot-long (1.32-mile) alignment for the proposed City of Llano West RR 152 Pedestrian Sidewalk Improvement project (Figure 5). Survey included intensive pedestrian survey with shovel testing along the southern side of RR 152 including a low water crossing at the proposed sidewalk's crossing of Flag Creek (Figures 6 and 7).

**Figure 6.** Overview of bridge crossing at Flag Creek, view east.

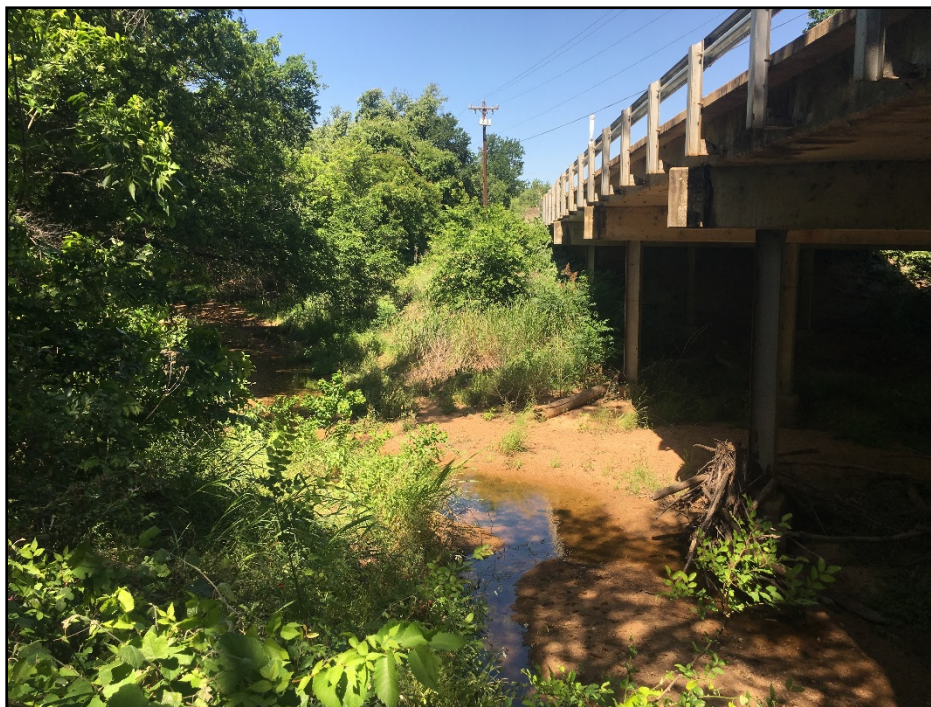
**Figure 7.** View of the channel of Flag Creek and the adjacent bridge.

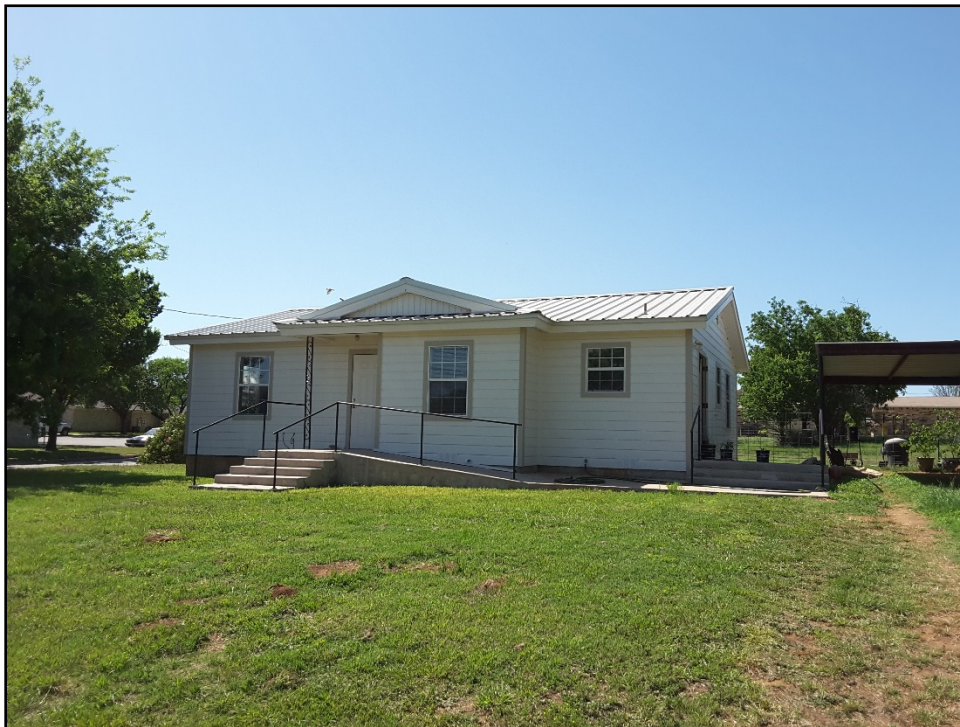
The structure is a one story, ca. 1940 Minimal Traditional dwelling with a moderate pitch, cross gable roof of modern standing seam metal. It is elevated approximately two feet on a concrete block foundation. Windows are vinyl sash replacements. The partial width porch is under a central front gable supported by a decorative metal post on the left and by an enclosed room on the right. The door is a modern panel replacement and the porch has concrete steps and a metal handrail leading toward the street and a concrete ramp running parallel to the house. The right elevation also has a concrete deck porch leading to a side door. There is a detached metal carport on the lot. Street view imagery from August 2013 show the house with historic metal sash windows, wood drop siding, board and batten skirting, and what appears to be a flush door. Due to the major modifications to windows, doors, and siding within the past five years, the house is not eligible for the NRHP. The remaining structures in the immediate project area are all less than 45 years of age. The one historic age structure is not eligible; therefore, there are no historic properties present or affected in the project area.

**Figure 12.** Historic age structure at 1200 RR 152, view south.
