# A Cultural Resources Survey of the Cross Roads Special Utility District US Hwy 259 Water Well and Pump Station Rusk County, Texas

Antiquities Permit #7433 Final Report

Project Number 567

September 2015

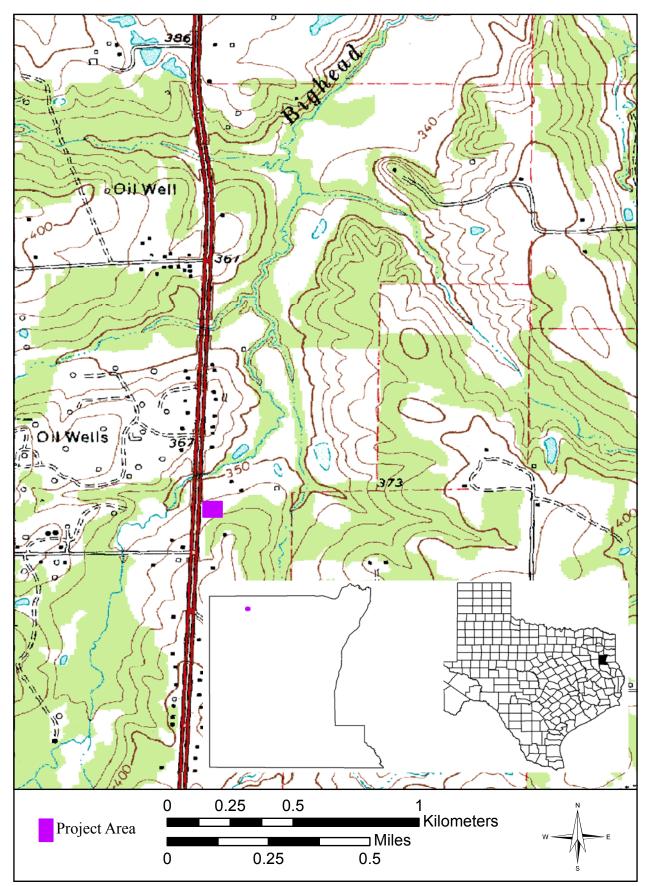
Figure 1. Project area on Kilgore SE 7.5' Quad.

The projects area includes a 63.7 square meter (m) (209 foot (ft)) square property totaling 0.4 hectares (ha) (1.0 acres (ac)). The corners of the property were staked by land surveyors. Along with survey stakes and pins, the property is delineated by a fenceline to the north and a tree line to the south. The western boundary is the US Highway 259 corridor. The eastern boundary was marked with surveyor pins and stakes. Vegetation was mostly mature pine trees with a moderate understory of various bushes and shrubs. Ground cover was pine straw and leaf litter. Soils were described as Cuthbert fine sandy loam, 25 centimeters (cm) (10 inches (in)) deep over clay (NRCS 2015).

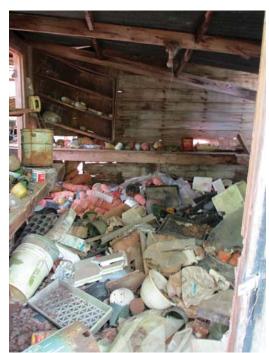
The building is a single story, earth-fast frame structure, with a dirt floor and vertical board walls. The roof was corrugated tin and plastic. The building has garage doors on the east and west side with one large room between them. Windows were 9x9 or horizontal lights in aluminum frames along the north and west walls of the building. Aluminum frame windows were not common place until the 1970's (Staveteig 2008). The interior of the room is littered with debris from potting plants (e.g., plastic and earthen plant pots of various sizes, buckets, plastic pallets, fragments of wood boards, etcetera. There is a second room south of the initial room with a continuous shelf around

Interior of building, note flower pots and pallets

The proposed Cross Roads Special Utility District water well will include clearing the one acre property, demolishing the building, removing the debris, and filling the old water well before constructing the proposed water well and pump facility. The observed building appears to be less than 50 years old. It is made of modern materials and debris observed in the building suggest it was used as a place for selling potted plants. Texas Antiquities Permit #7433 was obtained by DETAC for the cultural resources survey of the proposed water well and pump facility.

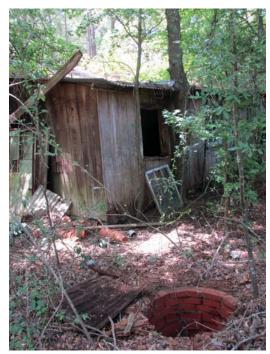
Water well on northeast corner of the building

the south side of the room. Window openings were large and covered with remnants of chicken wire; no frames or glass were observe around the second room. Dry-pressed Whitecastle Brick was observed around the base of the house along with other paving stones. Other modern cultural features included the bed of a 1970's pickup truck filled with scrap metal in the powerline right-of-way and a water well roughly 80 cm (32 in) in diameter line with modern dry-pressed brick near the northeast corner of the building.

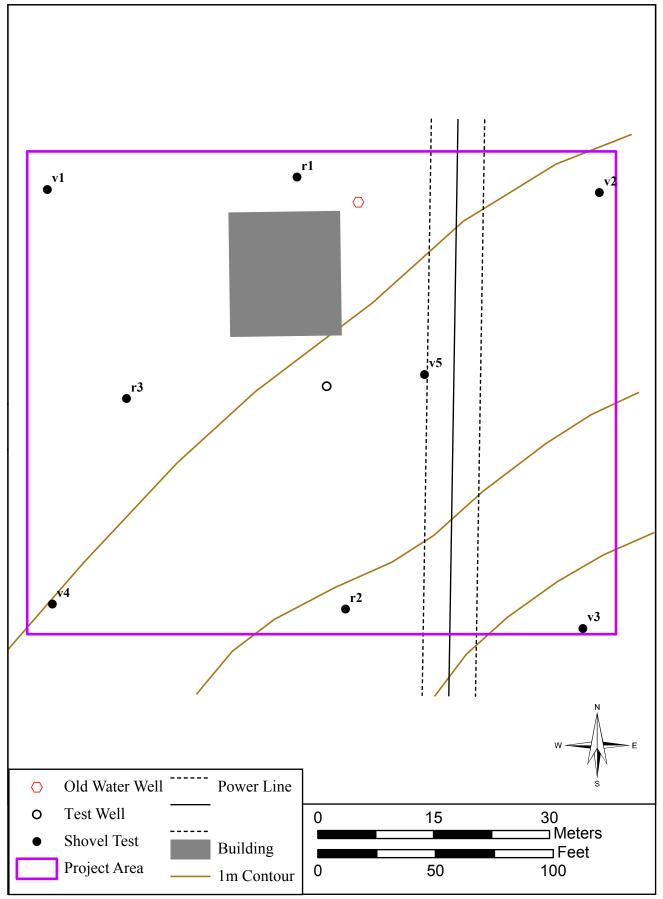
Figure 3. Project area shovel tests and surface features

A total of eight shovel tests were excavated across the property (Figure 3). Shovel testing found 10 to 30 cm (4 to 12 in) of light brown, reddish brown, and grayish brown sandy loam (Table 1). No cultural material was observed in the shovel testing or during the surface inspection of exposed areas beyond modern debris.
