## Intensive Archeological Survey of Old Gertrudes Road at Stewart Creek, Jack County, Texas

## Intensive Archeological Survey of Old Gertrudes Road at Stewart Creek, Jack County, Texas Fort Worth District

Kevin Hanselka, Principal Investigator  
Texas Antiquities Permit No. 8247  
CSJ: 0902-40-027  
January 12, 2018

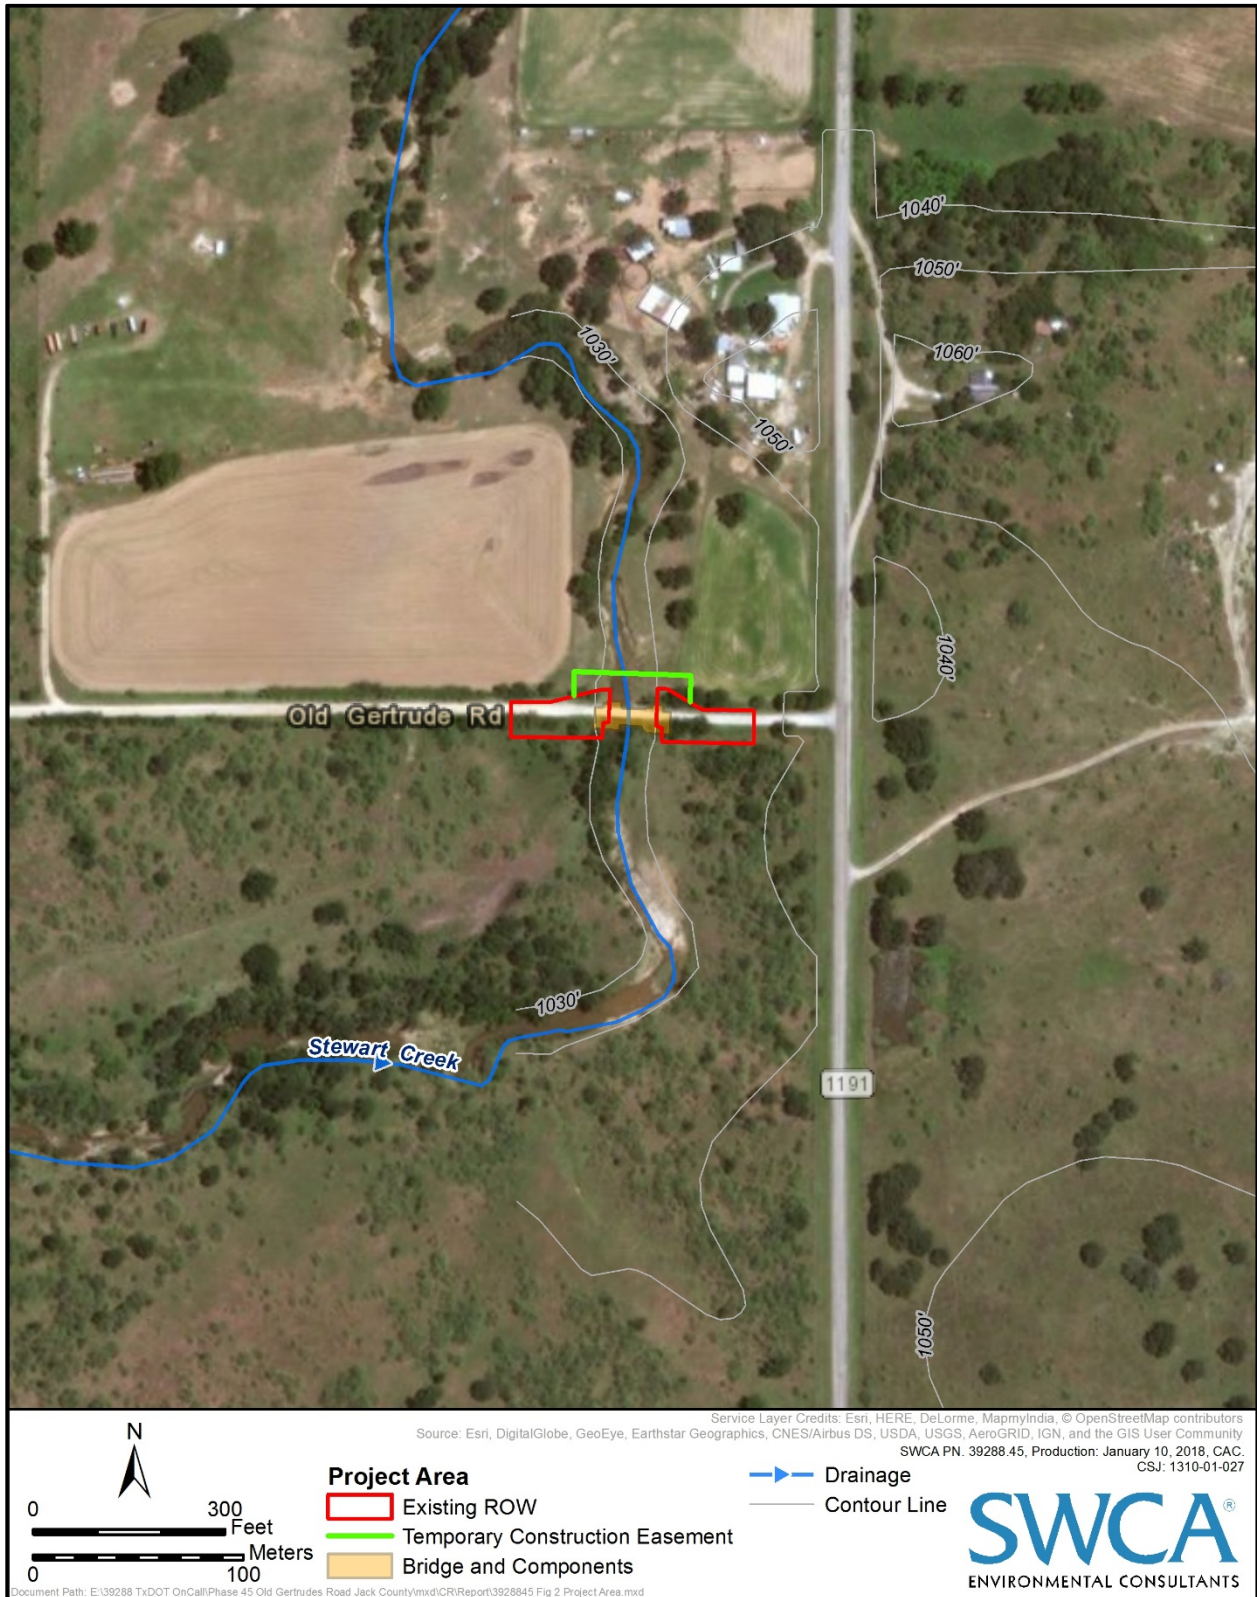
Figure 2. Project area.

**Area of Potential Effects (APE):** The total APE is about 375 feet long and covers approximately 0.74 acre, including 0.58 acre of existing ROW and 0.16 acre of temporary construction easement on the northern side (Figure 2). Typical depth of impacts are approximately 12 to 24 inches for the approaches, while maximum depth of impacts may reach over 10 feet for gabion protection and six 36-inch-diameter drill shafts.

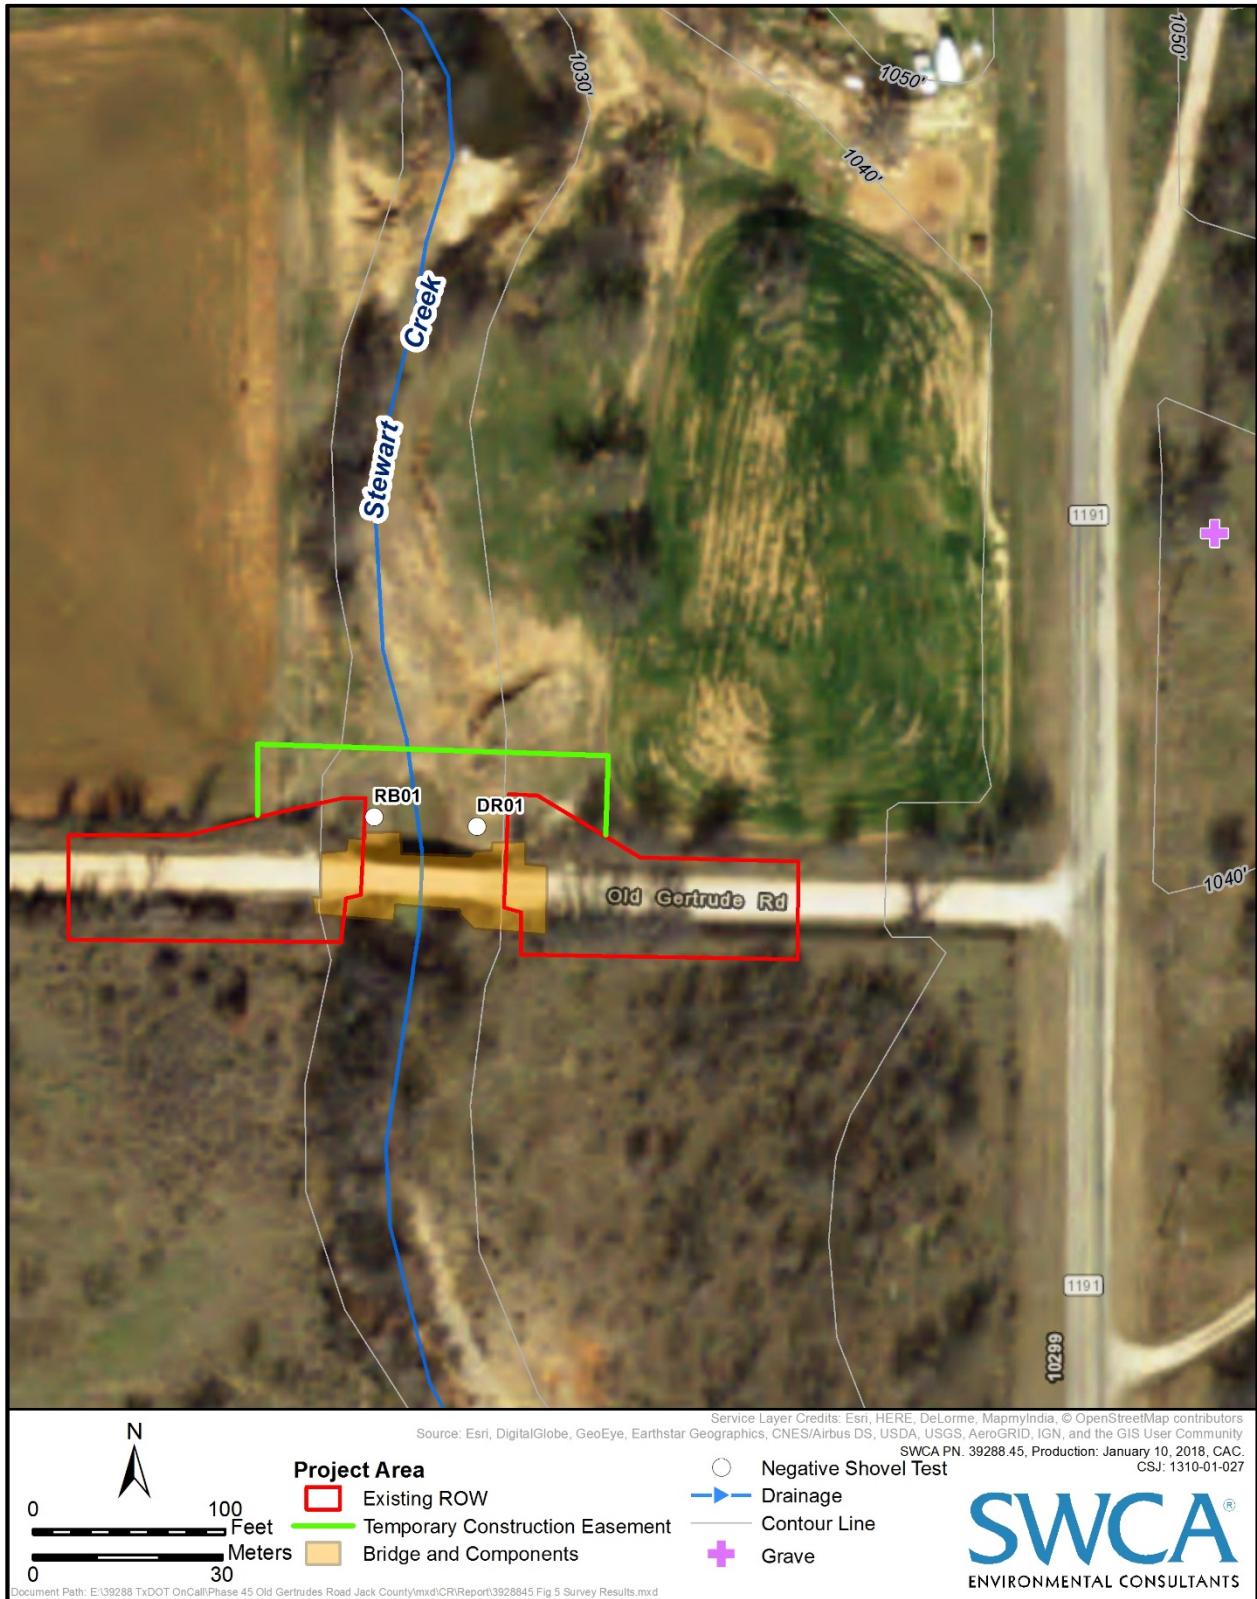
Figure 5. Survey results

**Methodological Description:** The field investigations complied with the THC Archeological Field Survey Standards (THC 2018b) and Council of Texas Archeologists guidelines. The investigations entailed an intensive pedestrian survey of the entire 0.74 acre (Figure 5). Shovel test locations were chosen at the discretion of the project archeologist and focused on areas with the least disturbance within the APE, as well as areas with alluvial deposits. Archeologists also examined of extensive natural exposures located within the APE. In areas with a potential for deeply buried deposits, deep testing (e.g., mechanical trenching) is required to assess impacts commensurate with the depth of the APE. For this Project, deep testing was not conducted for several reasons: 1) the natural profiles (see discussion below) did not reveal deep alluvial deposits; 2) the existing ROW has been thoroughly impacted; 3) deep impacts are not expected within the temporary easement.

**Project Area Description:** On January 4, 2018, SWCA archeologists conducted a pedestrian survey of the APE, using shovel testing and available exposures to assess the potential for buried cultural deposits (see Figure 5). The existing ROW has been disturbed by the original bridge and roadway construction. Gabion structures around both bridge footings support elevated fill sections (Figures 6 and 7). On both sides of Stewart Creek, terraces were low and had a hummocky topography because of differential erosion and various disturbances. Sparse grasses afforded moderate surface exposure, which was augmented by cutbank profiles. A thin line of trees borders the existing roadway.

**Further Work:** No further work is recommended.

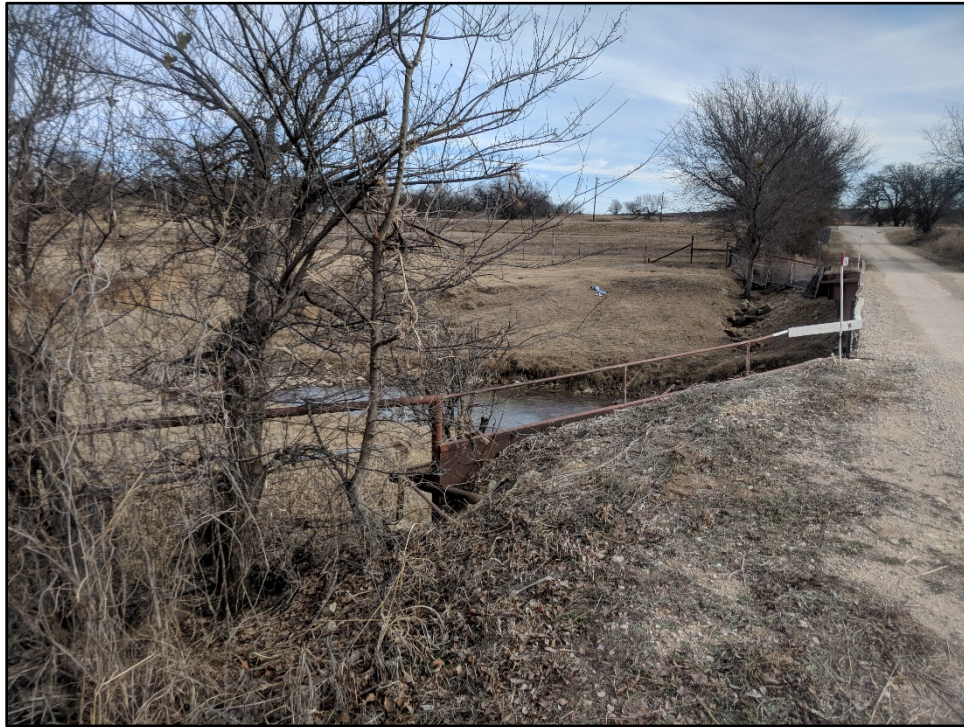
**Figure 6.** Fill section behind gabion wall in existing ROW, facing east and showing temporary easement on northern side of APE.

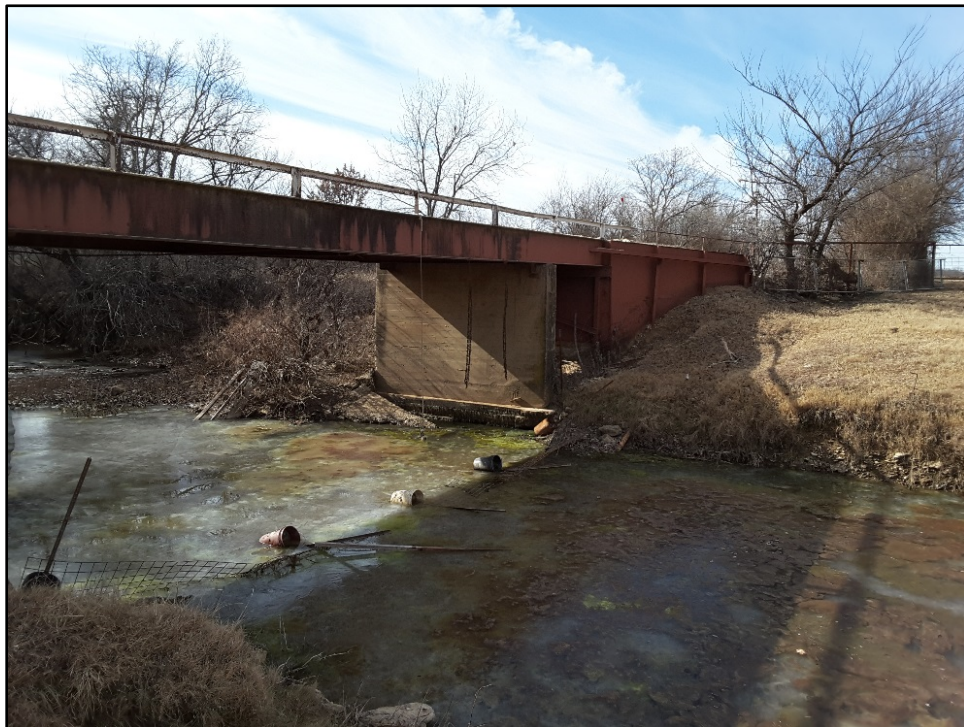
**Figure 7.** Temporary easement on northern side of APE.

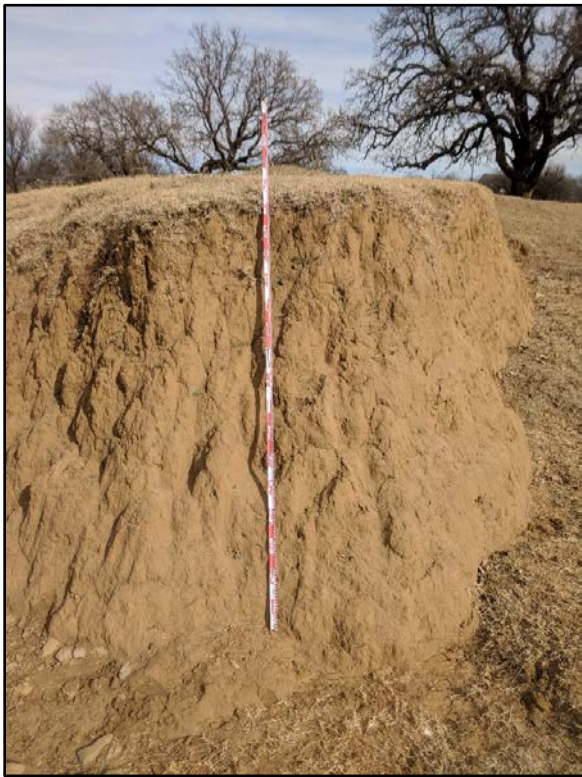
Erosional cutbanks were primarily located in the temporary easement in the northeastern quadrant, but also along the lower terraces bordering the creek. The profiles showed approximately 1 to 1.5 m of fine sandy loam overlying a substrate of gravels and cobbles, likely channel deposits from a relict stream (Figures 8 and 9). The channel deposits were poorly sorted, subangular to angular limestone and sandstone. Overlying sediments were tan to lightly rubified with a slightly darker, weakly developed upper A horizon. Boundaries are gradual to diffuse; inclusions include rootlets, few gravels, and insect burrows. The soils are described as calcareous, but no pedogenic calcium carbonate development was clearly discerned. Sediments apparently derive from both alluvial and colluvial input; located immediately upslope to both the east and west of the easements, agricultural fields provide sources of slopewash deposition (see Figure 5).

**Figure 8.** Natural erosional profile in temporary easement in southwestern quadrant, facing west. Note gravels and cobbles at base of profile.

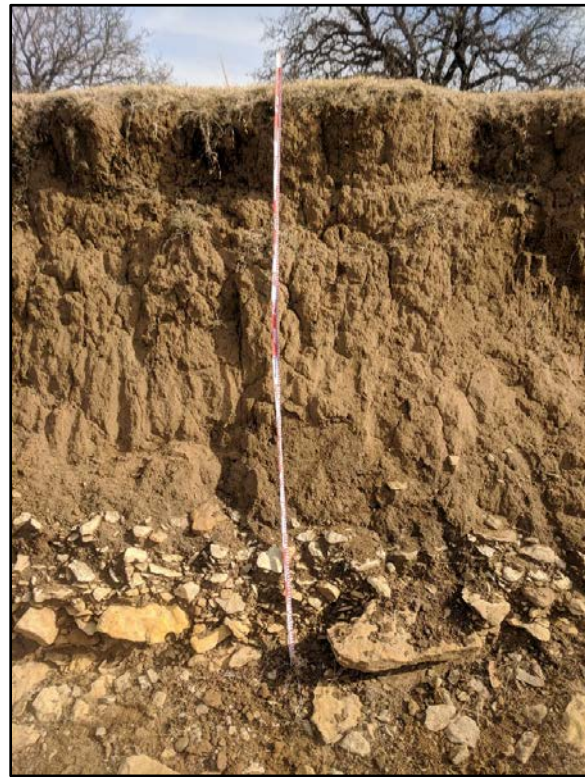
**Figure 9.** Natural erosional profile in temporary easement in southwestern quadrant, facing west. Note gravels and cobbles at base of profile.
