# FORT WORTH ZOO CREEK DRAINAGE IMPROVEMENTS PROJECT

TARRANT COUNTY, TEXAS

USACE Project Number SWF-2017-00128 Texas Antiquities Permit Number 8179

Cultural Resources Report 2017-72 December 05, 2017

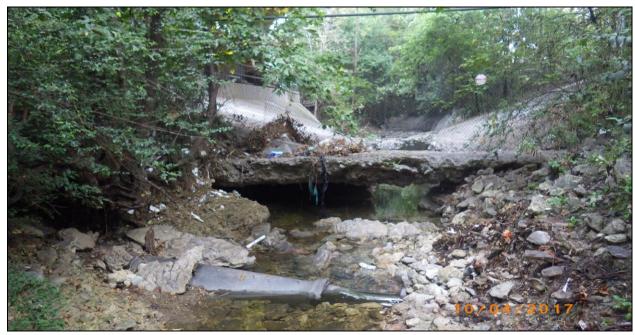
Figure 7. Exposed sewer line in Zoo Creek under Park Hill Bridge.

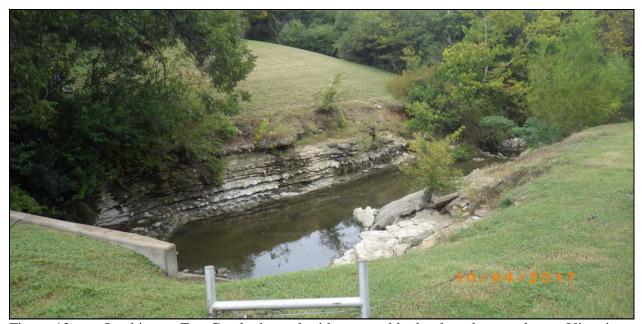
Figure 12. Looking at Zoo Creek channel with exposed bedrock and steep slopes. View is to the southeast.

The Detention Wall survey area follows the existing sewer line and had good ground visibility (greater than 30%) during the survey. Both the western and eastern ends were very steep and have been impacted by the sewer line as well as bridge construction (Figure 6). The existing sewer line is exposed in the Zoo Creek channel, where the creek crosses under the Park Hill Bridge (Figure 7). The Sewer Line survey area was situated on the highest elevations in the northeast and consisted of steep slopes and short grasses (Figure 8). The Culvert Replacement survey area was generally level (Figure 9) and the culvert was recorded as site 41TR306. The Forest Park Shelter, adjacent to the culvert was recorded as site 41TR307 (Figure 10). The Stormwater Outfall survey area had been extensively impacted by culvert and road construction projects (Figure 11) and had steep slopes (Figure 12).

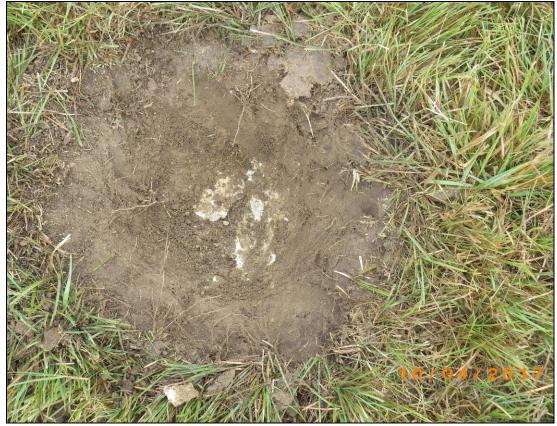
Figure 16. Bedrock exposed at the bottom of ST7.

55 cm below the surface (Figure 16). ST1 and 2 had construction fill associated with the existing sewer line that will be abandoned, while ST5-8, and 10 had brown gravely loam resting on the bedrock. ST14 yielded comparable results with bedrock at 20-cm and displaying very dark grayish brown gravely loam. ST11 was the deepest, revealing brown sandy soil to a depth of 55-cm. ST8 was the only shovel test displaying a color change, with a 35-cm layer of dark grayish brown clay loam overtop a 10-cm layer of very dark grayish brown clay loam. No prehistoric or historic cultural resources were recovered in any of the STs.

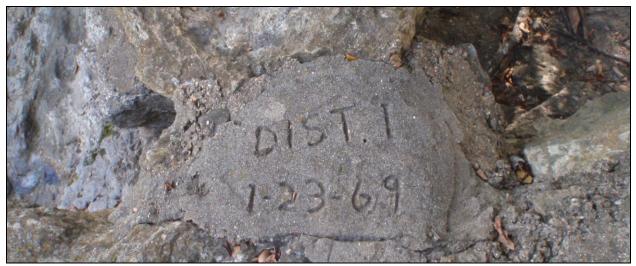
Figure 17. Date inscribed in the mortar on the culvert (41TR306).

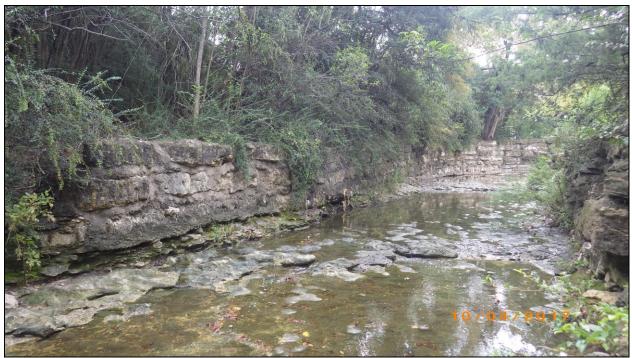
Figure 18. Retaining walls on the downstream (east side) of culvert (41TR306). View is to the southwest.

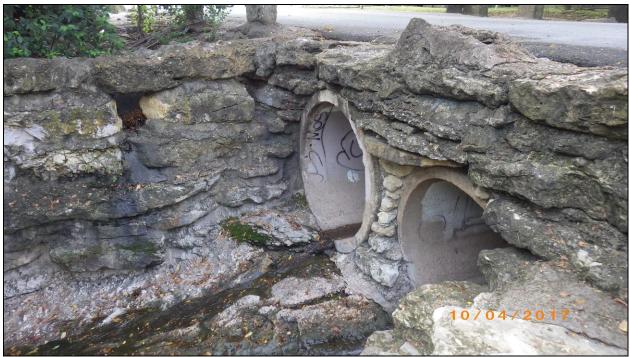
Close-up of where culvert and retaining walls meet. Only the culvert portion will be replaced (41TR306). Figure 19.

The purpose of this investigation was to determine if significant cultural resources are present in the proposed Fort Worth Zoo Creek Drainage Improvements project area in Tarrant County, Texas. Site 41TR306 is the remains of a historic culvert on S. Forest Dr. This culvert will be replaced and is not recommended eligible for NRHP or SAL listing. Site 41TR307, is a park shelter just outside the impact areas. The structure will not be impacted, but is recommended as eligible for listing on the NRHP and as an SAL. No other cultural resources were identified on or below the surface during the survey. Based on the results of the survey, ARC concludes that further cultural resource investigations for this project are unwarranted, and requests that the THC and USACE concur with this recommendation. However, if buried cultural materials are discovered during construction, the Archeology Division of the THC and the Fort Worth District of the USACE should be notified.

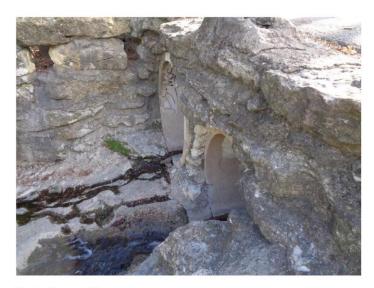
Figure 6: East side of culvert. Looking south.

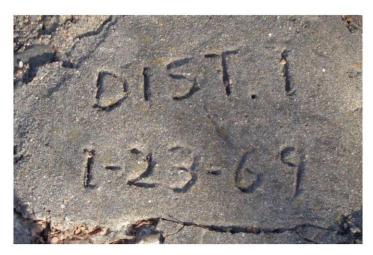
Alterations: As mentioned, it was likely that the culvert was repaired with concrete in 1969. Differences in the color of stone around the culvert pipes on the east face suggest that there may have been repairs in that general area, too.

Figure 8: Concrete patch near the south end of the east edge of the culvert dated 1-23-69.

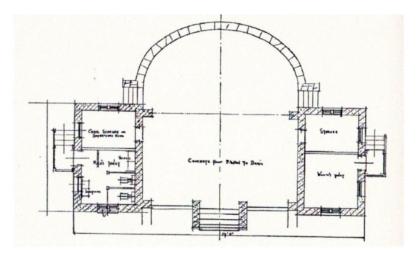
Figure 20: Hillside Park shelter floor plan, designed by Hare & Hare, and featured in the book *The New Play Areas: Their Design and Equipment* (1938), p. 134. This shelter is not extant.
