Report for Archeological Survey

CSJ: 0915-45-053,
County Road 622 at San Francisco Perez Creek
Medina County, San Antonio District

Eric R. Oksanen, Principal Investigator; Antiquities Permit No. **8194**

November 2, 2017

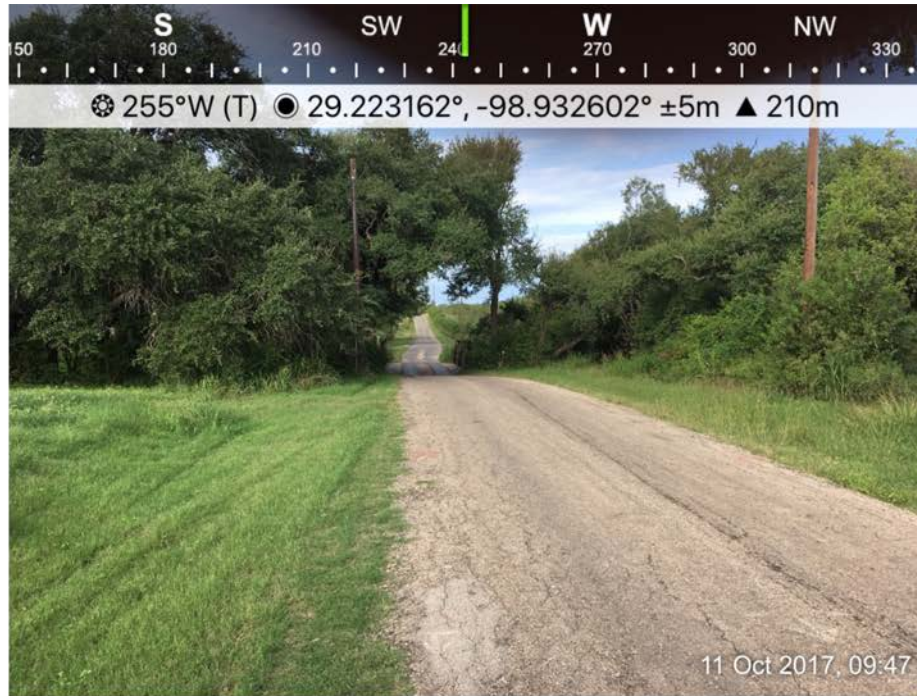
Figure 11. Overview of roadway showing elevated section.

- **Project Area Description:** The APE has been impacted by construction of the roadway and bridge and by maintenance of the facilities and structure. The roadway is on an elevated fill section with open drainage ditches between the roadway surface and boundary of the right of way (**Figure 11**). During the survey, the APE was covered in mixed grasses and forbs of varying height and density, with varying surface visibility.

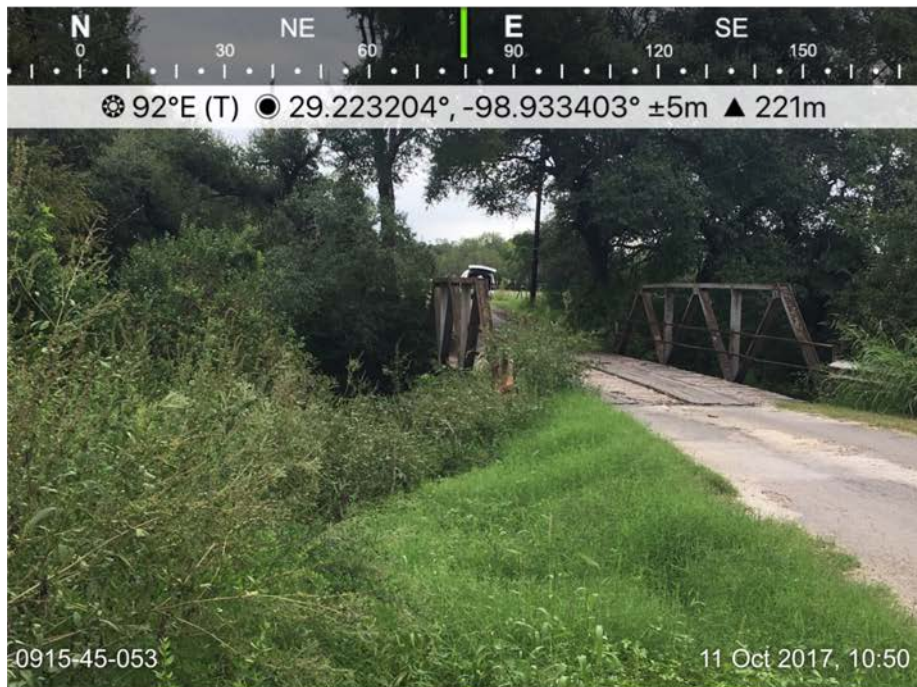
Figure 12. West abutment.

The APE has been modified by bridge and road construction. The approaches and the abutments are constructed on fill sections that have been used to elevate and stabilize the road and bridge (**Figures 12 and 13**). A single shovel probe was excavated to a depth of 42 cm in the northeast quadrant. No cultural material was observed and the excavation was terminated by a lens of cobble-size gravels (**Figure 14**). Thick gravel lens were observed in the stream channel. The sediments in the APE are clays with gravels and are unlikely to contain buried intact archeological deposits.

The APE has been impacted by construction and maintenance in the narrow 40-ft wide right of way. These impacts include stabilizing the stream banks at the abutments and elevating the approaches and excavating drainage ditches. Therefore, it is unlikely that intact archeological deposits exist in the APE. No evidence of archeological material associated with 41ME103 or 41ME159 were encountered in the APE.

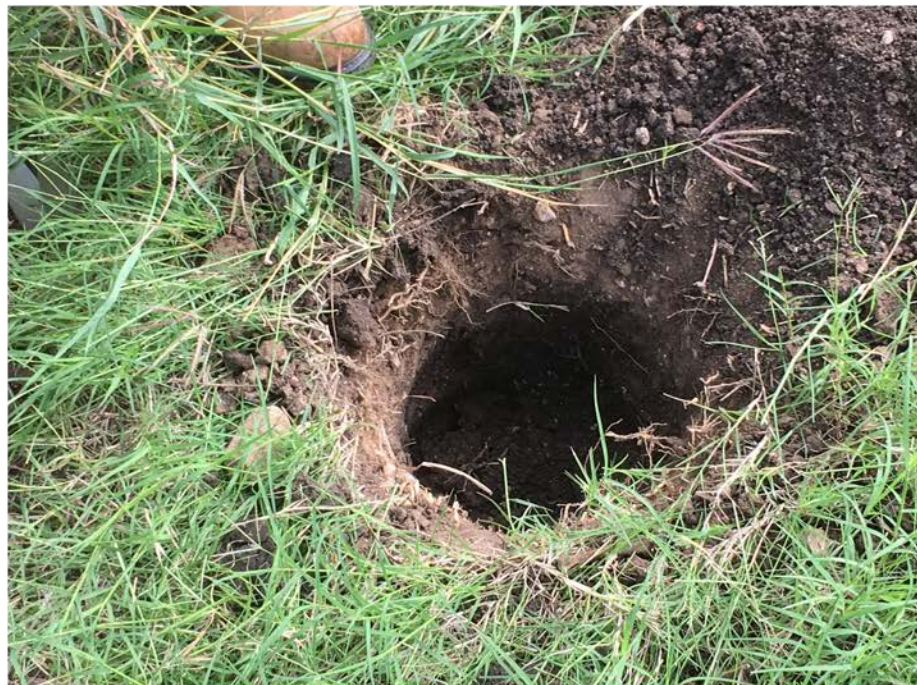
Figure 14. Shovel Test 1.

ST#	Depth (cm)	Description
1	0-30	10YR6/1 Clay loam with gravel inclusions.
	30-42 Terminated.	10YR6/2 Clay loam with cobble-size chert and limestone gravels.

- **APE Integrity:** The APE is in an active floodplain that is susceptible to high-energy flooding. Subsurface exposures and a single shovel probe revealed a matrix of clay and coarse gravels that are unlikely to contain intact archeological deposits. The recorded sites adjacent to the APE are characterized as surface scatters or shallow buried deposits of lithics and burned rock.
