## Cultural Resources Survey Of The Indian Creek Channel Improvements Project, Denton County, Texas

## CULTURAL RESOURCES REPORT

Cultural Resources Report  
August 2017

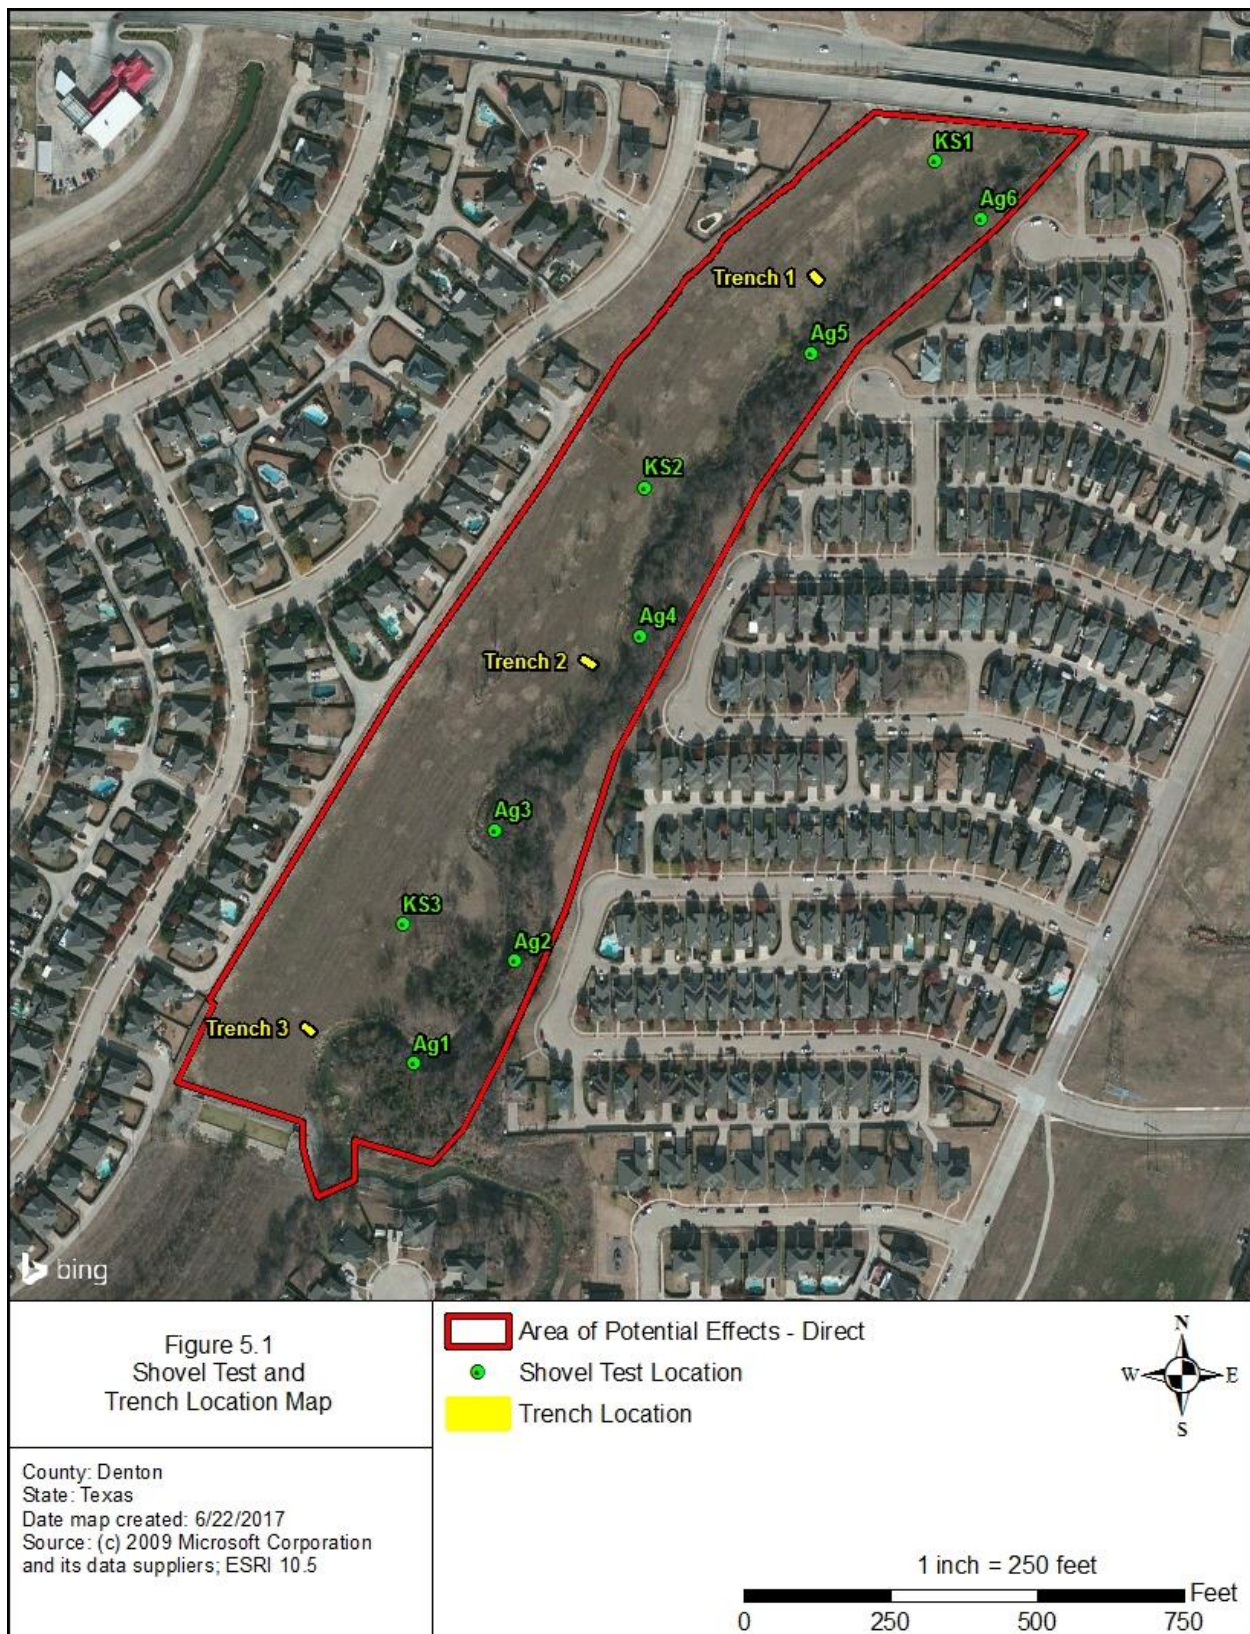
During the pedestrian survey, no cultural resources were encountered within the 17.6-acre APE. Shovel test unit and trench locations are illustrated in **Figure 5.1**, a photograph location map and photographs are located in **Appendix A**, and trench profile photographs are located in **Appendix B**.

During the pedestrian survey, nine negative shovel tests were excavated throughout the APE (**Figure 5.1**). Shovel tests AG1 through AG6 were located within the upland slopes and narrow floodplain terrace on the east side of Indian Creek. These shovel tests primarily encountered silty clay (10YR 4/2 and 10YR 5/2) that exceeded 40 cmbs and were terminated due to the perceived culturally sterile nature of the soil. Due to the limited space east of the creek, and the topographic setting, shovel tests were primarily placed directly adjacent to the creek when the slope was less steep. Based on observations made during the survey and through shovel testing, it was determined that there was no potential for deeply buried deposits to be located east of the creek and therefore would be sampled entirely through shovel testing.

Prior to the survey, IES archeologists were aware that there was potential for deeply buried archeological sites to be located within the floodplain west of the creek. As such, the floodplain area would require backhoe trenching to properly assess the area. Shovel testing was also conducted to ensure that appropriate sampling was achieved within the floodplain. Shovel tests KS1 through KS3 were excavated in between trench locations and typically encountered a silty clay loam (10YR 4/3) that exceeded 60 cmbs.

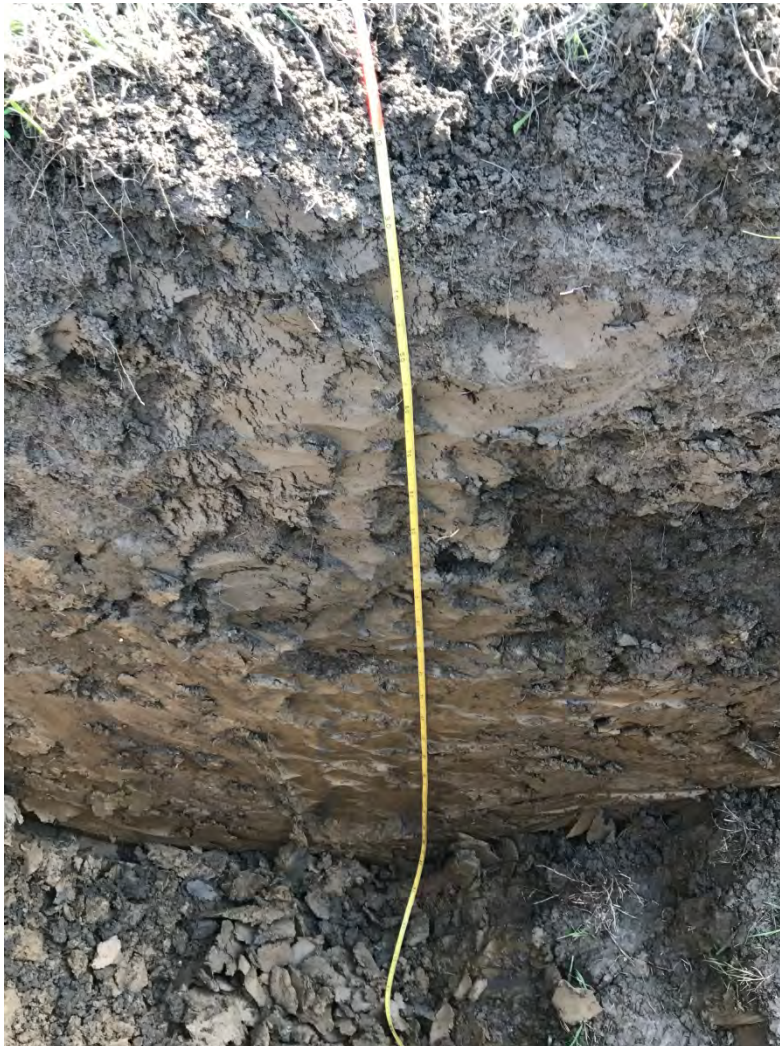
Photograph 1 – Trench 1

Trench 1 was located approximately 110 m southwest of Hebron Parkway and approximately 10 m northwest of Indian Creek. Trench 1 was 5.6 m long, 1 m wide, and 2.5 m deep. The trench was excavated perpendicular to the Indian Creek channel and identified four distinct soil zones (**Appendix B, Photograph 1**). The trench was within a minimally sloped and uniform topographic setting (**Appendix A, Photographs 12 through 16**). No cultural deposits were identified within Trench 1.

- Zone 1 was characterized by a modern vegetative zone to a depth of approximately 30 cmbs. This zone consisted of a homogenous, olive brown (10Y 4/3) silty clay loam with abundant rootlet fibers less than 2 millimeters (mm) in diameter and few round gravels less than 1 cm in size. This zone featured a fine granular structure that was friable. The lower boundary transition was diffuse and wavy.

- Zone 2 contained an olive brown (10Y 4/3) silty clay loam to a depth of approximately 160 cmbs. The silty clay soil was blocky and friable and contained common rootlet fibers and a few roots less than 2 cm in diameter. The zone contained 1 to 2 cm diameter mottles of 2.5Y 5/4 soil, which were comprised of a fine sand. This zone had a lower boundary that was clear and smooth.

- Zone 3 was characterized by a homogenous, very dark grayish brown (10Y 3/2) clay loam to a depth of approximately 140 cmbs. This zone contained unconsolidated Calcium Carbonate (CaCO<sub>3</sub>) inclusions approximately 3 cm in diameter that were common and small angular gravel less than 3mm in diameter. A few krotovina were present and exceeded the depth of the zone. The bottom of the zone contained an abrupt and smooth transition.

- Zone 4 contained an olive brown (10Y 4/4) clayey soil that feature common CaCO<sub>3</sub> inclusions (3 cm in diameter), a wedge structure, and a high amount of minerals. The zone exceeded 250 cmbs and had a few krotovina present to the bottom of the trench.

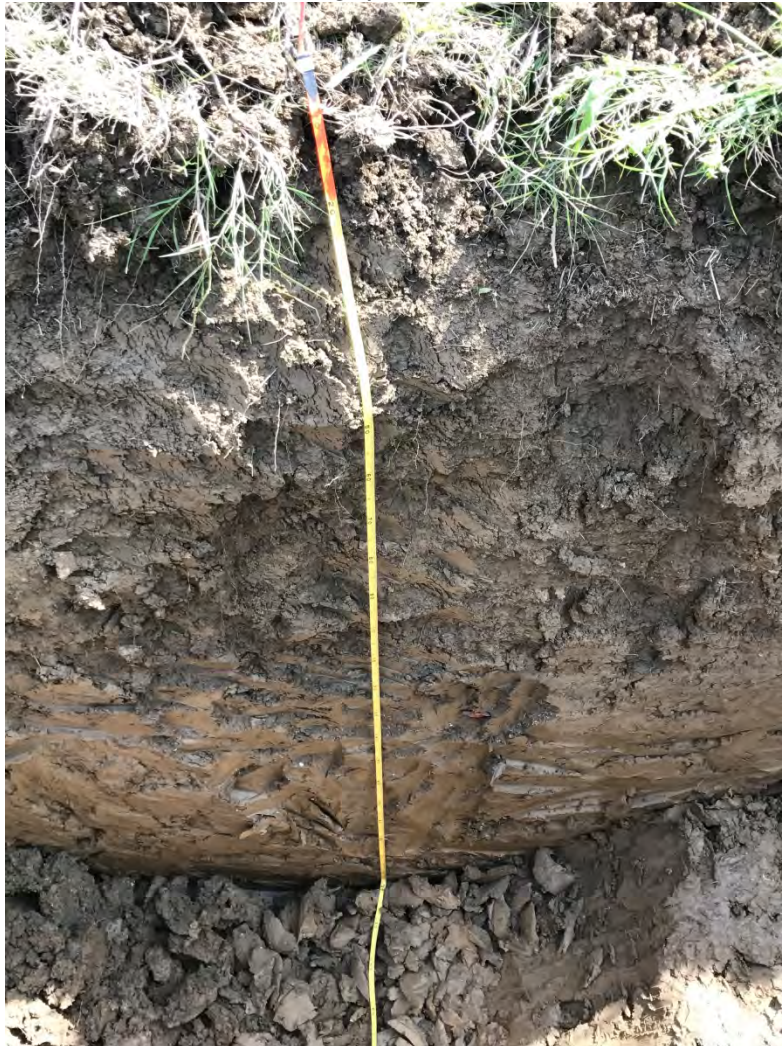
Photograph 2 – Trench 2

Trench 2 was located approximately 340 m southwest of Hebron Parkway and approximately 13 m northwest of Indian Creek. Trench 2 was 5 m long, 1 m wide, and 2.4 m deep. The trench was excavated perpendicular to the Indian Creek channel and encountered five distinct soil zones (**Appendix B, Photograph 2**). The trench was within a minimally sloped and uniform topographic setting (**Appendix A, Photographs 17 through 21**). No cultural deposits were identified within Trench 2.

- Zone 1 was characterized by a modern vegetative zone to a depth of approximately 30 cmbs. This zone consisted of a homogenous, olive brown (10Y 4/3) silty clay loam with abundant rootlet fibers less than 2 mm in diameter and few round gravels less than 1 cm in size. This

zone featured a fine granular structure that was friable. The lower boundary transition was diffuse and wavy.

- Zone 2 contained an olive brown (10Y 4/3) silty clay loam to a depth of approximately 160 cmbs. The silty clay soil was blocky and friable and contained common rootlet fibers and a few roots less than 2 cm in diameter. The zone contained 1 to 2 cm diameter mottles of 2.5Y 5/4 soil, which were comprised of a fine sand. This zone had a lower boundary that was clear and smooth.

- Zone 3 was characterized by a mottled, dark grayish brown (2.5Y 4/2) silty clay to a depth of 130 cmbs. The soil in this zone featured a very firm massive structure with common root fibers less than 1 mm in diameter and a gradual and wavy lower boundary. Mottling less than 1 cm in diameter was common and consisted of a reddish brown (5YR 4/4) and was clayey.

- Zone 4 contained a dark gray (10YR 4/1) clay loam that contained abundant brown (10YR 4/3) mottling that exceeded 150 cmbs. This zone contained a blocky structure that was sticky and featured abundant mussel shell fragments, charcoal, and marine snail. This zone had a diffuse and wavy lower boundary.

- Zone 5 contained a dark gray (10YR 4/1) clay loam that contained abundant brown (10YR 4/3) mottling that exceeded 240 cmbs. This zone contained a few mussel shell fragments and charcoal flakes. The zone had a fine granular structure that was blocky and very sticky.

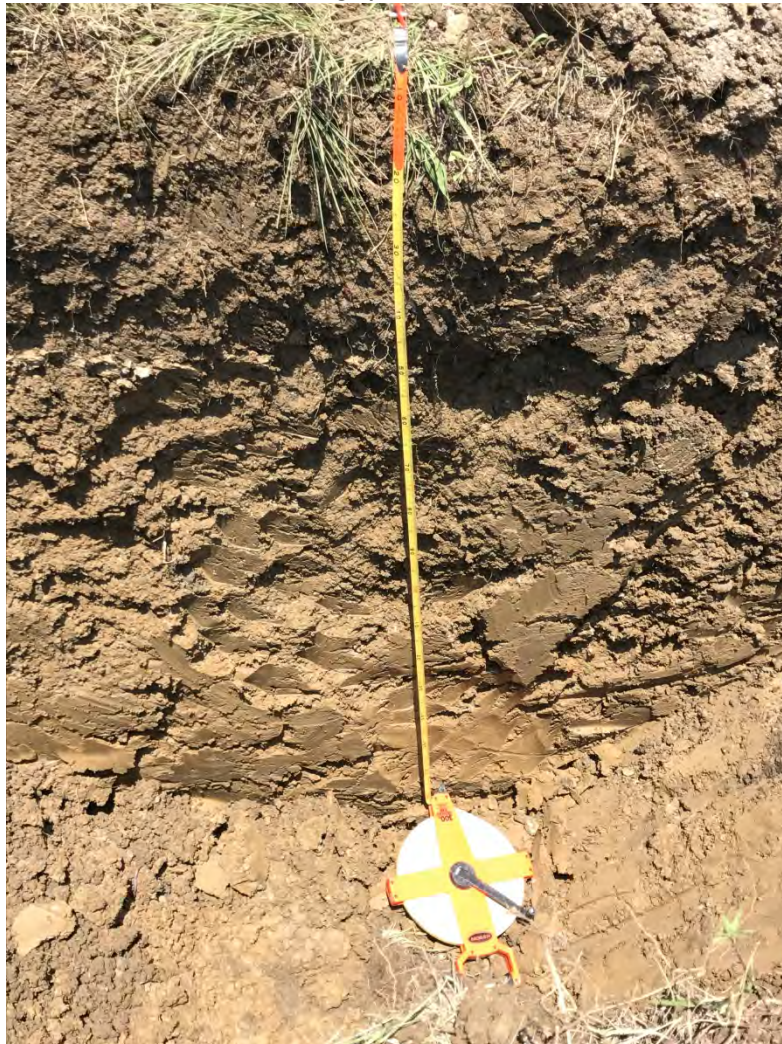
Photograph 3 – Trench 3

Trench 3 was located approximately 575 m southwest of Hebron Parkway and approximately 10 m northwest of Indian Creek. Trench 3 was 5.3 m long, 1 m wide, and 1.7 m deep. The trench was excavated perpendicular to the Indian Creek channel and encountered four distinct soil zones (**Appendix B, Photograph 3**). The trench was within a minimally sloped and uniform topographic setting (**Appendix A, Photographs 1 through 4 and 11**). No cultural deposits were identified within Trench 3.

- Zone 1 was characterized by a very heterogeneous soil that was clearly disturbed and contained concrete chunks and large rocks. The gravelly silty clay loam was characterized by a dark grayish brown (10YR 4/2) mottled by very dark grayish brown (10YR 3/2) and dark yellowish brown (10YR 4/4). Between 45 and 50 cmbs, there was a dense lens of concrete chunks. This zone featured a medium to coarse granular structure that was friable. The lower boundary transition was abrupt and wavy.

- Zone 2 contained an olive brown 2.5Y 4/3 silty clay soil that contained few unconsolidated  $\text{CaCO}_3$  inclusions less than 1 cm in size, few rootlet fibers, small angular gravel, and krotovina. (10YR 5/6) sand to a depth of approximately 19 cmbs. This zone contained a fine grain wedge structure and had an abrupt and smooth lower boundary.

- Zone 3 was characterized, by an olive brown (2.5Y 4/4) clay loam to a depth of 140 cmbs.  $\text{CaCO}_3$  inclusions increased within this zone to an abundant level. Few rootlet fibers and gravel were present. The soil in this zone featured a very firm massive structure and a clear and smooth lower boundary.

- Zone 4 contained an olive brown (2.5Y 4/4) clay loam that exceeded 170 cmbs. This zone contained few  $\text{CaCO}_3$  inclusions and had a wedge shape structure that was firm and contained mineral crystals 1mm in size.
