Intensive Archeological Survey: State Highway 159 at East Mill Creek, Austin County, Texas

Report for Archeological Survey

CSJ: 0408-02-046

December 14, 2017

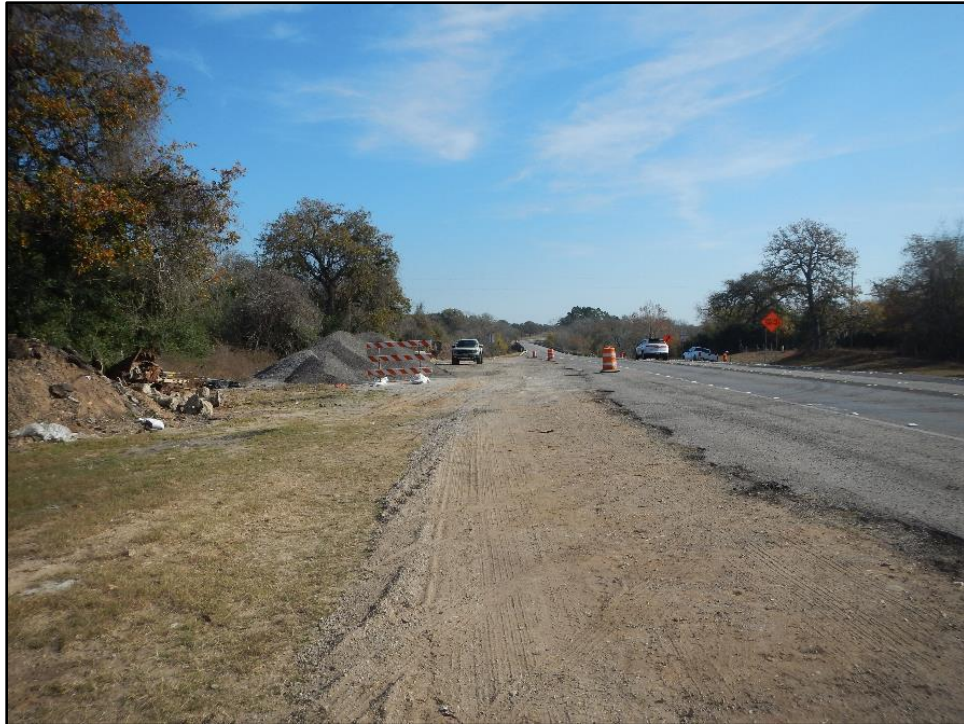
driveways (Figure 6). At the time of field investigations, active TxDOT construction activities were underway along the entire northern existing ROW. The southern existing ROW is heavily disturbed due to existing overhead and buried utilities as well as large areas of fill and ditch. The East Mill Creek floodplain is frequently flooded and large areas were inundated during the investigations, precluding backhoe trenching. The backhoe trenching investigations are further discussed in its respective section further below.

Figure 6. Overview of APE within existing ROW showing disturbances, facing east.

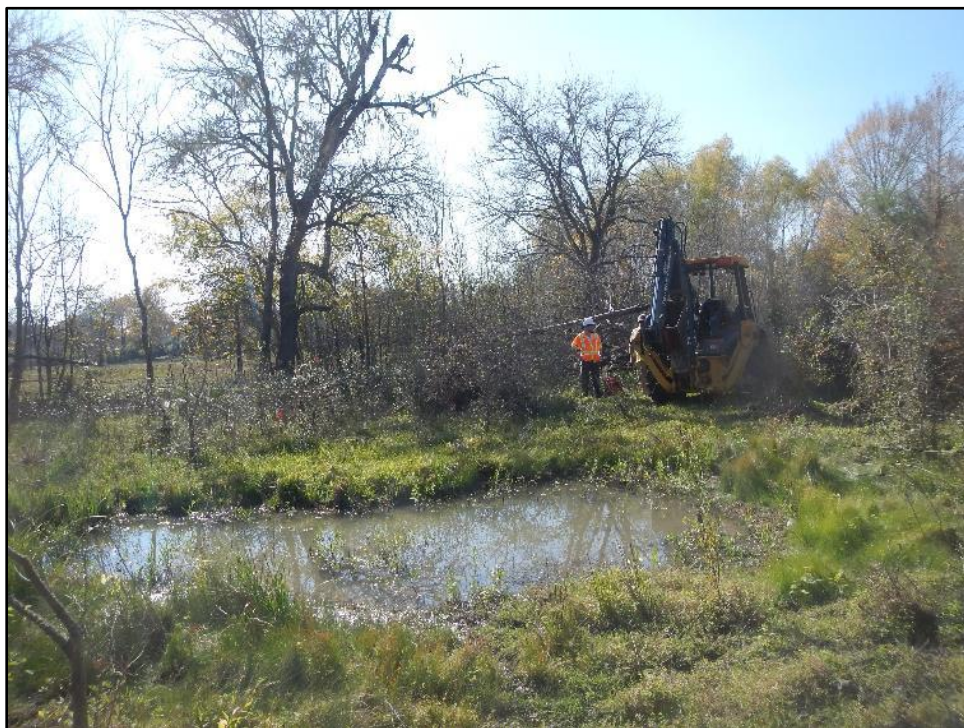
The portion of the existing ROW along the uplands consists of short grasses and is largely devoid of vegetation, particularly along the northern ROW currently under construction, affording abundant ground surface visibility. The portion of the existing ROW along the floodplain contains short grasses within the northern ROW and moderate to dense vegetation within the southern portion and immediately adjacent to the creek (Figure 7).

Figure 7. Overview of APE along low-lying floodplain of East Mill Creek, facing southeast.

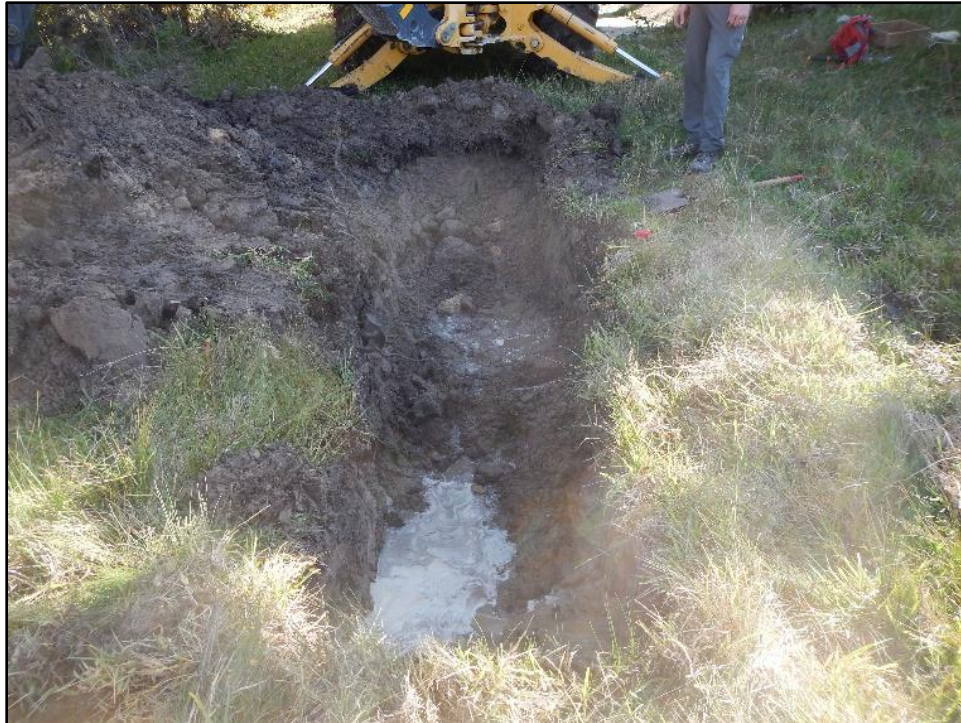
SWCA excavated four BHTs within the project APE. Additional trenches were originally planned, but ground conditions along East Mill Creek precluded access due to existing bridge pillars and wetland areas, on both the northern and southern sides of the roadway (Figure 8). Three trenches (BHTs 1, 2, and 3) were excavated on the southern side of the APE. BHTs 1 and 2 had similar profiles: very dark gray (10YR3/1) clays with a firm blocky angular structure. Moisture increased with depth, and standing water was commonly observed in the surrounding areas. In BHT 1, well-developed calcium carbonate nodules were identified at approximately 125 centimeters below ground surface (cmbs). The BHT 2 profile was similar but encountered modern debris in the upper 35 cm, and disturbed sediment between 105 and 115 cmbs. BHT 3 consisted of two strata, a grayish brown

The area on the northern side afforded one spot for a backhoe trench, BHT 4, between the fill section of the bridge and the edge of the ROW. BHT 4 encountered dense rubble from the original construction of the bridge; the trench was excavated to 85 cmbs when the water table was encountered.

Figure 8. Backhoe Trench 4 showing shallow water table in East Mill Creek floodplain.
