## US 83 La Joya Loop Project, Hidalgo County, Texas

# Report for Archeological Survey

US 83 La Joya Loop Project,  
Hidalgo County, Texas

Intensive Archeological Survey on 10.2 acres  
(Area 1) of US 83 La Joya Loop Hidalgo  
County, Texas

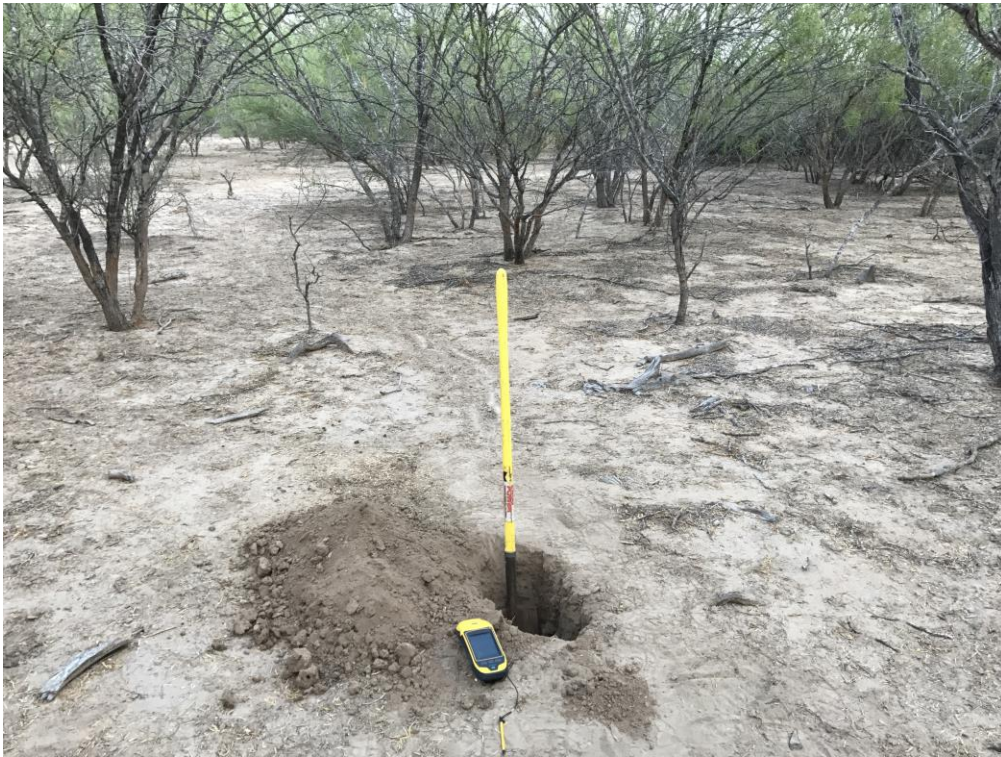
Figure 11. Survey Area 1. Shovel Test 15 Note excellent surface visibility.

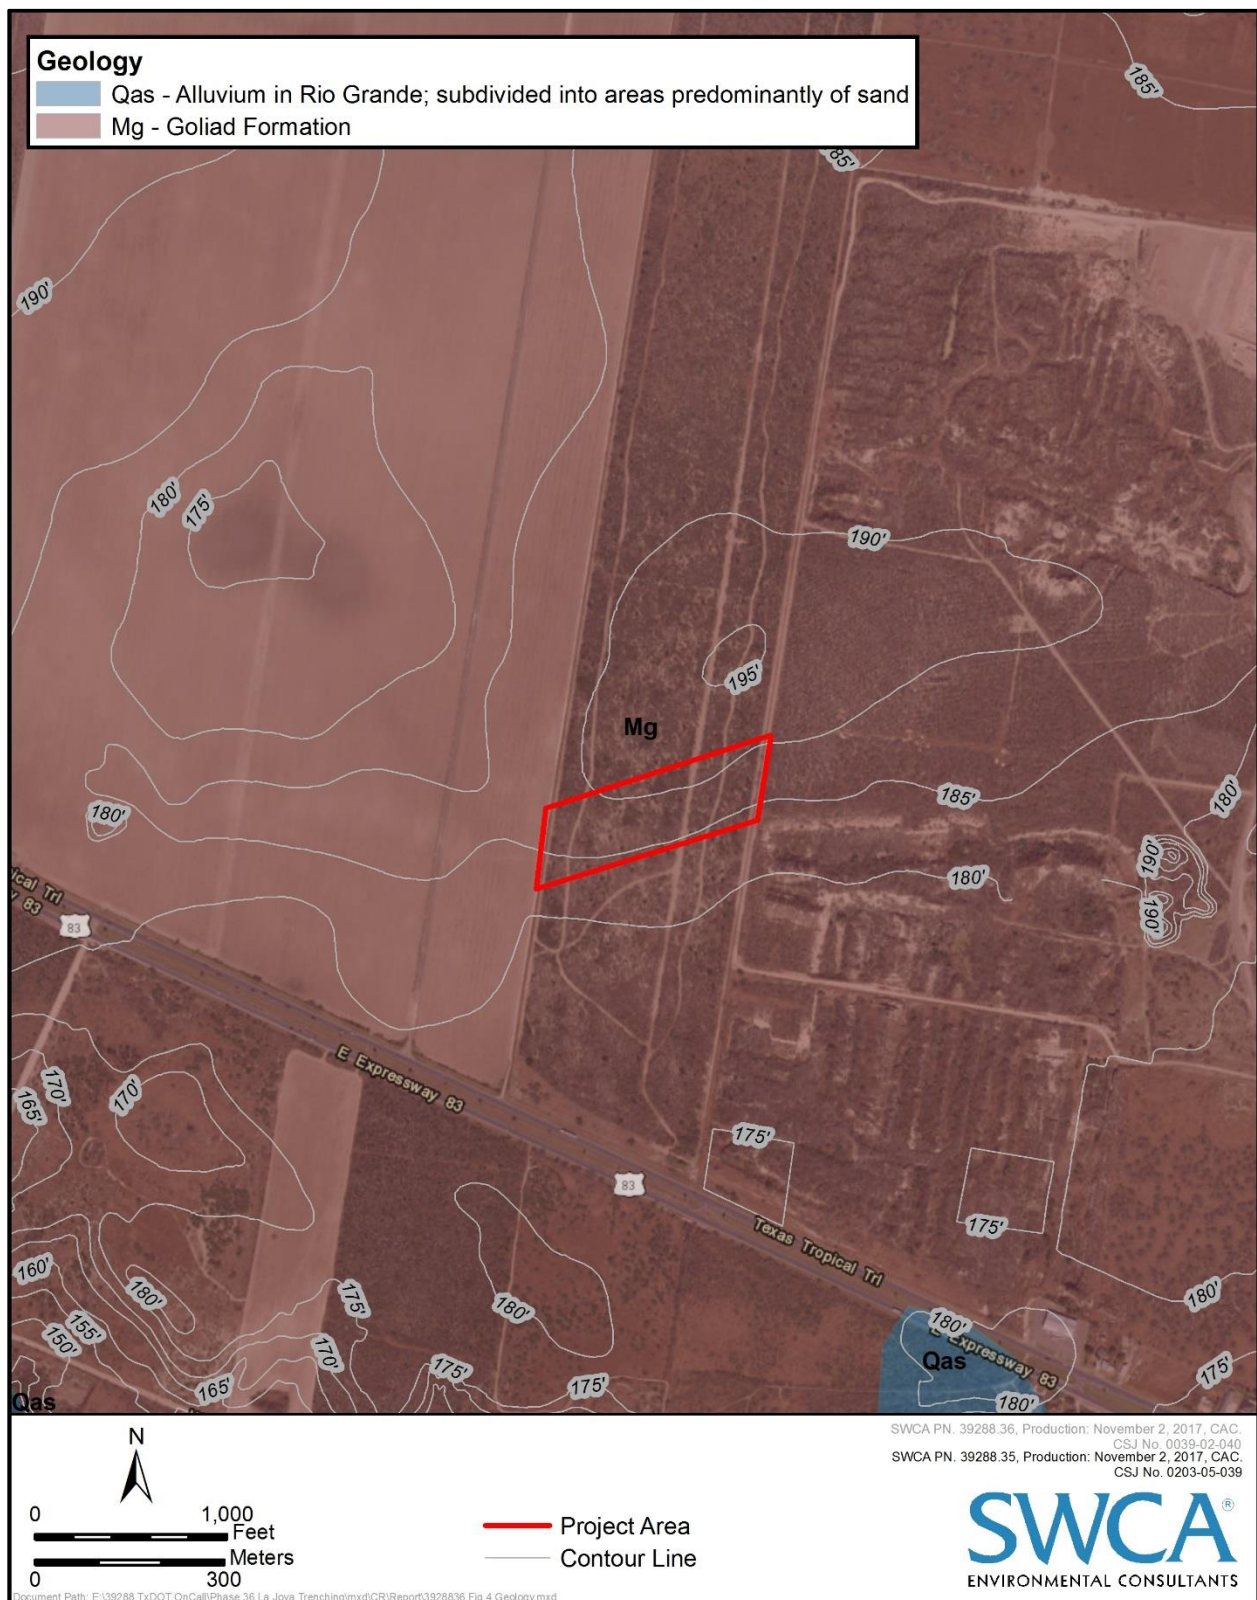
Figure 3. Project area geology.

- **Geology:** According to the Geologic Atlas of Texas, Seguin sheet, the APE is underlain by the Goliad Formation (Mg). This formation consists of clay, sandstone, marl, caliche, limestone, and conglomerate of Miocene age (Barnes 1974) (Figure 3).

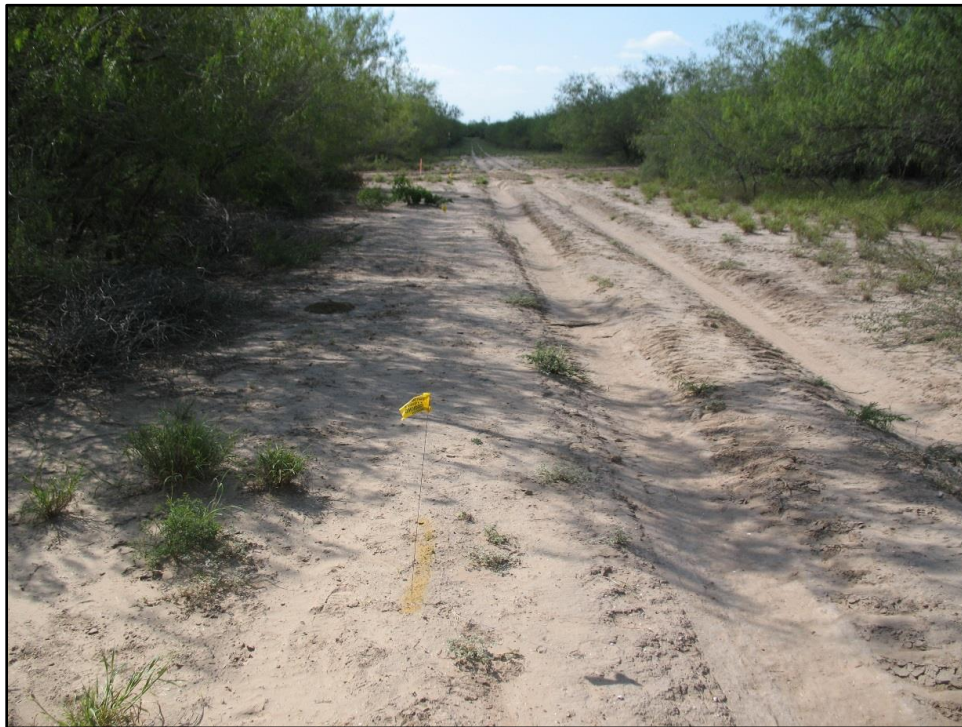
**Figure 6.** Overview of buried gas line in proposed ROW.

- **Project Area Description:** SWCA archeologists conducted intensive pedestrian survey throughout the proposed project area with backhoe trenching (Figure 5). The investigations determined that the proposed ROW has been modified by the installation and maintenance of a buried utility (Figure 6). Although the extent and magnitude of disturbance is unknown, the proposed ROW has also been affected by vegetation removal by heavy machinery at some point in the recent past. The survey observed disturbance down to roughly 30–40 centimeters below surface (cmbs) from this vegetation removal. Below 40 cmbs within the proposed ROW, the deposits are reasonably intact, but have been disturbed by extensive bioturbation. The proposed ROW contains scattered mixed hardwoods (mesquite), shrubs, and short grasses. Surface visibility within the proposed ROW ranged from 30 to 100 percent, but was typically 50 percent.

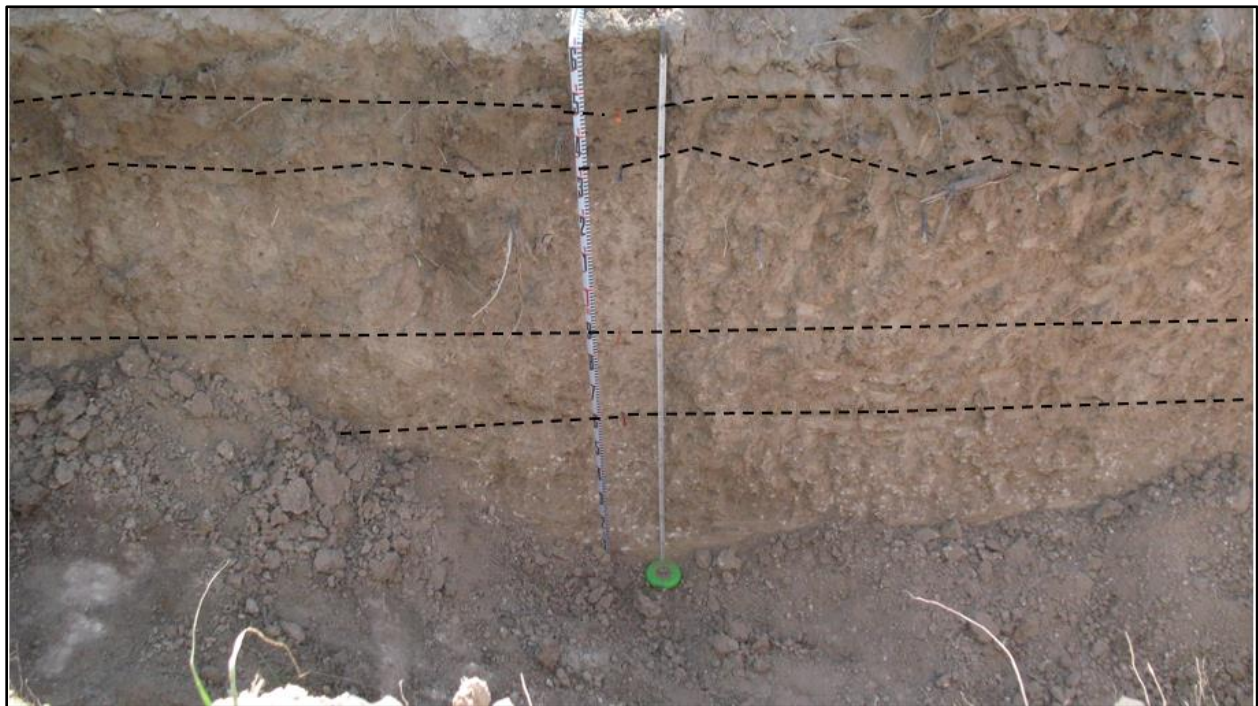
**Figure 7.** Overview of typical profile (BHT08) in proposed ROW, facing south.

The excavations across the proposed APE encountered very similar stratigraphy consisting of five strata, with the most variation noted in the disturbed surface horizons (Figures 7–10). Generally, the surface horizon, Stratum I, consists of a brown (10YR 4/3–5/3) loamy sand to sandy loam with a crumb structure (fine size, weak grade) parting to subangular blocky structure, loose to very friable consistency, and has a clear to abrupt and wavy lower boundary. Inclusions include insect cavities and galleries (15%–20%), roots (5%), and rootlets (15%–20%). Stratum I is interpreted to be an Ap1 horizon, and in all of the trenches is roughly 9 to 20 cm thick.

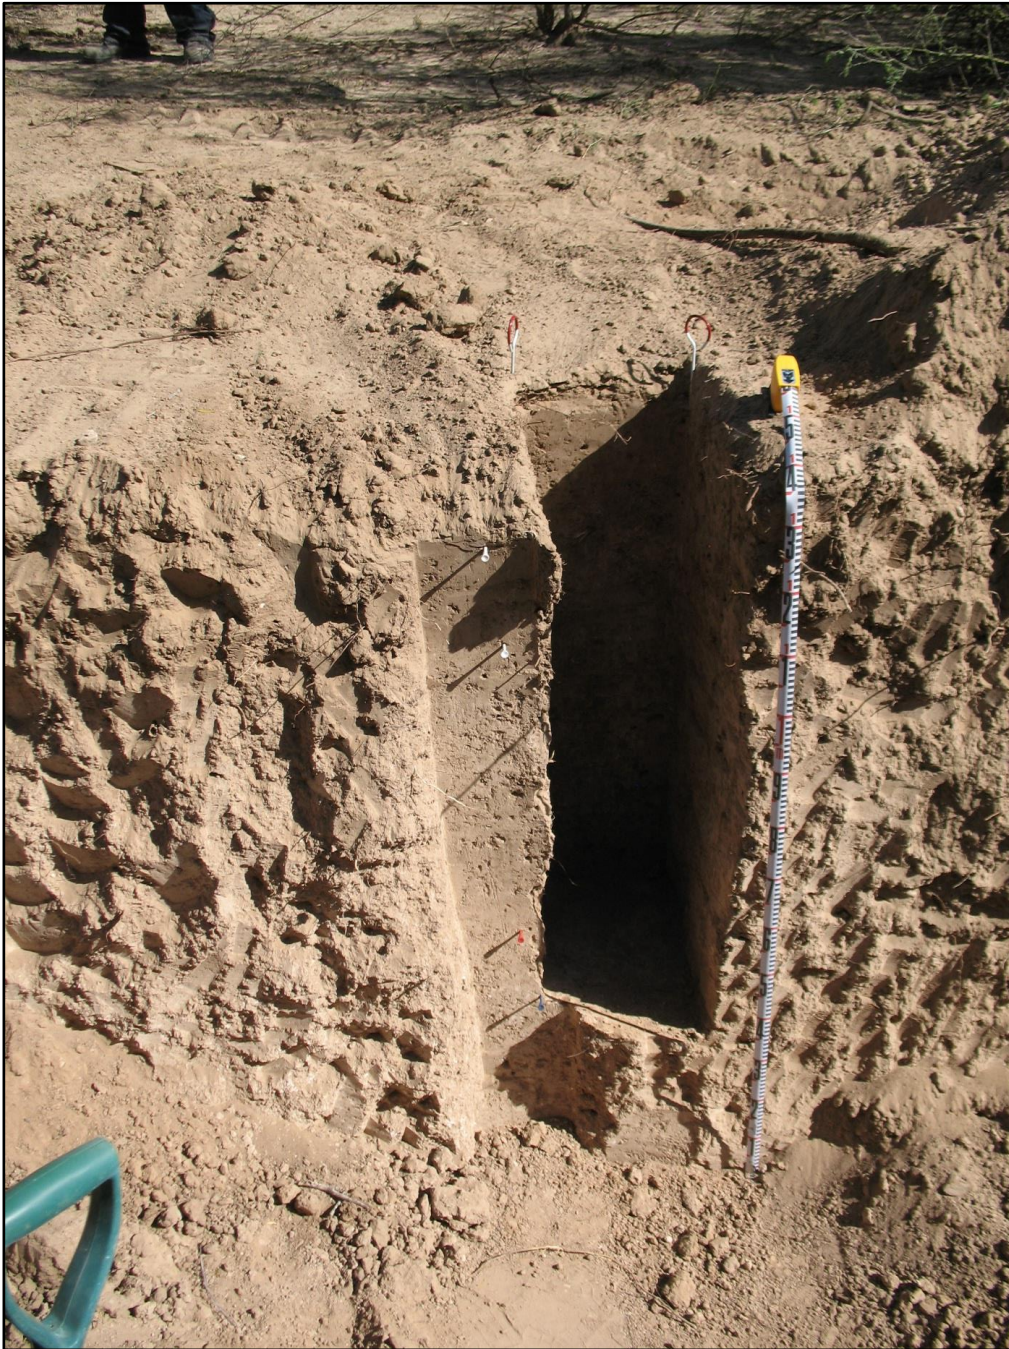
**Figure 8.** Overview of typical profile (BHT05, CS02) in proposed ROW, facing north.

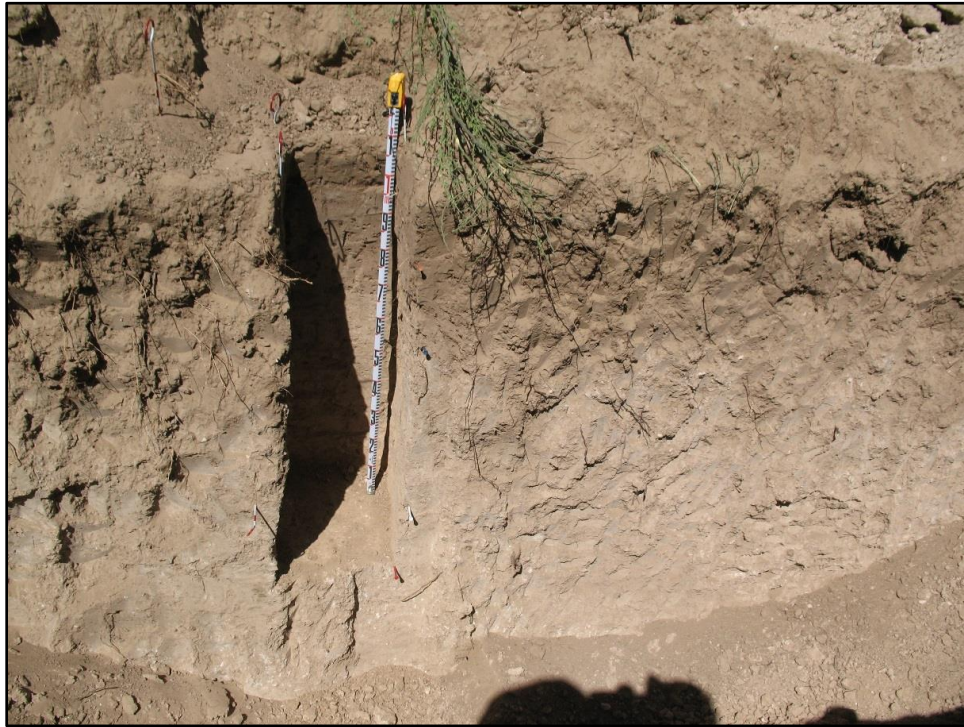
**Figure 9.** Overview of typical profile (BHT04, CS01) in proposed ROW, facing northwest.

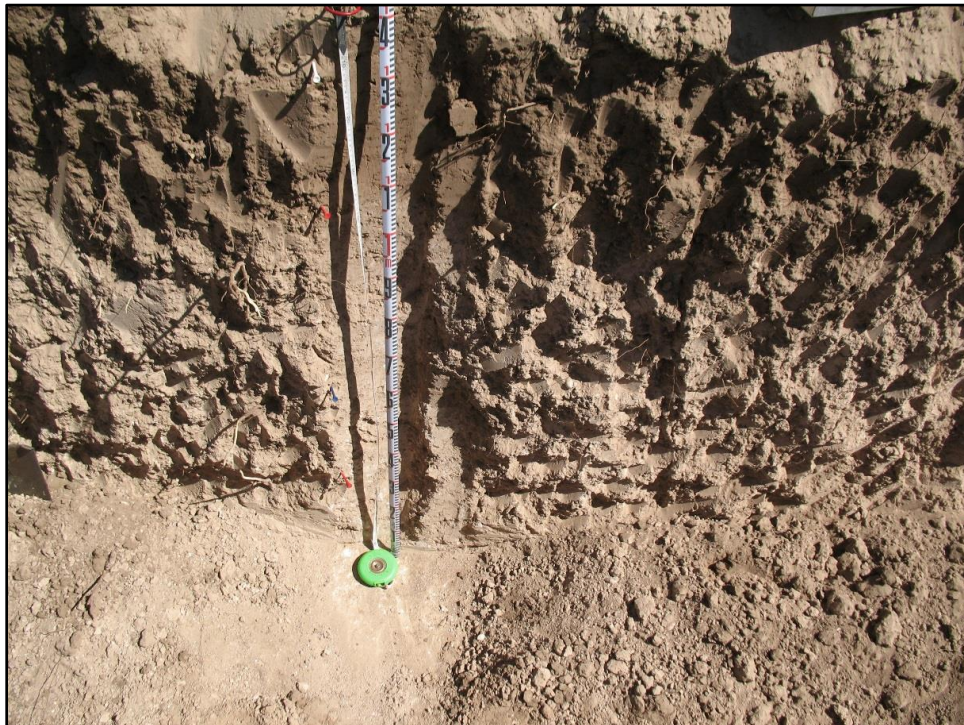
**Figure 10.** Overview of typical profile (BHT06) in proposed ROW, facing east.

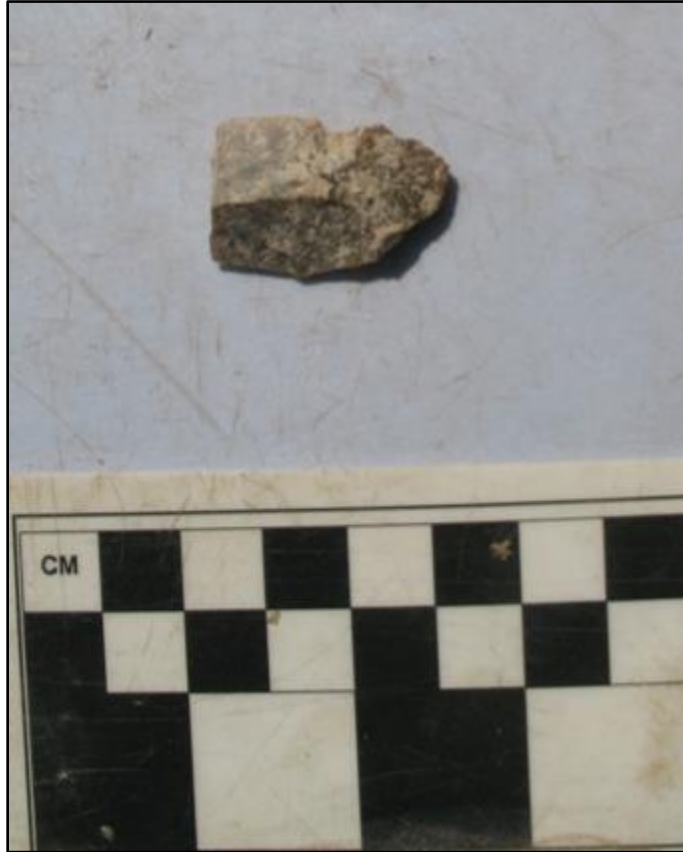
**Figure 13.** Chert flake observed in BHT04 at 78 cmbs in Stratum III.
