**ARCHEOLOGICAL SURVEY FOR THE CULEBRA CREEK NWWC
DRAINAGE PROJECT, SAN ANTONIO, BEXAR COUNTY, TEXAS**

LETTER REPORT NO. 922

Prewitt and Associates, Inc.
Cultural Resources Services
Austin, Texas

November 2017

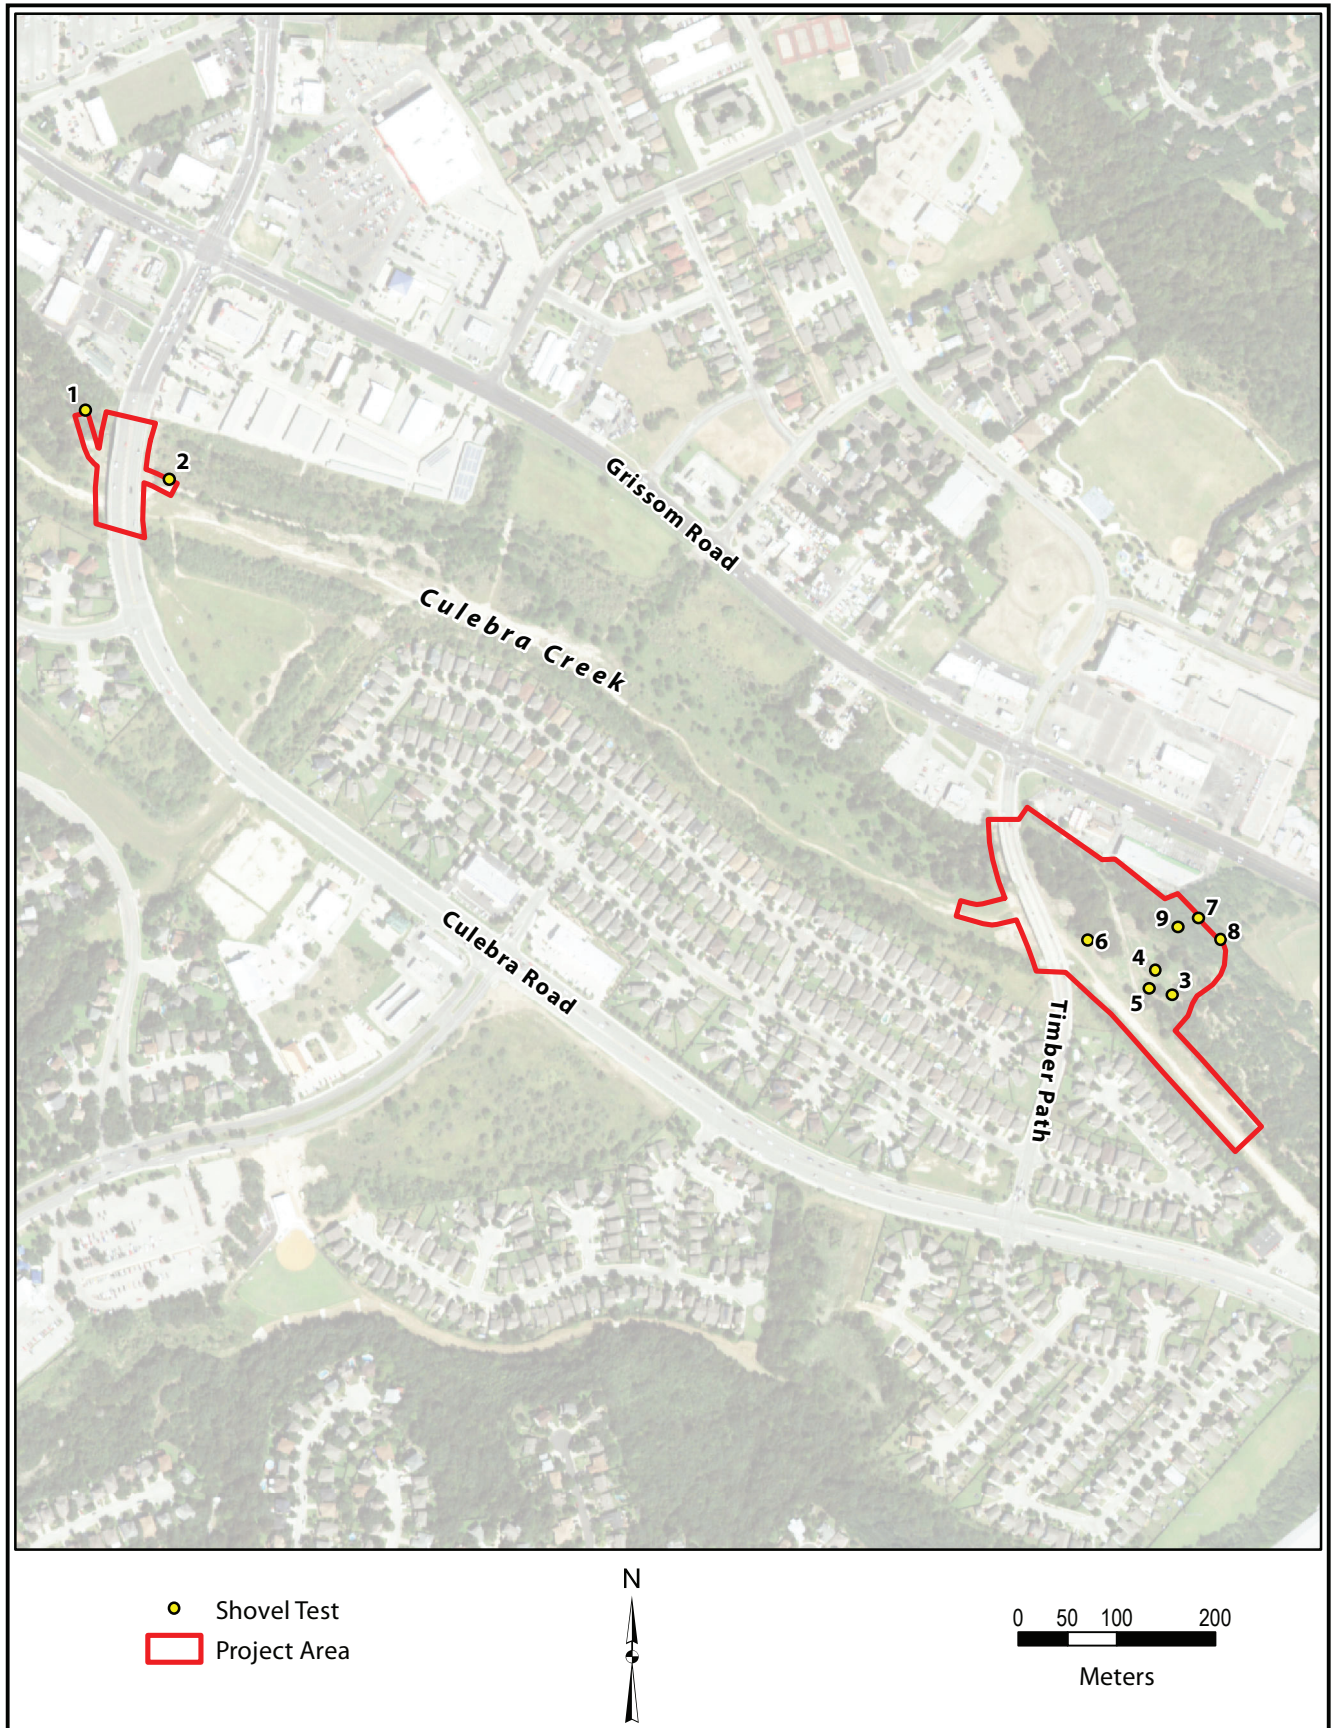
Figure 2. Modern aerial photograph of the project area showing the APE and shovel test locations. The Culebra Road survey area is on the west, and the Timber Path survey area is on the east.

Surface visibility in the APE typically varied from 0 to 30 percent, with higher visibility on the channel floor, on cut banks and bench margins along existing channel segments, on portions of the north bank wall, and along two-track roads and abandoned roads. Nine shovel tests were excavated in and immediately adjacent to the APE (Figure 2). Shovel Tests 1 and 2 were placed near the ends of the proposed pilot channel below Culebra Road. Shovel Tests 3–9 were southeast of Timber Path on the channel floor, at the foot of the channel wall, and on terrace margins north of the creek. Shovel tests were not systematically spaced along survey transects. Most of the tests were placed in locations that appeared to be relatively undisturbed and/or appeared to have the greatest potential for archeological deposits according to landform. Some of the tests were excavated to demonstrate the character of the subsurface deposits in areas otherwise obscured by surface vegetation. If the APE acreage is rounded up to 11 acres, then the resulting shovel test density of 1 test for every 1.2 acres exceeds the Texas Historical Commission's minimum archeological survey standard of 1 test every 2 acres on tracts of this size. This level of effort is considered sufficient given the geomorphic setting of the APE and the extent and level of natural and artificial disturbance within it. Backhoe trenching is considered unnecessary within the APE for the same reasons.

Shovel Test 1 was on a bench between the north bank wall and the existing stream channel near the west end of the proposed pilot channel. Natural benches in this location stand about 1.5 m above the floor of the channel, and these consist of 40 to 50 cm of sediment atop a thick gravel base. No artifacts were observed in the inspected cut banks, and none were recovered in Shovel Test 1. Sediment in the top 28 cm of the test consisted of moderately consolidated brown silt loam that graded to silty clay with depth. This sediment contained occasional fine gravels and abundant snail shells. Pieces of plastic and rubber were common in the top 15 cm. The next layer of sediment, exposed to a depth of 35 cm, consisted of well-consolidated, light

Shovel Test 2 was on a vegetated gravel bar along the north edge of the proposed pilot channel east of the bridge. This 15-cm-deep test revealed 3–4 cm of grayish brown clay loam and roots above well-consolidated yellowish brown silty and sandy clay with abundant rounded gravels and carbonate flecks. The existing channel cut roughly 5 m south of the test shows a heterogeneous deposit of fine to coarse gravels (up to 45 cm across) with little intervening sediment that is at least 1 m thick.

Shovel Tests 3–6 were in relatively flat areas on the broad channel floor, between abandoned road segments and the current channel cut. Surfaces at these four tests were covered with a dense mat of grasses and forbs. Shovel Tests 3–5 were within 20 to 30 m of each other on what appeared to be a wide bench flanked by the bedrock-floored channel to the east and northeast. Shovel Test 3 revealed 7 cm of loose sandy loam with a few gravels and some asphalt shingle fragments above tightly packed gravels interspersed with loam and silty clay; it extended to a depth of 13 cm. Shovel Test 4 exposed 12 cm of dark brown clay loam and clay with fine lenses of medium-grained sand over 18 cm of dark brown clay mottled with pale gray silt with few gravels. Beneath this was 30 cm of dry, strongly granular, dark brown clay with scattered fragments of indurated limestone that increased in frequency with depth. The test ended at limestone bedrock at 60 cm. Partially buried segments of rubber tubing were observed in an area of softer surface sediments about 5 m south of this test. Shovel Test 5 was about 10 m east of an abandoned road segment and excavated to a depth of only 20 cm because it revealed dry brown loam and sandy loam mixed with high-density small gravels and some asphalt fragments. Shovel Test 6 was on a flat area composed of fine-grained sediments and surface gravel deposits south of a braided channel segment. The test revealed 6 cm of moderately consolidated, granular, silty clay over 9 cm of dark brown, granular, silty clay and clay with few gravels and *Rabdotus* shells. Sediment in the remainder of the test (to a depth of 45 cm) was very dark brown clay with a few small gravels and scattered carbonate flecks.

Shovel Tests 7–9 were north of the existing stream channel. Shovel Tests 7 and 8 were on top of the north bank on the leading terrace edge. Shovel Test 9 was on a bench below a 25-m-long by 15-m-wide mechanical cut in the bank wall. These tests ranged from 25 to 28 cm in depth. Shovel Test 7 revealed 25 cm of strongly granular, reddish brown silt loam with abundant fine gravels and some snail shells above tightly packed calcareous gravels interspersed with silty clay. Shovel Test 8 exposed strongly granular to blocky, dark brown silty clay with a few fine gravels to a depth of 25 cm. Shovel Test 9 revealed 22 cm of strongly granular, dark brown silty clay loam and silty clay with a few fine gravels above well-consolidated brown clay with carbonate flecks.
