## Intensive Archeological Survey on Farm-toMarket 767 at Punta de Agua and Rita Blanca Creeks, Hartley County, Texas

# Report for Archeological Survey

Intensive Archeological Survey on Farm-to-Market 767 at Punta de Agua and Rita Blanca Creeks, Hartley County, Texas

CSJ: 1108-01-020

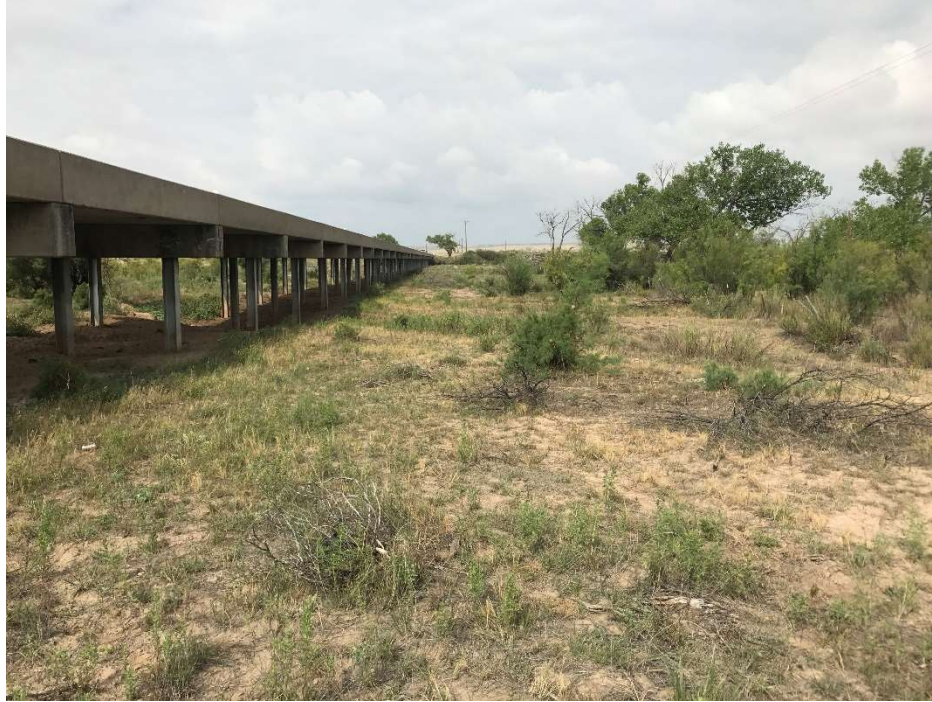
**Figure 4.** Overview of sparse grasses within the floodplain of the Rita Blanca and Punto de Agua Creeks, facing west.

**Vegetation:** The existing APE consists of sparse short grasses with a few mesquite, oak, and juniper bordering the roadway (Figures 4 and 5).

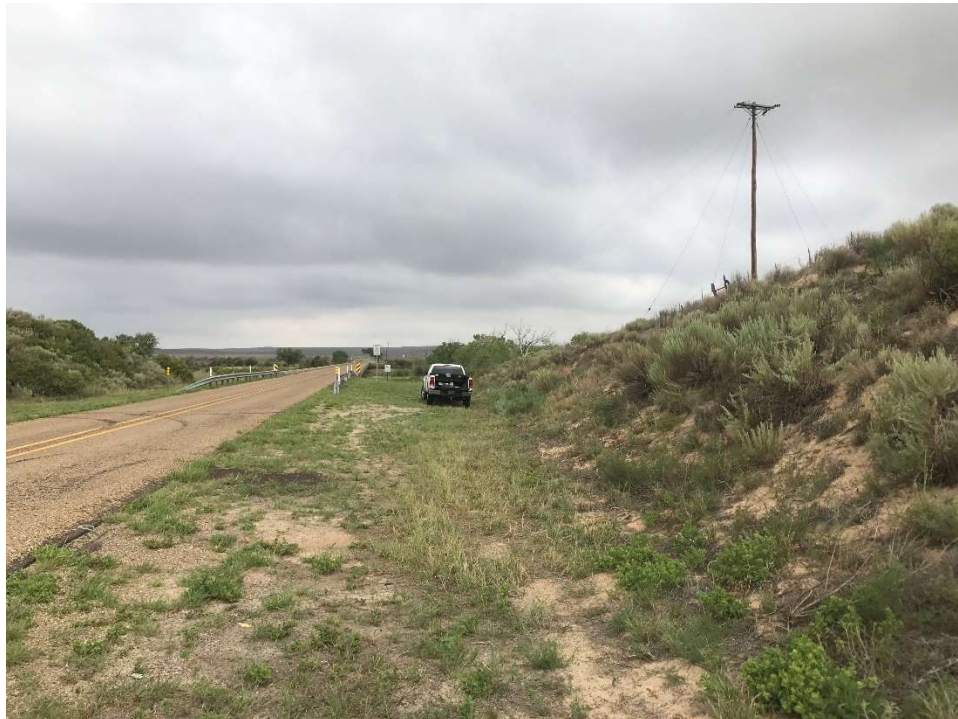
**Figure 5.** Overview of vegetation along downcut dune in existing ROW within northeast quadrant, facing west.

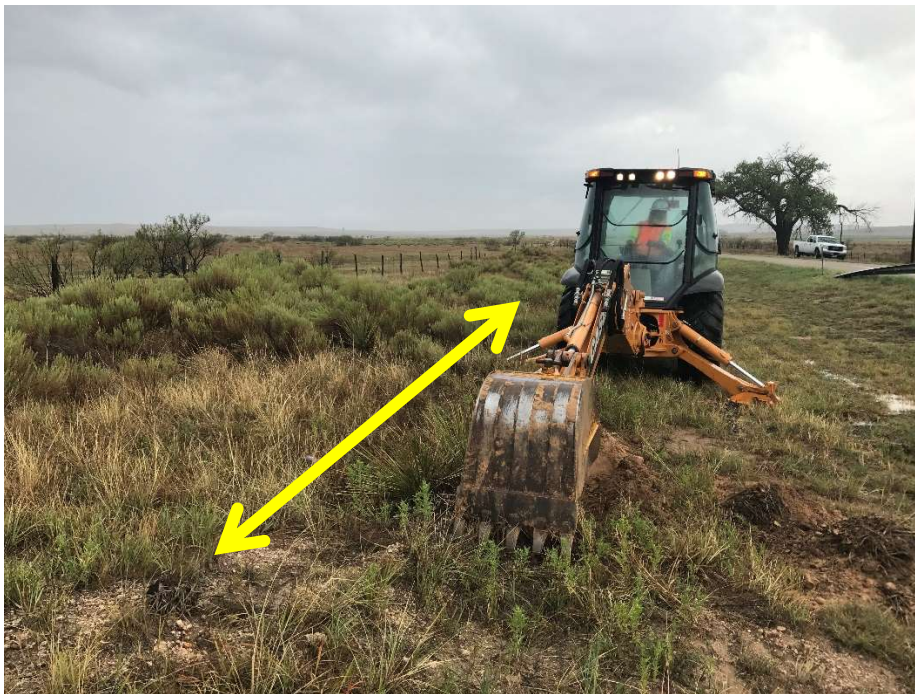
**Figure 6.** Overview of BHT 5 showing setting on western side of APE with artificial berm along ROW margin (denoted by bi-pointed arrow), downcut drainage ditch that has likely removed much of the archeological potential, and fill section that raises existing roadway above surrounding landscape.

BHT 05 is in the southwestern quadrant and revealed shallow soils in a heavily disturbed ROW. Beneath a thin layer of road fill, the profile contained 4 strata, a very pale brown (10YR 7/4) loose sand to a depth of 45 cmbs (18 inches) over a brown (10YR 5/3) sandy loam extending to a depth of 60 cm (24 inches). Beneath these upper strata, two rubified (7.5YR 5/6 and 5/8) calcareous sandy clay loam to sandy clays with very firm blocky angular structure were represented.

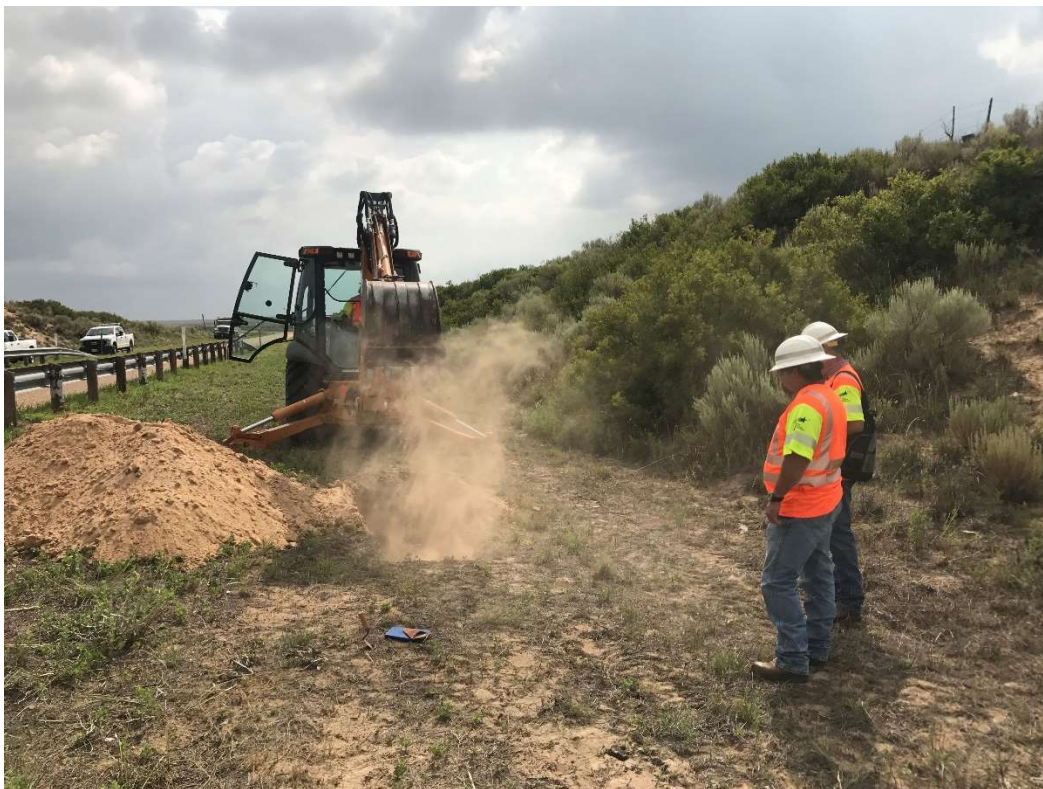
**Figure 8.** BHT 02 in southeastern quadrant showing 5 m deep cut section through dunal ridge, facing east.

Four trenches (BHTs 01 through 04) were excavated in the southeast quadrant of the APE (Figures 8 and 9). The BHTs were excavated to varying depths, ranging from a minimum of 204 cm (6.7 feet) to a maximum of 270 cm (8.9 feet). The trench dimensions were typically 0.9 m (2.95 feet) wide and 5 m (15 feet long). All four trenches encountered unconsolidated very pale brown (10YR 7/4) eolian sands, revealing deep deposits associated with a dunal ridge that was apparently active as recently as several years ago, but has now since stabilized (Figure 10). No pedogenic development was noted in the sandy deposits. Of the four trenches in the southeastern quadrant, BHT 03 was the only trench to encounter a substrate, a grayish brown (10YR 3/2) clay loam at 186 centimeters below surface (cmbs [6.1 feet]). There was some calcium carbonate development in the clay loam, but the age of the deep deposits (e.g., pre-Holocene?) is unclear. Other than modern glass and metal on the surface, no cultural materials were found in BHTs 01 through 04.

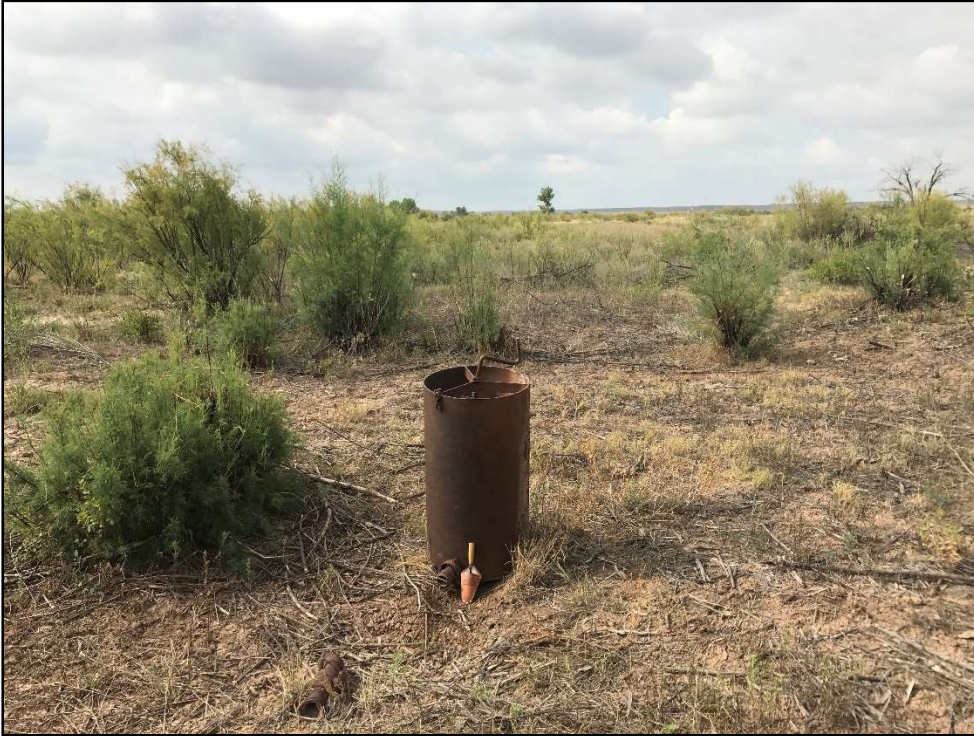
The metal mixer/separator is made of thick-gauge (1/4-inch) tubular iron and measures approximately 36 inches in height and 16 inches in diameter (Figures 11 and 12). A 3-inch pipe or hose valve is located on the enclosed bottom. The top is

open with a three-spoked welded metal divider serving as an axle for a hand-cranked rod extending down into the interior of the device. The rod has welded horizontal metal slats that appear to function as mixing paddles when churned. Several links of chain are welded to the top. No manufacturer marks were identified, and it is plausible this is not a mass-produced item but rather locally produced by a welder for some specific purpose. The metal is rusted but not sufficiently rusted to indicate a historic age.

**Figure 11.** Isolated find, a metal mixer or separator. Note trowel for scale, facing southwest.

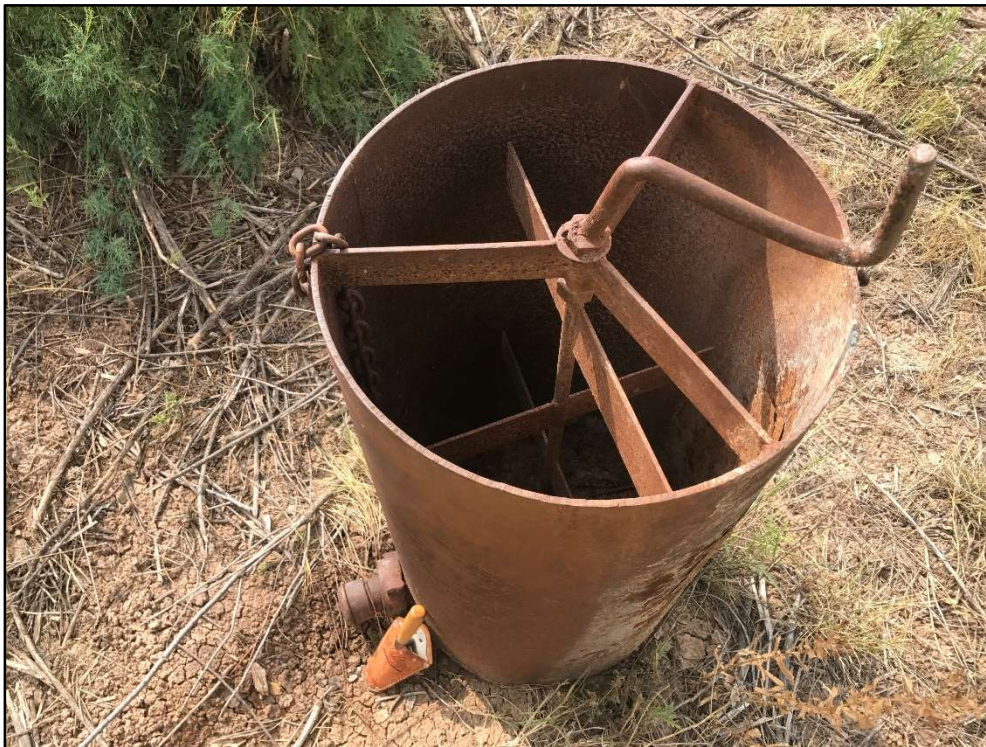
**Figure 12.** Interior of metal mixer or separator.
