**A Cultural Resource Survey of the Lower Greens Bayou
Detention Embankment Project,
Harris County, Texas**

HCDCD Project ID P500-01-00-E001

MOORE ARCHEOLOGICAL CONSULTING, INC.
HOUSTON'S FIRST ARCHEOLOGY FIRM

Report of Investigations Number 676

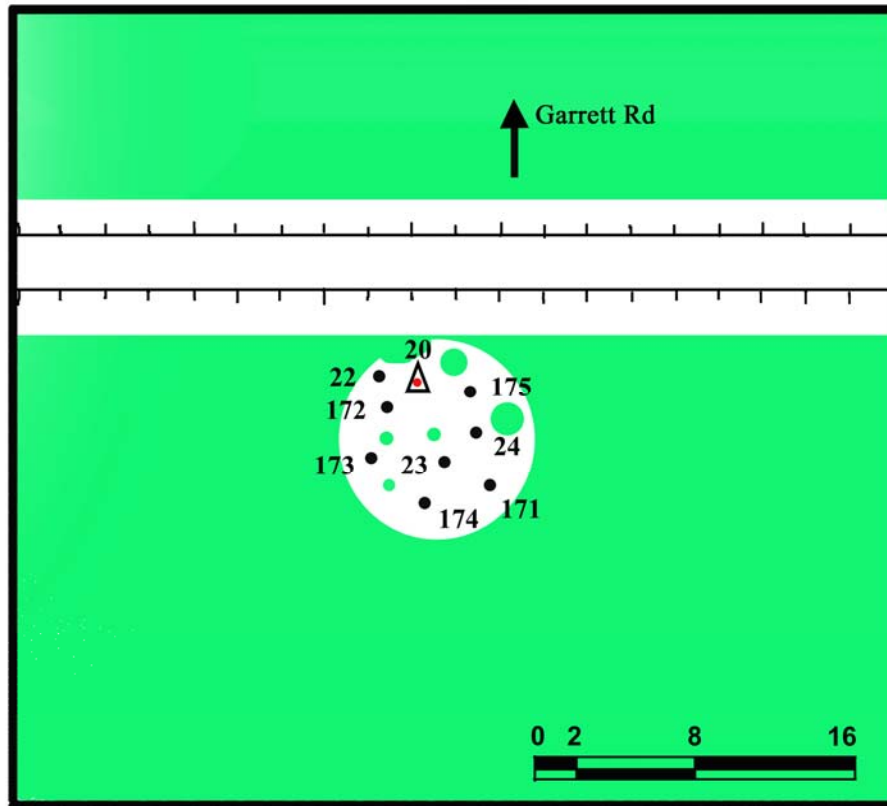
Temporary Site 1 was found a low mound on the south side of the embankment near Garrett Road (Figure 6, 8, and 9). This mound fell within the buffer of the project corridor. The mound is about 8 m wide in either direction and marginally higher on the north side nearest the embankment.

Figure 8: Map of Temporary Site 1.

The one positive shovel test (ST20) contained a single piece of lithic debitage (Figure 10). Although numerous additional shovel tests were dug on and around the periphery of this mound, no additional cultural material or features were found. As a result, it was determined that this was an isolated object and not a “site”. The artifact was recorded and reburied in place as per the collection policy we submitted to the THC. No site forms will be submitted and no further work on this location is recommended.

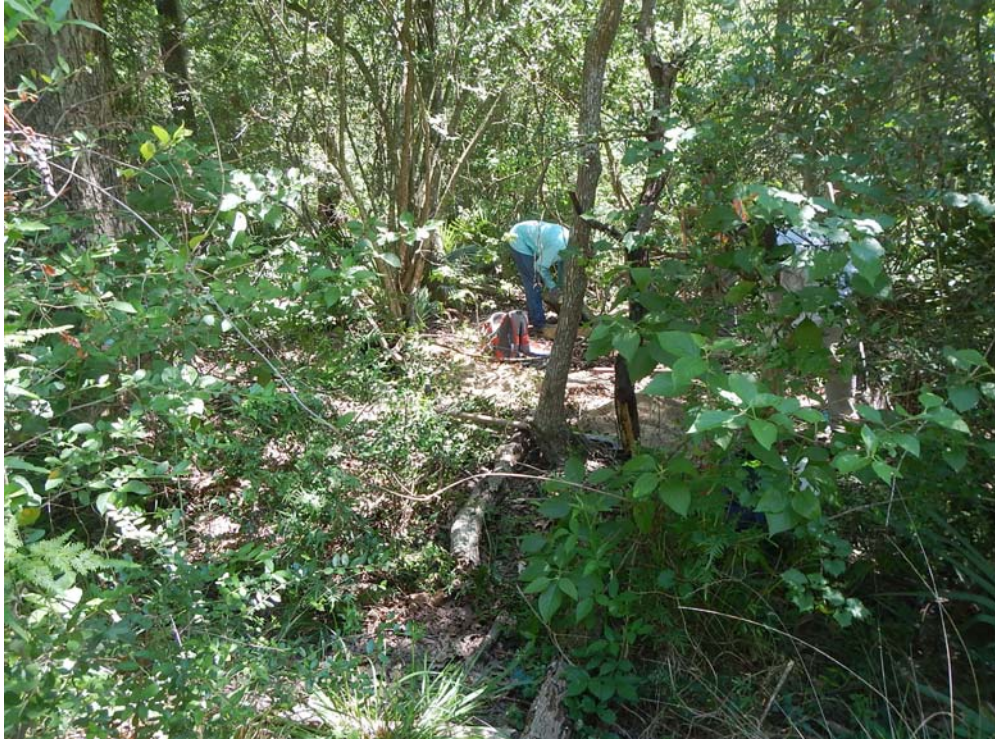
Figure 9: The mound where Temporary Site 1 was found.

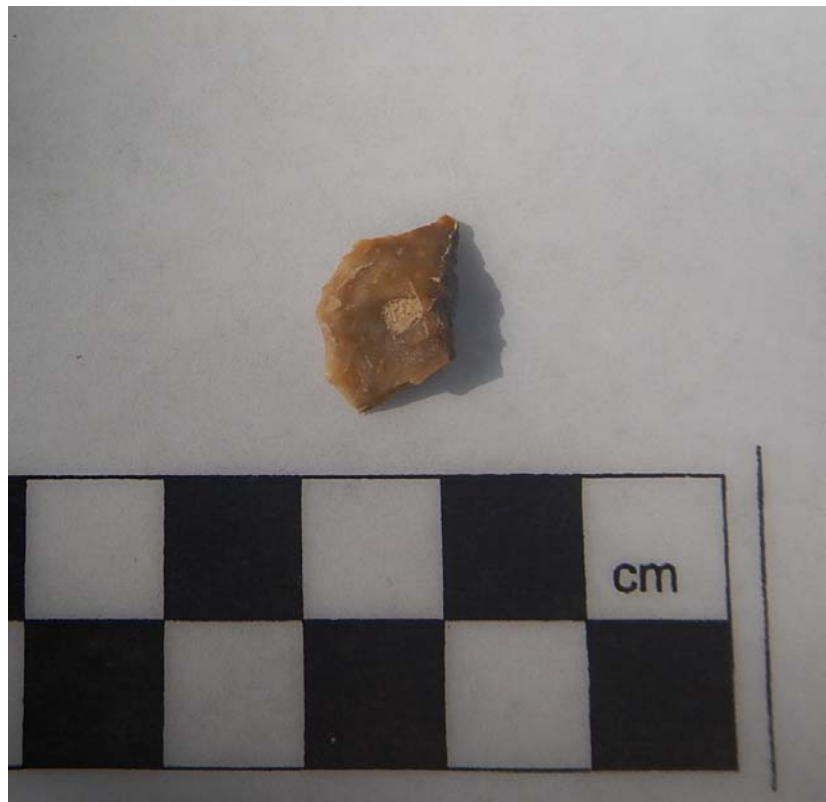
Figure 10: A single tertiary flake found in ST20 (Temporary Site 1). Reburied in place.

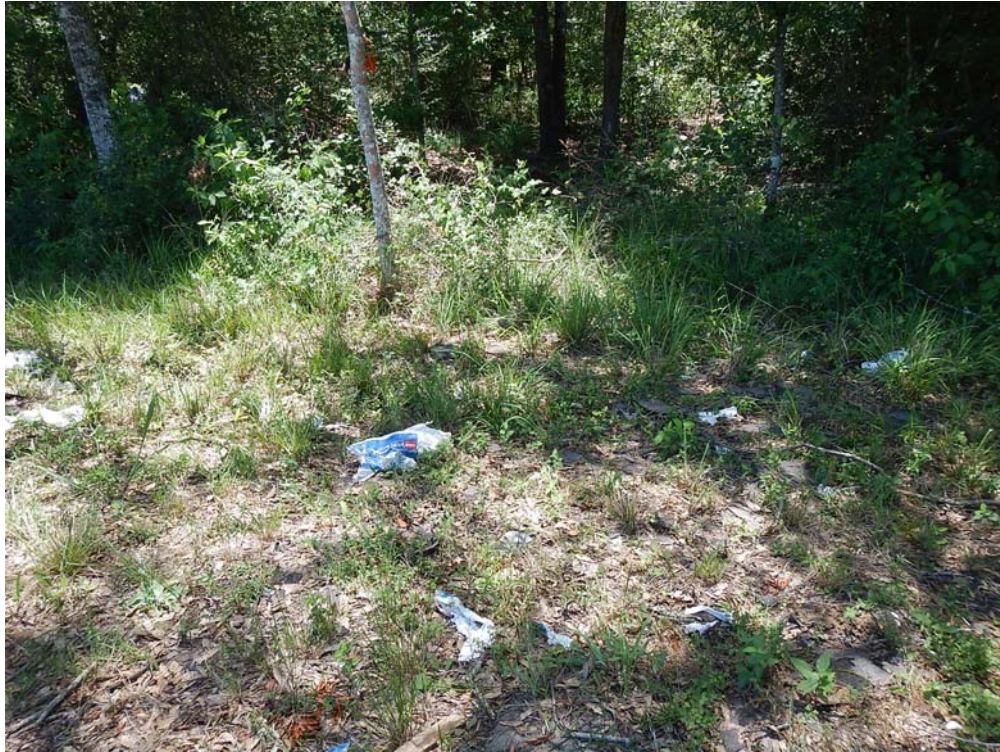
Temporary Site 2 was found along both sides of the existing embankment on the south side of where the project corridor wraps around the William Scotsman Inc. property (Figures 6, 11, and 12). The first evidence of this locale was an increase in modern debris or trash, dating to the late twentieth to early twenty-first century, observed on the surface atop the embankment and adjacent to the project corridor. This debris included small brick and mortar fragments that appear to have been part of the roadbed matrix. At shovel test 76 (ST76) these brick fragments began to show up in the subsurface excavations as well. More of the same brick fragments appeared in STs 79, 80, and 81, as did a layer of scattered charcoal and fire stained soil between 10-20 centimeters below surface (cmb). The evidence of a burning incident was most clear in ST80, which had pieces of burned clay as well as a burned section of a tree branch. Modern debris and trash continued to be found on the surface along this entire segment of the project corridor, including beyond where the shovel tests were finding the same sort of material.

All evidence in the field suggested that the material observed was of recent origin, most likely the result of trash being dumped and, at times, burned in this locale in the late twentieth century and into the twenty-first century. This would coincide with the construction of the embankment and associated road sometime between 1989 and 1995. Examination of aerial imagery and topographical maps dating back to as early as 1944 (in the case of the aerials) and 1920 (USGS quadrangle maps) revealed that there has never been any residential occupation of this locale that would serve as the source of this material and that even commercial activity didn't begin until a structure was built where the William Scotsman Inc. site now stands somewhere between 1955 and 1967. As a

Figure 12: Trash and debris scattered around Temporary Site 2.

As a result of this information, the age of the debris, and the shallow nature of the subsurface finds, we determined that this locale is not a “site”. All items were recorded onsite and reburied in place as per the collection policy we submitted to the THC. No site forms will be submitted and no further work on this location is recommended.

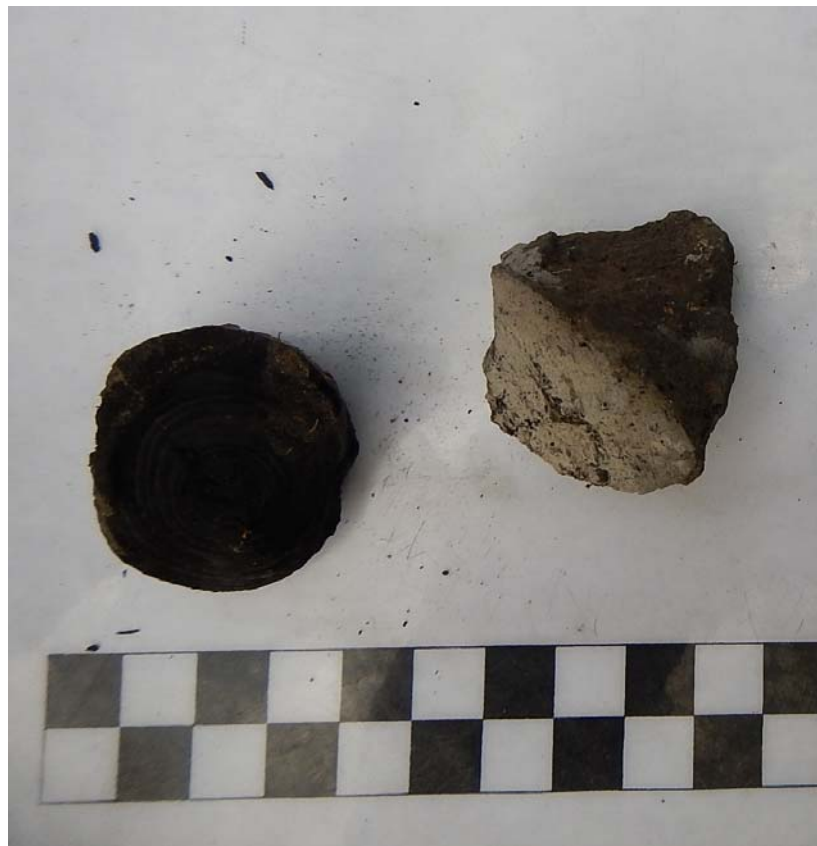
The burned material found in several of the shovel tests was, as previously mentioned, consistently shallow and included modern material. It is most likely that this represents a modern fire incident, either man-made to burn trash, or accidental. This appears to have been covered by a thin layer of colluvial slope wash from the roughly meter high embankment immediately adjacent. It is just such erosional activity that has led to the need for the proposed improvements to the existing structure.

Figure 13: Partially burned wood and burned clay from Level 1 of ST80 at TS2. Reburied in place.

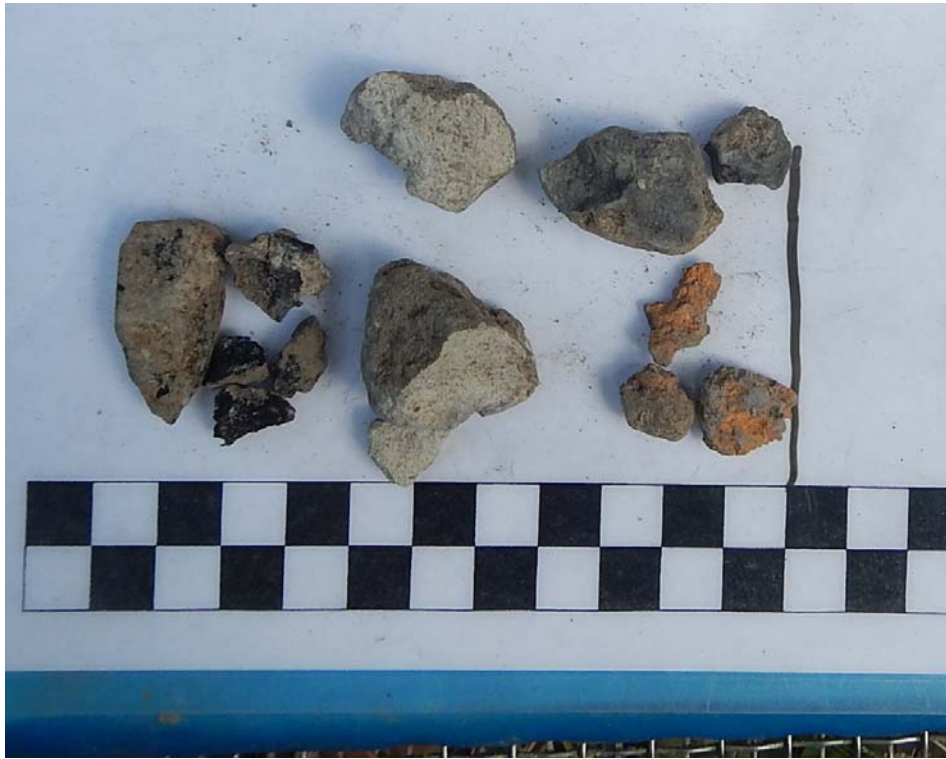
Figure 14: Burned wood, brick and mortar fragments, and debris from ST81 at TS2. Reburied in place.
