# CULTURAL RESOURCES SURVEY OF THE PROPOSED ±15,034-FOOT SHINER NORTH LOOP 12-INCH INLET GONZALES COUNTY, TEXAS

January 2015

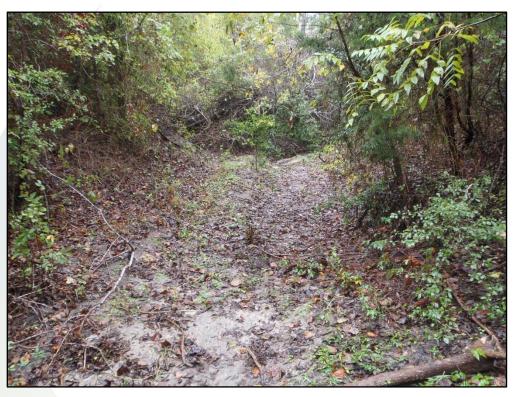
Review Area 1 encompassed a well-channelized segment of Gelhorn Creek, proper. The stream had incised into the landscape between 4.9 and 6.6 feet (1.5 and 2.0 m) in depth and measured between 3.3 and 6.6 feet (1.0 and 2 m) in width (Appendix B, Photo 1). Both banks of the stream ascended steep inclines to nearly level terraces. Ground surface visibility within Review Area 1 was variable within the APE ranging between 40 and 60 percent. Vegetation within the area of review included grasses, mesquite, green briar, oak, cedar elm, and hackberry.

Photo 1: Overview of Stream within Review Area 1, Facing Northeast

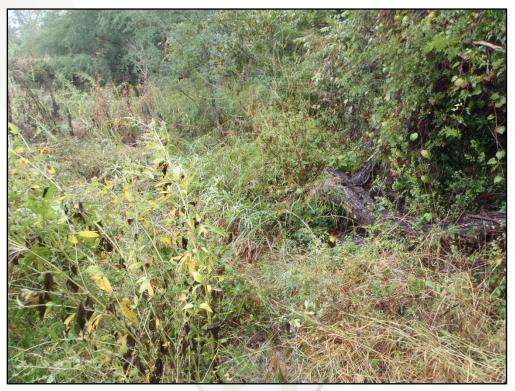
Review Area 2 encompassed another well-channelized segment of Gelhorn Creek, proper. The stream had incised into the landscape between 4.9 and 6.6 feet (1.5 and 2.0 m) in depth and measured between 4.9 and 6.6 feet (1.5 and 2 m) in width (Appendix B, Photo 2). Both banks of the stream ascended steep inclines to nearly level terraces. Ground surface visibility within Review Area 2 was highly viable within the APE ranging between 10 and 60 percent. Vegetation within the area of review included grasses, mesquite, green briar, oak, cedar elm, and hackberry.

Photo 2: Overview of Stream within Review Area 2, Facing Southwest
