Archeological Testing of the Engstrand Well 41WM1157, in Williamson County, Texas

Principal Investigator: James W. Karbula

Prepared for: Texas Department of Transportation—Environmental Affairs Division

TxDOT Archeological Studies Program No. 100

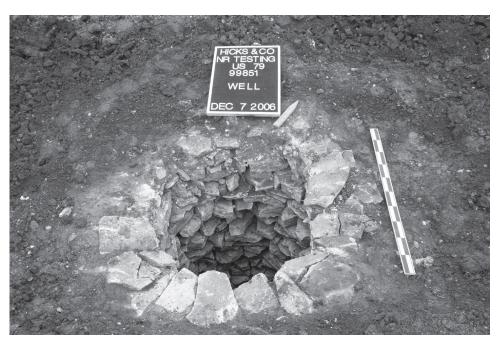
Figure 4. 41WM1157 exposed prior to investigations.

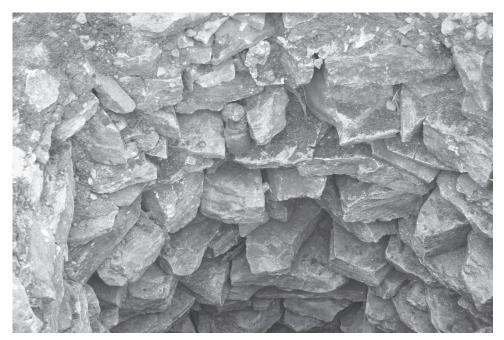
Figure 5. Close up of well wall illustrating dry stack construction technique.

The results of the archeological testing documented a circular well constructed of rough-hewn tabular limestone that extended to a depth of 5.9 meters (20 feet) below the surface at the time of investigation (Figure 4). The construction style was dry-stack, though a small amount of mortar was noted in the upper layers of stone suggesting at least some mortaring to ensure the stability of the surface (Figure 5). Observed during the excavation of the well structure was the original limit of excavation of the well shaft visible as a darker soil surrounding the outside of the well. From the surface, investigators noted that the well contained historic period debris and soil fill starting at approximately 10 feet (3 meters) below surface (Fig**ure 6**). The construction of the well is fairly typical of the nineteenth century. A number of similar nineteenth century wells (Clark 2004; Feit and Clark 2002; Anthony 1996; Wright 1997) have been recorded in Austin and San Antonio.

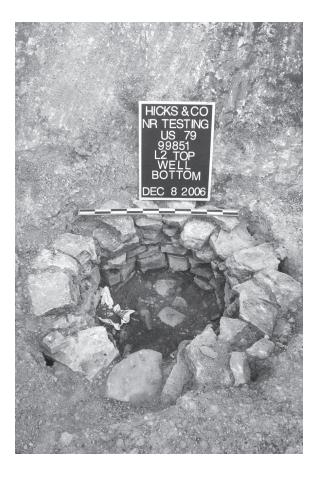
Figure 6. Original surface of well fill (following removal of upper portions of well).

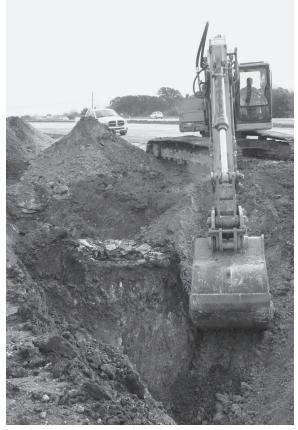
Figure 7. Well being isolated during excavation by trackhoe.

After cleaning, drawing, measuring and photographing the well from the existing surface, a trackhoe was used to first reveal then truncate the well to the depth of the observed fill debris in the well (**Figures 7 and 8**). Once this was done, the trackhoe cleared an area around the well, to enable investigators to work at the trench's base, sloping the walls for safety in conformance with Occupational Safety and Health Administration OSHA regulations. Sloping at a 1:1 ratio of the northern edge of the trench was prevented by the presence of

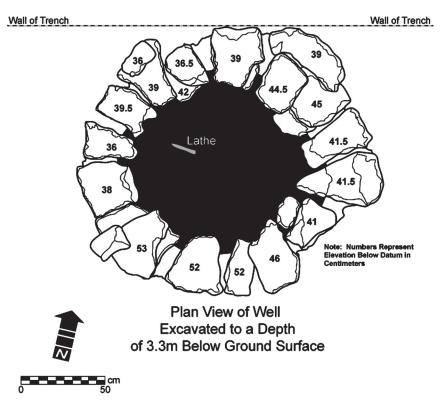
Figure 8. Plan view of well.
