Intensive Pedestrian Archaeological Survey of the Lower Segment of San Pedro Creek, South Alamo Street to the Apache-Alazán Creek Confluence, San Antonio, Bexar County, Texas

Texas Antiquities Committee Permit Number: 6913

April 2015

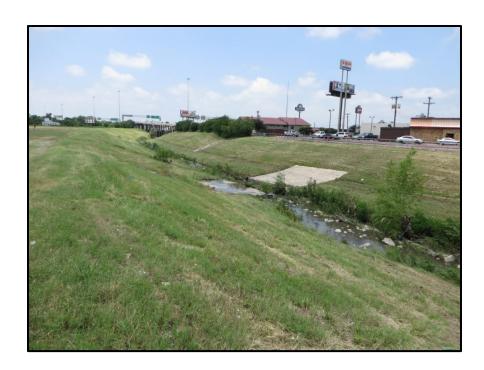
Figure 1-3. Graded San Pedro Creek banks south of FM 536 (South Alamo Street).

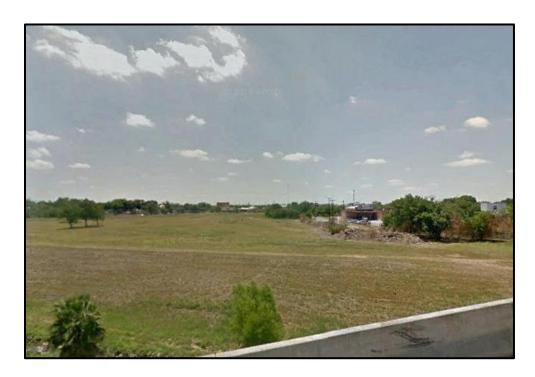
Figure 1-4. Terrace of San Pedro Creek in the vicinity of U.S. Interstate Highway 10, near the south terminus of project area.

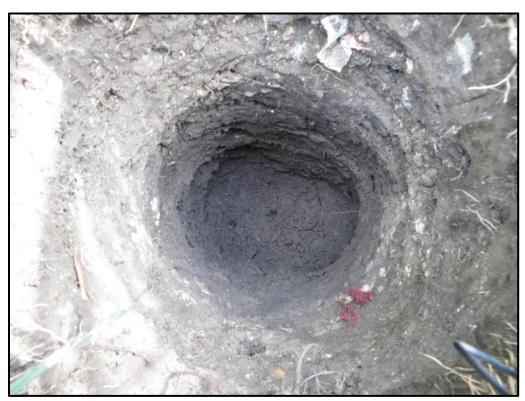
Figure 5-2. Photograph of Shovel Test 2.

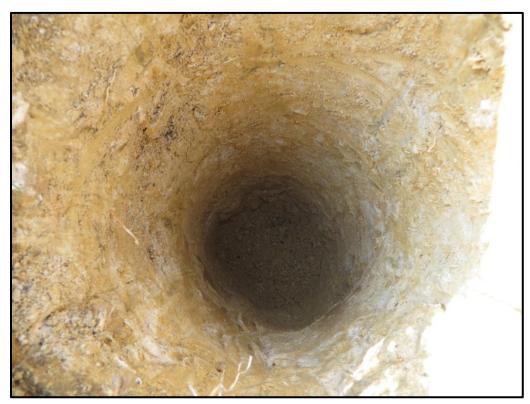
The soil of each of the shovel tests in this section of the APE differed greatly. Shovel Test 1 exhibited brown silty clay in the upper 20 cmbs. Level 3 (20-30 cmbs) was a transition zone, with yellowish brown silty clay. The remainder of the shovel test exhibited yellowish brown clay with varying percentages of gravels (10-35 percent). Shovel Test 2, which had the highest density of artifacts, exhibited dark brown silty clay in the upper 50 cm. The soil changed to dark gray silty clay which continued to a depth of 80 cmbs (Figure 5-2). Shovel Test 3 also exhibited dark brown silty clay in the upper 30 cm below surface. Level 4 (30-40 cmbs) transitioned to a dark brown silty clay that was moister than the upper levels. At Level 5 (40-50 cmbs) the matrix became brown silty clay with higher clay content than silt. Gravels increased at this level as well. The last two levels (60-76 cmbs) changed to pale brown caliche-like clay with very few gravels. Shovel Test 4 exhibited dark brown silty clay loam in the upper 10 cm. This layer capped yellow mottled clay (Figure 5-3).

Figure 5-3. Photograph of Shovel Test 4.

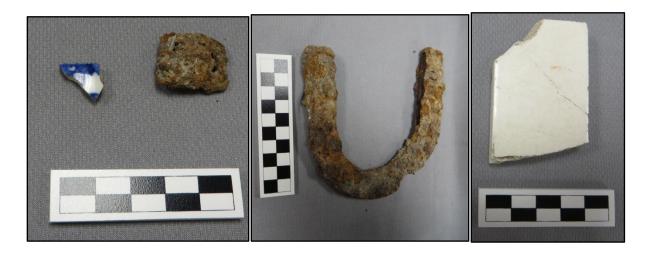
The majority of the artifacts consisted of glass, metal, and plastic. Shovel Test 2 produced the highest density of artifacts with 111 items collected. Plastic fragments comprised the largest number of the items (n=39) in the "Other" category and were recovered to a depth of 60 cm below surface (cmbs). Between 60 cmbs and 80 cmbs the "Other" category consisted of fragments of slag. Brick, concrete, and a fragment of granite were classified as "Construction Material." Of the seven fragments of ceramic, six were classified as undecorated white earthenware. One was a fragment of transferware. These ceramics have been manufactured over a long period of time, throughout the mid-century and into the 20th century (**Figure 5-4**). Glass fragments were recovered throughout Shovel Test 2. Ten of the twelve fragments were clear container glass. One fragment was clear flat glass and another was a fragment of brown container glass. These glass colors are typically associated with later dates. The personal items consisted of a metal belt buckle, a scarf fragment, and a button. The unidentified metal fragments comprised the largest portion of the metal category (n=16). In Shovel Test 2, one cut nail was recovered in Level 4 (30-40 cmbs). One horseshoe was recovered in Level 7 (60-70 cmbs).

Figure 5-4. Examples of potentially historic artifacts recovered during the survey (I-r: Transferware, buckle, horseshoe, undecorated white earthenware).

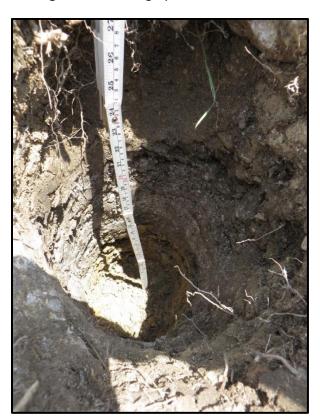
Figure 5-9. Photograph of Shovel Test 9.

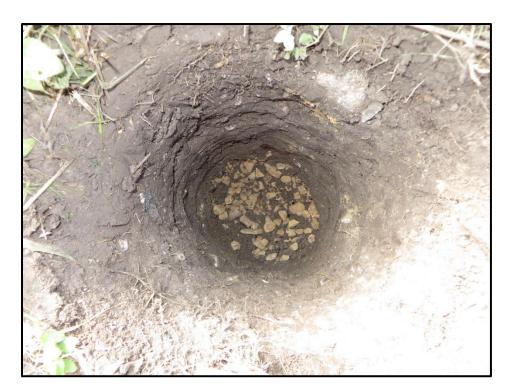
approximately 65 cmbs. In Level 8 (70-80 cmbs), the matrix consisted of 100 percent gravels (**Figure 5-10**). This gravel layer was not encountered in the other shovel tests.

Figure 5-10. Shovel Test 12 exhibiting the gravels encountered.
