Report for Archeological Survey

Dick Skinner Road at Tributary of
Neches River,

Polk County, Texas

CSJ: 0911-04-059

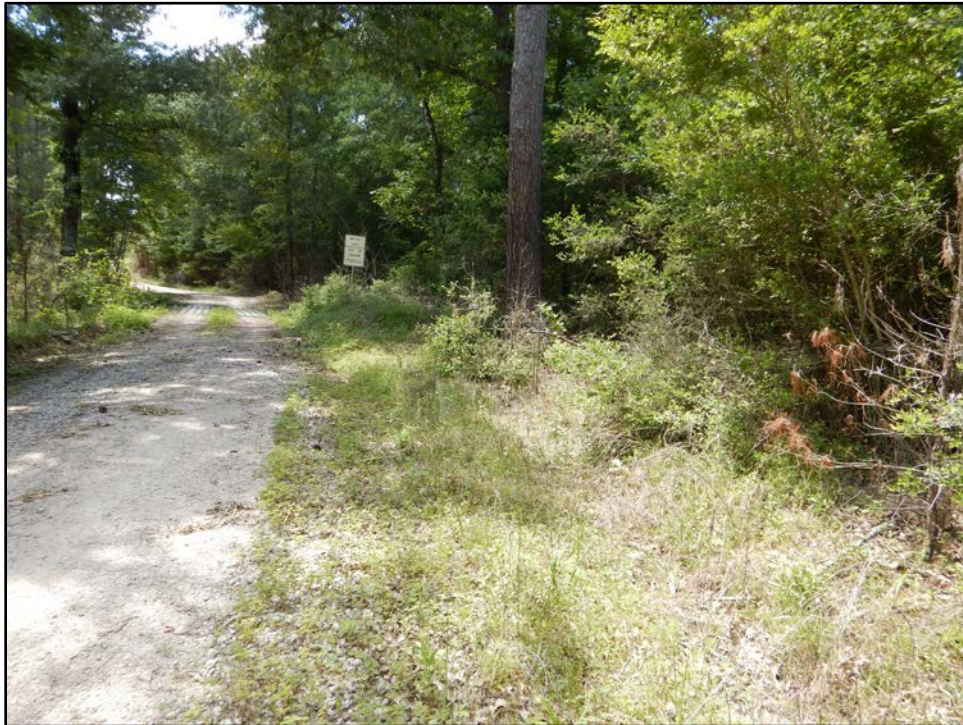
Figure 2. Photo of existing bridge (at the sign) and ROW facing east.

- **Topography:** The project area is situated on a rolling surface within the Interior Coastal Plains (Wermund 2012). These areas are characterized as hilly dissected uplands with geologic strata derived from recent unconsolidated sand and mud alluvium (Wermund 2012). The approaches on both banks cross alluvial terraces of the tributary, which extend beyond the limits of the project area. The approaches continue to be level for about 0.16 mile away (east) and 0.06 mile away (west) from the bridge, where it rises gradually in elevation 3 m (10 feet) (Figures 2 and 3).

- **Land Use:** Pine farms occupy the eastern quadrants surrounding the project area (see Figures 2 and 3). The western quadrants contain mixed piney woods for residences and hunting leases.
- **Vegetation:** The crossing contained few mixed grasses (10 percent) along the roadway in all quadrants. The drainage in all quadrants is bracketed by a young, mixed pine and hardwoods (50 percent), and an abundance of vines and shrubs (50 percent).
- **Estimated Ground Surface Visibility:** 0 percent.
- **Previous Investigations and Known Archeological Sites:** The background literature review determined that the APE has not been previously surveyed for cultural resources and no previously recorded archaeological sites are located adjacent to the current APE. In addition, there are no reported surveys and no recorded cultural resources within a 1-kilometer radius of the APE.

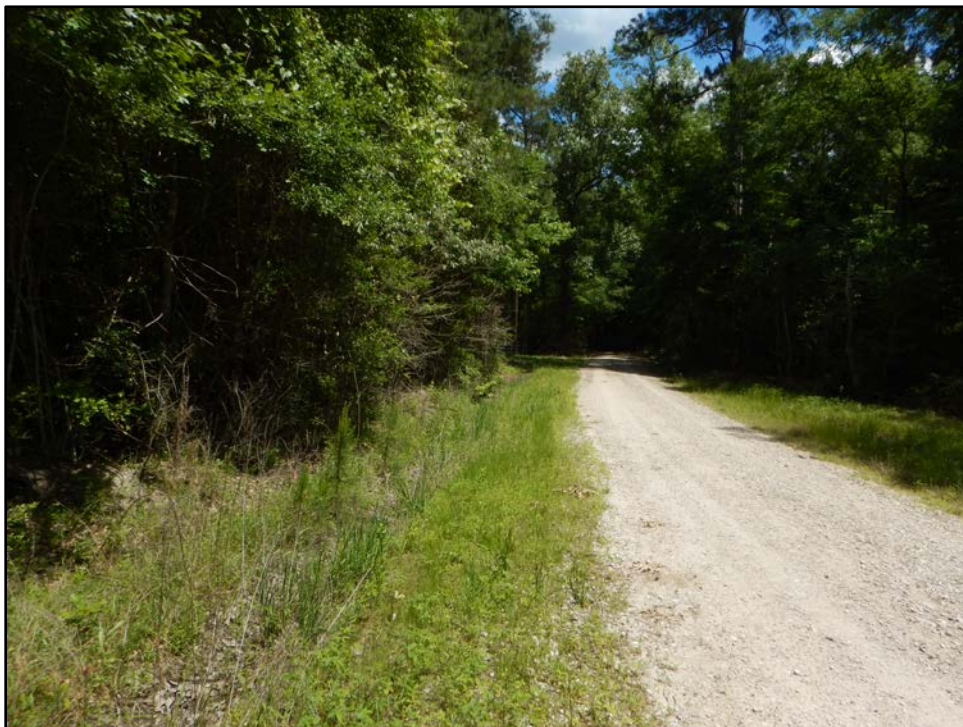
Figure 3. Photo of approach to bridge facing west showing gradually sloping landform.

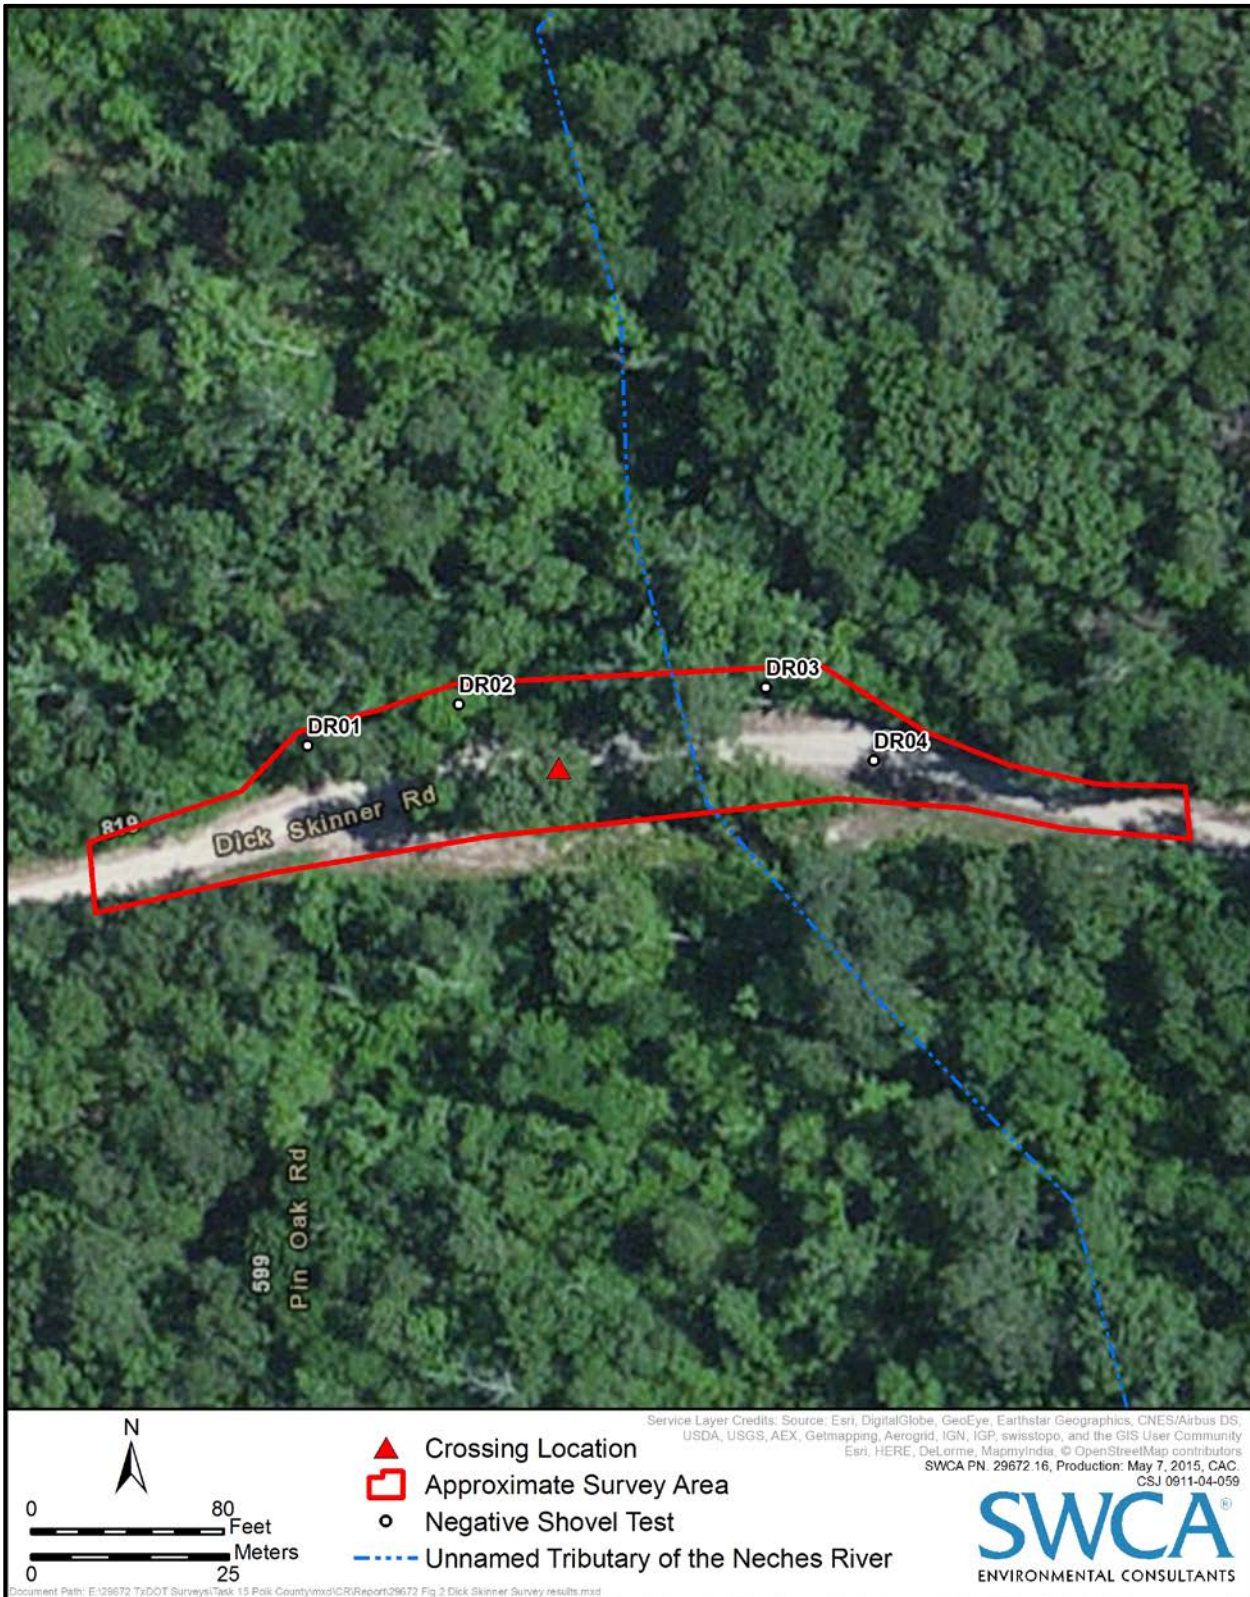
Figure 5. Results of investigation.

As mentioned above, two shovel tests were excavated on each side of the tributary, for a total of four (Figure 5; Table 1). These shovel tests were placed north of the existing road, near the fence line, but still within the existing TxDOT ROW. These areas were on the boundary of mixed woods with dense secondary brush. Disturbance from previous bridge construction, such as push piles, and modern trash within the erosional drainages to the tributary were observed within the area.
