**AN ARCHAEOLOGICAL SURVEY FOR THE CITY OF TEMPLE
RECYCLING AND DISPOSAL FACILITY EXPANSION PROJECT
IN BELL COUNTY, TEXAS**

Texas Antiquities Permit No.7143

***Ed Baxter Consulting
Archaeological Report 2015-01***

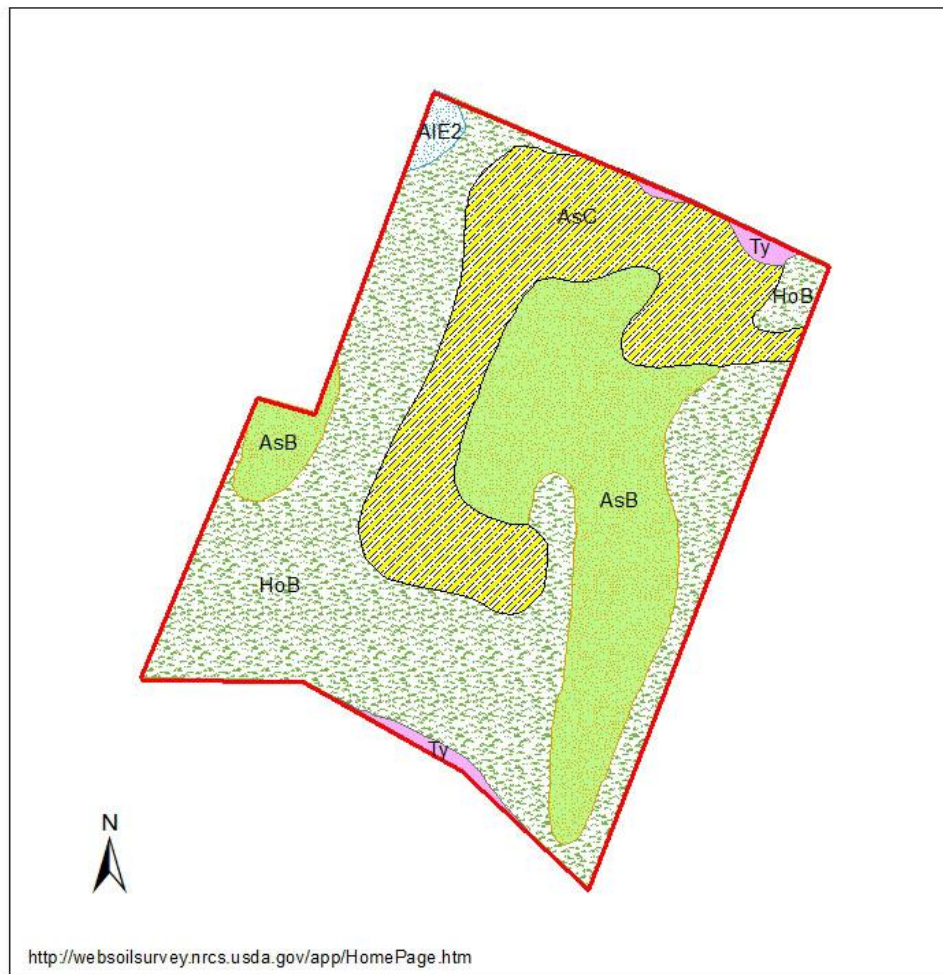
Figure 4. Project Area Soils

AsC Austin silty clay, 3 to 5 percent slopes, is found on ridges, the parent material is Residuum weathered from chalk. The typical profile is H1 - 0 to 14 inches: silty clay, H2 - 14 to 29 inches: silty clay, and H3 - 29 to 80 inches: bedrock.

HoB, Houston Black clay, 1 to 3 percent slopes, is found on ridges, the parent material is clayey residuum weathered from calcareous mudstone of upper cretaceous age. The typical profile is Ap - 0 to 6 inches: clay, Bkss - 6 to 70 inches: clay, BCKss - 70 to 80 inches: clay.

Ty, Tinn clay, 0 to 1 percent slopes, frequently flooded is found on flood plains, the parent material is clayey alluvium of Holocene age derived from mixed sources. The typical profile is H1 - 0 to 6 inches: clay, H2 - 6 to 72 inches: clay, H3 - 72 to 80 inches: clay,

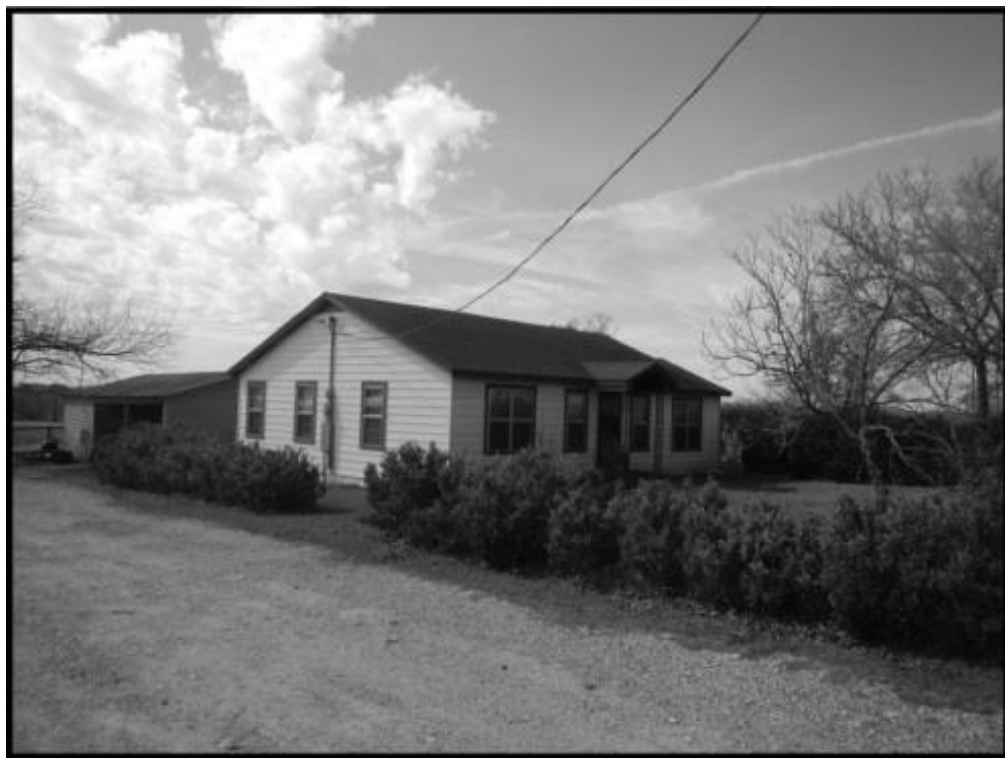
Figure 9. View of 1947 House Facing Southwest

A historic house built in 1947 and moved to the project area in 1985 was found between sites 41BL1386, and 41BL1387. The owner stated he moved the house there after he purchased the land. The house is a rectangular structure with a shingled gable roof and has modern siding. Consultation with the THC (personal communication William Martin 1-21-2015) resulted in the recommendation that whereas the house was historic, it was not a recordable historic and a photograph of the site would provide sufficient documentation (Figure 9).

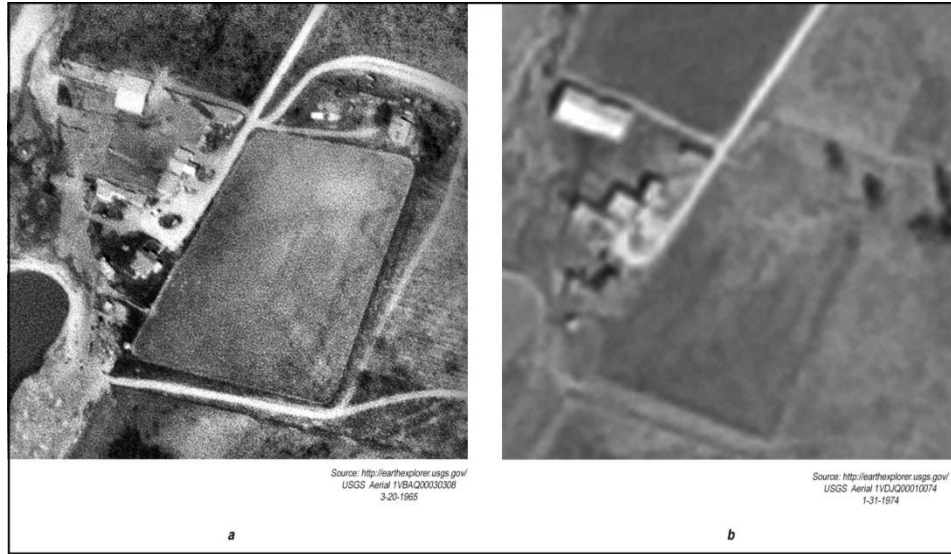
Figure 10. Historic Aerial Photographs of Site 41BL1384

Three historic aerial photographs dated 1964, 1965 (Figure 10a) and 1974 (Figure 10b) show that the farmstead was comprised of two residences and a dairy operation. The site map (Figure 11) shows the location of these features. The features are labeled "a" through "n" for identification in the descriptions.

The historic house (a) was not found during the field investigation. The aerials show it to have been located approximately 80 meters (262 feet) east of the dairy complex. A 1964 aerial photograph shows that it was a square building and had a gable roof and a shed roofed porch addition on the west side. According to information obtained from a nearby landowner, Johnny Herring (Personal Communication, 2-2-15), the historic house (a) burned in the early 1970's and was replaced in 1978 by a newer brick home. The former landowner Tom Hamff (Personal Communication, 1-27-15) built the new house in the immediate vicinity of the older house and said he has never seen any sign of the previous structure. The second residence (k) was in closer proximity to the dairy operation and lies 25 meters (82 feet) to the south. The 1964 and 1965 aerial photographs show the house to have been a rectangular house with a gable roof with a small roofed porch along the north elevation. A rectangular addition is shown on the south side of the house. The house is now in ruins with only a few partial walls standing (Figure 12a & 12b). It was a frame structure with horizontal 1x6 inch wood siding covered with 1950's asbestos siding. Overall maximum dimensions of the house are 45 feet N-S and 35 feet E-W. There is a septic depression (m) south of the house.

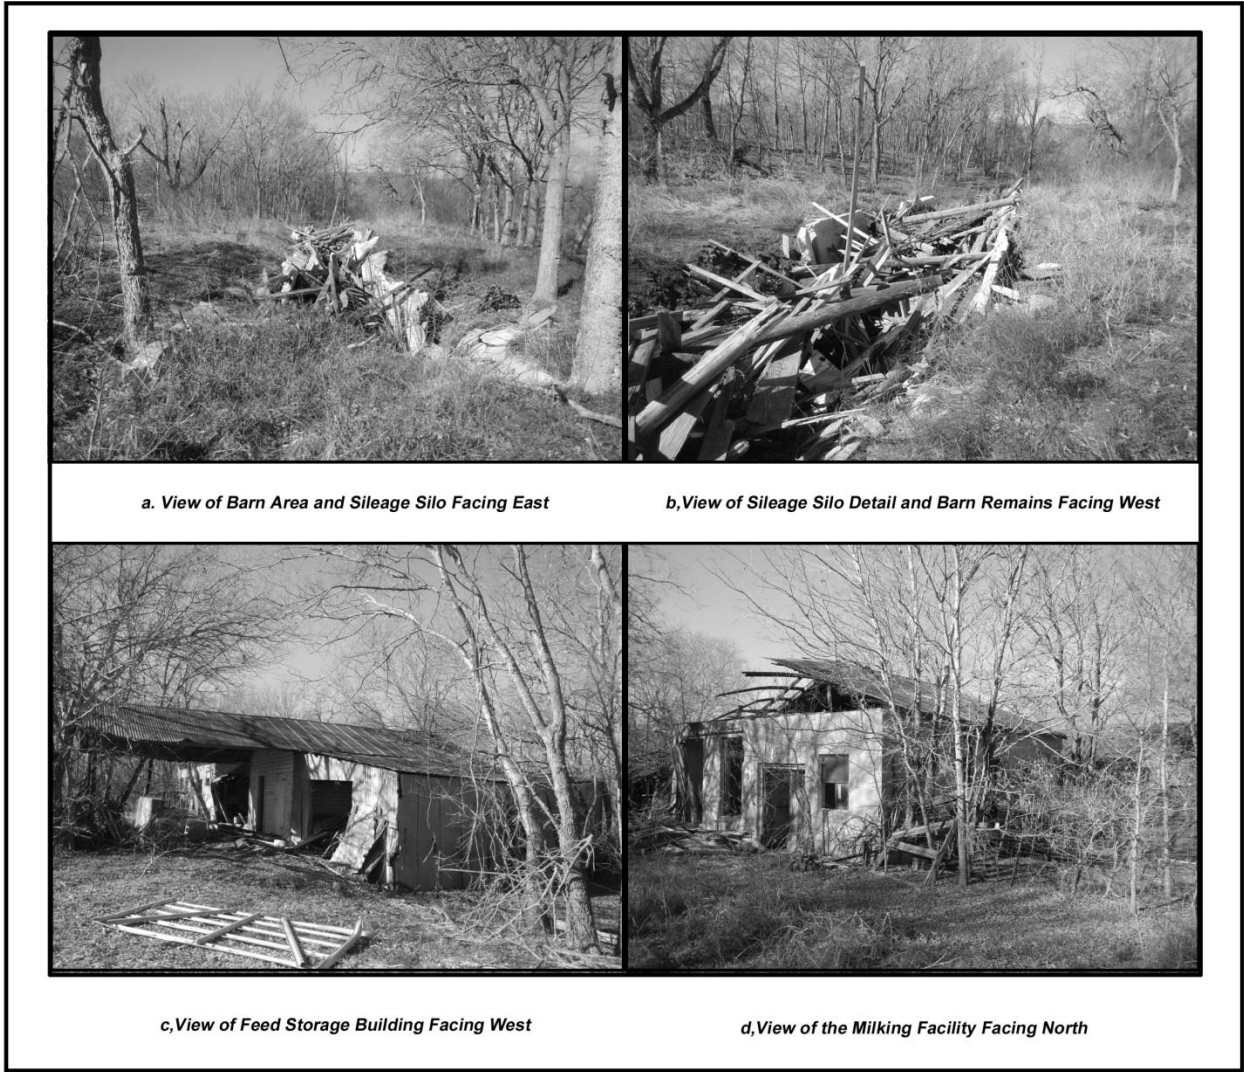
Figure 13. 41BL1384, Views of the Dairy Barn, Feed Storage Building, and Milk House

The dairy complex consisted of a calf pen with a covered roof section (b), a dairy barn with an underground silo for silage storage (c), and a complex of buildings devoted to the milking operation and storage (d through i). These buildings represent two separate eras of the milking operation. They are similar to dairy operation plans presented in a publication entitled “Dairy Barn and Milk House Arrangement” (Frandsen and Nevens, 1919).

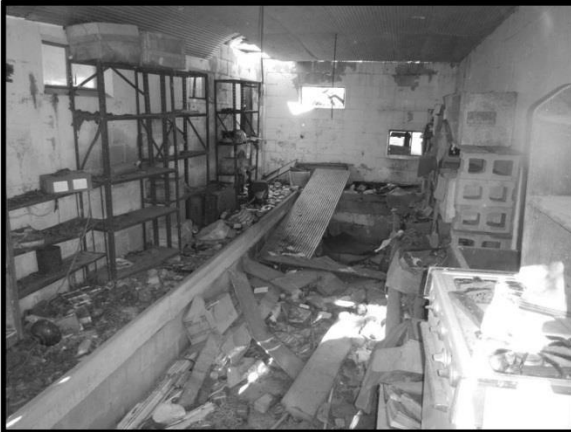
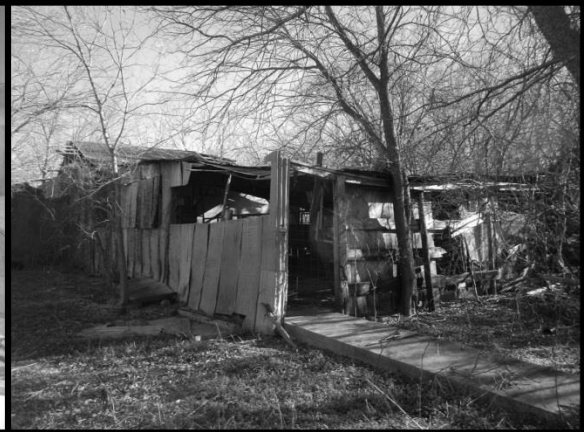
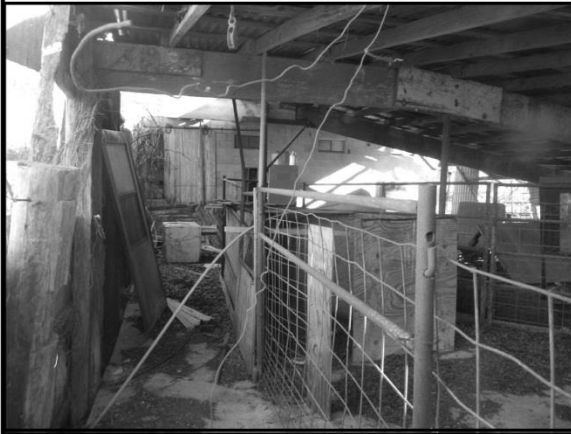
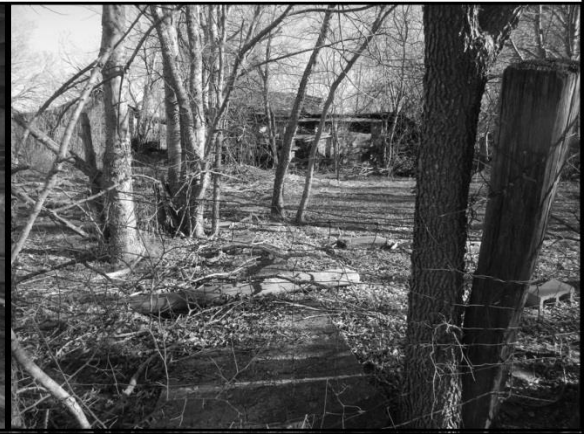
Figure 14. 41BL1384, Views of the Milking Room and Covered Cattle Pen

a. View of Milking Room Interior Facing North.

b. View of Covered Cattle Pen and Walkway Facing East

c. View of Covered Pen Interior Facing East

d. View of Covered Cattle Pen and Walkway Facing Northeast

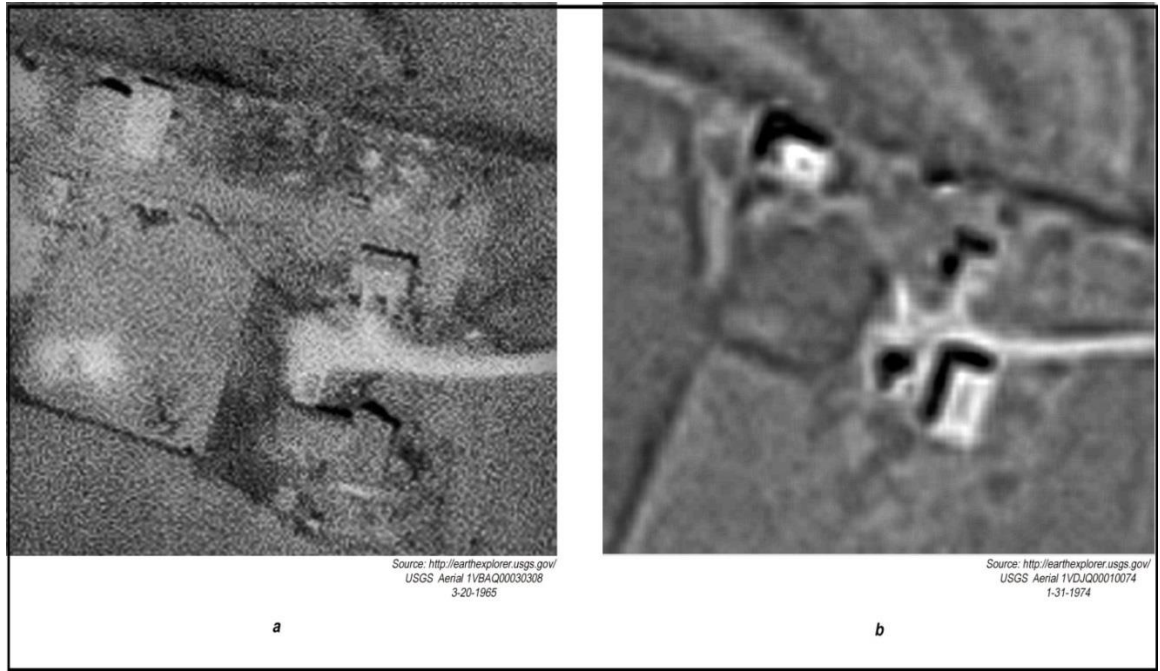
Figure 16. Historic Aerial Photographs of Site 41BL1385

Historic aerial photographs dated 1965 (Figure 16a) and 1974 (Figure 16b) show that the farmstead was comprised of an L-shaped house with a gable roof, a rectangular garage with a gable roof and a rectangular barn with attached cow pen. The site map (Figure 17) shows the location these features. The features are labeled “a” through “g” for identification in the

The history of the area dates 41BL1385 from the late 19th century to the mid-20th century. Since no 19th century historic artifacts were observed during the site inspection, the building construction techniques fall within the early 20th century and the amount of structure destruction and decay it is recommended that the site does not meet the criteria for inclusion on the National Register of Historic Places, 36 CFR Part 60.4d. It has not yielded nor is it likely to yield information important to history or prehistory.

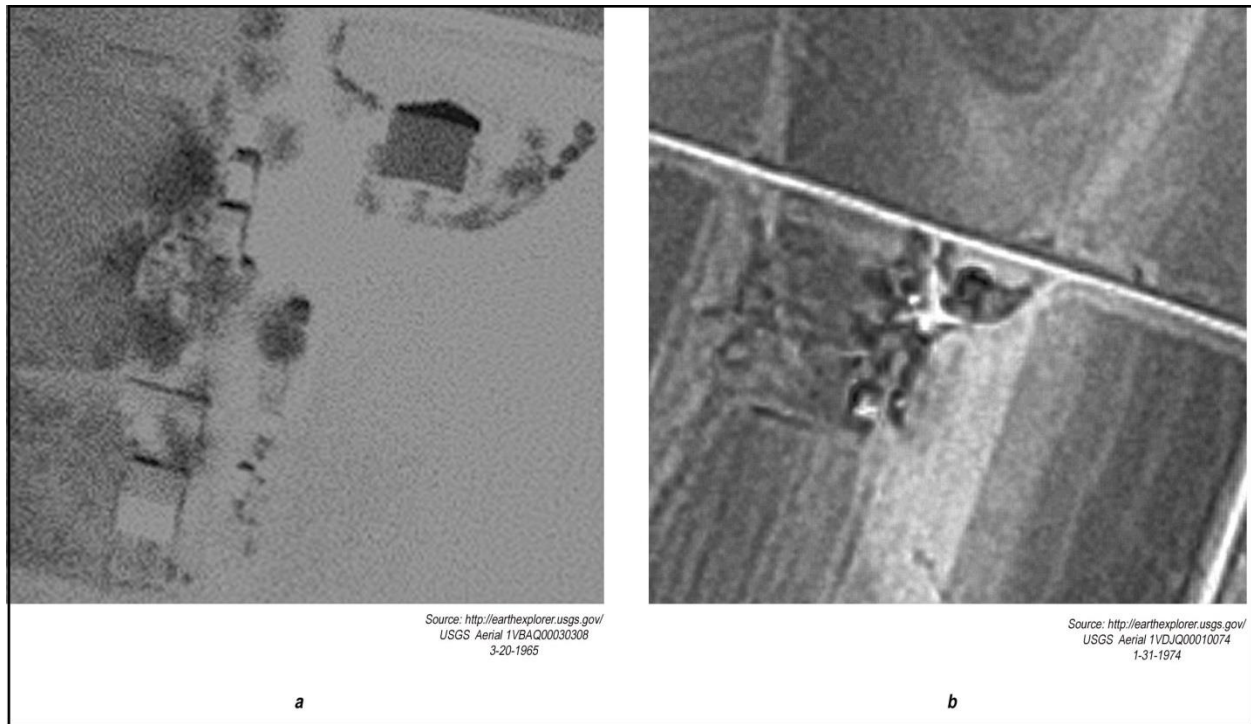
Figure 20. Historic Aerial Photographs of Site 41BL1386

Historic aerial photographs dated 1965 and 1974 (Figure 20a, & 20b) show that the farmstead was comprised of a house, smokehouse with attached hog pen, barn, cattle feed lot, feed shed, and a small shed. The site map (Figure 21) shows the location these features. The features are labeled “a” through “h” for identification in the descriptions. The historic house (a), smokehouse with attached hog pen (b), cattle pen (e), and barn (f), are no longer there. These structures were torn down in the 1970’s by Johnny Herring, the previous landowner (Personal Communication, 2-2-15). Mr. Herring stated that the house was constructed of 4x4 inch and 2x6 inch lumber with board and batten walls constructed with square and wire nails. The house also had a front porch, loft and breezeway. The 1965 aerial shows the house faced the road to the Northeast and had a tin covered gable roof. The barn consisted of pole barn and sided with vertical 1x12 inch boards. A modern shed now sets at the old barn location.

The history of the area dates 41BL1386 from the late 19th century to the mid-20th century. No 19th century historic artifacts were observed during the site inspection; however the reported presence of square nails and building construction techniques of the house that was destroyed may date the site to the late 19th Century. The building construction techniques of the remaining buildings fall within the early 20th century. Due to the amount of structure destruction and decay it is recommended that the site does not meet the criteria for inclusion on the National Register of Historic Places, 36 CFR Part 60.4d. It has not yielded nor is it likely to yield information important to history or prehistory.
