Report for Archeological Survey

CSJ 0923-06-056, CR 225 at Clear Creek
Brown County, Brownwood District

Jon Budd - Principal Investigator, Antiquities Permit No. 7536

February 3, 2016

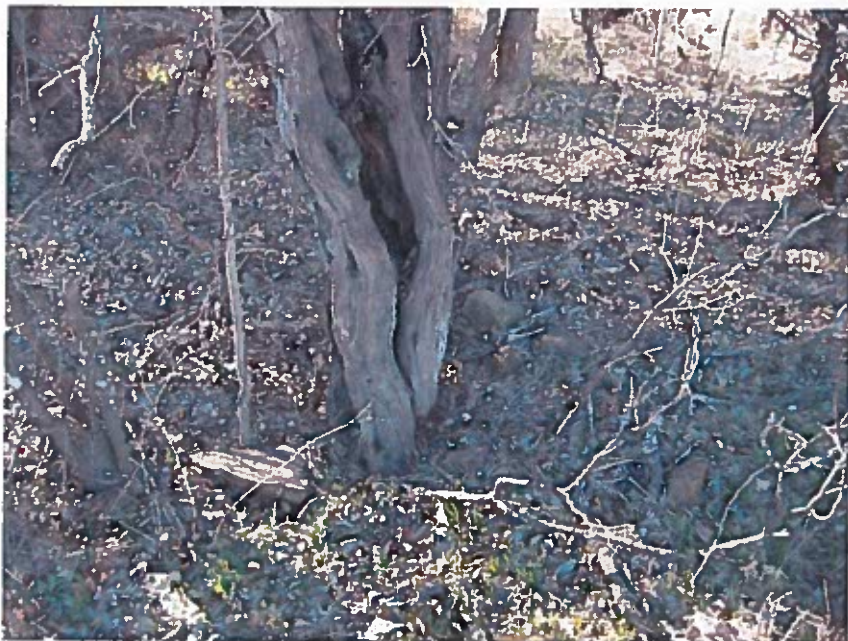
Photo 2: Facing west just beyond the limestone slab noted above. Note the old oak tree and smaller limestone cobbles. GAT #1 was placed here to investigate whether these marked a gravesite.

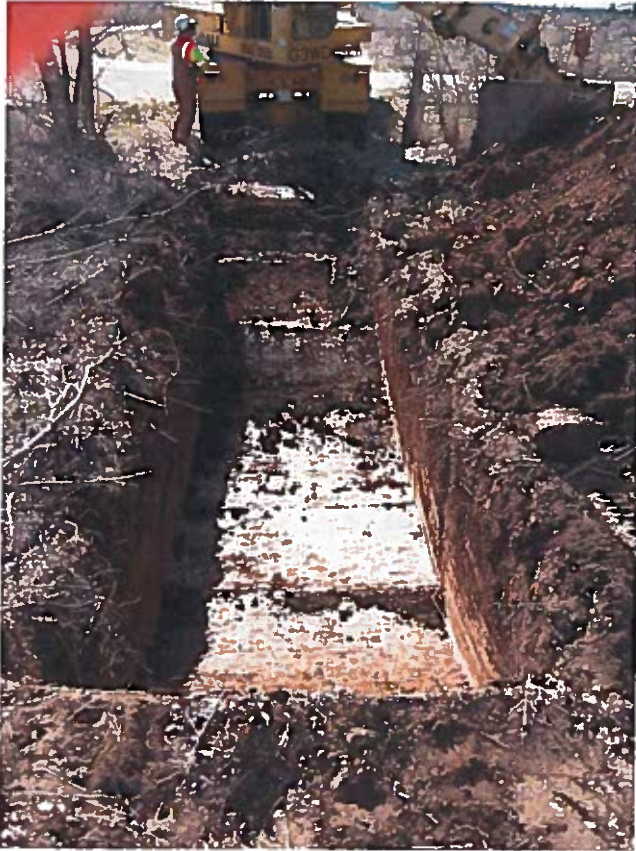
Photo 6: Facing west towards GAT #3 in process. It was also negative for archeological remains.
