Negative Findings Report Cultural Resource Survey

Comanche Trail Pipeline, LLC.

San Elizario Crossing FERC Regulated Area El Paso County, Texas

Technical Report 298
July 2015

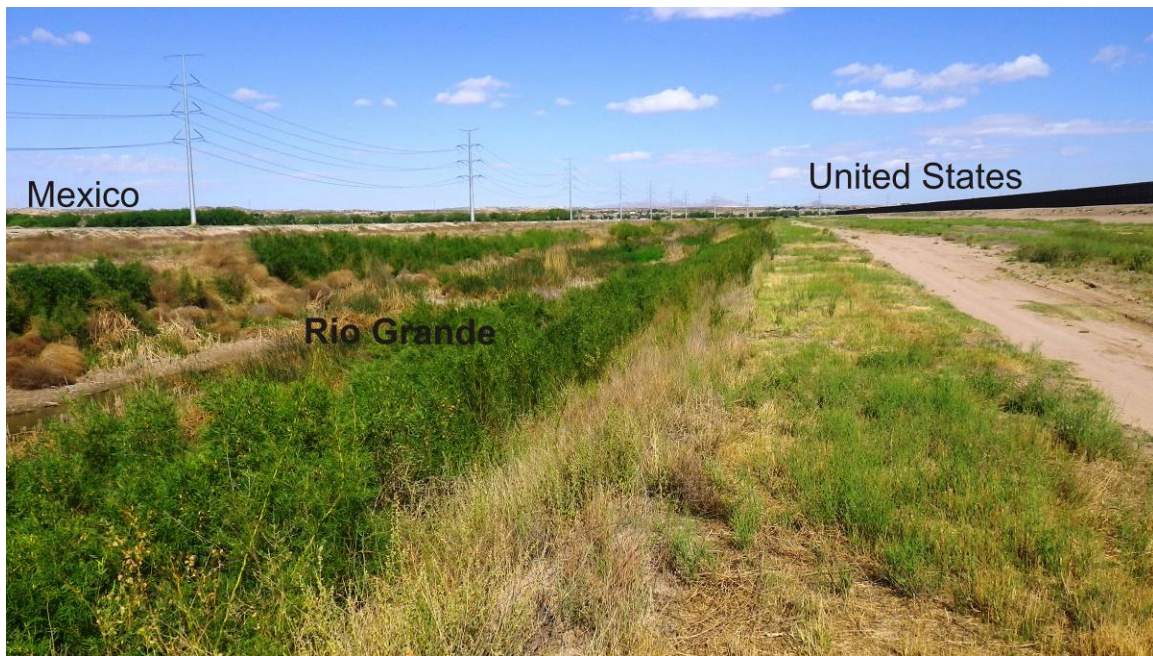
Figure 7. Photo of Rio Grande from pipeline crossing looking northwest.

Topography is level at 3,631 feet above mean sea level (amsl), only dipping at the Rio Grande channel, which has been straightened and modified. At the

proposed crossing, the Rio Grande is little more than a channelized drainage ditch. The river was dry and easily crossable (Figure 7).

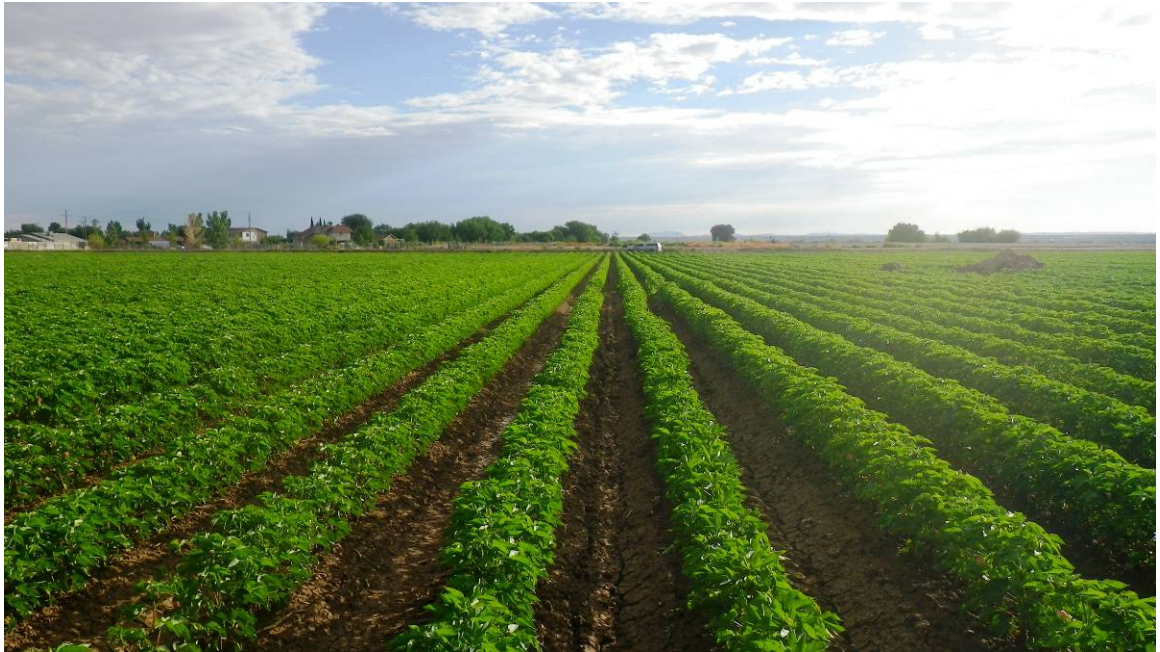
Figure A-6. Overview of planted cotton field where trenches were dug, looking north from Trench 2. Note Trench 1 in the distance to the right.

The trenches were dug in an agricultural field that has been row planted for decades, mixing the upper 30 cmbs of soil into homogenous brown clay devoid of stratification (Fig. A-3). Current trenching found silty clay over fine sand indicating that the Ap horizon has been removed or altered in the last 45 years, leaving only the C1 and C2 horizons relatively intact.

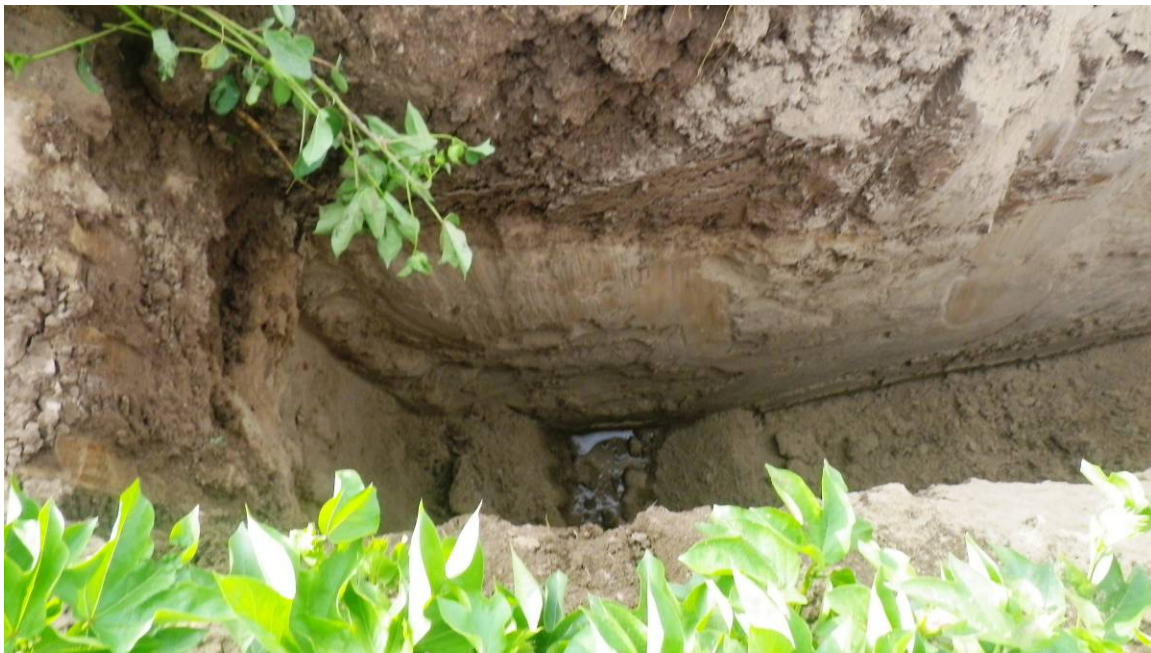
Figure A-9. Water table at the bottom of Trench 1.

Trench 1 was dug along a 200 degree (magnetic) trajectory following the planted cotton rows. The trench was 15.5 m in length by 2.4 m in depth by 65 cm wide, with a safety step along the west side (Fig. A-4). The trench revealed 10YR 3/3 dark brown clay ranging in depth from 55-110 cmbs over 10YR 6/3 pale brown silty sand with layers of lamellae dispersed throughout (Fig. A-5). The water table was encountered at the bottom of the trench at 240 cmbs (Fig. A-6). The upper stratification of soil was a homogenous layer of dense, blocky clay with very minute amounts of small gravel and roots. No other inclusions were identified. The sub-layer of silty sand was laid down in countless thin, stratified levels created from multiple floods of the Rio Grande. This section was devoid of gravel or roots. Several lenses of darker silty clay lamellae were scattered throughout this zone (see Fig. A-5 and Fig. A-9). No archeological material was identified.

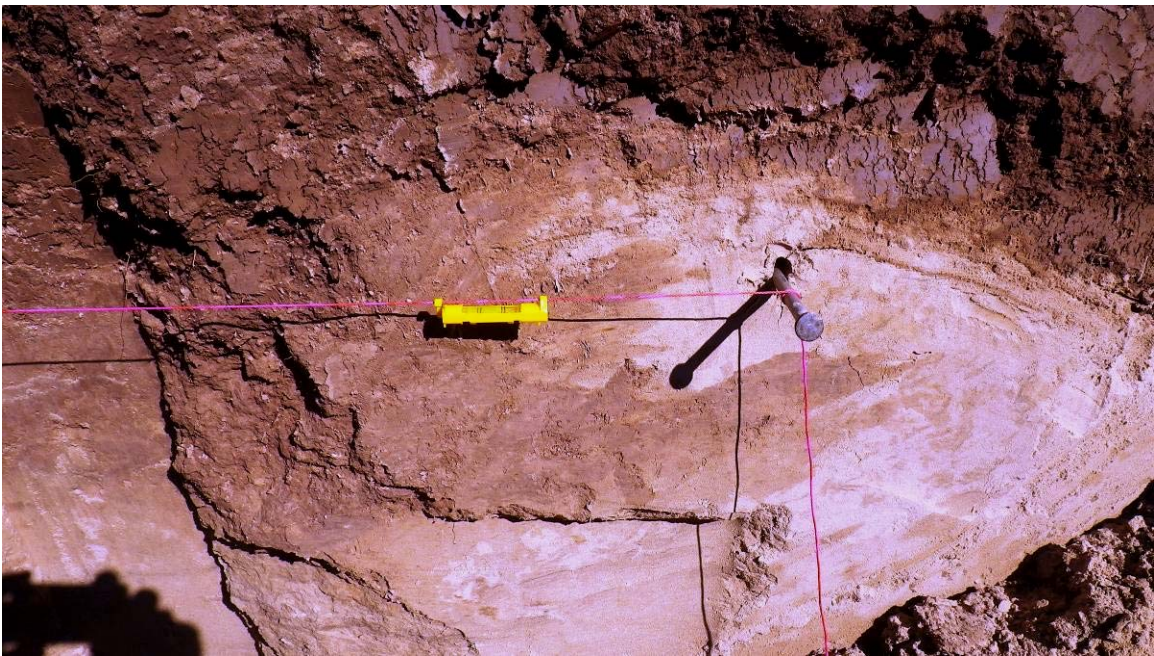
Figure A-13. Rodent burrow near intersection of Zones I and II, west wall Trench 2 - approximately 40 cmbs.

multiple floods of the Rio Grande. This section was devoid of gravel or roots. Several burrows were evident near the convergence of the two stratigraphic zones (Fig. A-10). No archeological material was identified.
